# Environmental and Social Monitoring Report

#4 Semiannual Report (October 2018 to March 2019)  
June 2019

## Maldives: Kulhudhuffushi Harbour Expansion Project

Prepared by Ministry of National Planning & Infrastructure for the Government of Maldives and the Asian Development Bank

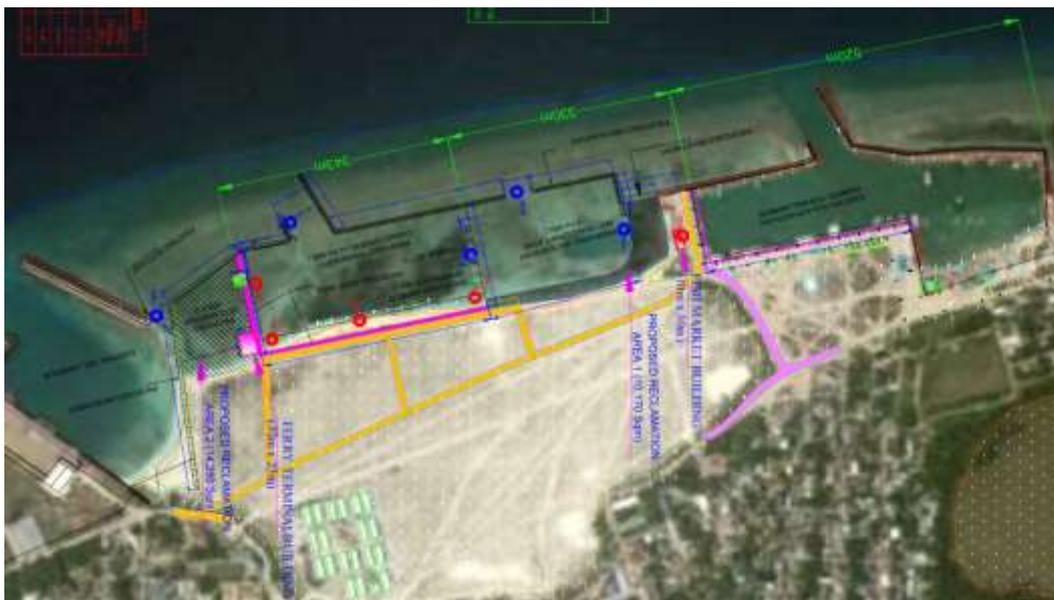
**Kulhudhuffushi Harbour Expansion Layout**

4. The Government of Maldives has applied for a grant from ADB for the Kulhudhuffushi Harbour Expansion Project and intends to apply a portion of proceeds to engage a consultant to support the Ministry of National Planning and Infrastructure in the project implementation process for development of Kulhudhuffushi Harbour Expansion Project.
5. Following is the harbour layout of the Kulhudhuffushi Harbour Expansion Project:

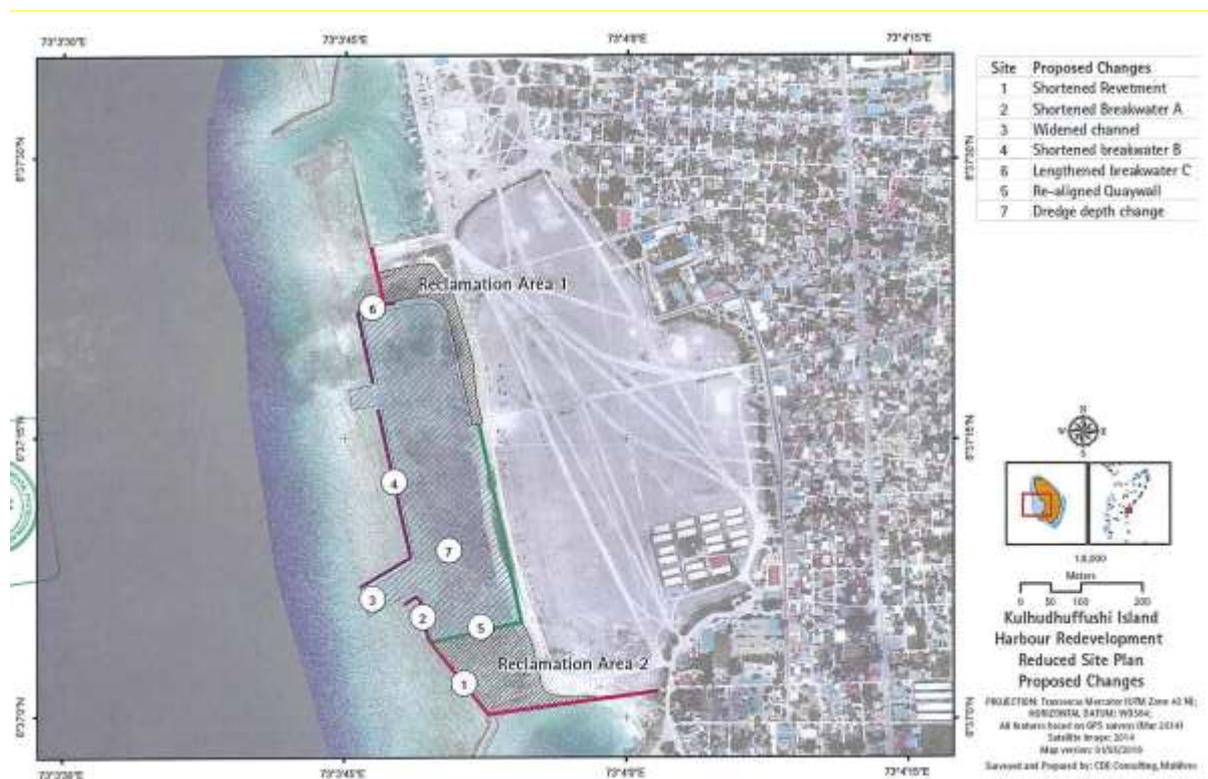
- i) Increasing the channel width from 30m to 56m;
- ii) Construction of a 136m new quay wall perpendicular to the shoreline with a 20m ramp;
- iii) Reduction of breakwater length from 641m to 638m;
- iv) Reduction of revetment from 505m to 481m;
- v) Increasing dredge volume of harbour from 153,339m<sup>3</sup> to 216,663.80m<sup>3</sup>;
- vi) Expansion of Fish Market area from 15m by 10m to 31.2m by 11.1m;
- vii) Expansion of Terminal Building from 14m by 14m to 31.95m by 22.25m;
- viii) Removal of Fruit and Vegetable area from the plan; and
- ix) Removal of Ice Plant from the plan.

8. The following figure outlines these changes:
