# Environmental Monitoring Report

## SRI : Dry Zone Urban Water and Sanitation Project (DZUW&SP) – Mannar and Vavuniya Districts

# Environmental Management and Monitoring Report

For the period from January to June 2016

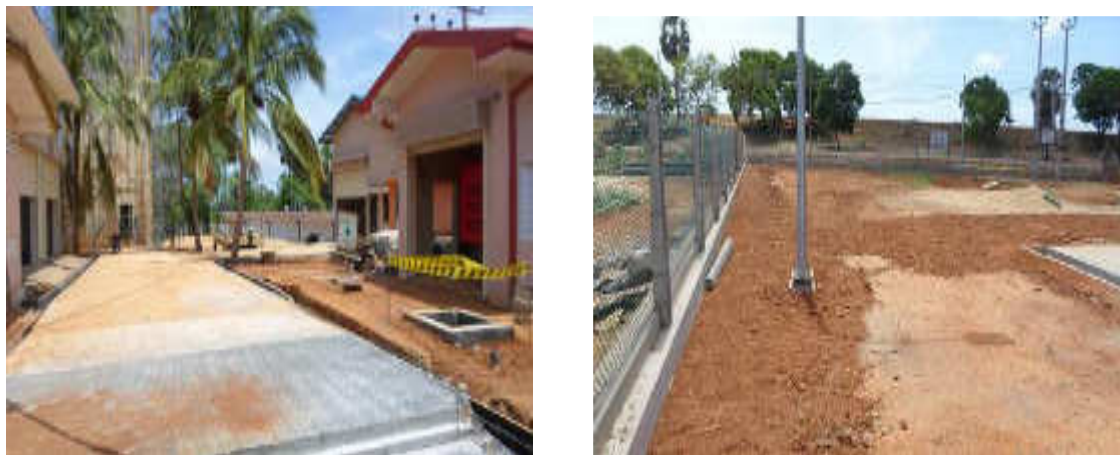
Figure 3.1. Site cleaning and landscaping works in progress at Murunkan site

Site landscaping was also done during the reporting period. Below figures taken at Murunkan and Eluthoor sites, presents the progress of landscaping in each subproject site.

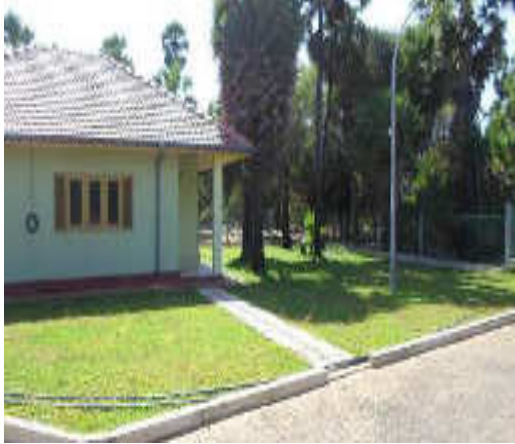
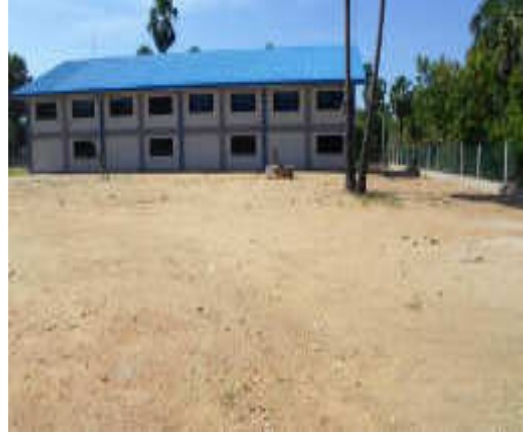
Figure 3.2. Site cleaning, turfing and site fencing works at Eluthoor site

As recommended the contractor will plant some shade trees at Eluthoor and Murunkan sites before they are handed over to Client. The same will be done at the intake and WTP at Vavuniya.

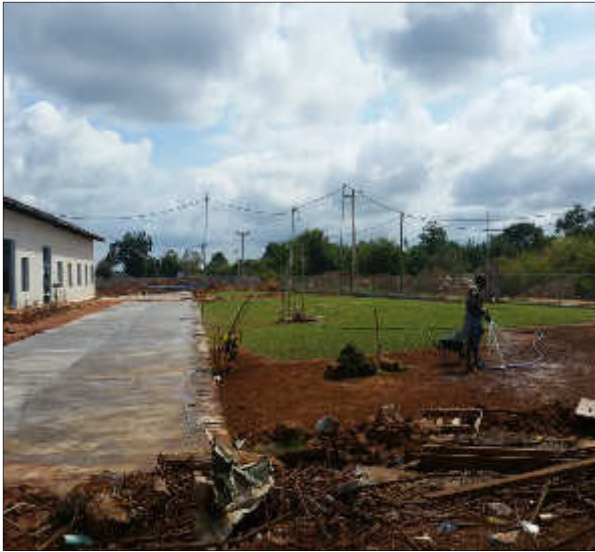
Figure 5.1. Watering the turfed area – WTP at Vavuniya

As per the results of table 2.3 it is observed that the dust fallout rate at both locations (L1 and L2) has exceeded the recommended level. Existing dry weather and earth backfilling operations at site during the measurement period could be considered as attributes to high rates of dust fallouts. Hence the contractor was instructed to increase the frequency of water spraying and haul/move earth after conditioned with water. However the dust fallout rates will be permanently reduced as the contractor has now commenced turfing and improving the ground cover within the WTP site.

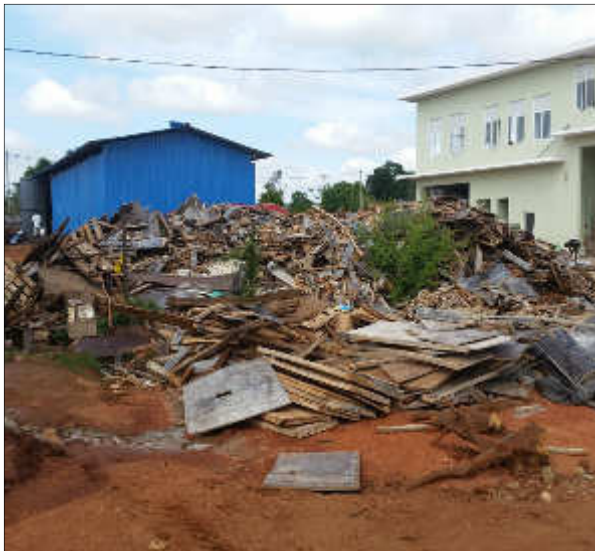
Figure 5.2. Construction debris collected to be removed – WTP at Vavuniya

Sites at Murunkan and Eluthoor are nearing completion and are in the process of site cleaning and landscaping as the major activities. All major construction works at the Water Treatment Plant in Vavuniya has also ended. Hence no major non-compliance issues were recorded during the reporting period. Below figures illustrate few good practices at Vavuniya water treatment plant.
