Environmental Monitoring Report

For the period covering July–December 2018
Project Number: 38412-023
June 2019

India: Assam Integrated Flood and Riverbank Erosion Risk Management Investment Program — Project 1

BI-ANNUAL REPORT ON IMPLEMENTATION OF EMP

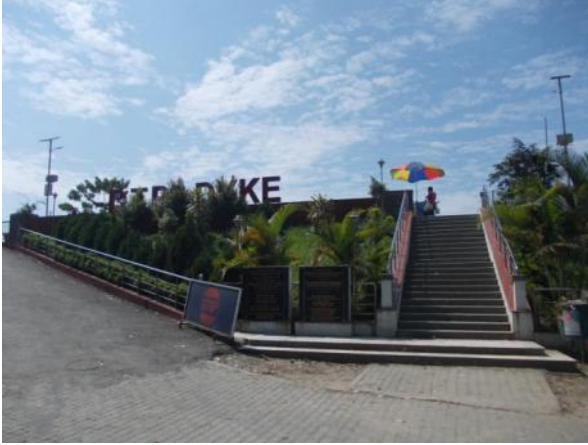
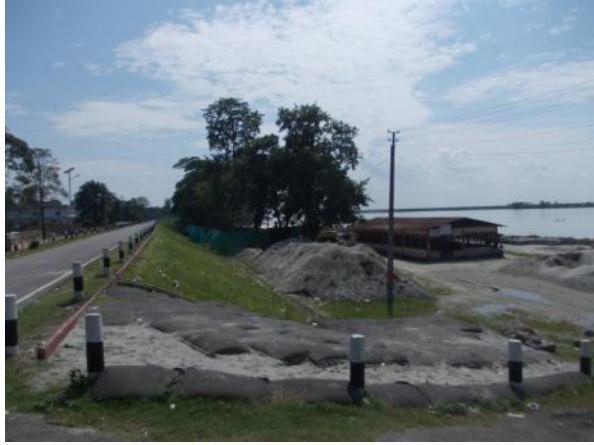
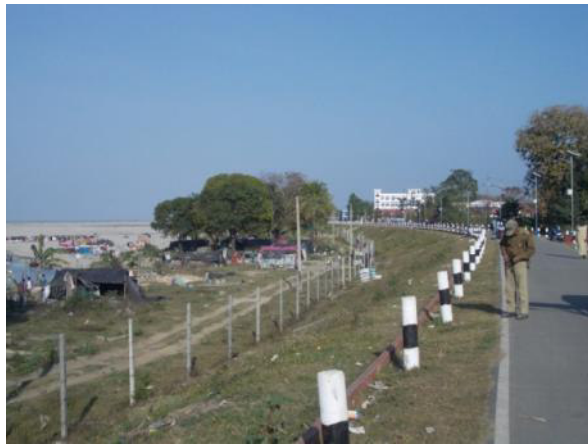
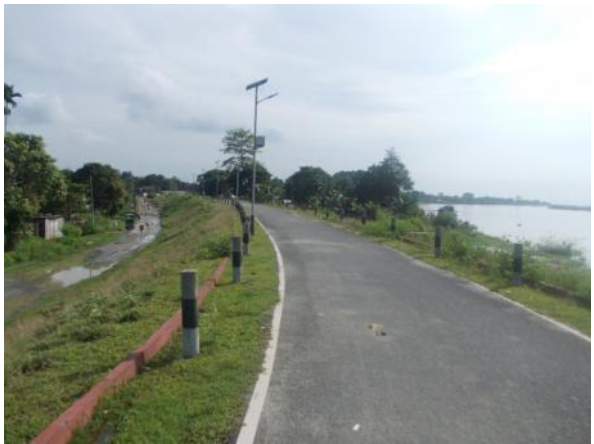
DTP Dyke

The overall condition of the embankment is good. No inundation occurred after completion of the embankment in all the three sites (Palasbari, Gumi and Dibrugarh).

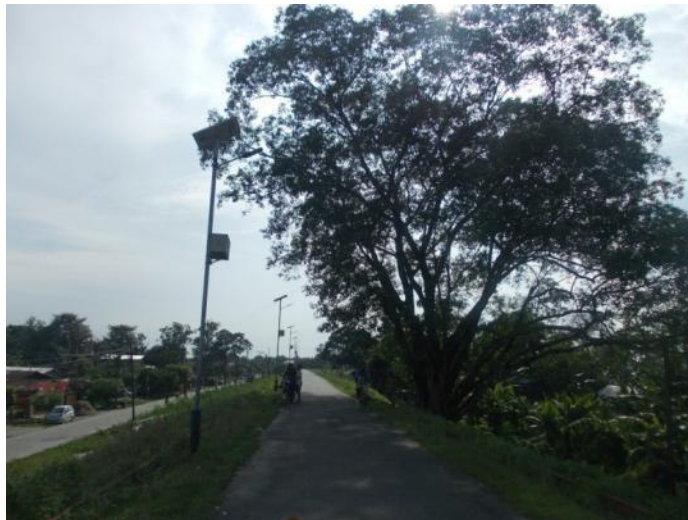
- **Pollution monitoring**
 - Air, Water and noise quality monitored till construction phase. Operation phase monitoring of ambient environment carried out in the month of June, 2018, remaining surface water monitoring were carried out in November, 2018.
- **Preservation of trees**
 - Protection of trees for their preservation.
Major trees near the embankment in Dibrugarh DTP Dyke (3 nos) were protected.

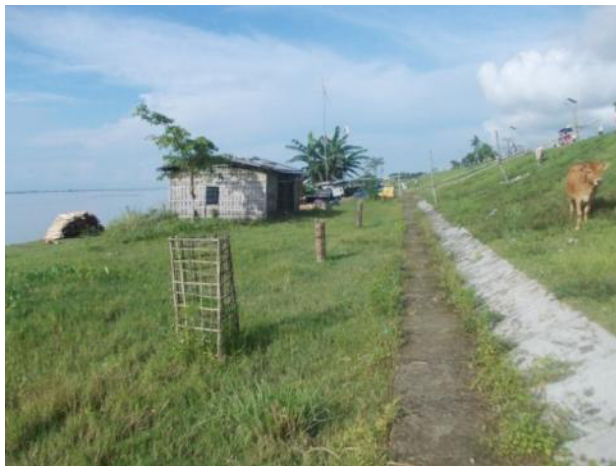
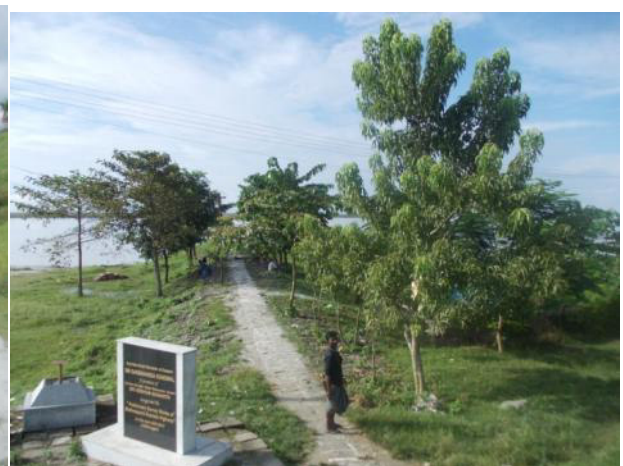
- Monitoring of the planted trees.
Survival rate of the planted trees are 80 %. More trees will be planted next monsoon.

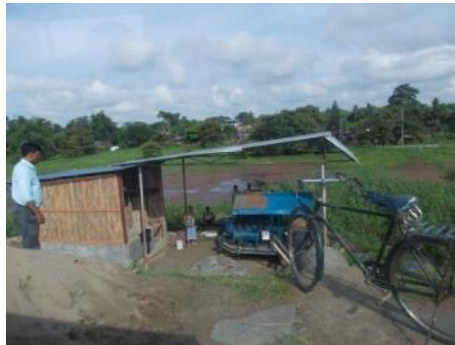
Monitoring the water pumps at Dibrugarh

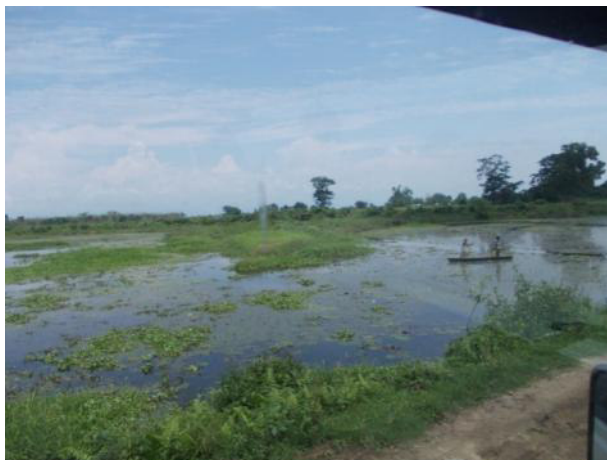
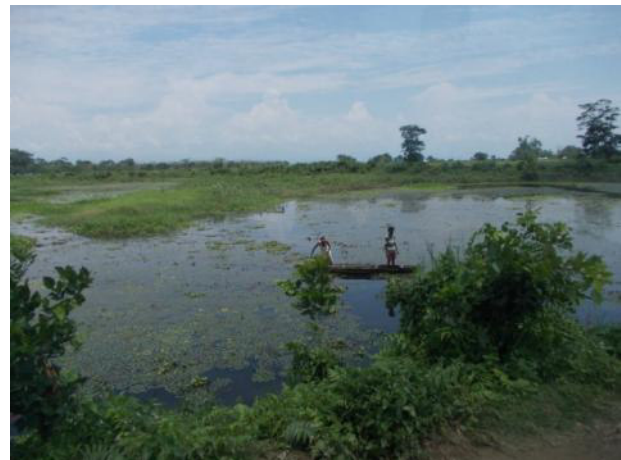
Fishing activities in Dibrugarh

- **Consultation with Fisherman in the Tranche-1 reach.**
During the field visit fisherman were interviewed. List of species found in the reach were recorded.

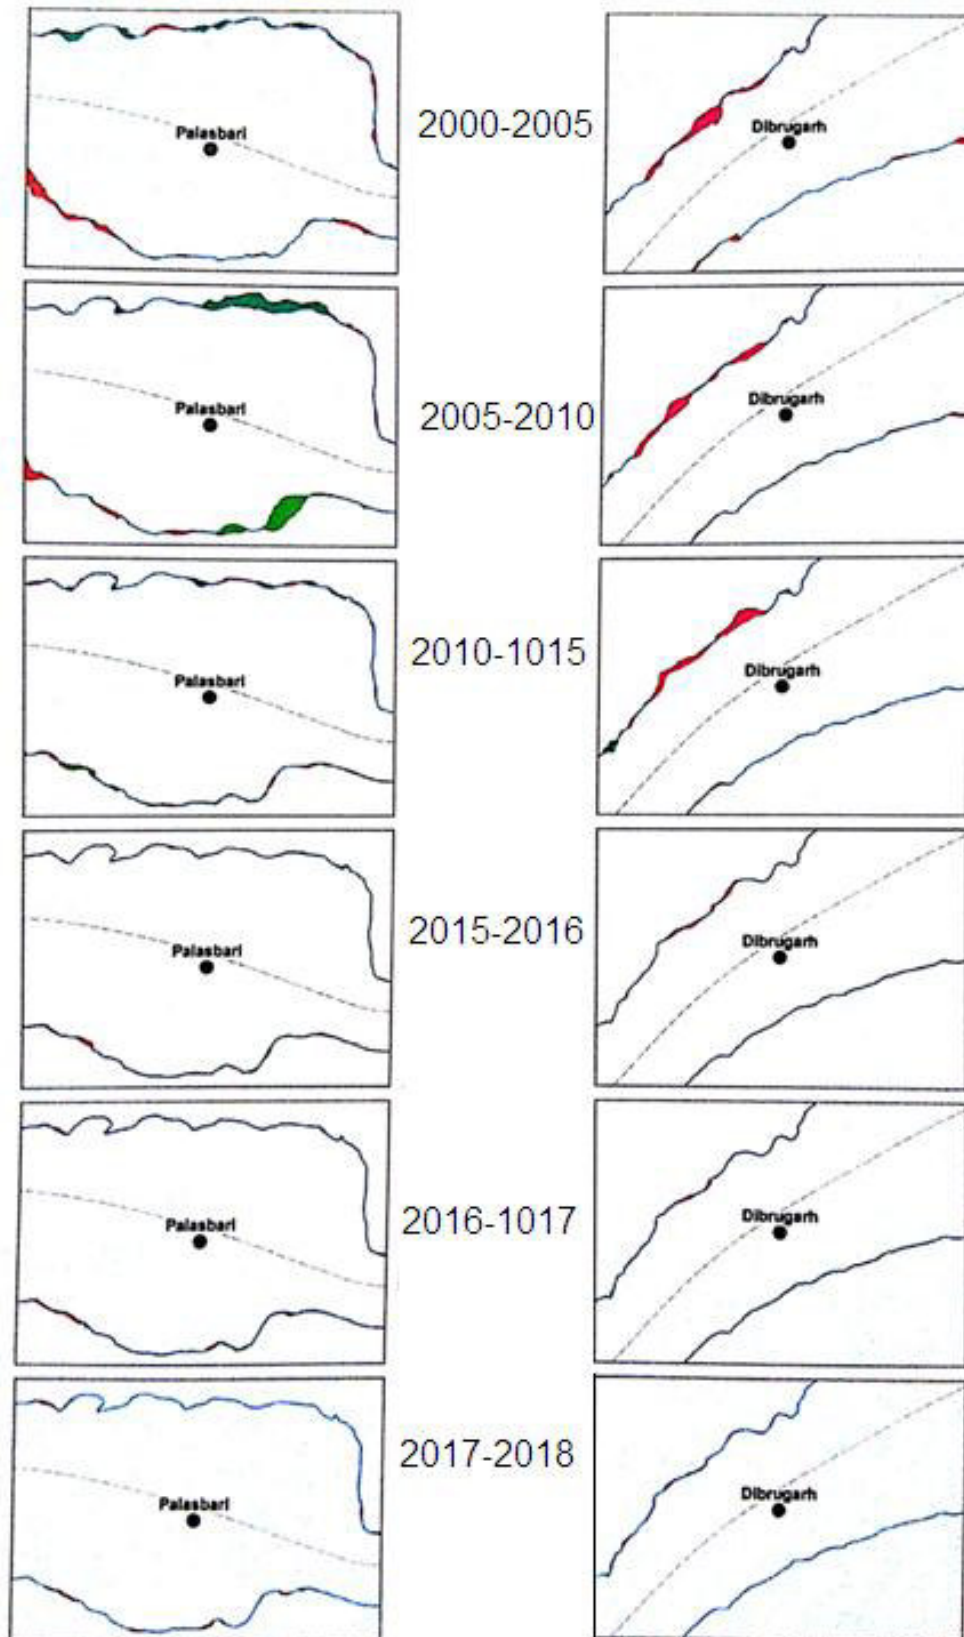
- Monitoring river bank line: (source DHI, FREMAA from satellite images)

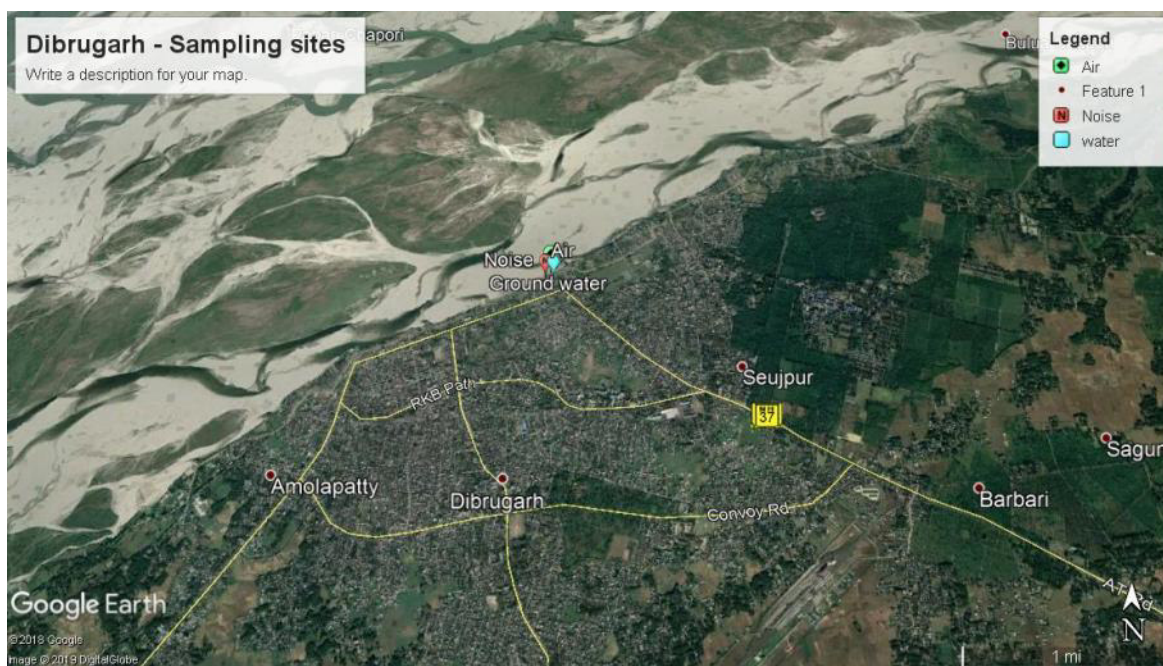
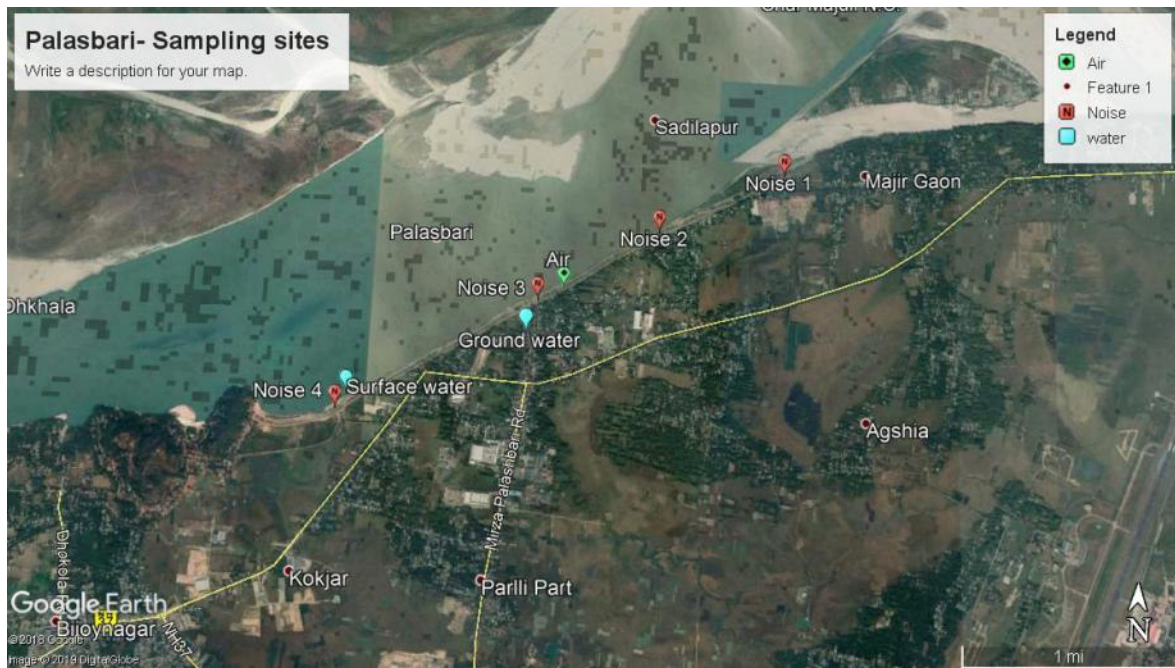
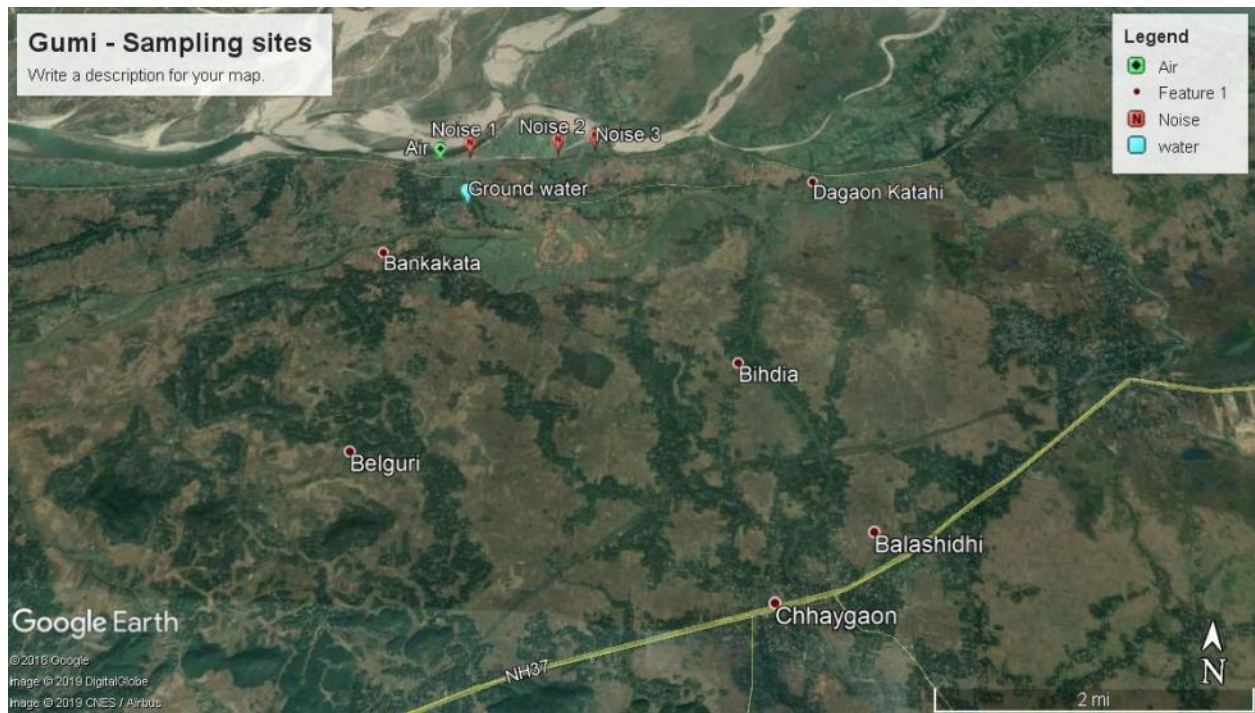
Test of ambient environment monitoring sites:

Explanatory comments
Ambient Environment condition	Good	<ul style="list-style-type: none"> • Operation phase monitoring performed in the month of June, 2018 and November 2018. • Air qualities are within prescribed limits of CPCB. • Noise levels are within the levels of Residential area and commercial area. • As the surface water at the site contains grease and oils less than 5 ml/l, it indicates that the users following the environmental norms prescribed to reduce water pollution. • For those site where the tests are being conducted in operation phase, the results are within the prescribed limits of the Central Pollution Control Board, MoEF&CC, GOI. • Other monitoring Hydrology, sediment flow, drain congestion, fish diversity, cropping pattern were monitored on regular basis.
