Environmental Monitoring Report

For the period covering January–June 2019
Project Number: 38412-023
September 2019

India: Assam Integrated Flood and Riverbank Erosion Risk Management Investment Program — Project 1

**Bi-Annual Report on Implementation of Environmental Management Plan
January 2019 to June 2019**

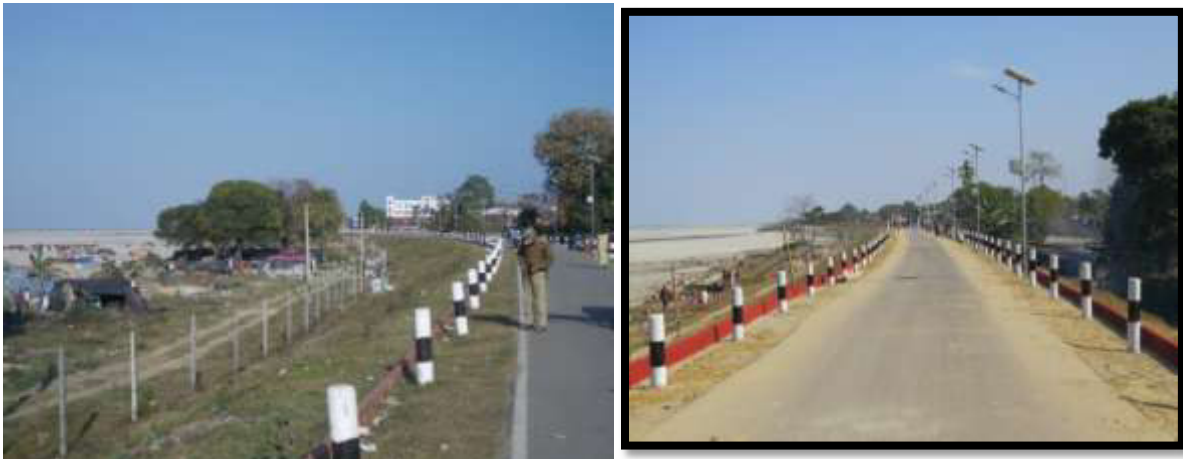
DTP Dyke

Condition of the embankment :

The overall condition of the embankment is good. No inundation occurred after completion of the embankment in all the three sites (Palasbari, Gumi and Dibrugarh).

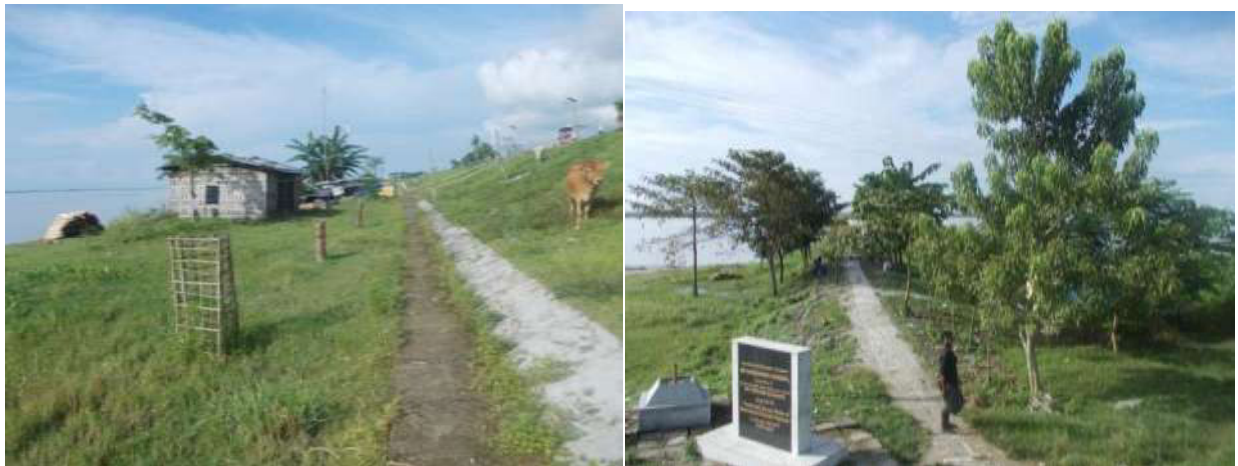
- Monitoring of the planted trees.
Survival rate of the planted trees are 80 %. More trees will be planted next monsoon.

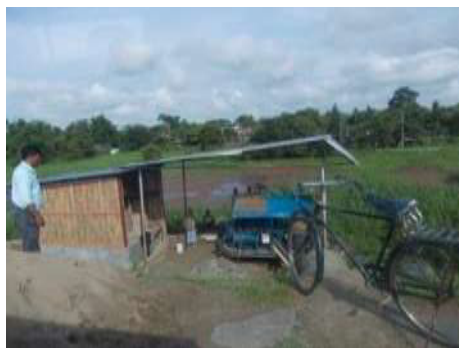
Monitoring the water pumps at Dibrugarh

- All **natural channels** were monitored by SIO and were monitored before monsoon season.

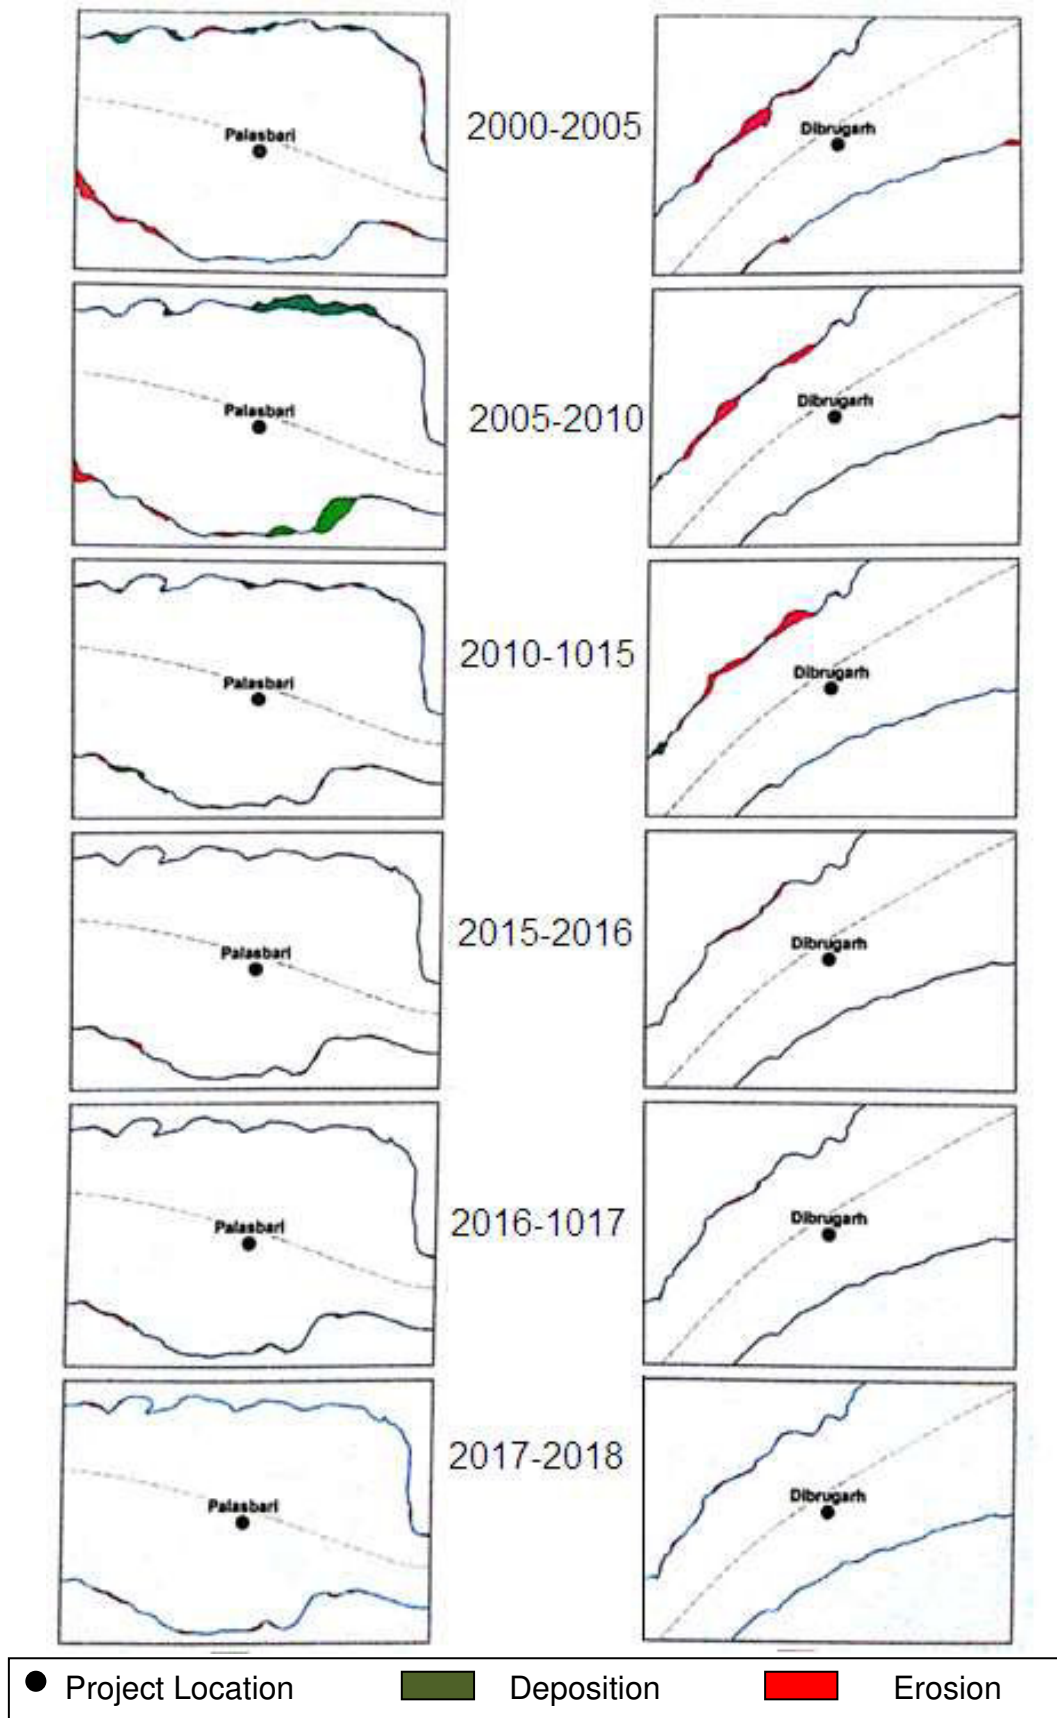
- Monitoring river bank line: (source DHI, FREMAA from satellite images)
