## India: MFF - Assam Integrated Flood and Riverbank Erosion Risk Management Investment Program — Tranche 1

# **BI-ANNUAL REPORT ON IMPLEMENTATION OF EMP**

**(OPERATION PHASE TRANCHE 1)**

**Reporting Period: January to June 2020**

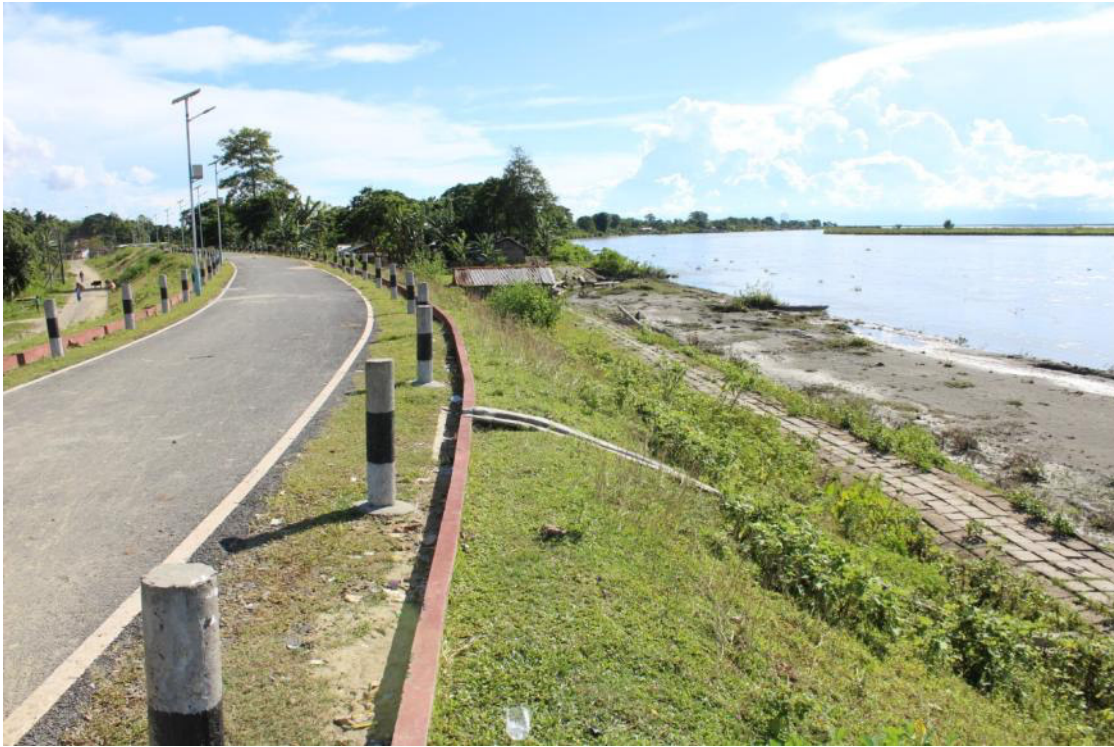
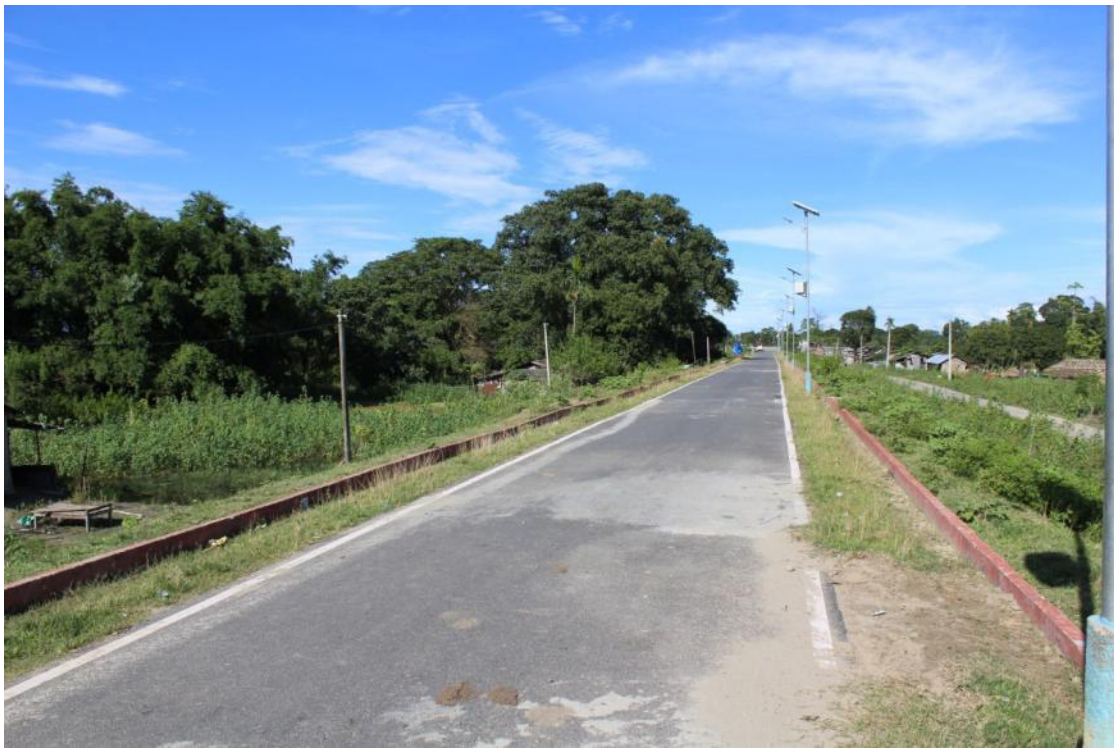
**Photographs of the present conditions of the Tranche 1 works**  
**DTP Dyke**

The overall condition of the embankment is good. No inundation occurred after completion of the embankment in all the three sites (Palasbari, Gumi and Dibrugarh).
