Environmental Monitoring Report

Project Number: 40156-023
November 2015

Period: January 2015 – June 2015

IND:MFF - Sustainable Coastal Protection and Management Investment Program (SCPMIP) - Tranche 1

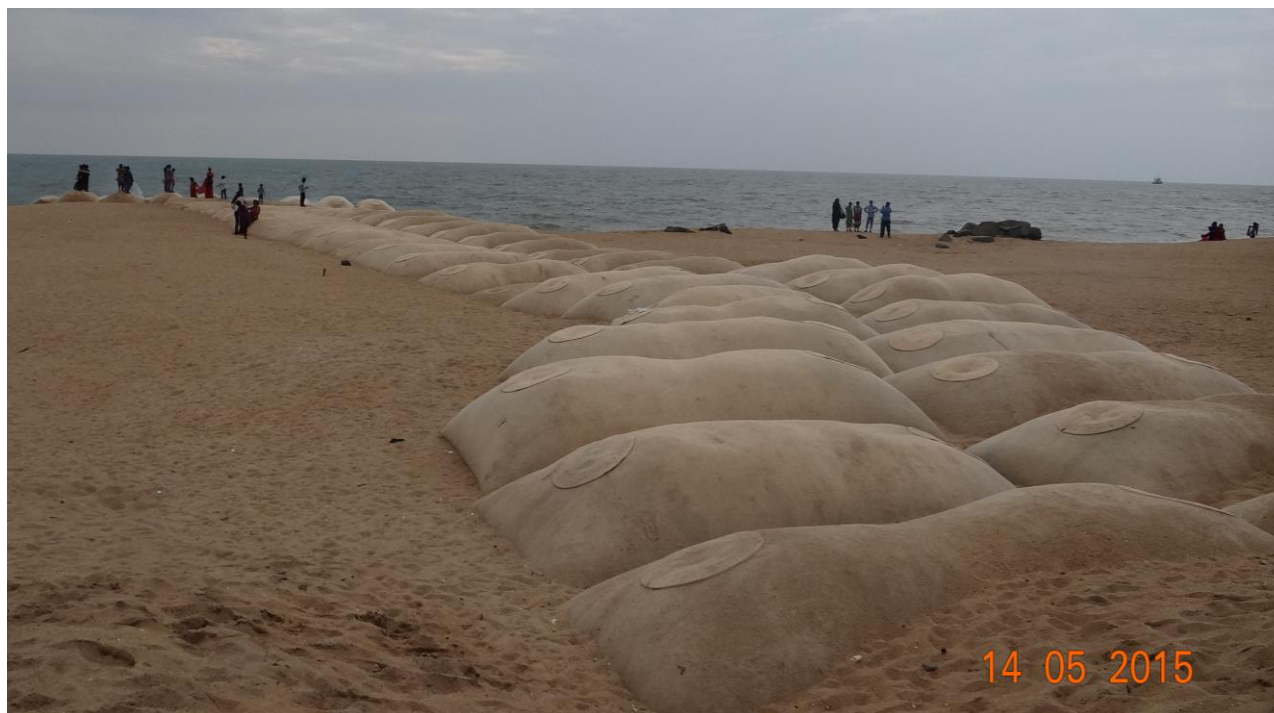
Figure B.2: Inshore Berm

Inshore Berms - 4 numbers of Inshore berms are 'T' gryone like structure, forming a length of 120m each placed into sea. The construction of the four in-shore berms commenced in December 2013 and the completion date of the construction is February 2016. The construction materials used are sand filled geotextile bags and containers.

The contractor has procured 22,252 no's of geotextile bags and the stem portion of Inshore berm no 4 has been completed for a length of about 70 meter using 1356 no of 1 cum bags, 935 no's of 2.5 cum bags and 62no's of 7.5cum bags. Simultaneously, the construction of inshore berm no 2 has also started in the month of April 2015 and about 25 meter length has been constructed using 340 no of 1 cum bags and 201 no's of 2.5 cum bags

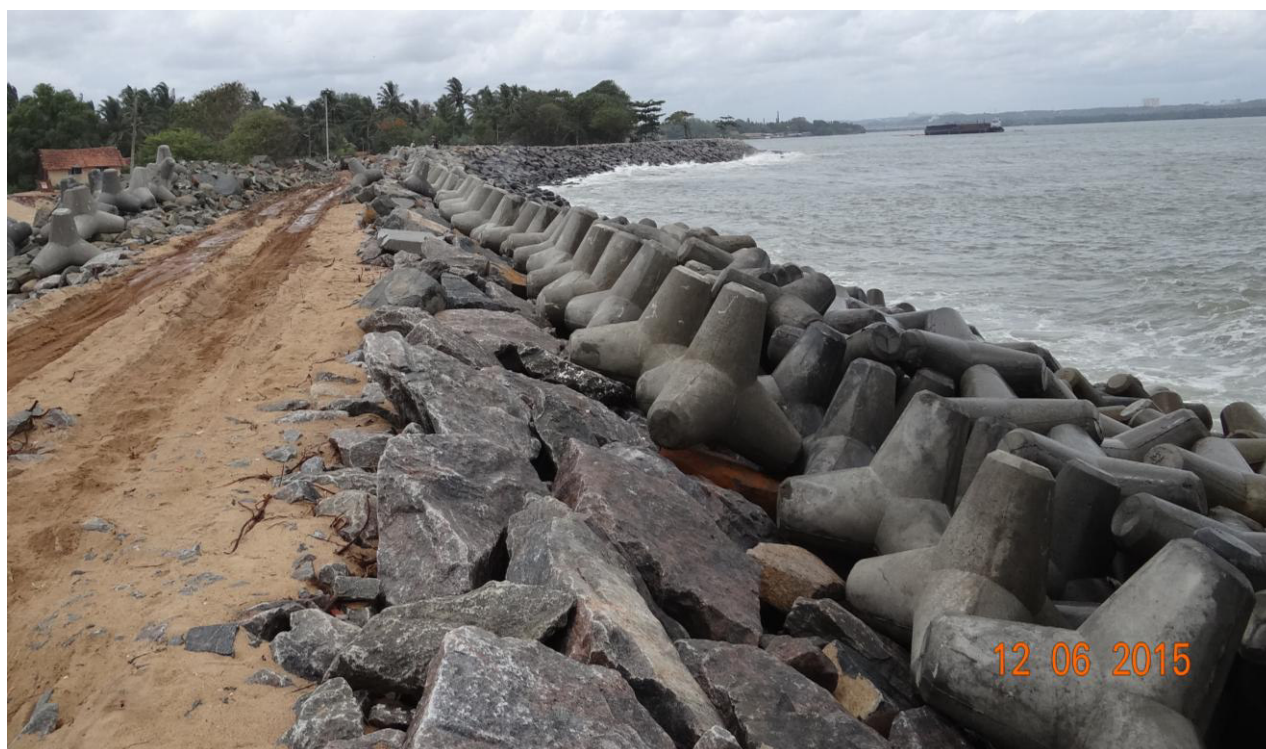
Figure B.3: North Breakwater

Contractor deployed men & machineries at site in the month of January 2015. Presently about 4616no's of 2T and 386no's of 7T Tetrapods are casted and stacked at yard and casting in progress. Revetment portion from chainage 0 to 225 m is completed upto crest level (+5.00 m). The north breakwater portion from chainage 225 m to 325 mtrs is nearing completion with slope protection using 2 T tetrapod towards sea side upto 6.00 m crest level.
