# Environmental Monitoring Report

Project Number: 40156-023  
March 2018

## IND: MFF - Sustainable Coastal Protection and Management Investment Program (SCPMIP) - Tranche 1

Reporting period: (July- December 2015)

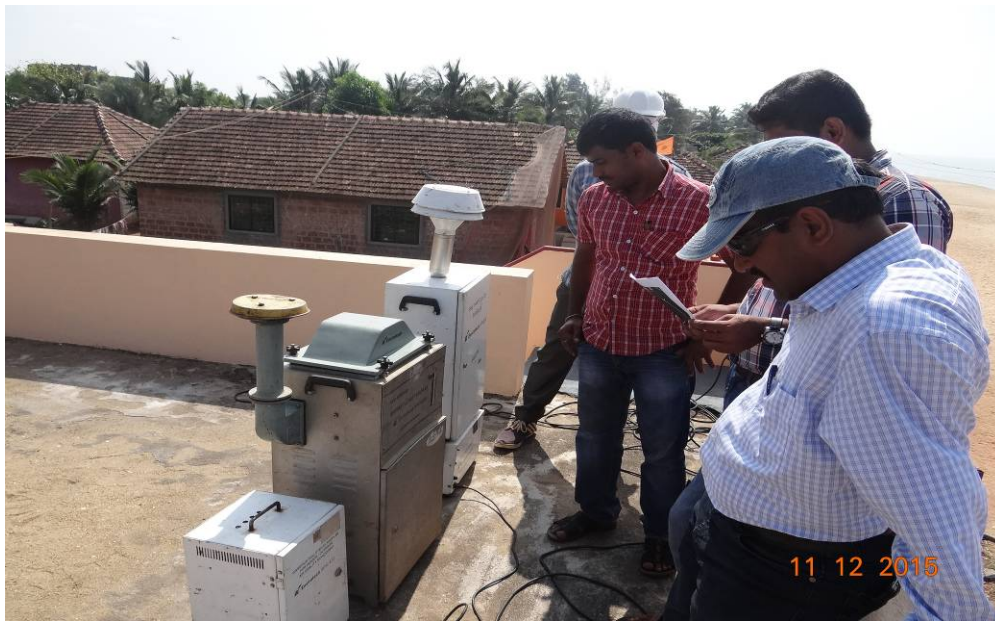
Figure B.1: Ambient Air Quality Monitoring at Ullal

The Ambient air quality testing was conducted for 24 hours on 11 December 2015 at two location one near the Inshore Berm no 4 and other near north break water. This was a normal day having clear sky and no rainfall. The results of both location are well within the permissible limits of National Ambient Air Quality Standards.

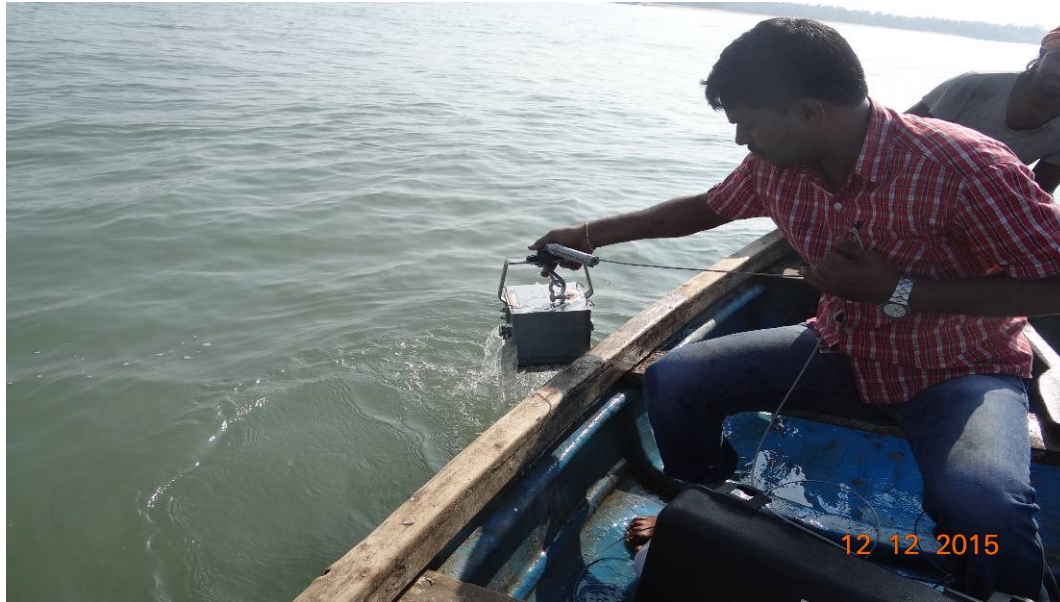
Figure B.3: Off shore sediment sample collection

Sediment testing has also been conducted for the samples collected from the sea bed near north reef and north breakwater. The parameters selected are Cadmium, Chromium, Copper, Nickel, Mercury, Lead, Silver, Zinc, Oil & Grease and Polynuclear Aromatic Hydrocarbon. Out of the above parameters, mercury, oil & Grease and Polynuclear aromatic hydrocarbons are absent in both sample. While Cadmium is absent in the sample of North reef.

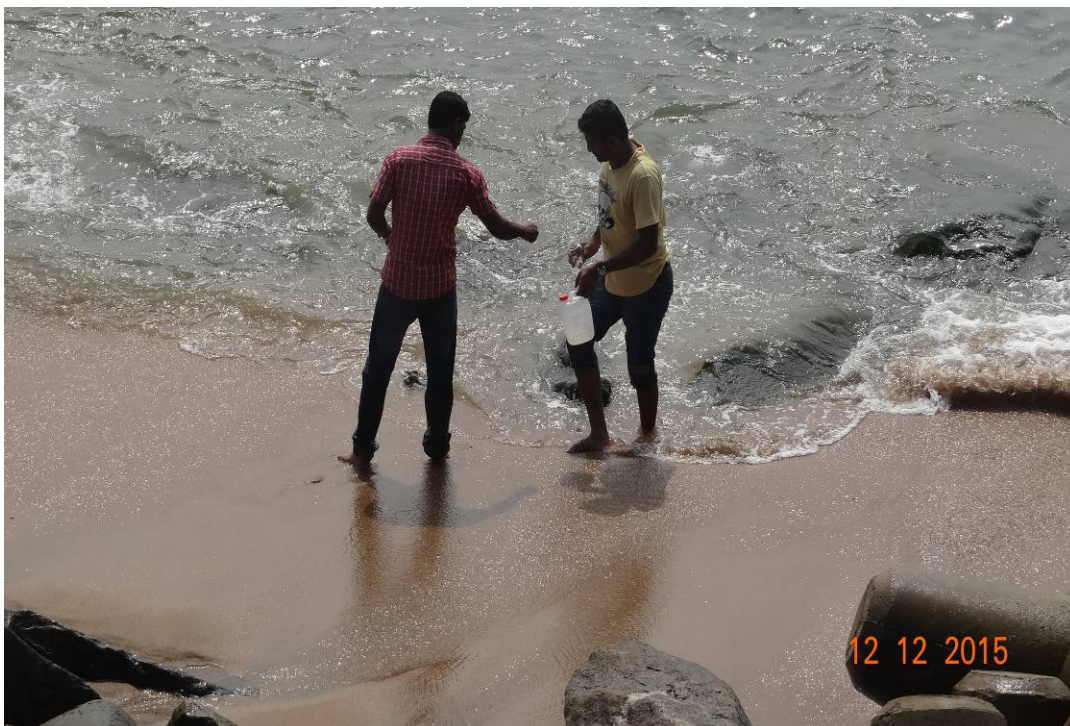
Figure B.4: Nearshore marine water sample collection

Water Quality Testing has been conducted for 3 location. Since entire work involves sea water, so the sampling has been done accordingly. There is no standard stipulated for sea water. While comparison of result has been done with drinking water standards. The results are far beyond the drinking water standard.

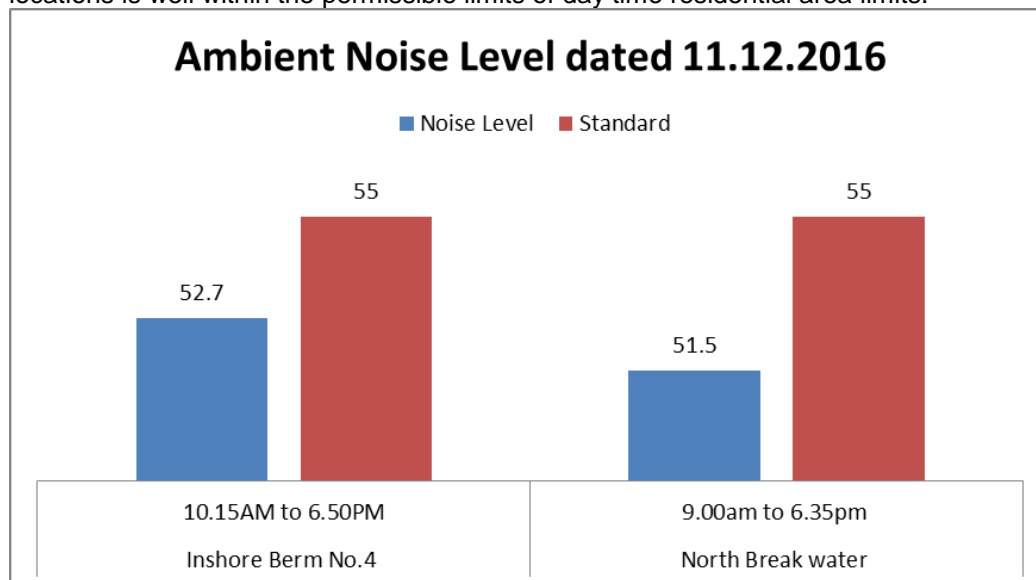
### C.2. Ambient Noise Level Monitoring

Noise level testing was conducted at Inshore Berm no 4 and North Break water. Noise level of both locations is well within the permissible limits of day time residential area limits.
