HIGHLANDS REGION ROAD IMPROVEMENT INVESTMENT PROGRAM -PROJECT 3 Gewa-Gembogl Road Sub-Project

Prepared by Department of Works for the Asian Development Bank

ENVIRONMENTAL SAFEGUARDS MONITORING REPORT

(January - June 2018)

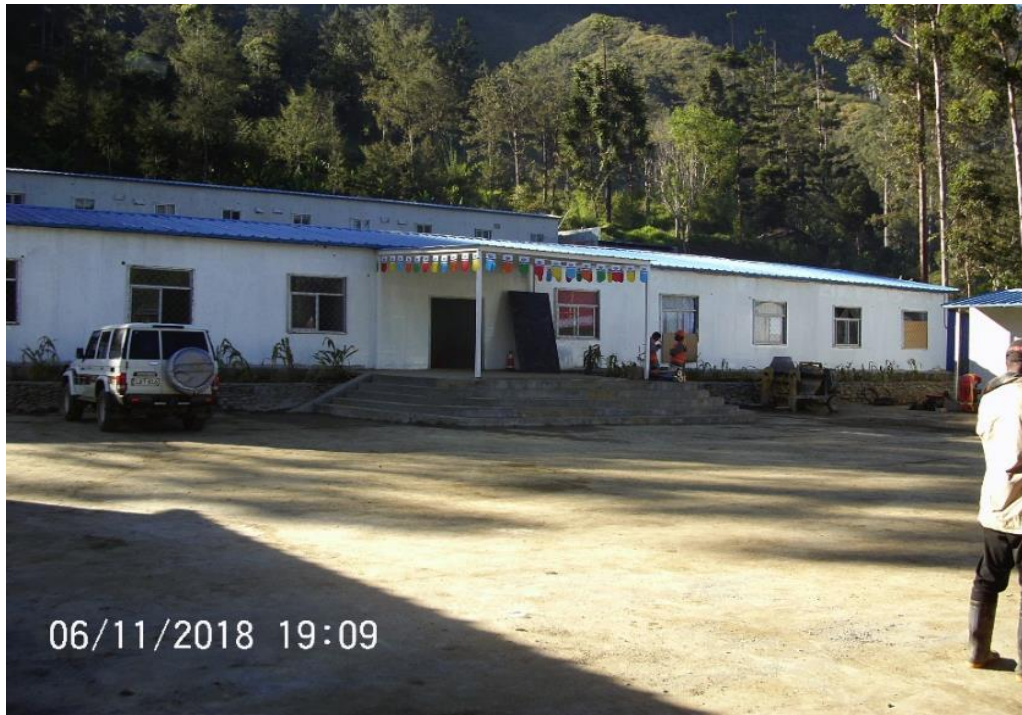
41. The Contractor's camp at Goglme is almost complete as of June and contains offices and living quarters of the expatriate community and other workers (Photograph 1). A Site Development Plan has not been provided to review its sewage facilities among others. The preservation of the scraped topsoil in the camp site should be used for future rehabilitation after the project.
42. The Contractor's Solid, Liquid and Hazardous Waste Management Plans were not approved by DOW-ESSB based in its review of March 22, 2018. The contractor has to address the necessary revisions for approval. Compliance monitoring will focus on the provisions of these plans and best management practices.
43. Reports of foul odor and the possible contamination of the local community's water system from the leaking sewage of the contractor is possible (Photograph 2).

Photo 1. The contractor's camp site.

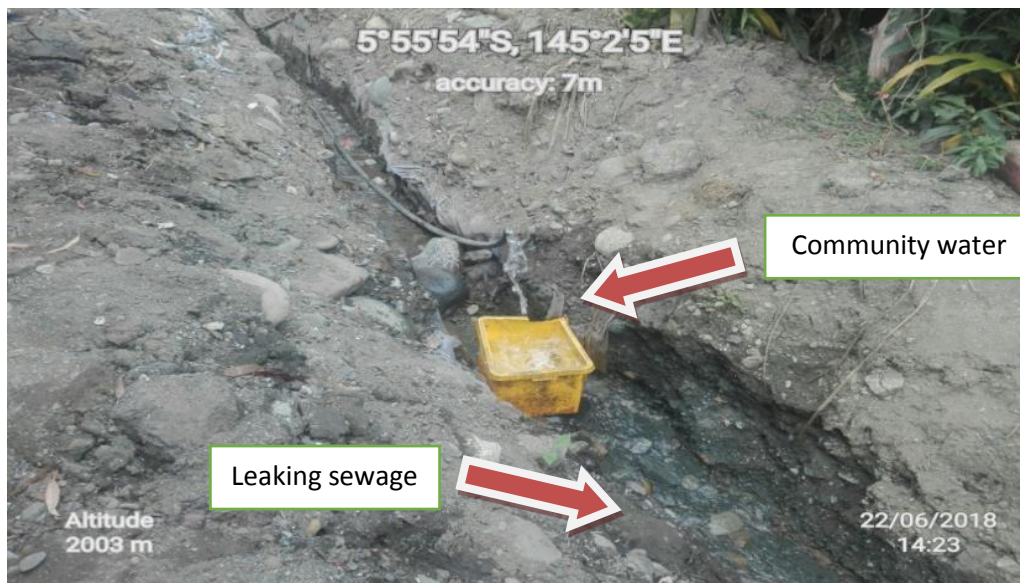
Photo 2: Leaking sewage near the water supply

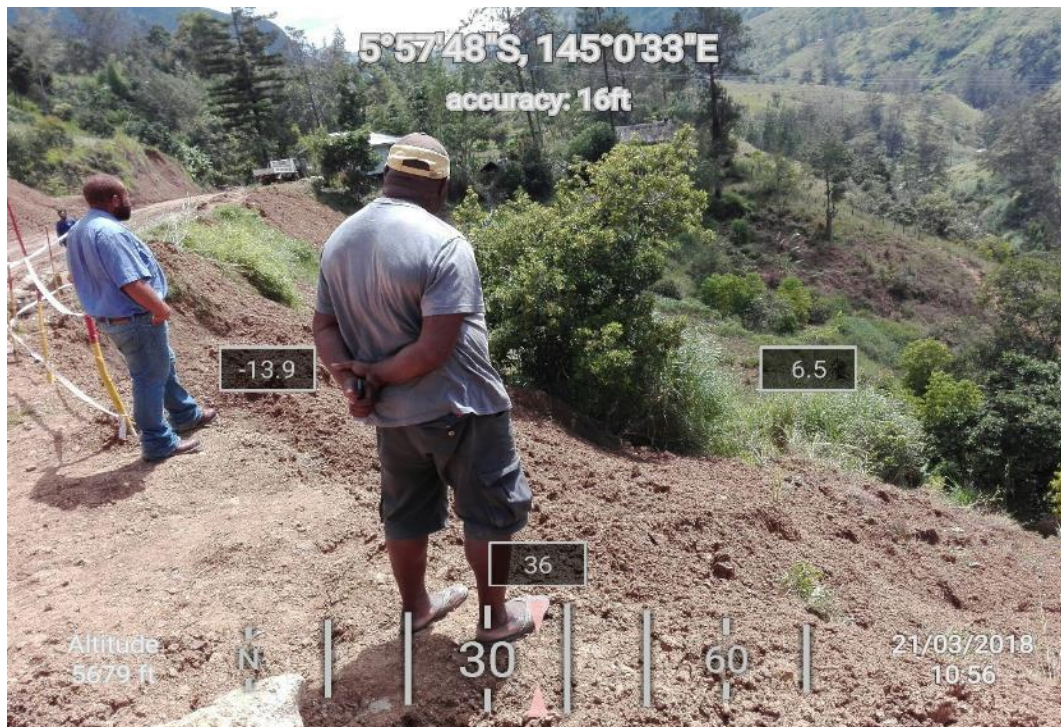
Photo 3: Dumping of spoils at Ch 12+520.

79. An agreed spoil disposal site is located on top of a stream used for drinking by the local community which had materials eroded into it due to rainfall at Ch.12+520. This caused the local community to complain. The resolution of this issue is solely with the contractor who needs to refer this to a local Environmental Grievance and Redress Committee. The issue will be closely monitored.

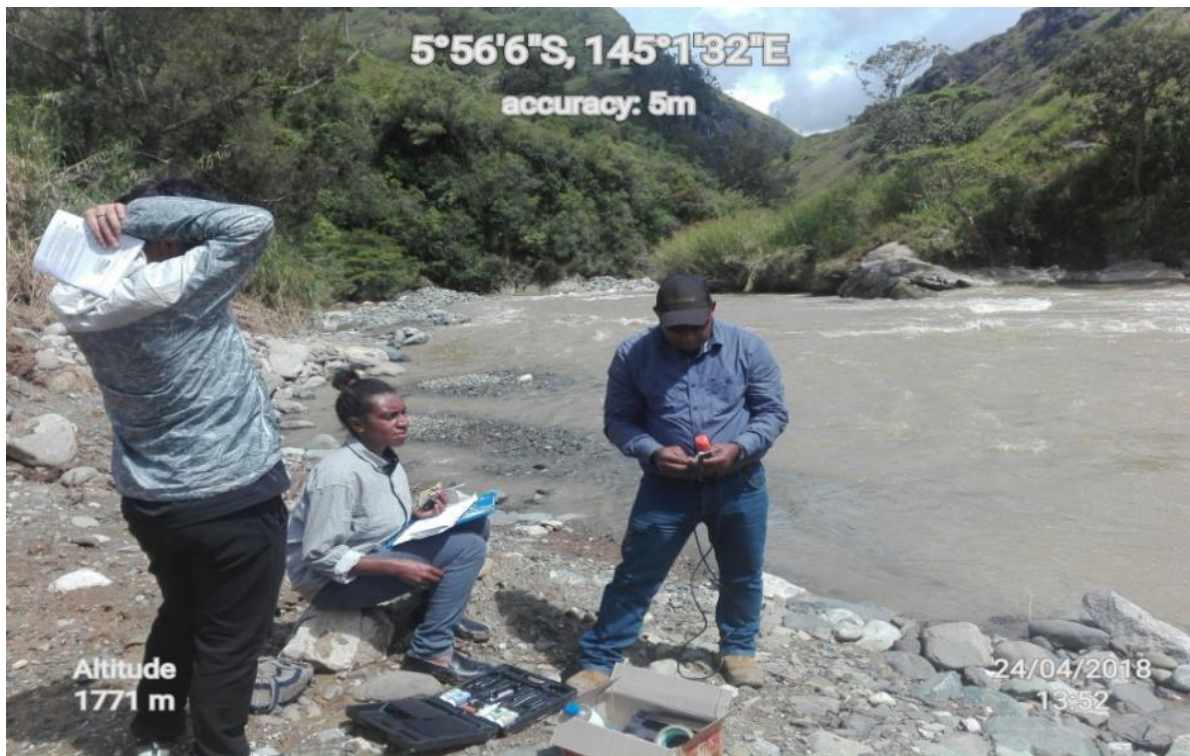
46. The monthly monitoring activities for April and June using in-situ equipment show that dissolved oxygen is below the PNG standards for sampling stations 1, 3, 4 and 5 including those water bodies not previously identified only for the month of June. These results could be an anomaly resulting in a defective equipment or erroneous calibration (Photograph 4).

Photo 4: Water sampling and in-situ environmental monitoring.

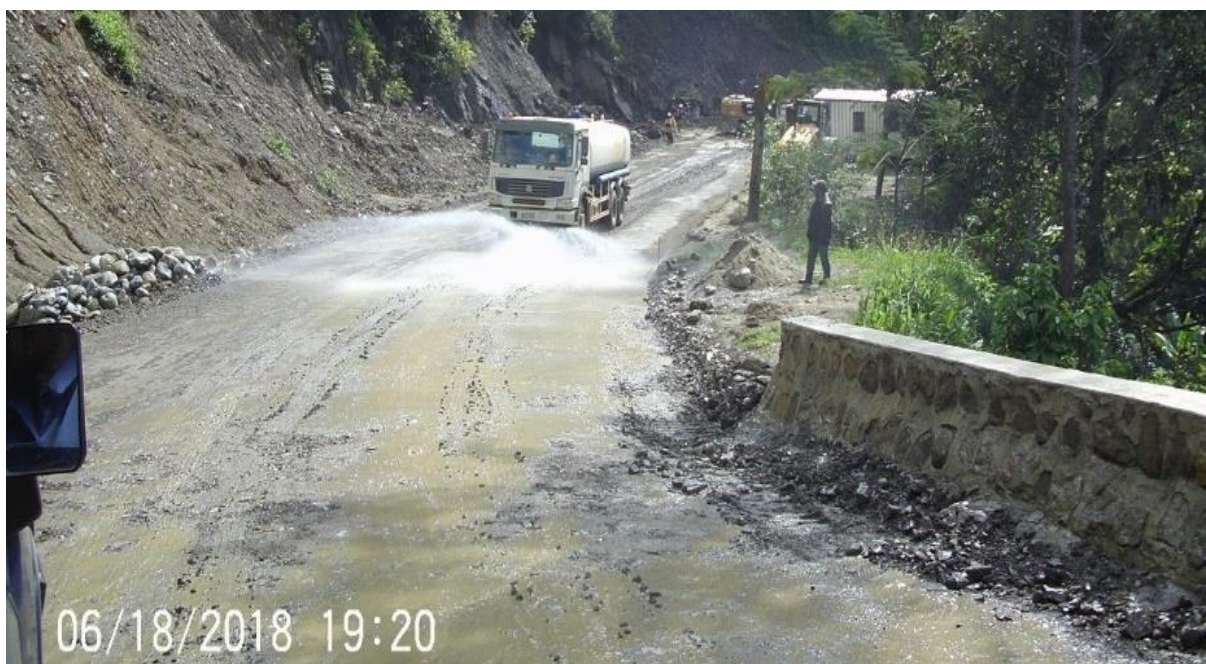
Photo 5: Water spraying truck to reduce dusts during construction.

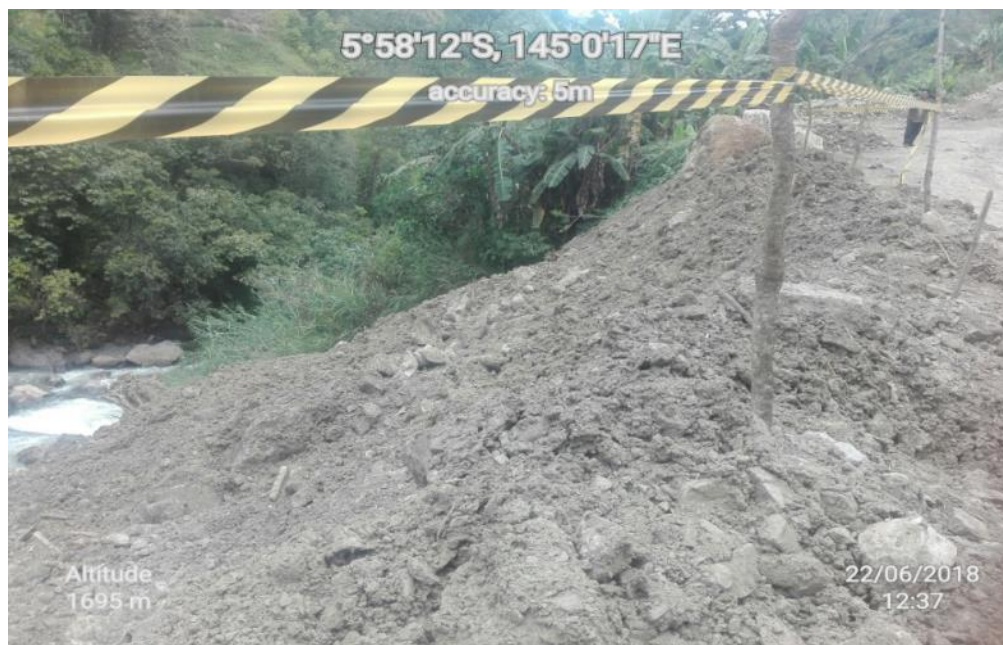
53. The disposal of wastes from clearing and grubbing indicate that these are not disposed of in the approved disposal sites (Photograph 6).
54. A memorandum of agreement with the owner of a disposal site at Ch.12+520 was too steep and has affected a stream which is being used for drinking water for Baizengigl village. The owner has denied signing the agreement although there is evidence of his concurrence. An environmental complaint has been prepared for this incident.
55. Additional waste bins need to be provided to ensure that solid waste segregation and disposal is done. The Contractor's Solid Waste Management Plan has not been approved by DOW-ESSB and would require revision. A report from HRMG indicated that there were piles of used and damaged tires at the contractor's camp at Wina Lodge.

Photo 6: Deposition of spoils into river at Chainage 11+400.

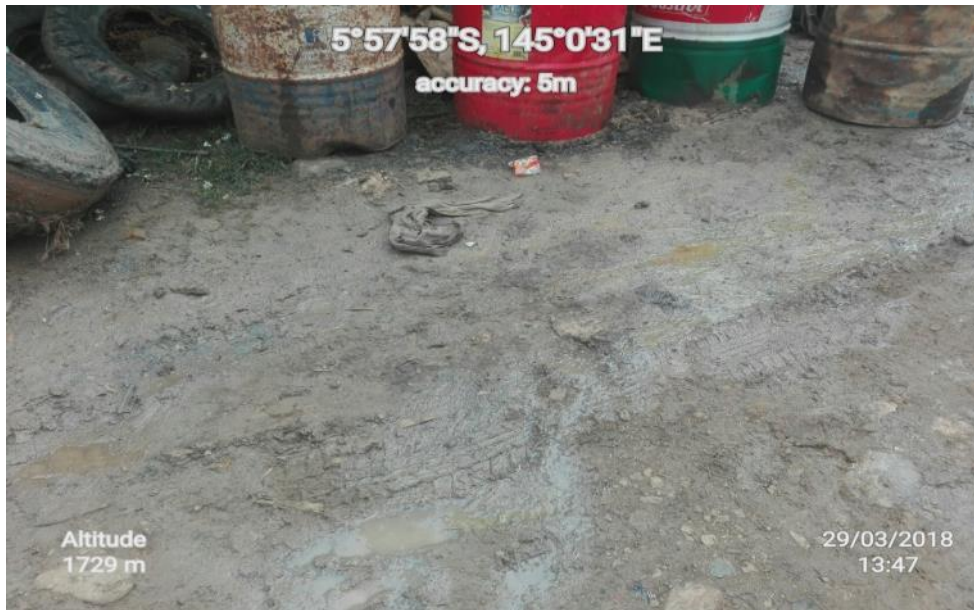
57. Drums of fuel and lubricants are stored at the camp with direct ground contact (Photograph 7). The surface of the storage area should be cemented to prevent contamination from leaks and bunds to prevent leaks from spreading. The Materials Safety Data Sheet (MSDS) for these wastes will also be part of the HWMP to ensure the proper handling of these materials. A report from HRMG show that the contractor need to mitigate oils spills at its camp at Wina Lodge.

Photo 7: Leaking fuel drums at temporary camp site at Wina Lodge.

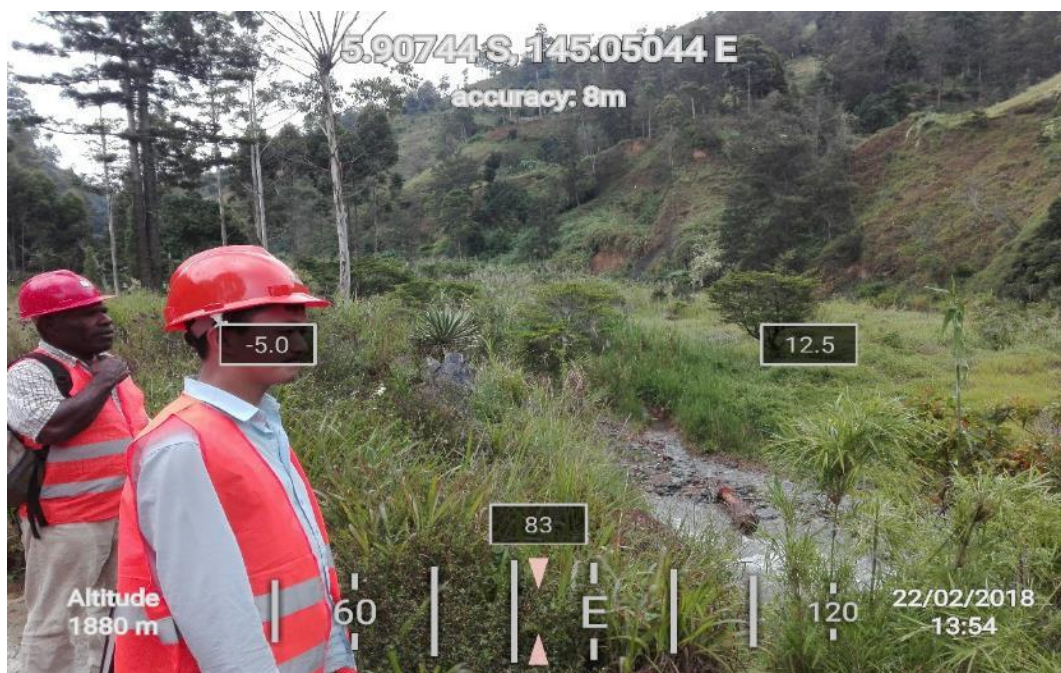
58. The contractor shall be extracting gravel materials from the Sumburu Quarry which is located along the Koglnige River at Ch 24+500 (Photograph 8). The area will also accommodate the bitumen and crusher site. Another potential quarry site was identified at Bamunda.
59. Baseline environmental data have been obtained for the Koglnige River (Table 3) for comparison during the monthly monitoring. The Quarry sites must not be occupied, prepared or operated before the necessary land occupation permit and Environmental Permits have been obtained from the CEPA and other authorities as required.

Photo 8: Proposed Sumburu Quarry and Crusher Site.

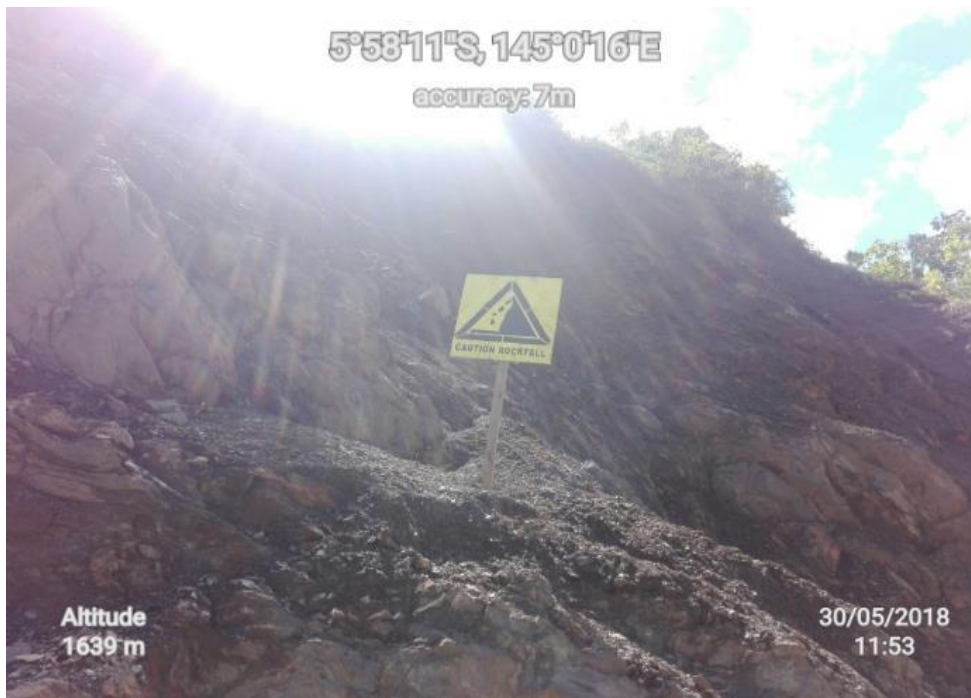
68. The contractor has provided visual safety aids such as visual tapes and painted posts for hazardous areas (Photograph 10). The risks to public safety in terms of erosion and sedimentation of water bodies and home gardens need to be assessed for future road work activities. The use of Geographic Information Systems could serve as a tool for this activity.
69. A Contingency Emergency Response Plan has also been submitted by the Contractor focusing on the construction works that they will undertake in their specific areas of concern and the attendant potential risks and hazards.

Photo 10: Warning signage for public safety.

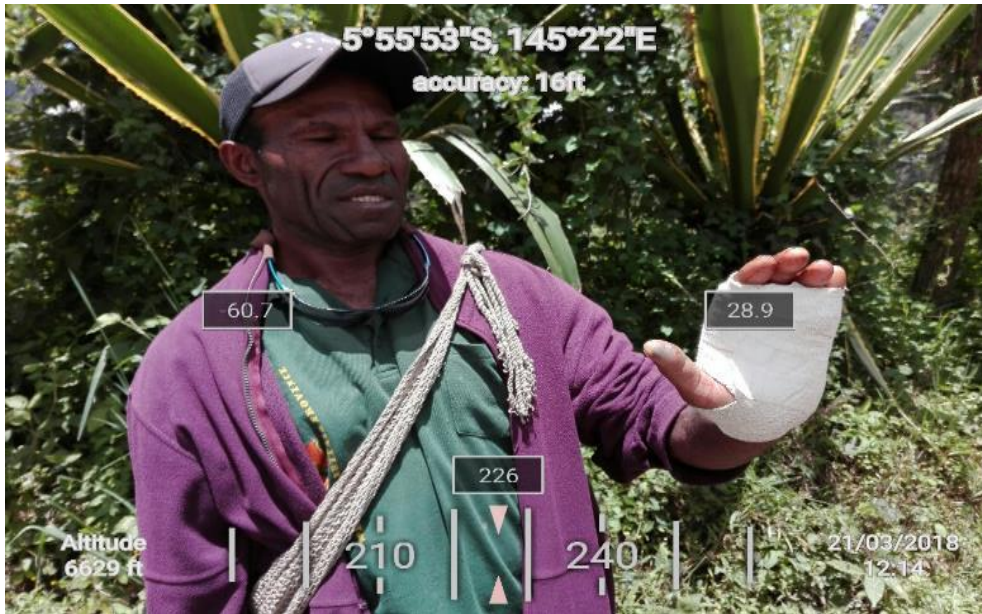
70. An accident has been reported in March 2018, when one of the local workers injured his hand while handling aluminum roofing without wearing hand gloves (Photo 11). This incident highlights the need to educate and provide PPE and medical first aider to all employees.
71. The Contractor has prepared an Occupational Health and Safety Management Plan which (OHSMP) with operational details and was approved by DOW-ESSB last March 22, 2018.
72. The Contractor has provided protective clothing and safety equipment or Personnel Protective Equipment (PPE). A number of these PPE have been purchased (Photo 12). An inventory of its use and distribution should also be made to inform local employees on correct use of PPEs.

Photo 11: Injury encounter due to negligence on the use of PPE.

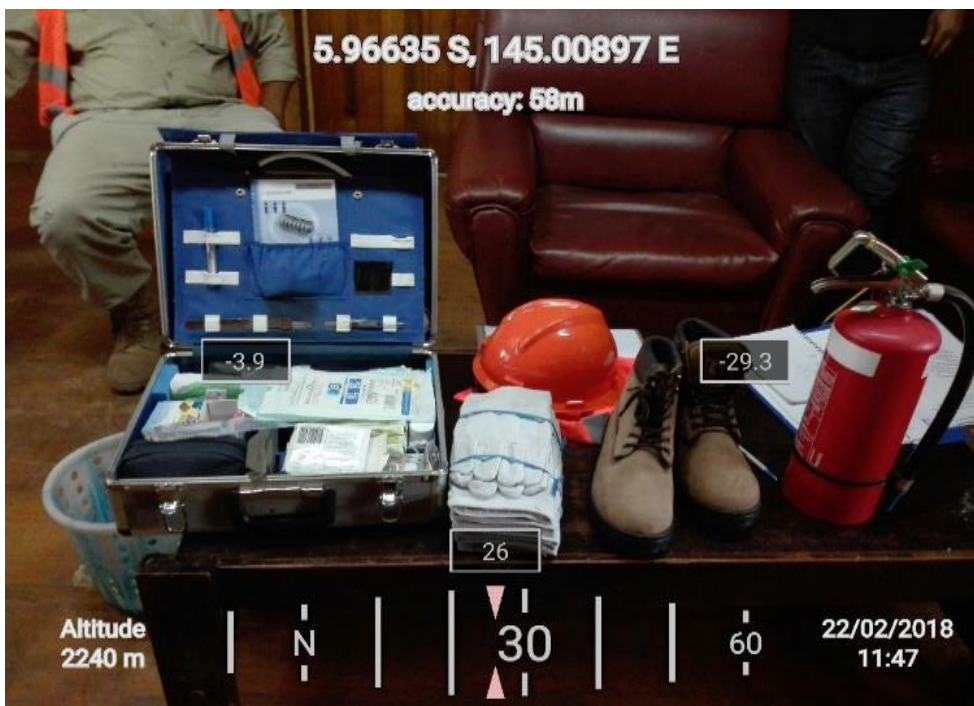
Photo 12: Some of the PPEs purchased by the contractor.

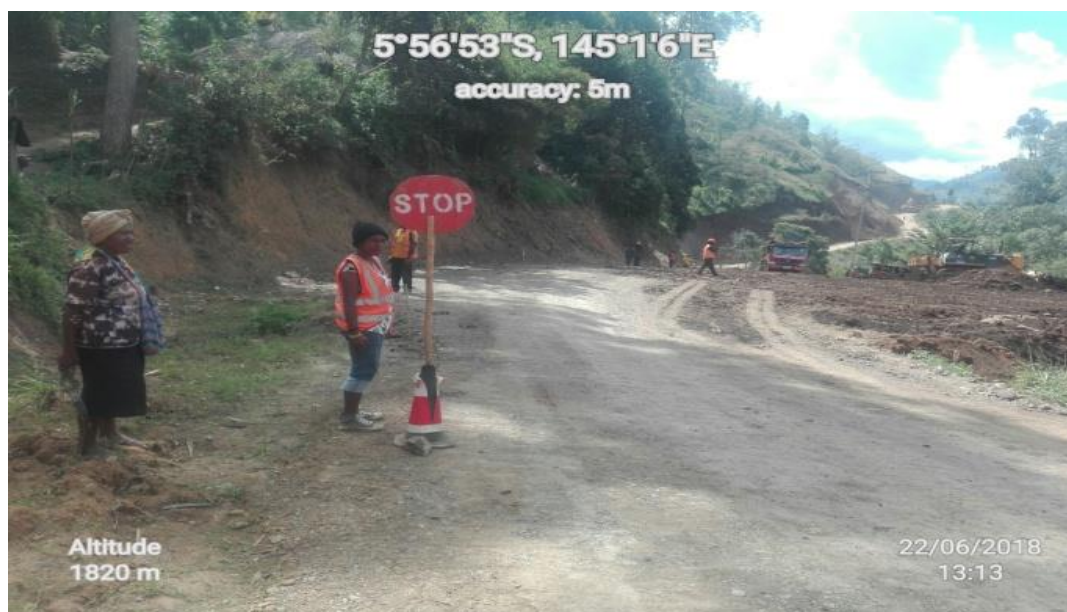
73. The Contractor has submitted a Traffic Management Plan which has been approved by DOW-ESSB last March 22, 2018. This will be the basis for the monitoring activities of HRMG and PSC.
74. The contractor has hired women traffic aides to provide traffic warning signs to motorists (Photograph 13).

Photo 13: Women traffic aide provides traffic signage.

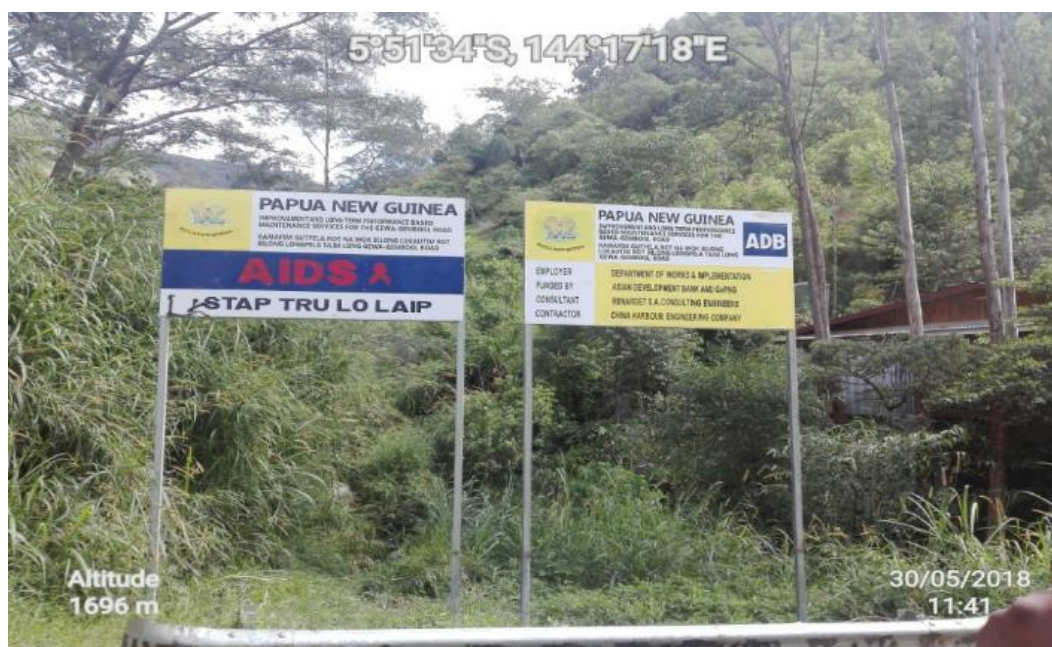
75. The Contractor has submitted its HIV-AIDS Plan but require improvement and revision. It has also proposed to engage the services of a HIV/AIDS and STDs service provider Gande STI HIV-AIDS and General Patient Clinic to comply with the requirements for the plan and its subsequent implementation.
76. There has been no HIV-AIDS activity except for a billboard that has been erected in May (Photograph 14).

Photo 14: HIV-AIDS awareness displayed on bill board.
