**PNG: HIGHLANDS REGION ROAD IMPROVEMENT
INVESTMENT PROGRAM (TRANCHE 3)
Nipa-Munihu Road Sub-Project**

Nipa-Munihu Sub-Road Project

ENVIRONMENTAL SAFEGUARDS MONITORING REPORT (January - June 2018)

**Project Implementation Unit
Department of Works
National Capital District
Papua New Guinea**

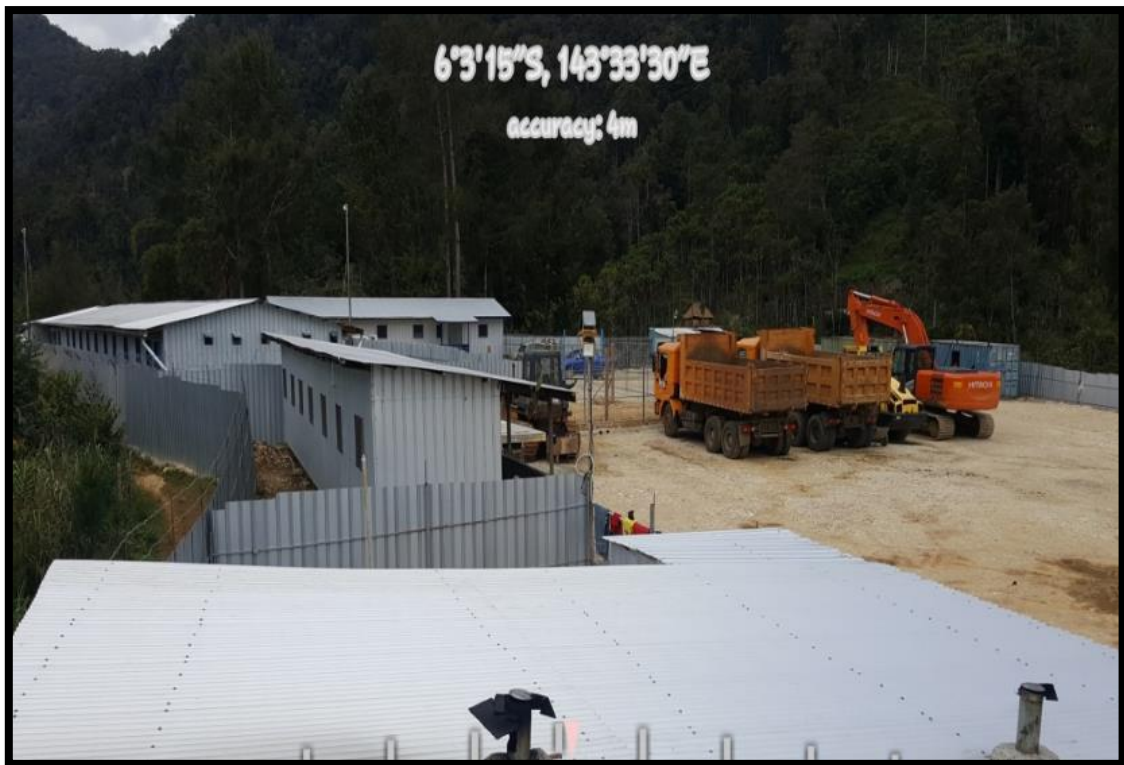
39. The Contractor has completed and occupied its camp at Mt. Wiru. The Engineer's quarters and offices have also been completed (Photograph 1). The Site Development Plan and the sewage treatment facility design need to be provided.
40. The contractor has also provided leisure facilities including a basketball court, tennis court, vegetable garden and duck pond. It is hoped that these facilities would provide health benefits while the last two could be used for the solid waste management strategies including fertilizer production from composting.
41. The use of an old garbage dump at the back of the camp has to be monitored in terms of the trash that are deposited following segregation procedures.
42. An old septic tank is leaking sewage into a nearby drain. This must be investigated to ensure that it would not pollute adjacent water bodies (Photograph 2).

Photograph 1: The contractor's camp at Mt. Wiri.

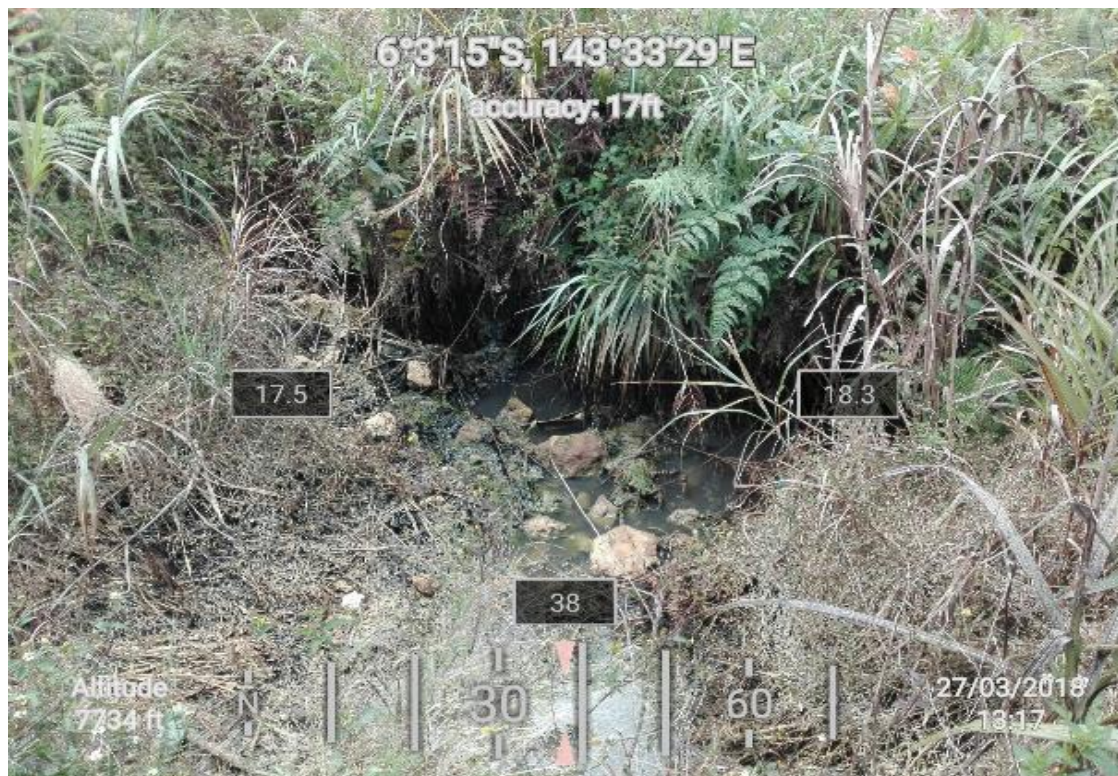
Photograph 2: Old sewage pond that needs to be investigated.

80. A perennial problem is the sewage treatment facilities which do not conform to best practices and should be done properly.
81. There is a need to revise and submit the Quarry Management Plan, HIV/AIDS & STD Plans, Hazardous Waste Management, Sewerage Waste Management, and Solid Waste Management Plans which were not approved by DOW-ESSU.

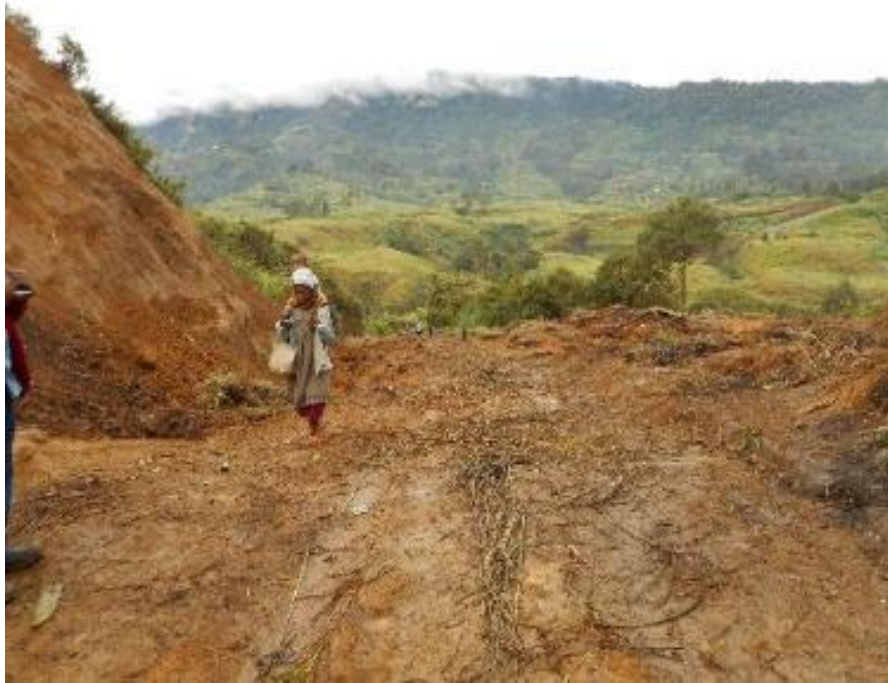
43. The massive earthquake of February 26, 2018 has damaged existing infrastructure and has also curtailed movement and communications in the project site (Photograph 3).
44. The contractor done clearing and grubbing activities including excavation works at the Munihu side at Chainages 21-27. The unwarranted deposition of cut and fill materials along the roadside need to be stopped and mitigated (Photograph 4).

Photograph 3: Clearing activities of roads from earthquake-induced landslides.

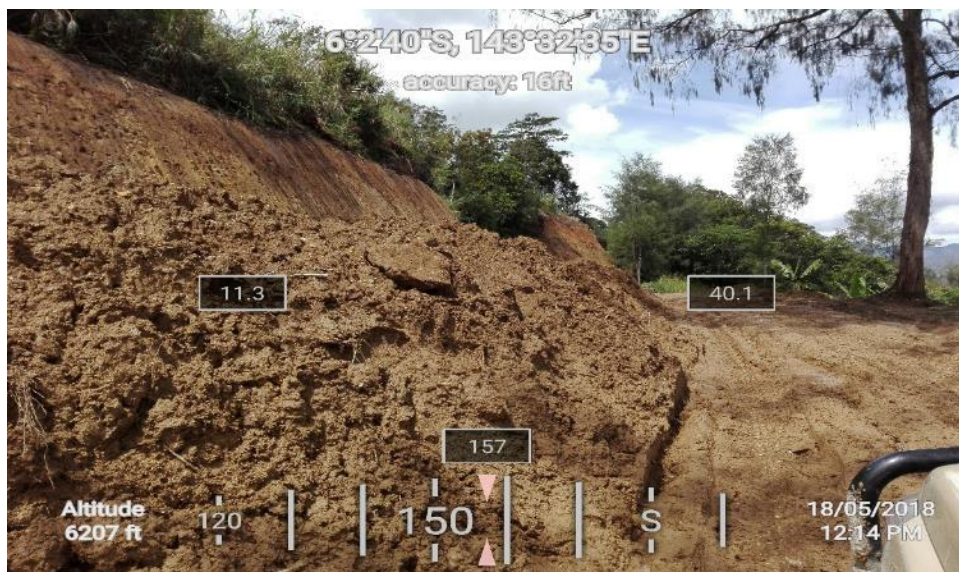
Photograph 4: Waste deposited from clearing activities need to be disposed.

50. The categories of wastes generated from the project consists of overburden from construction sites and improper disposal of spoils from excavation and other earth moving works such as clearing and grubbing. The contractor has obtained permission from landowners for the waste disposal. The proper disposal of camp wastes would also constitute this section. An agreement with owners of disposal sites is required for this purpose.

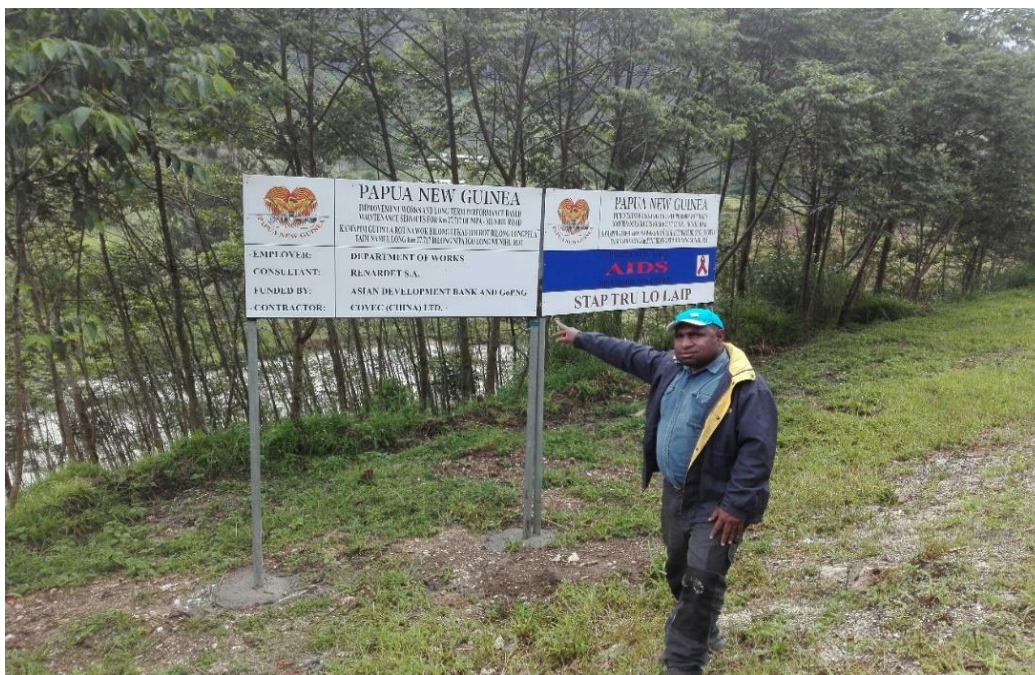
71. The Contractor has submitted an HIV/AIDS and STDs plan to DOW-ESSU but has not been approved. Negotiations are under way for a service provider, the Munihu Health Centre.
72. The contractor's HIV/AIDS sign board has been erected at both end of the project. One at the Nipa end and the other at the Munihu end (Photograph 5).

Photograph 5. HIV-AIDS STD Signboard
