**PNG: HIGHLANDS REGION ROAD IMPROVEMENT
INVESTMENT PROGRAM (TRANCHE 3)
Pangia-Wiru Loop Road Sub-Project**

HIGHLAND REGION ROAD IMPROVEMENT INVESTMENT PROGRAM – PROJECT 3

Pangia-Wiru Loop Sub-Road Project

ENVIRONMENTAL SAFEGUARDS MONITORING REPORT **(January - June 2018)**

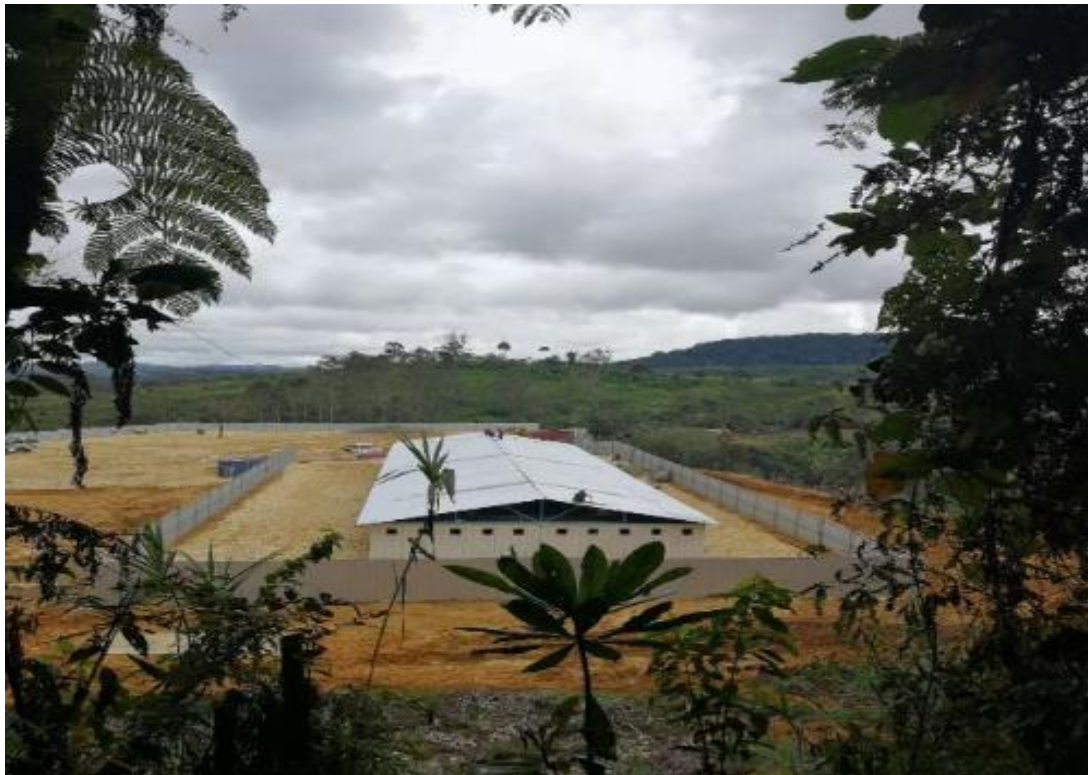
Photograph 1: The contractor's base camp and offices in Pangia.

39. The Contractor has almost completed its camp facilities (Photograph 1). The environmental issue observed by the environmental officers is the leaking sewage facility (Photograph 1). The contractor needs to present the design of the septic tank to determine whether a problem exists.

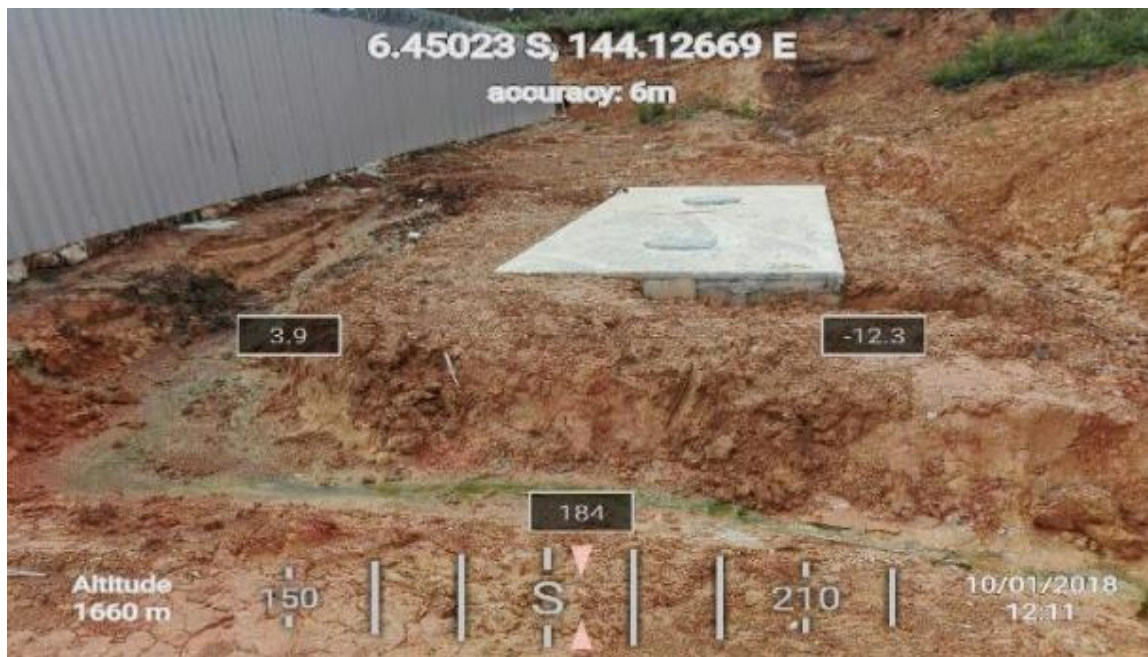
Photograph 2: Leaking sewage at the Langane camp site.

| NON-COMPLIANCE | MONTHS | | | | | |
|--|---|---|---|---|---|---|
| Leaking sewage treatment facility in the camp. | X | X | X | ✓ | ✓ | ✓ |

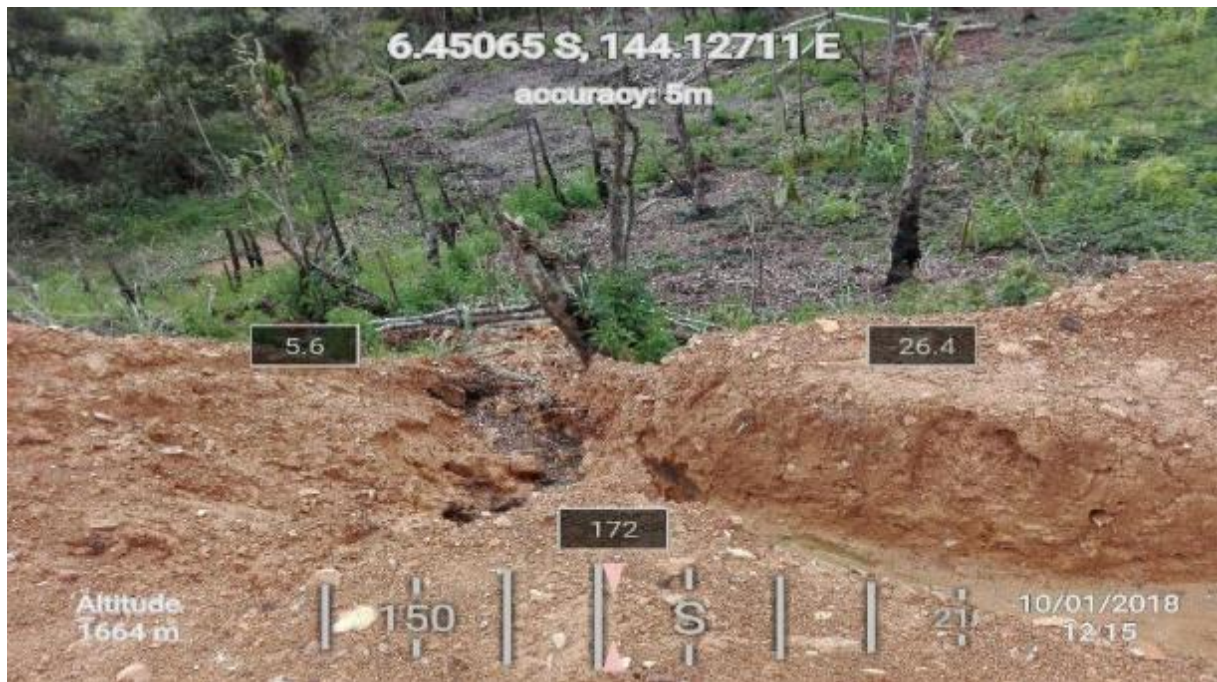
41. The contractor has carried out clearing and grubbing for approximately 22 kilometers and in some areas, it was observed that the contractor has deposited its wastes in the designated sites. However, some wastes need further soil conservation measures (Photograph 3).

Photograph 3: Eroded spoils spilling into food gardens.

42. As previously suggested, a helpful manual to address the issue was provided during the induction meeting entitled Erosion and Sediment Control Best Management Practices Manual.

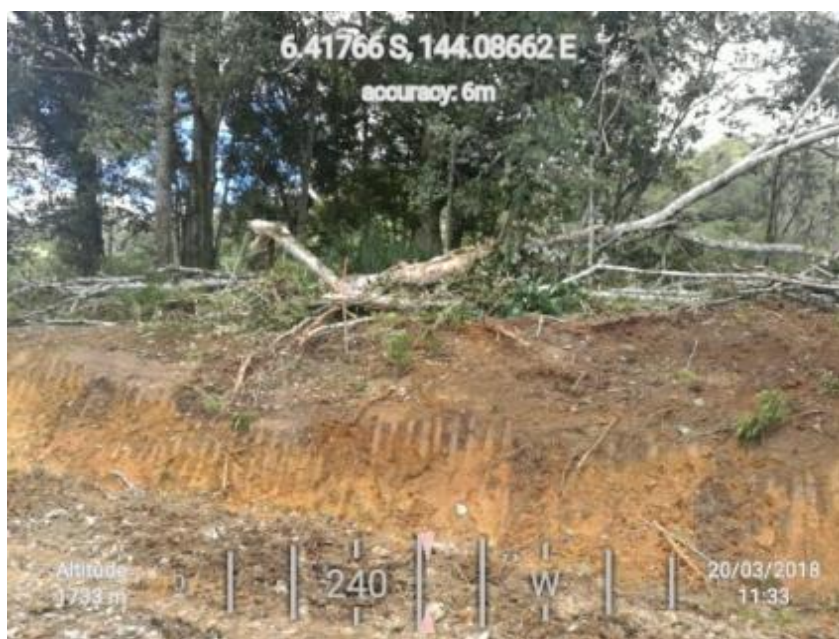
55. The project has started the clearing and grubbing activities for at least 22km. The contract document stipulates that the Contractor shall ensure that no trees or shrubs are felled or harmed except those required to be cleared for the execution of the works.
56. All the affected trees were identified and marked for removal by the Environmental Officer of HRMG and PSC and were removed (Photograph 4). No tree shall be removed without the prior approval of the Engineer and any competent authority.
57. A seminar workshop on Tree Planting and Management has been conducted last March 8, 2018 to implement this activity.

Photograph 4: Trees were marked and inventoried prior to cutting.

| NON-COMPLIANCE | MONTHS | | | | | |
|--|---|---|---|---|---|---|
| Cutting of trees and vegetation need to be properly marked and inventoried for replacement | X | X | X | ✓ | ✓ | ✓ |

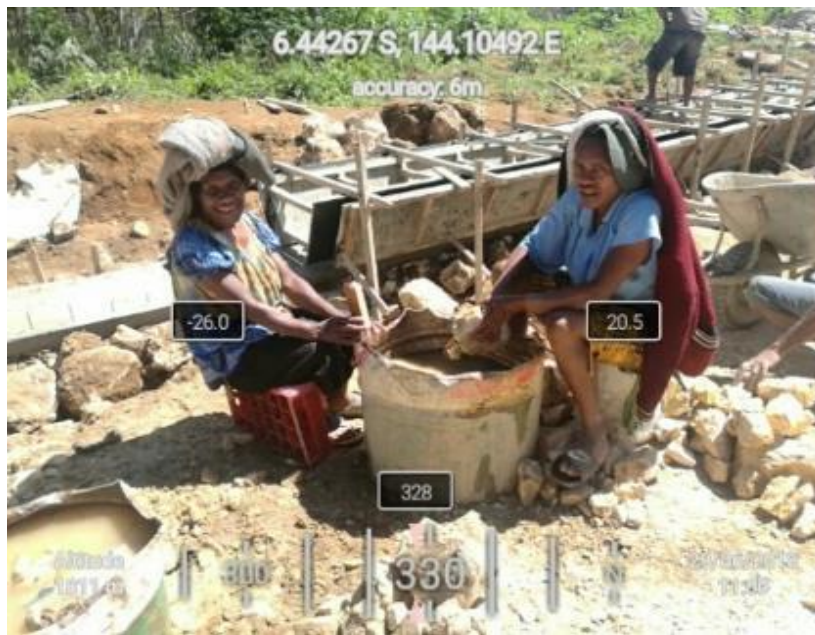
Photograph 5: Women workers without any PPE doing line drain works.

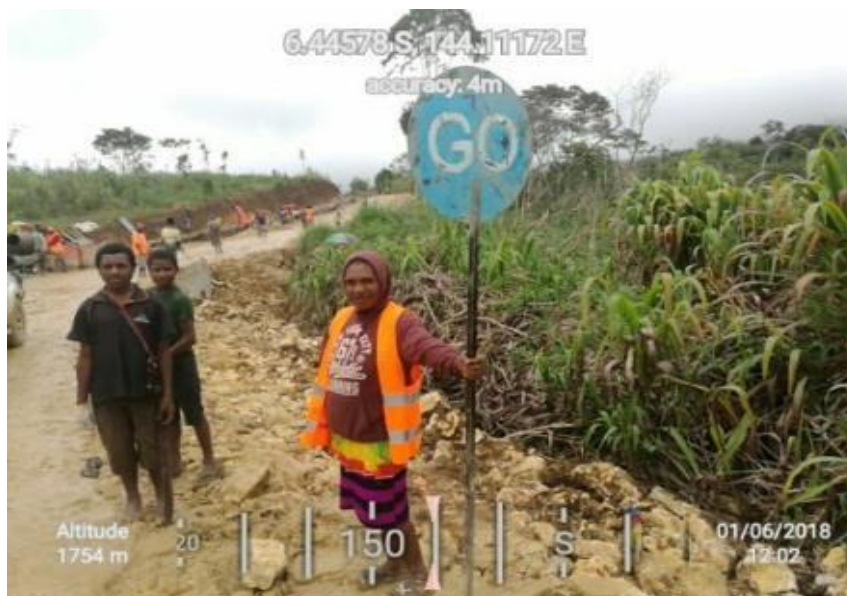
73. The Contractor has not submitted a Traffic Management Plan for their respective work areas with the necessary materials, equipment and human power.
74. The monitoring activities shall be based on the Contractor's adherence to the stated TMP. A traffic aider is shown with a reflective vest (Photograph 6).

Photograph 6: Female traffic aider worker with reflective vest.
