## **PNG: HIGHLANDS REGION ROAD IMPROVEMENT INVESTMENT PROGRAM (HRRIP) – TRANCHE 3**

### **HENGANOFI-NUPURU ROAD SUB-PROJECT**

# **SEMI-ANNUAL ENVIRONMENTAL SAFEGUARDS MONITORING REPORT**

**(JULY TO DECEMBER 2019)**

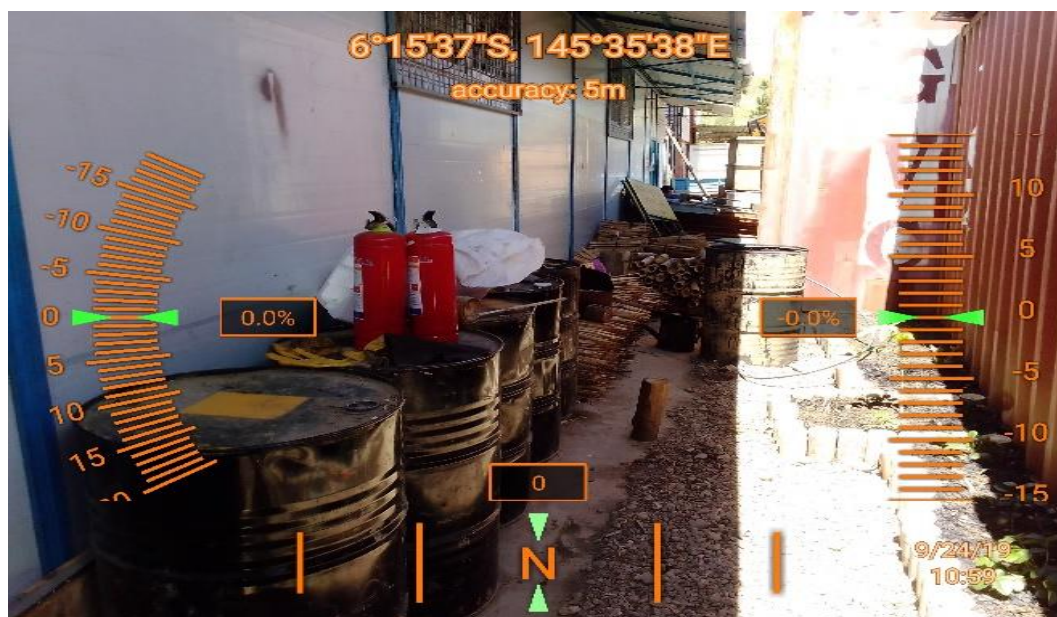
Picture 1: Items stored neatly at Contractors storage area

39. The campsite Yard was generally well maintained. Each section was well supervised as well.

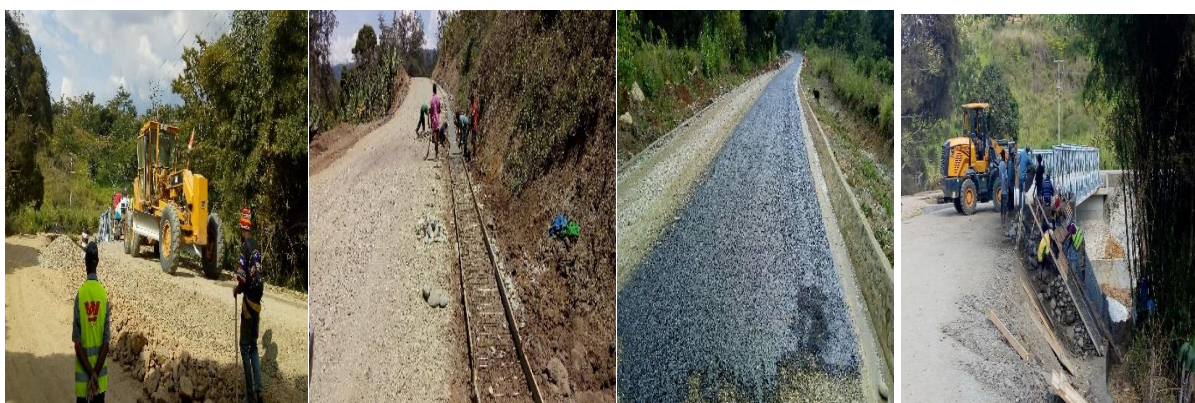
**Picture 2: Photos showing work progress during this period.**

10. Gabion Basket works carried out at 24 + 600 – 27 + 680.
11. Culvert installation has been inserted at CH: 29 + 040, culvert instal with out land issues.

12. Total of six bridge works has been completed and currently is use while only Hogoteru bridge waitng for backfill.
13. Three (3) locations for the cabion baskets had been completed this month.

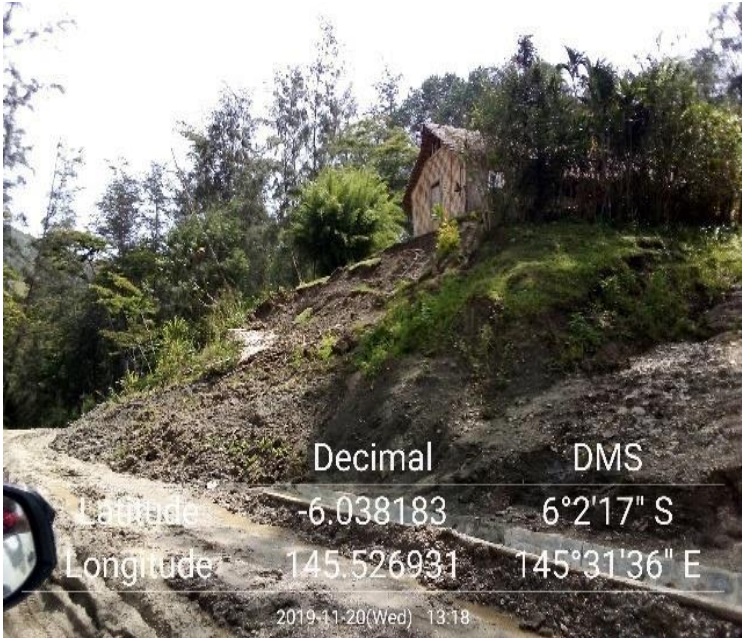
Location	Photograph	Description/Remarks
CH28+130

<p>Decimal      DMS</p> <p>Latitude: -6.038183      6°2'17" S</p> <p>Longitude: 145.526931      145°31'36" E</p> <p>2019-11-20 (Wed) 13:18</p>	<p>Sediments flow shown in the photograph from LHS of the road has caused demolition to 20 metres line drain.</p> <p>Also, the Kunai thatched church build there is most likely to be affected while other local crops planted along the side of the road were destroyed.</p> <p>Therefore, this place would need like drain rework and gabion baskets to be constructed to protect the sediments flow to avoid further damages.</p>

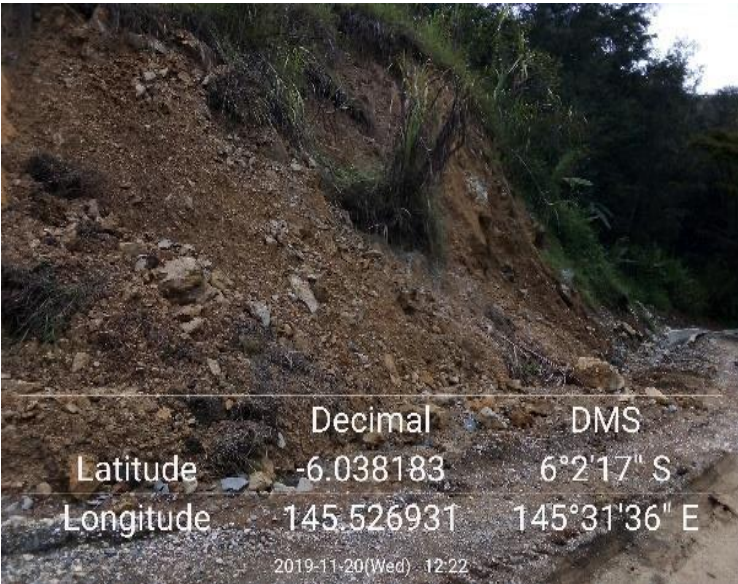
<p><b>30+620</b></p>

<p>As shown in the photograph, this small landslide alongside the road has demolished 30 metres Line drain.</p> <p>Therefore, this section needs re-work and clearance.</p>
<p><b>31+400</b></p>	 	<p>Landslip and sediment flow shown in the photograph has covered half of the road. This section was cleared for line drain and gabion basket.</p>

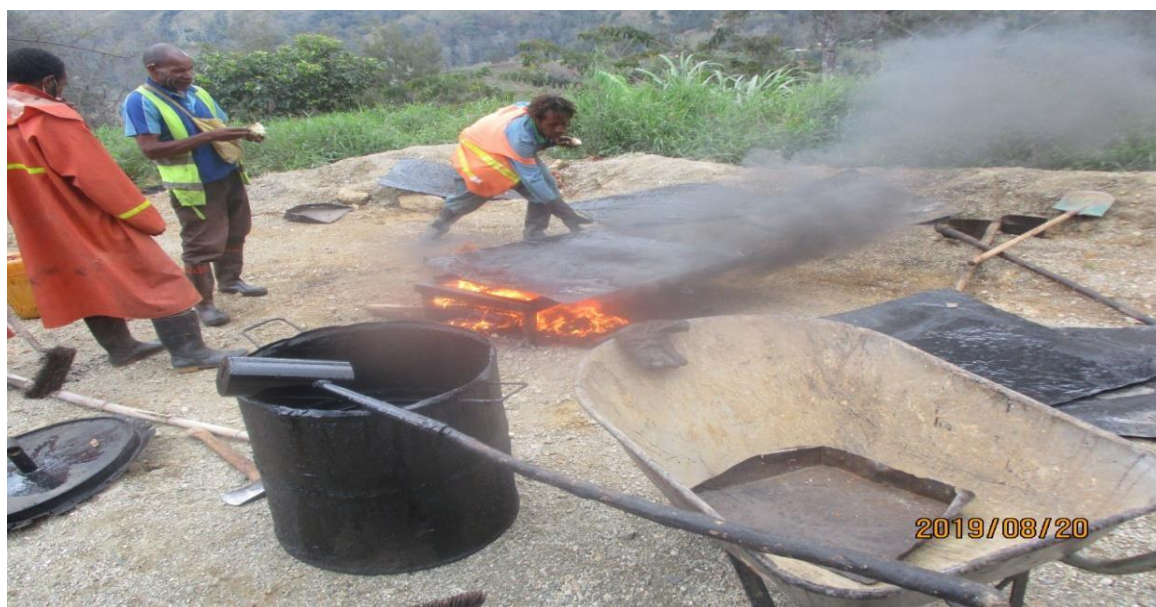
55. Hazardous material at the construction site and Konamempi camp site are poorly managed. As photographs shown below indicate burning of wastes bitumen after sealing along CH17+100. There are also traces of used oil being soaked up with saw dust and burnt at the camp yard.

56. Images show local employees of contractor in the act of burning bitumen in open air which is a direct cause of air pollution. There are also children and other local bystanders around who are also directly exposed to breathing the harmful fumes of the burning bitumen which can affect their lungs or cause other health problems.

**Picture 5: Contractor employees burning bitumen without wearing nose masks.**

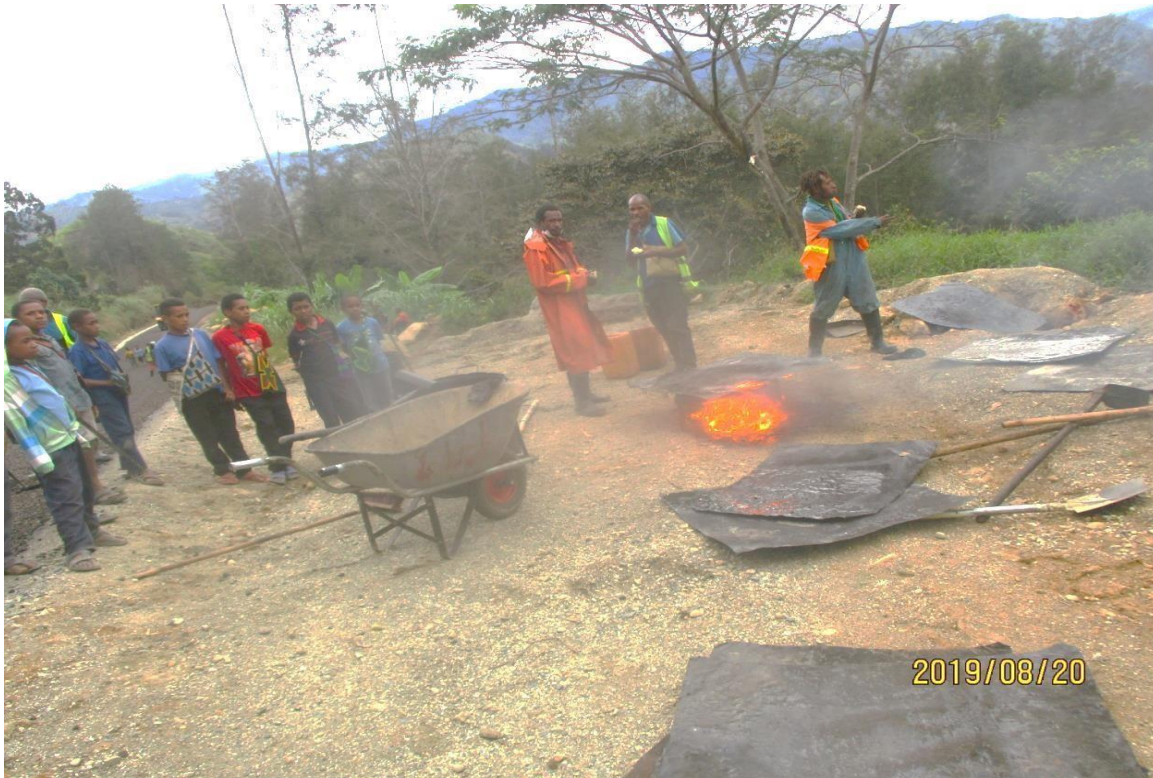
**Picture 6: By standers are exposed to harmful gas from burning of bitumen.**

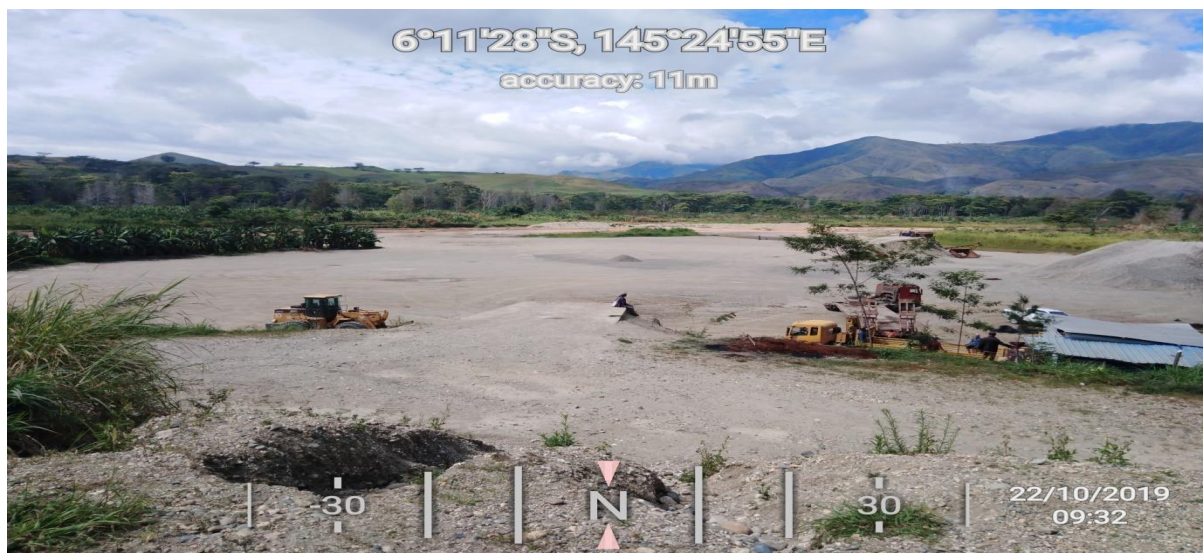
57. The Upegu Quarry was closed as of mid-October 2019 due to conflict over royalty payments amongst the landowners. T

58. The contractor is yet to provide a proper quarry closure plan for the Upegu Quarry. Thus, as of November the contractor has purchased materials and aggregates from the Bena Bridge Quarry.

**Picture 7: Quarry site at Upegu Quarry operation**

All machines were oved out crusher dissembled due to contractor winding down.

- 95 The contractor must assist monitoring team with information and data needed for report writings.
- 96 The contractor is required to provide a Quarry Closure Plan for Upegu Quarry immediately, as closing a quarry without proper close-up mitigation is an environmental violation.

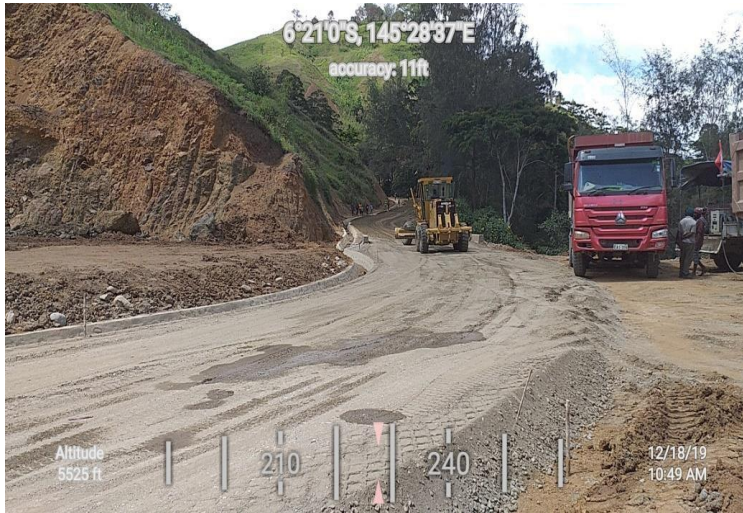
**Figure 11 laying of road base underway**

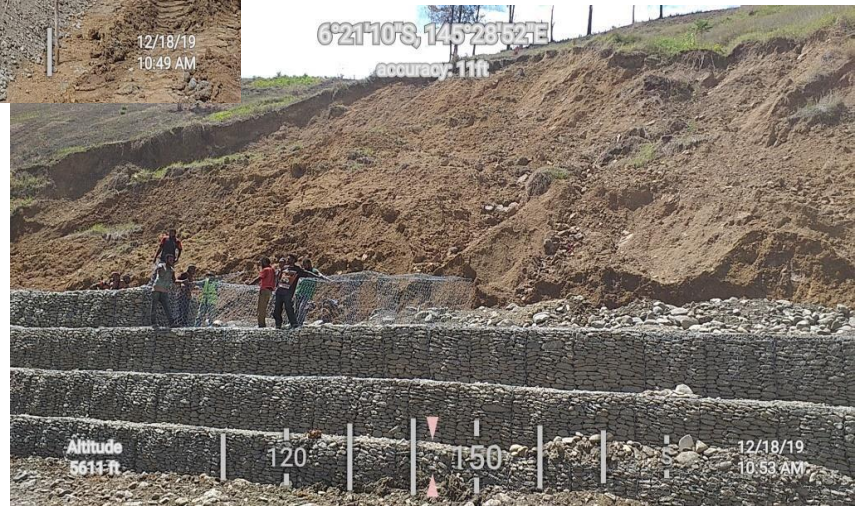
**Figure 12 Gabion baskets built to prevent future landslips**

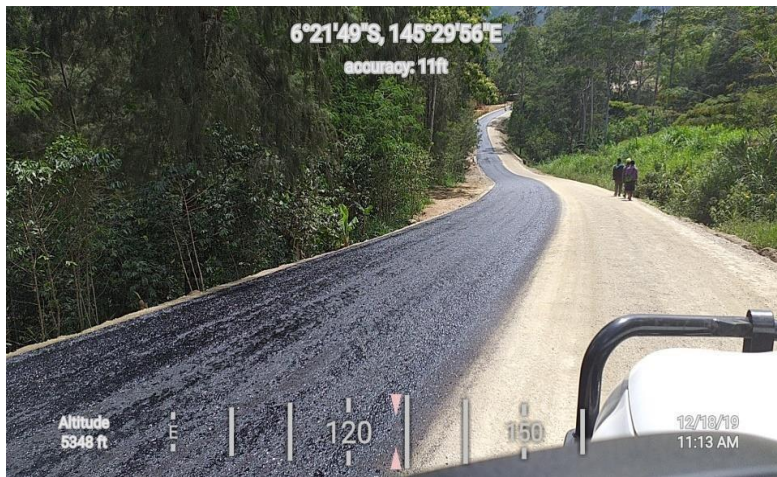
**Figure 13 Priming along 31km to 32km**

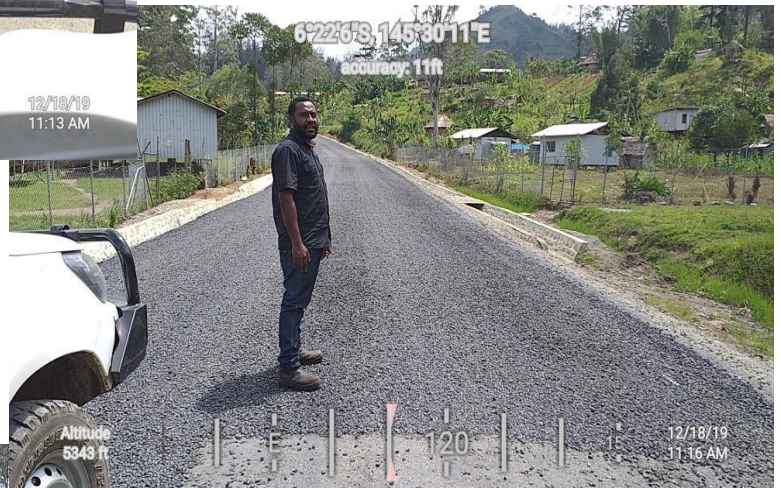
**Figure 14 Sealing at Imaka**
