## **PNG: HIGHLANDS REGION ROAD IMPROVEMENT INVESTMENT PROGRAM (HRRIIP) – TRANCHE 3**

### **NIPA-MUNIHU ROAD SUB-PROJECT**

## **ENVIRONMENTAL MONITORING REPORT**

Semi-Annual Report (July-December 2019)

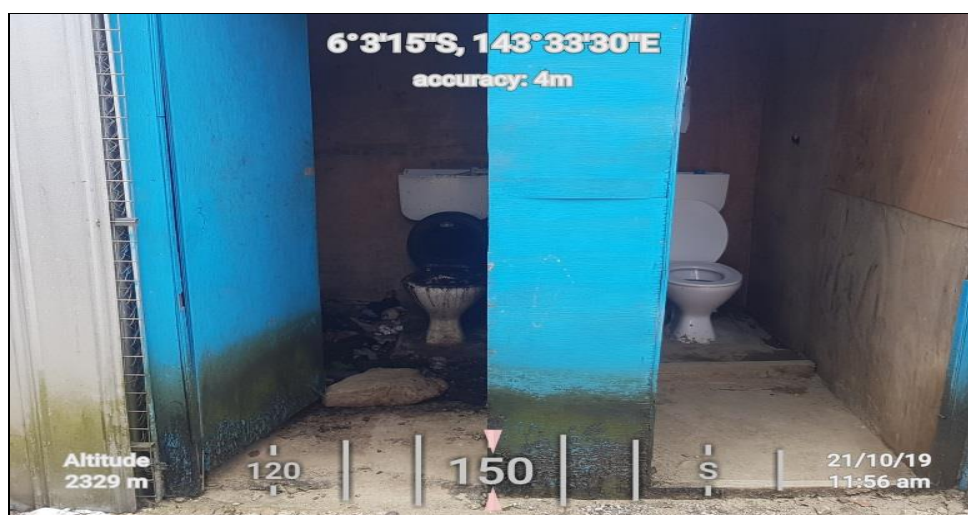
**Picture 1: Septic toilets provided for national workers at Wiri camp**

The toilet pits for other national workers at Mt Wiru camp for both male and female are almost full and resulted in producing bad odour polluting the workers living nearby. Some people used surrounding bushes to dispose their wastes (faeces) which is been discouraged by camp administration. This may cause water and air borne diseases such as diarrhoea, typhoid and TB. Hence, it is recommended that septic toilets must be provided for all the workers in all the contractor's camps and workshops

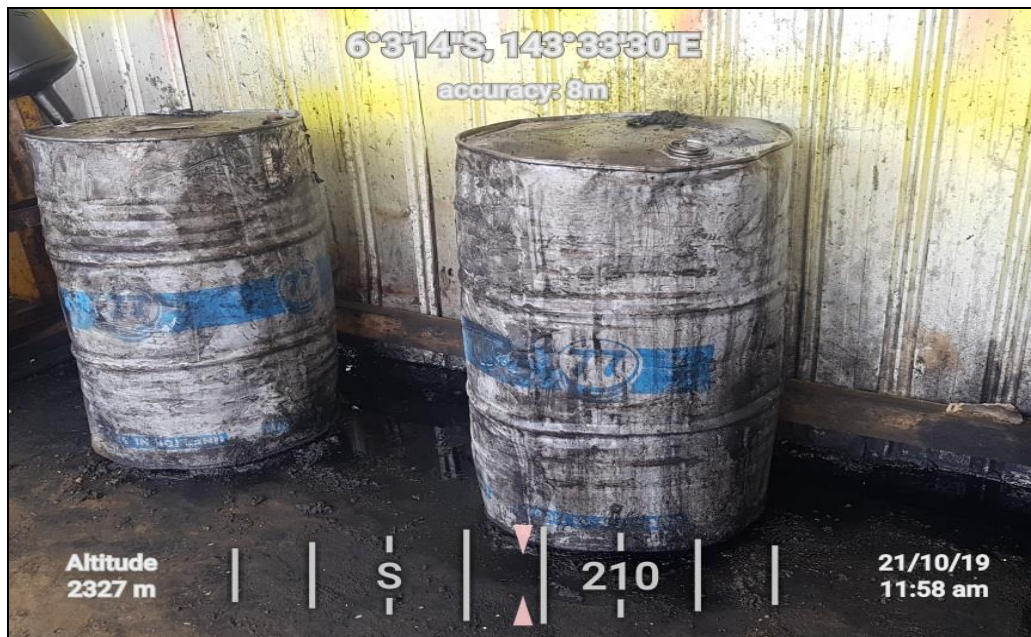
The proper containment of used oil and lubricants need to be followed and closely monitored due to a recurring problem of spillage and improper disposal which has been observed flowing into the storm drain. There has been spillage of used oils and lubricants near the contractor's workshop. This has been a concern to the surrounding food gardens and needs to be contained. The contractor also needs to do proper bunding on the newly constructed fuel storage facility.

**Picture 2: Oil leaking drums at Mt. Wiri contractor's workshop**

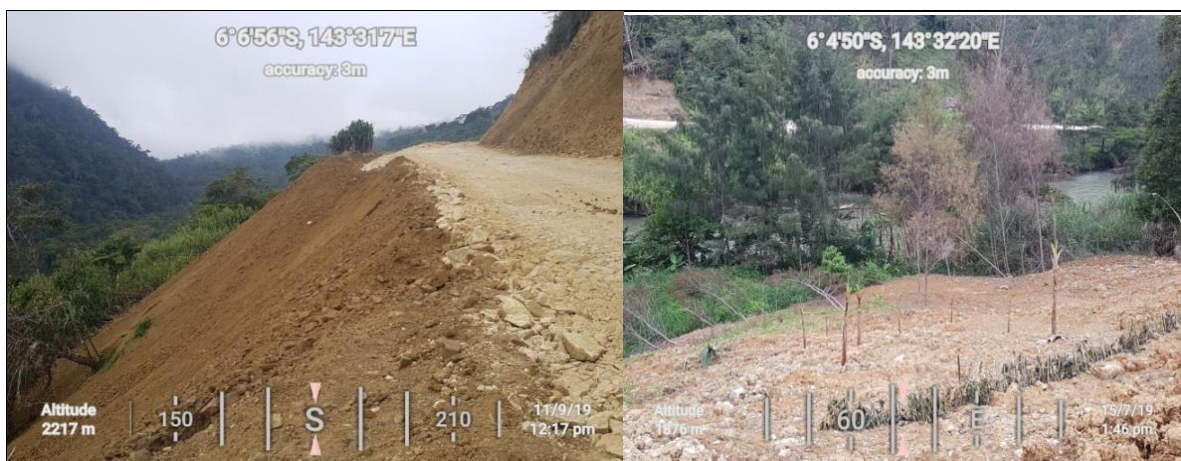
The recurring issue of improper waste disposal from clearing and grubbing has resulted in the deposition of silt and sediments in creeks and food gardens. The spoils along the roadside needs to be properly disposed in the designated sites. It is obvious that the contractor has not dumped that spoils from clearing and grabbing into the proper sites as shown at Sumbi village (Ch 19+000).

**Picture 3: Soil erosion and sediment loads near Lai River.**

The contractor must follow the CEMP guidelines on proper spoils disposal. Despite repeated warnings, the contractor has provided excuses and need to be closely monitored by the environmental officers concerned. The contractor will be issued a notice of violation for non-compliance.

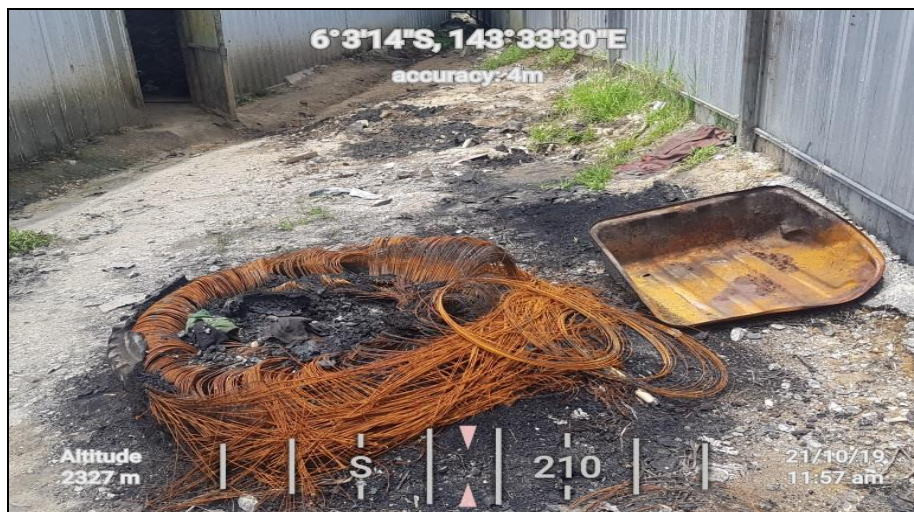
Hence, it is important that mitigation measures must be taken by the contractor to address the issue. Now, the contractor is using water truck to sprinkle water on the road surface to reduce dust emission. The contractor also does routine maintenances on its truck and machines to reduce fume emission. The burning of used tyres at the contractor's camp site is a great concern. The fumes produced during burning of these tyres is harmful and pose health risk for people living near the camp.

**Picture 4: Remains of burning of used tyres at Mt. Wiri Camp site.**

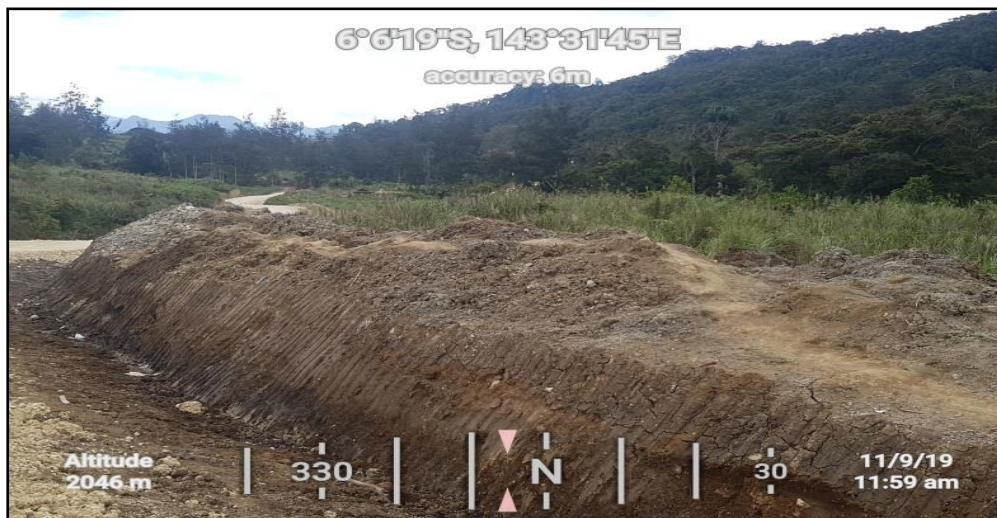
The categories of wastes generated from the project consists of overburden from construction sites and improper disposal of spoils from excavation and other earth moving works such as clearing and grubbing. The contractor has obtained permission from landowners for the waste disposal; however, the dumping of waste along the roadside is still a recurring problem.

Picture 5: Improper dumping of clearing and grubbing spoils on roadsides.

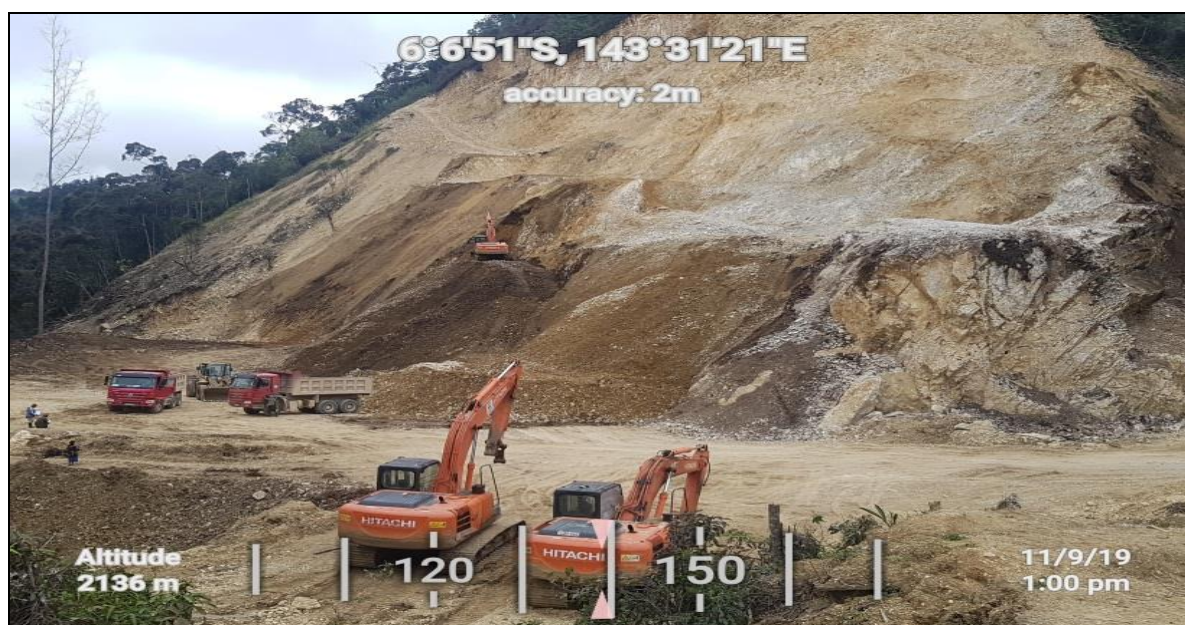
**Picture 6: Limestone extraction at Nimb quarry**

A technical assistance meeting was conducted to provide outlines and explanation on best practices for QMP management. There is need for better quarry management hence current practice could cause environmental harm from land slips and destruction of forests by using machines (Photograph 6).

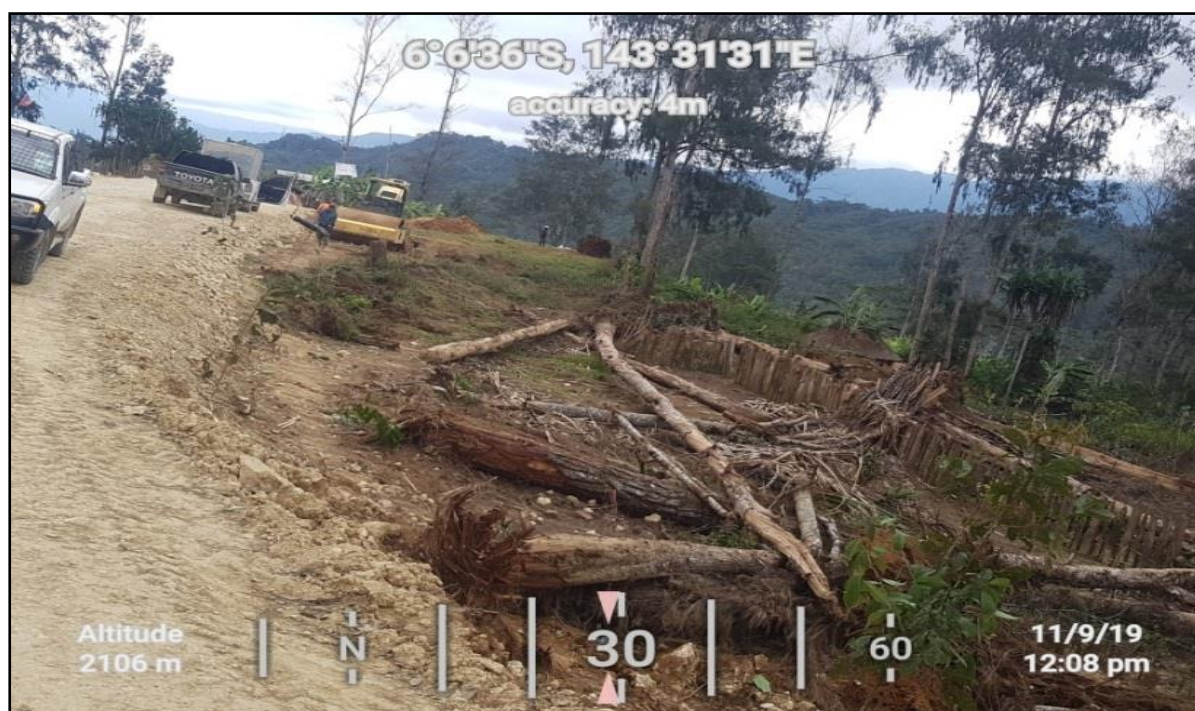
The felled trees from the clearing and grubbing operation were given to the respective landowners which were then turned into lumber and sold along the roadside (Photograph 7).

**Picture 7: Removal of trees for roadside clearance at Sumbi village**

However, the contractor needs to comply with the inventory and marking of all trees destined for removal. These should be marked together with the Environmental Officer of HRMG and only the marked trees can be removed. No tree shall be removed without the prior approval of the Engineer and any competent authority. The total number of trees to be removed during the DMS for the Nipa Munihi road project was not recorded in the IEE. Hence, trees were marked and removed as clearing and grubbing commenced. Some of the trees that were not removed during the clearing and grubbing phase were removed recently with the approval from the landowners.

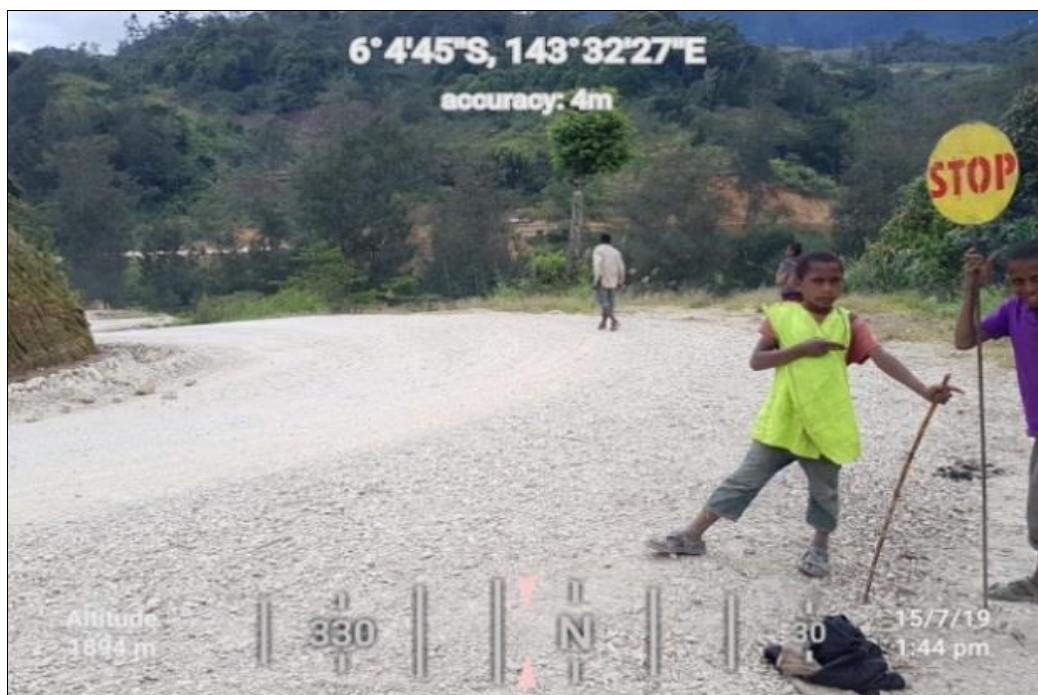
The Contractor has provided traffic signs or traffic aides for its project implementation in line with the requirements of the approved Traffic Management Plan.

**Picture 9: Traffic Signage**

The contractor has been advised to provide the required traffic management resources including standard traffic signage based on its stated TMP.
