PNG: HIGHLANDS ROADS IMPROVEMENT INVESTMENT PROGRAM (HRRIIP) – TRANCHE 3

NIPA-MUNIHU ROAD SUB-PROJECT

Prepared by Highlands Road Management Group (HRMG), Department of Works for the Asian Development Bank

Semi-Annual Report (January-June 2020)

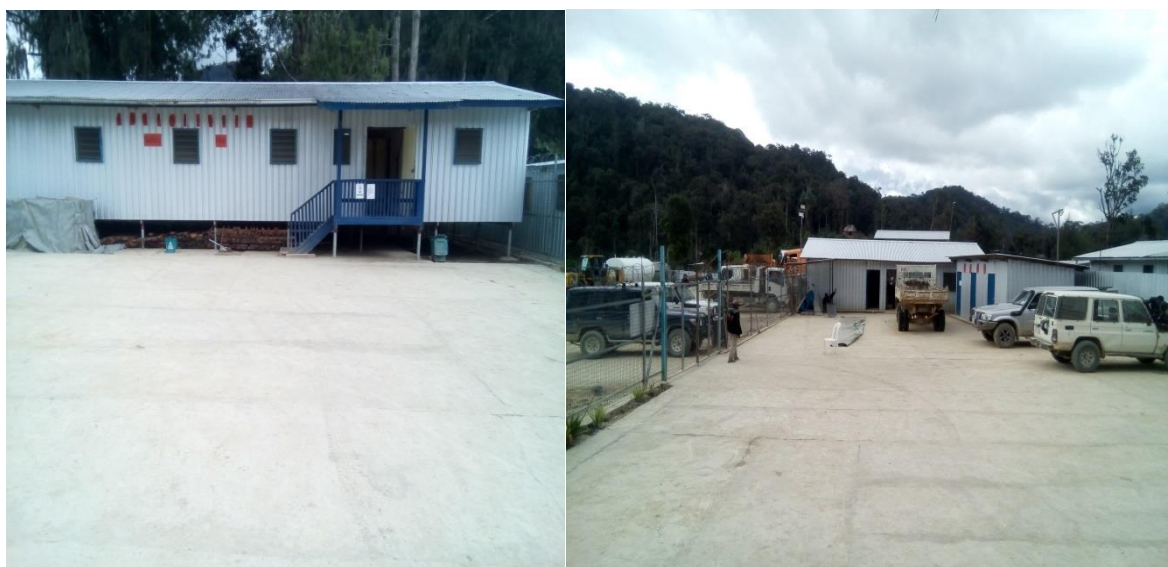
Photograph 1-2: Aerial view of Mt. Wiri Camp Site in Munihu

50. There Inspection was only done for Mt. Wiri campsite and yard. All facilities at the campsite were well maintained and properly cleaned.
51. The contractor operates two main camps and one sleeping quarters for fulltime local employees. Mt. Wiri Campsite is the contractor's main project management facility, while the River Nembi campsite hosts the project operations at the Nipa end of the project. The local employees' accommodation quarters is located 20m down the road from Mt. Wiri Campsite.
52. All office, accommodation, kitchen and entertainment facilities at Mt. Wiri and River Nembi Campsites were generally well maintained.

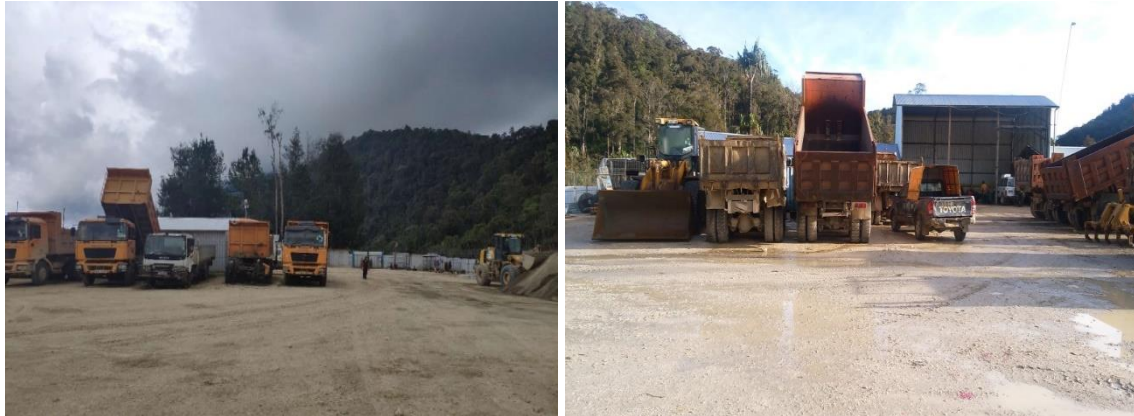
Photograph 3-4: Workshop at Mt. Wiri Camp Site in Munihu.

54. The workshop facilities/ yard in Mendi and Nipa are well maintained and fully functional with good updated modern operational mechanical tools for mechanic use. The workshops are used for the following activities: servicing of heavy equipment and machines; tyre fittings; electrical and auto-electrical servicing and welding and metal fabrications.

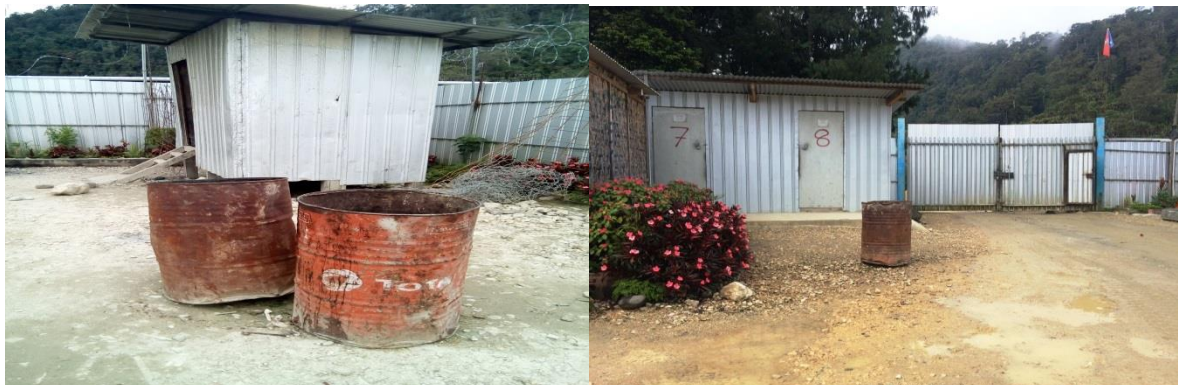
Photograph 5-6: General waste collected and dumped at Mt. Wiri Camp Site

55. Generally, the campsite wastes such as plastics, papers, timber off-cuts, cut boards and other degradable foreign substances were placed in a chronological order. The camp site both in Nipa and Munihu have been built wastes or general rubbish drum and a pit dug to collect any wastes found in the camp sites. Thus, a good indication of sanitation and general wastes management techniques application. Otherwise, there were no changes occurring to the status of the environment and there was no sign of waste found within the camp site.

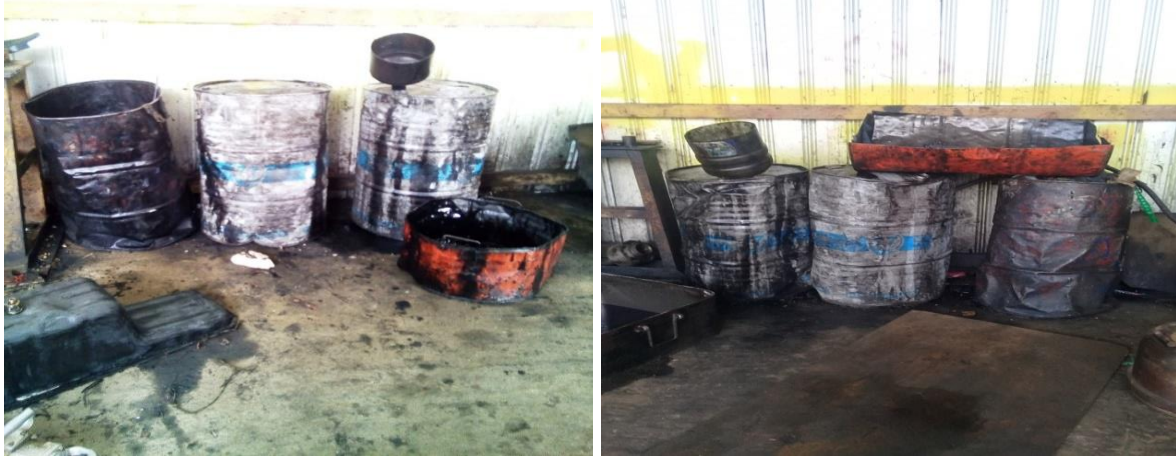
Photograph 7-8: Indicates used oils from the workshop been stored

56. Liquid wastes produced from the kitchen and sewage flows directly into the concrete constructed septic system. Liquid like oils from the workshop were properly deposited to temporary cut drums to be stored before being deposited to the proper disposal or deposited site.

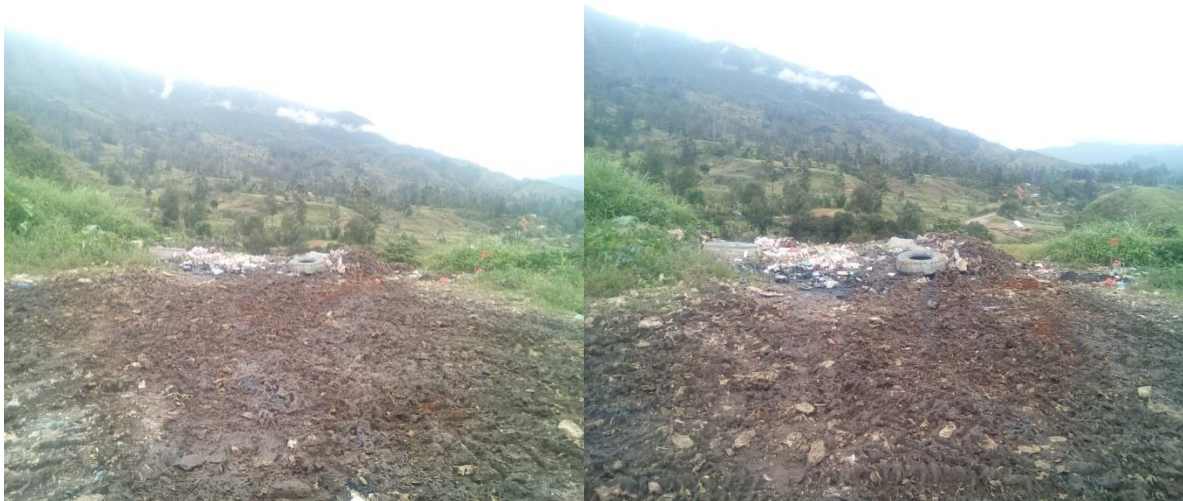
Photograph 9-10: Indication of the Public Dump site at Tende along the Mendi Kandep Road.

57. Construction spoils and other inert wastes from all earthworks and other construction activities produced both in Nipa and Munihu, some have no proper allocated location dump site or disposal area. All the spoilage and unused rocks or ground mud were dumped along the roadside purposely to develop new structures and for field development. Therefore, no specific dumping site was identified.

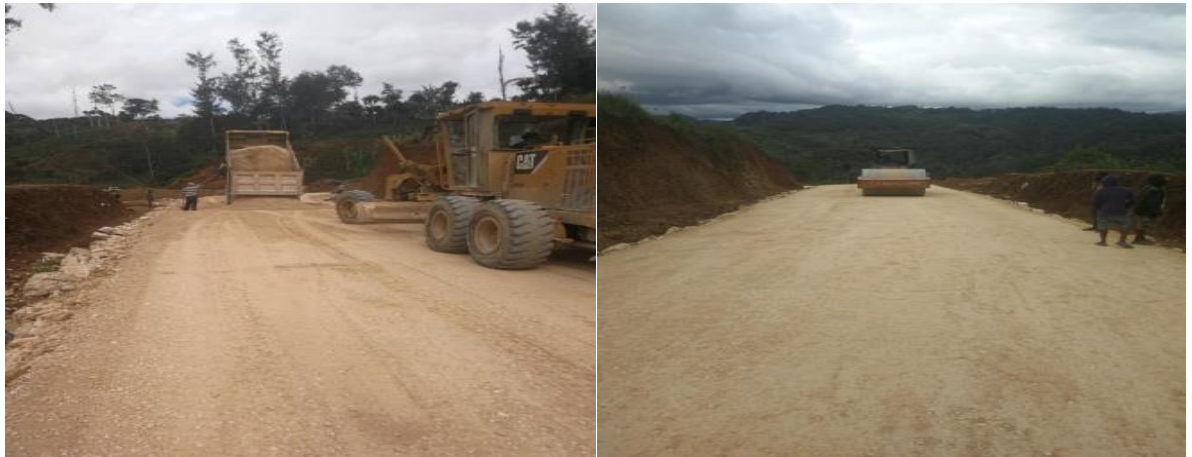
Photograph 11-12: indicating Sub-Base at Ch 8+000-Ch 9+000

61. The Sub-base stops at CH 9+460 and the base course from Munihu side is at CH 13+400 and Nipa Side is at CH 6+250.

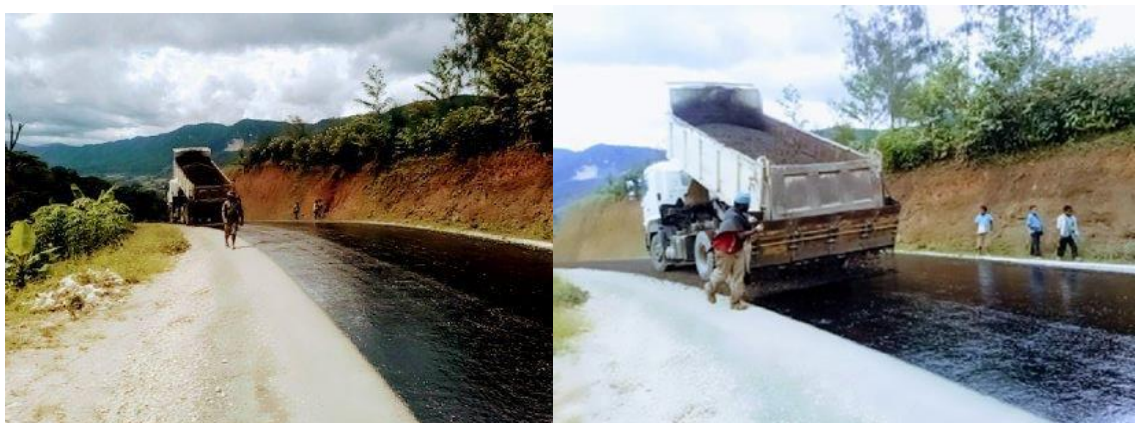
Photograph 13-14: Showing 19mm sealing at CH 20+100-20+400

62. For the month of June, there were several sealing and that has been done to the road project and also Prime Coat Sealing. The table below shows the Prime Cost and the First Coat Sealing done in June 2020.

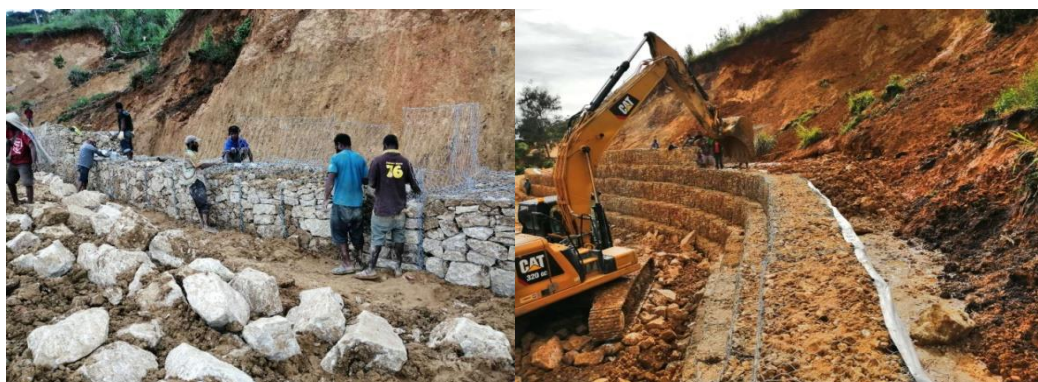
Photograph 15-16: Showing Gabion Work at CH 8+660- CH 8+740

63. There was a major erosion causing a big landslide at CH 21 +770 which the contractor has now maintained it already by building gabion baskets to uphold the unstable soil. Some other few small landslides inspected on the site during construction period are at 12+ 340 and 12+ 220 due to rainy season from the past month of April, but now the company extended the gabion baskets to minimise the erosion and landslide. The most of drainage systems and headwalls or culverts are installed; the erosion on the site would be minimized. Creeks, Streams and waterways were found near the construction site but fewer damages done.
64. Sedimentation was only expected during rainy season in both sides (Nipa & Munihu) because it always accompanies with landslide and deposition of debris and mud due to heavy floods.

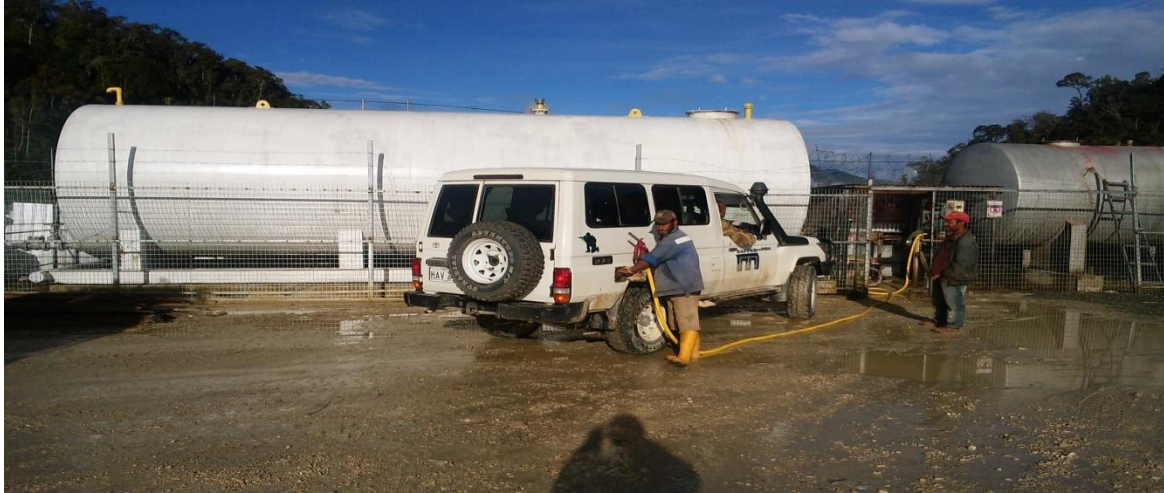
Photograph 17: Main fuel storage at Mt. Wiri Camp Site

66. All fuel for the project operations are stored in bulk fuel tanks. The contractor has a 20,000-liter capacity main reservoir diesel for both camps. An electrical fuel pump is attached to it for all fuel transfer and distributions.

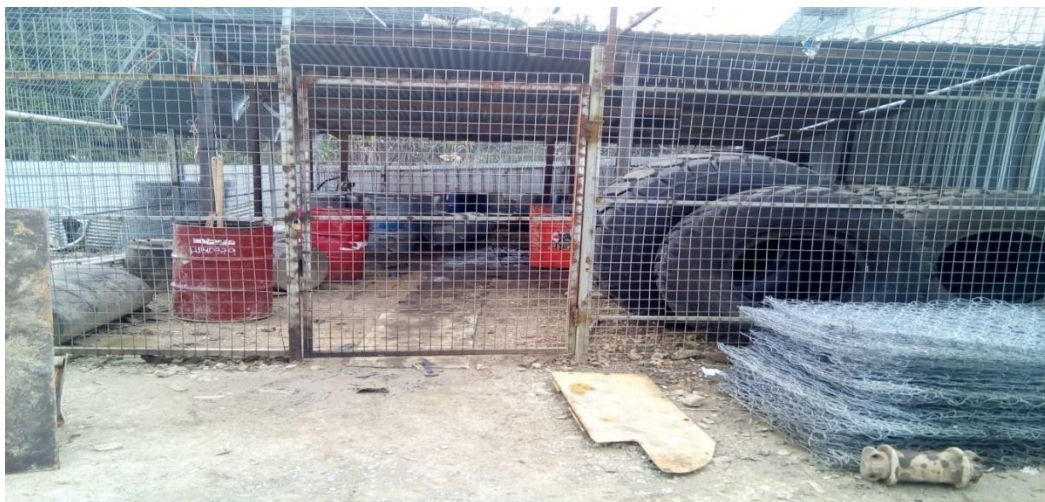
Photograph 18: Indicating how hazardous materials are stored at Mt. Wiri Camp

67. The common lubricants used on site including hydraulic oil, brake fluid and grease. All hydraulic oils and transmission gear oils are purchased in drums and stored in a cargo container.

68. All used and unwanted lubricants containers were collected and disposed at the landfill at the back of the campsite.

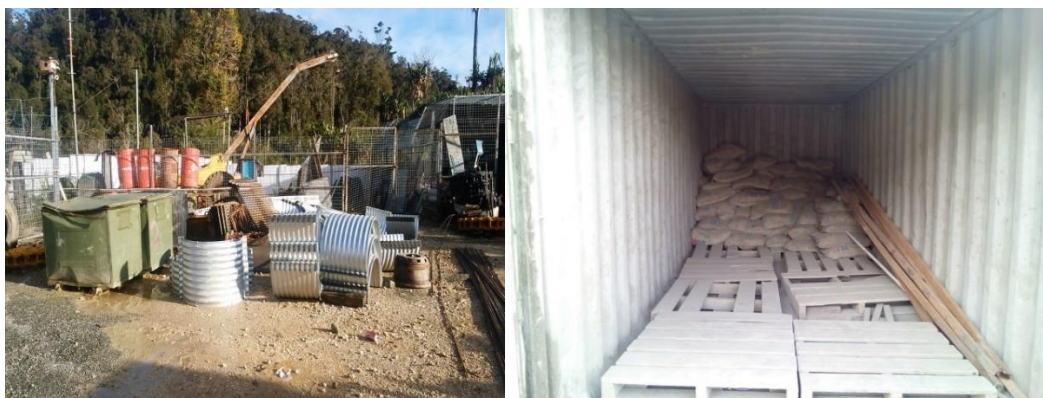
Photograph 19-20: Showing the construction materials stored at Mt. Wiri

70. The construction materials purchased at stored in Mt. Wiri Camp and later been distributed, supplied and transported to the construction site as required.

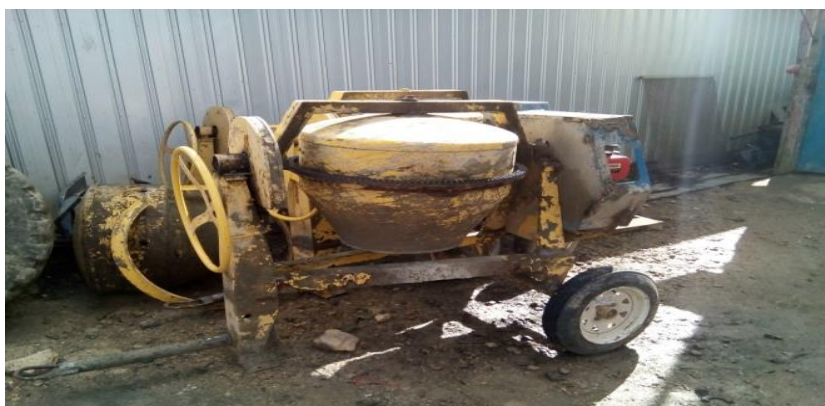
Photograph 21: Showing mobile cement mixers used for concrete production at road sites.

71. The Contractor has not permanently constructed a batching plant for all concrete mixing thus, mobile cement mixers are being used for all cement and fine sand mixing for concrete production throughout the project site. The mobile cement mixers are being transported to the required project sites when needed to carry out the required cement mixing.

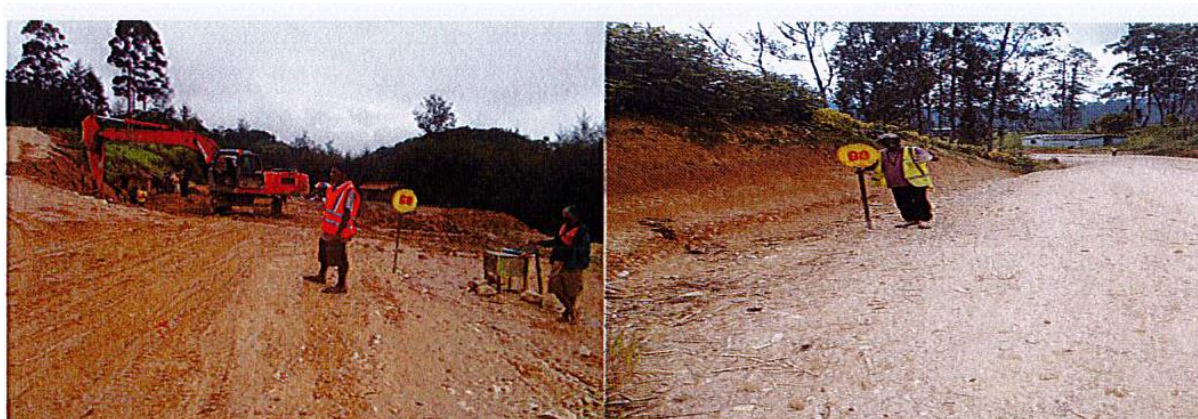
Photograph 22-23. Spotters with signage regulating the traffic.

109. The Contractor has provided traffic signs or traffic aides for its project implementation in line with the requirements of the approved Traffic Management Plan.
110. The contractor has been advised to provide the required traffic management resources including standard traffic signage based on its stated TMP.
