PNG: HIGHLANDS REGION ROAD IMPROVEMENT INVESTMENT PROGRAM (TRANCHE 3)

Henganofi-Nupuru Road Sub-Project

ENVIRONMENTAL SAFEGUARDS MONITORING REPORT

(January - June 2018)

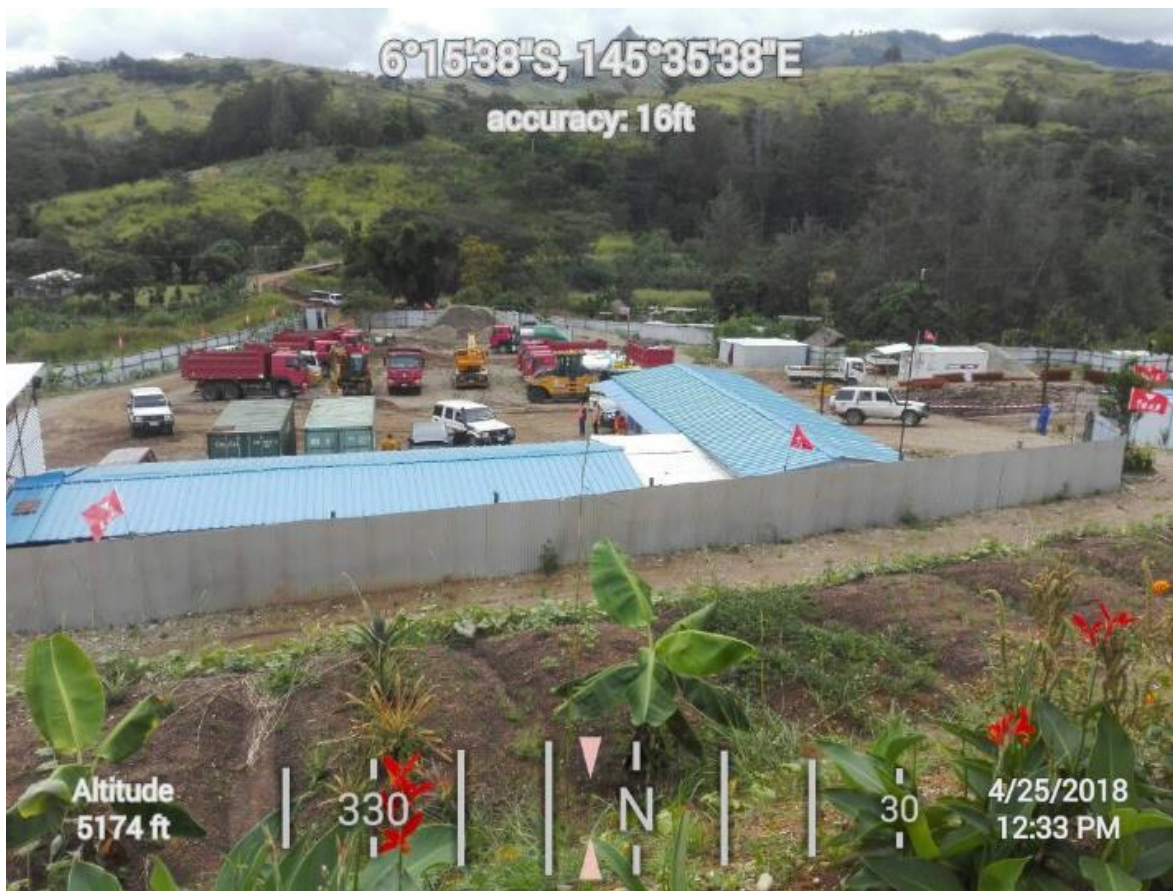
39. The contractor has established its camp site at Konanempi at Ch 00+300. The camp consists of offices and quarters for employees (Photo 1).
40. The main issues that were identified are the disposal grey water, leaking pipe from the septic tank and the disposal of waste water into a main drainage. An attempt was made by the contractor to provide a leach field which needs improvement to prevent contamination of surface and groundwater (Photo 2).
41. Close monitoring need to be conducted for solid waste, liquid waste and hazardous waste management plan compliance. The contractor has to provide the site development plan to determine sewage treatment facility for improvement and closure mitigation in the future.

Photo 1: Newly built contractor's campsite at Konanempi village.

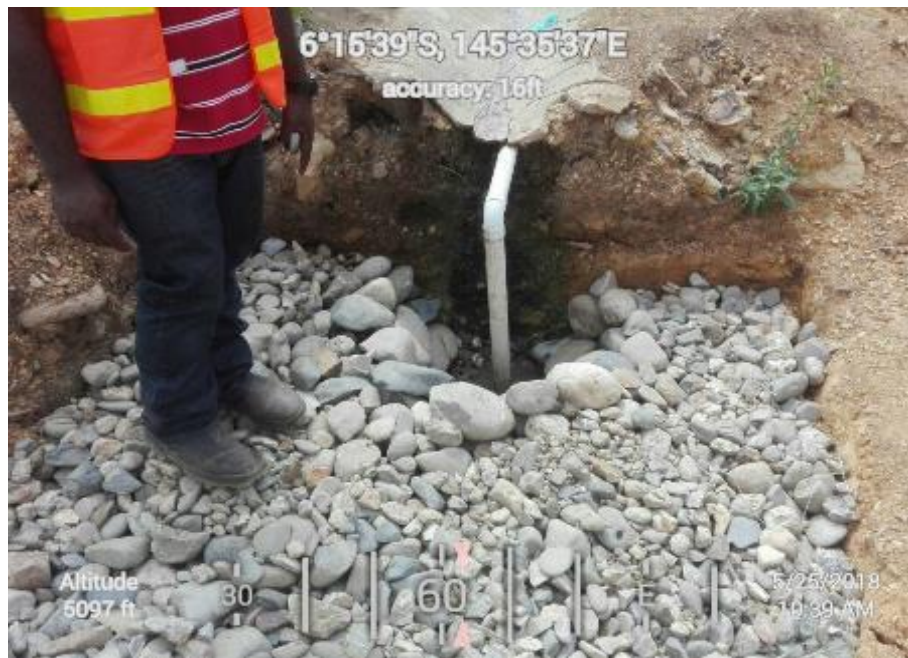
Photo 2: Sewerage pipe discharging to a leaching field.

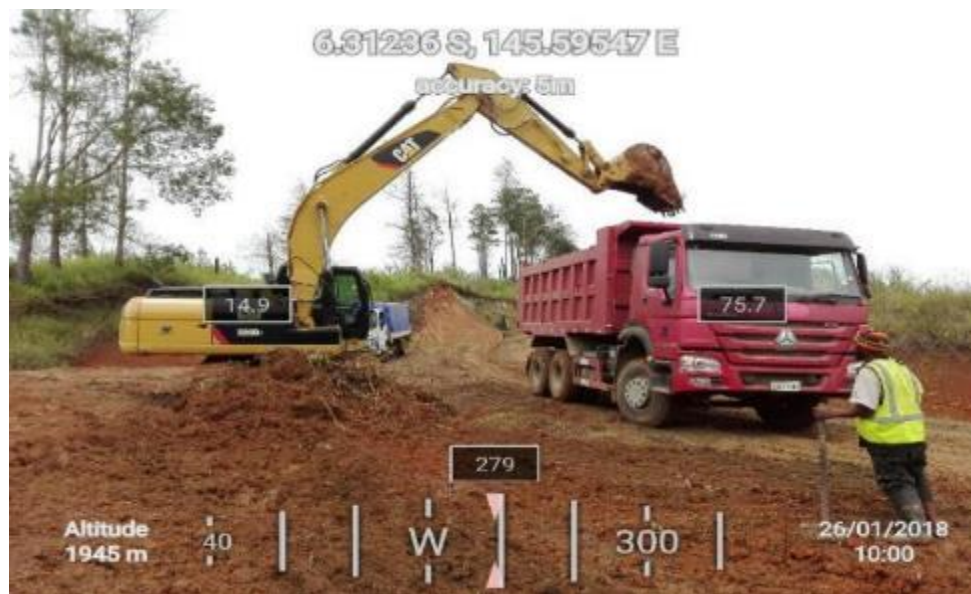
42. The contractor has shown responsible soil erosion control through the hauling of soil spoils to approved dumpsites (Photo 3) and working when there is no rain is also practiced.
43. Monitoring should be done in the clearing and grubbing area at Km 10+700, excavation and earthworks at Km. 7 and culverts installation at Km 0 – 10+700. An important resource is the Erosion and Sediment Control Best Management Practices Manual which was provided during the Induction Meeting.

Photo 3: Hauling spoil to the approved dumping sites.

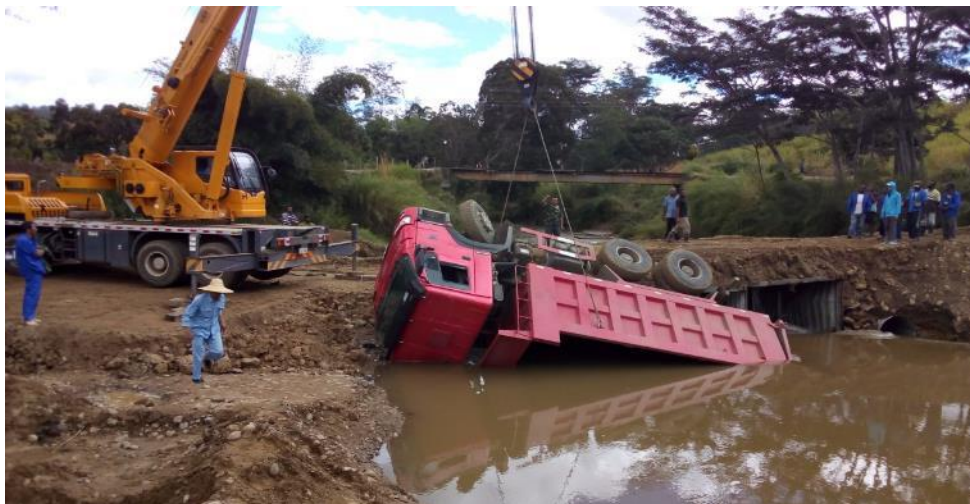
47. The PNG Environmental Water Quality Regulations of 2002 will be used as basis for baseline establishment and monthly compliance monitoring.
48. The contractor has created an access road from the quarry to the project site. This was done by re-channeling the river creating problems for the community downstream. The diversion of a river requires environmental permits from CEPA. This activity has also resulted in an accident when the contractor's truck fell into the river with slight injuries to the driver who was treated at Goroka Hospital (Photo 4).

Photo 4: Overturned contractor's dump truck.

69. The accident where a contractor's truck overturned while transporting quarry materials from Upegu quarry is the latest accident reported. The other risks to public safety in terms of erosion and sedimentation of water bodies and home gardens need to be assessed for future road work activities.
70. A Contingency Emergency Response Plan has been prepared by the contractor which will mainly focus on the construction works that they will undertake in their specific areas of concern and the attendant potential risks and hazards.

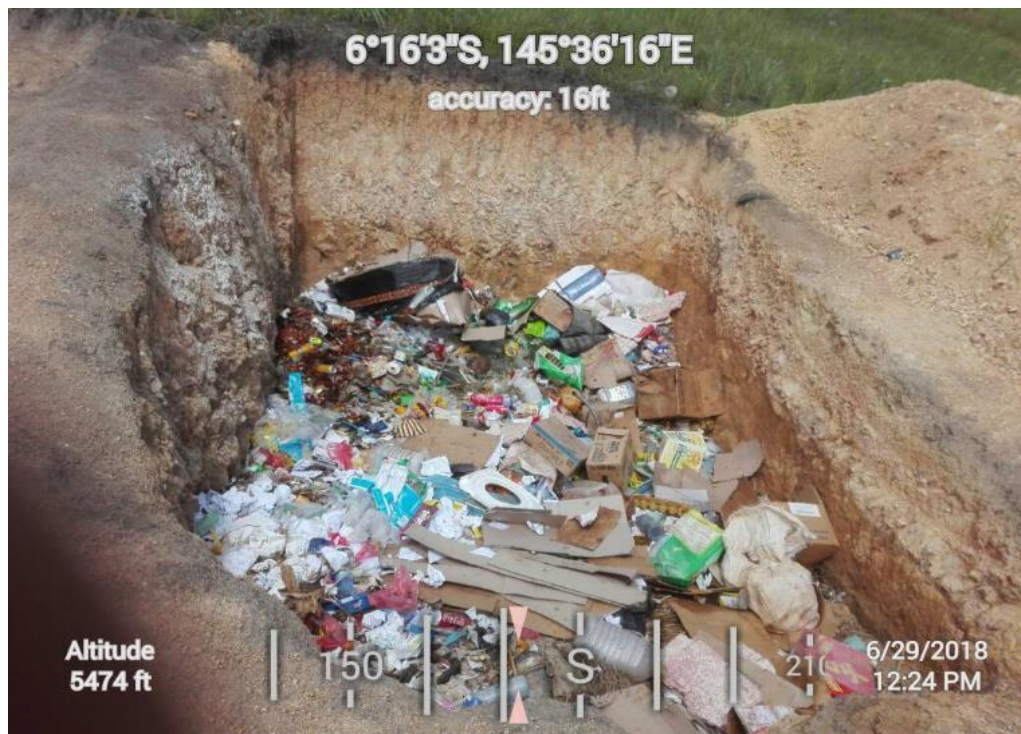
51. Clearing and grubbing spoils are deposited in agreed upon disposal sites with stable slopes and with the permission of the landowners. The monthly reports covering the period indicate that spoils are disposed of properly.
52. The contractor disposes its unsegregated solid wastes into open dump areas. . A daily cover of soil will reduce pests and prevent any residual smell. It is recommended that the contractor segregate its waste and follow best practices for solid waste management including composting and the principles of reduce, reuse and recycle.

Photo 5: Open dumpsite in the contractor's camp.

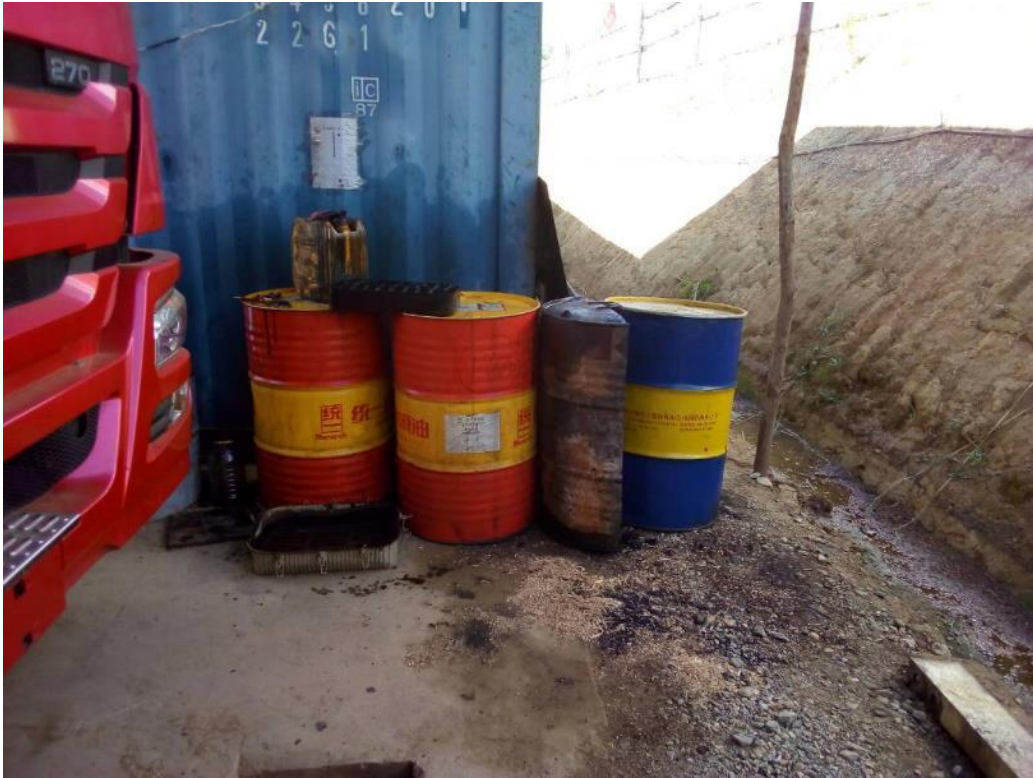
53. The hazardous wastes from the camp consist mostly of leaking lubricant drums which has seeped into the soil (Photo 6). The hazardous waste management strategy is to ensure that the soil is not contaminated by cementing the storage area and providing bunds to prevent leakage into other parts of the workshop area.
54. The management of hazardous wastes include their storage and ultimately disposal including fluorescent bulbs, computers and peripherals, printers and other equipment. This will also include used batteries, battery fluids, oils, lubricants, and asphalt products. There is a need to regularly monitor the implementation of the Hazardous Waste Management Plan.

Photograph 6: Leaking lubricant drums seeping into the soil and storm drain.

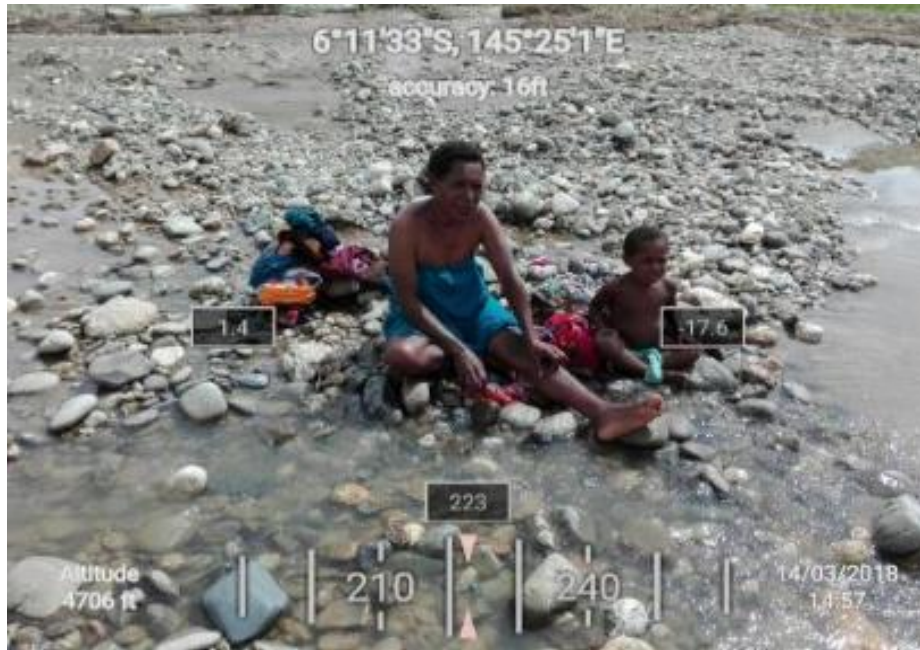
55. There are two quarries in the project. Upengu quarry is riverine while Minive is land based. The former is used for embankment works while the riverine quarry materials are used for base and sub-base works. The contractor has negotiated with the local landowners to extract materials from the quarry.
56. The Upegu Quarry has an approved QMP and Quarry Permit from CEPA, consisting of Permit No: EP-L2 (612) issued on 23/3/18 with a term of 10 years. Presently, the extraction volumes were estimated at 20,070 m³.
57. The Upegu Quarry is monitored to ensure erosion and sediment impacts mitigation measures are in place to reduce its impact to the communities who use it for domestic purposes (Photo 7).

Photo 7: A resident and her son doing laundry at Upegu River.

- IX. The Upegu Quarry has obtained a permit from CEPA last March 23, 2018 which is valid for a ten year period. Monitoring of this quarry needs to be done regularly as it is also used for domestic purposes.

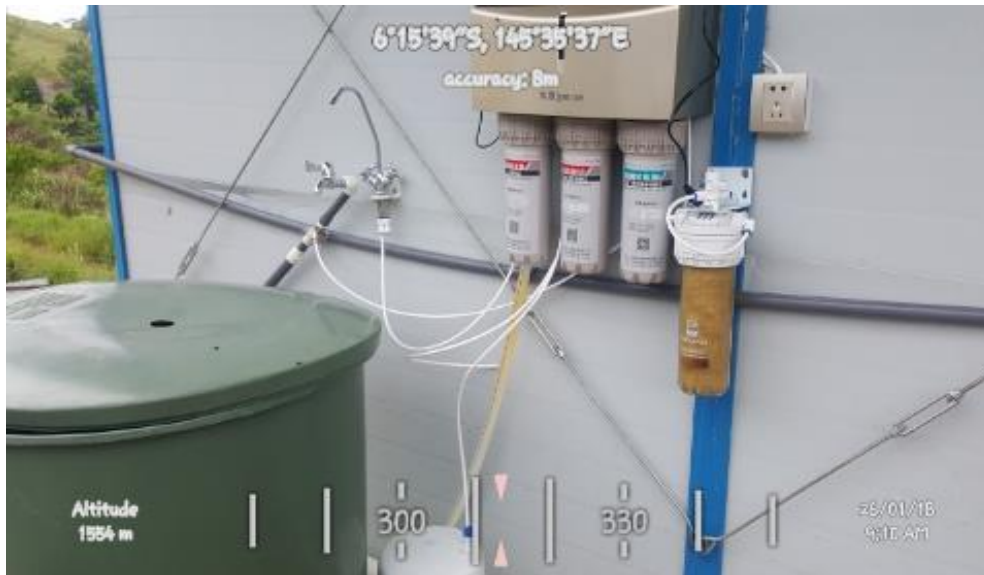
71. The contractor has to provide PPEs for its employees to prevent untoward accidents. Due to the non-compliance of this requirement, a Notice of Violation has been issued after many broken promises. The contractor has to follow its own Health and Safety Plan to address the safety and protection of all staff and the community traveling within the works. The contractor has provided a water filtration system for the convenience of the workers upon their request (Photo 10).

Photo 10: Water filtration system for the workers at the camp.

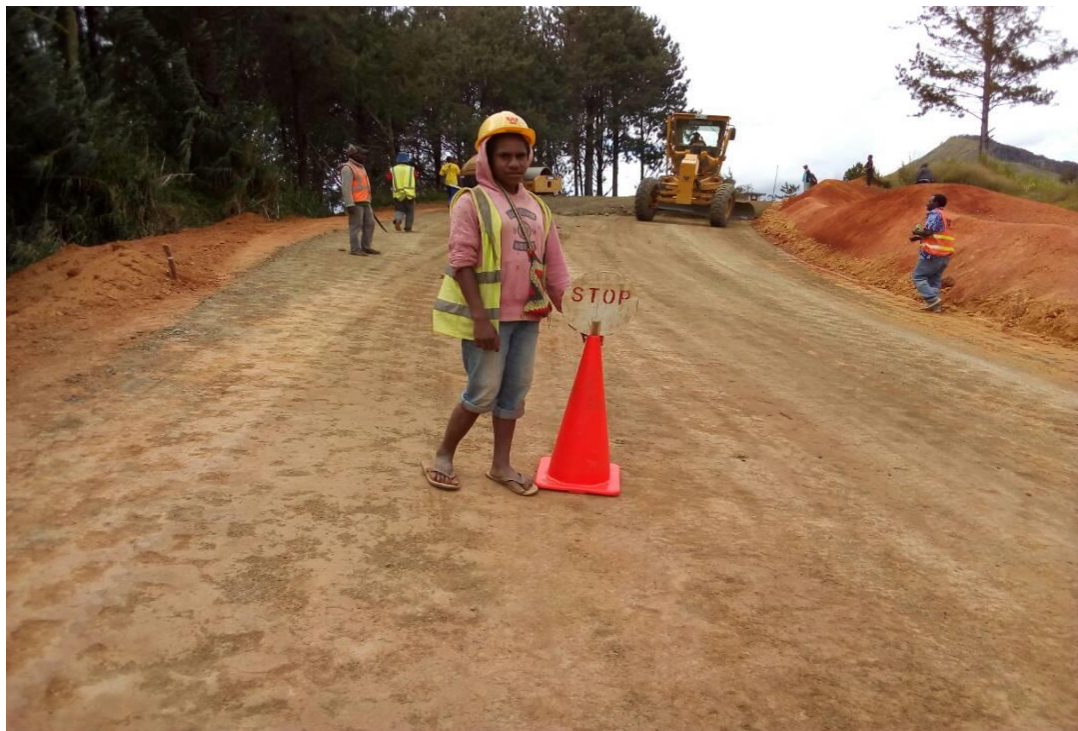
72. The contractor has prepared a Traffic Management Plan. However, improvement is required with the traffic signage and warning placards as they do not follow the traffic requirements and standards (Photo 11).
73. The contractor also has to provide signage; to warn motorists and the public of potentially hazardous situations including eroding areas and landslips.

Photo 11: A female traffic aider provides traffic assistance to motorists.
