Semi-annual Report

January 2019

**PNG: HIGHLANDS REGION ROAD
IMPROVEMENT INVESTMENT PROGRAM
(TRANCHE 3)
Nipa-Munihu Road Sub-Project**

Prepared by Highlands Road Management Group (HRMG) of the Department of Works for the Asian Development Bank

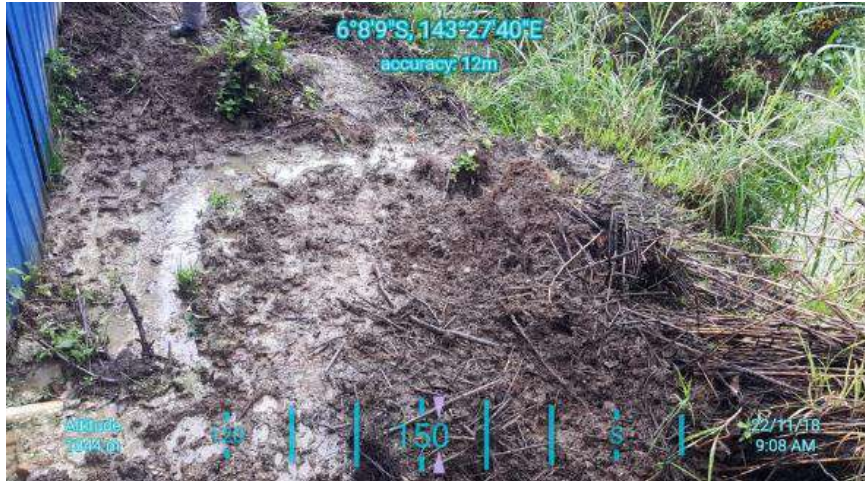
50. Following this observation, it was observed that during the third quarter of the year, the septic tank had been leaking which drained directly into the Nembi River (Photograph 1).

Photograph 1. Septage flows directly to Nembi River from Nipa Camp.

95. A potential problem is the sewage treatment facilities which do not conform to best practices and should be repaired immediately since it contaminates environmentally sensitive receptors such as water bodies.

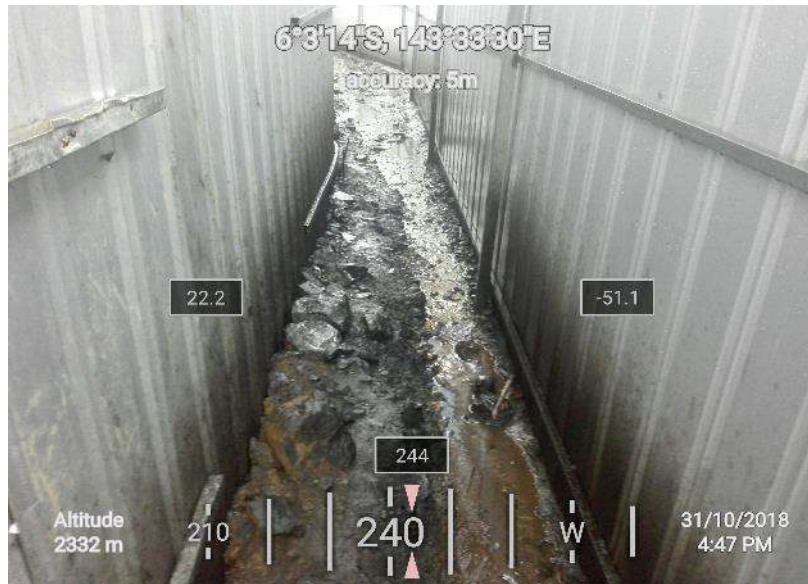
53. The proper containment of used oil and lubricants need to be followed and closely monitored due to a recurring problem of spillage and improper disposal which has been observed flowing into the storm drain (Photograph 2).

Photograph 2. The workshop's drain indicate waste oil discharges.

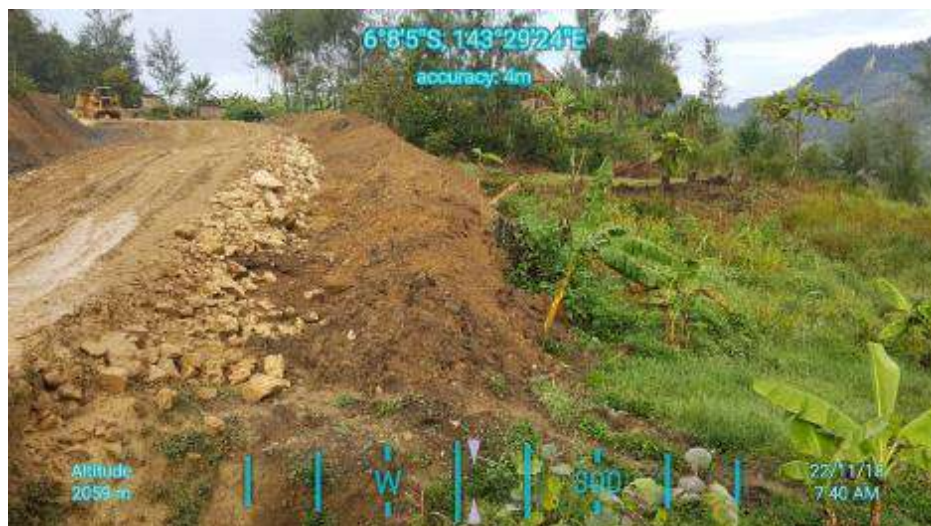
54. The recurring issue of improper waste disposal from clearing and grubbing has resulted in the deposition of spoils along the road side resulting in soil erosion and sedimentation of water bodies (Photograph 3).

Photograph 3. Spoils dumped along roadsides affecting food gardens at Ch 6+100.

55. The contractor has to follow the CEMP guidelines on proper spoils disposal. Despite repeated warnings, the contractor has provided excuses and need to be closely monitored by the environmental officers concerned.

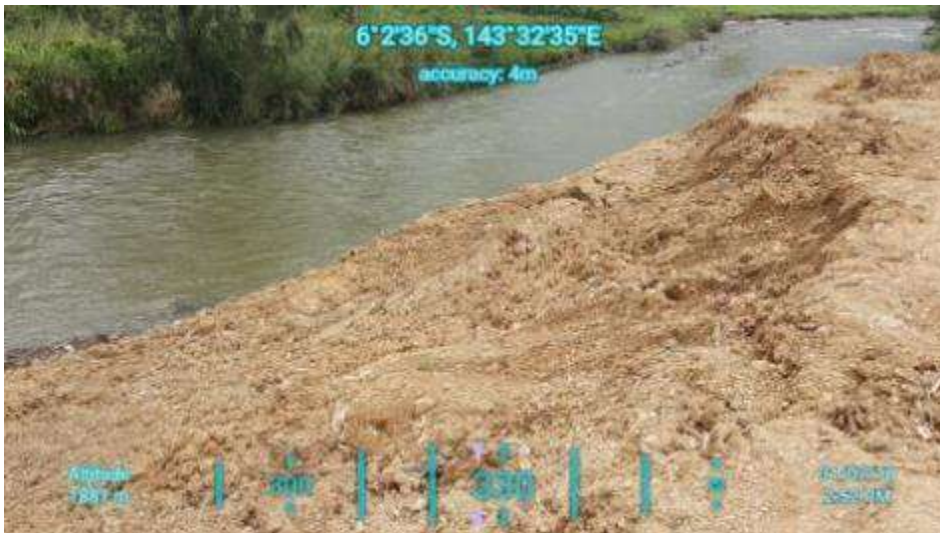
64. The categories of wastes generated from the project consists of overburden from construction sites and improper disposal of spoils from excavation and other earth moving works such as clearing and grubbing. The contractor has obtained permission from landowners for the waste disposal however, the dumping of waste along the roadside is still a recurring problem (Photograph 4).

Photograph 4. Waste earthworks dumped directly into the river Ch. 27+500.

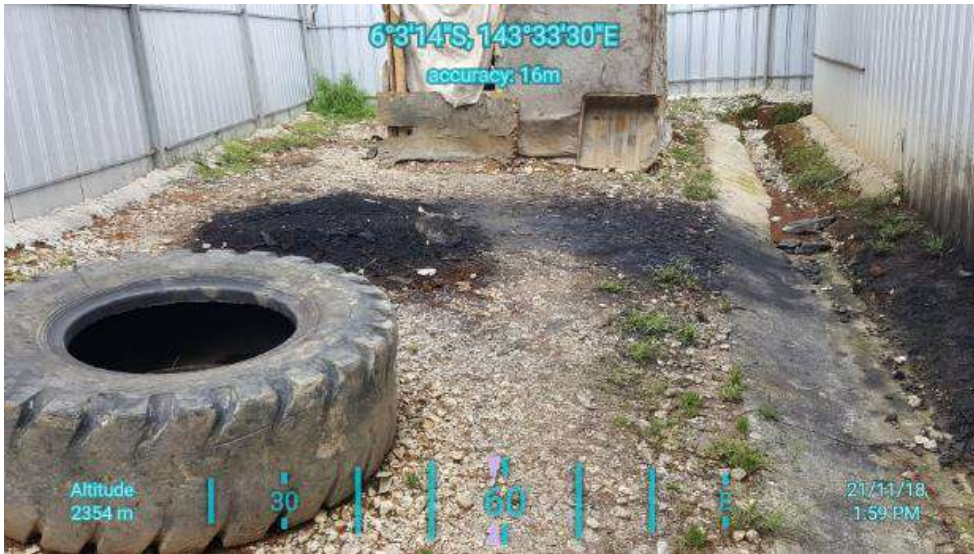
67. There are several instances of burning of used tires (Photograph 5). The contractor has to strictly implement the provisions of the submitted Hazardous Waste Management Plan. The Materials Safety Data Sheet (MSDS) for these wastes will also be part of the HWMP to ensure the proper handling of these materials.

Photograph 5. Evidence of used tires being burned at the camp.

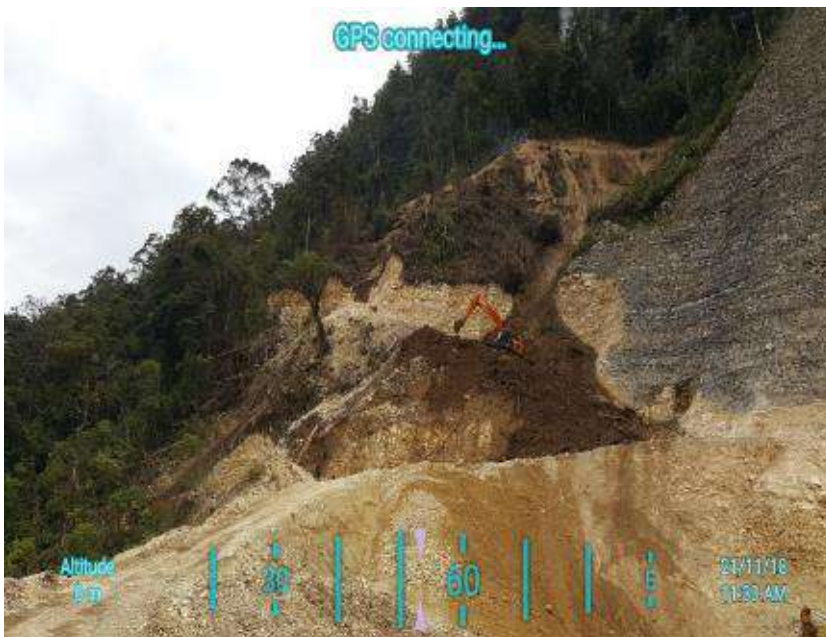
70. The need for better quarry management could cause environmental harm from land slips and destruction of forests (Photograph 6).

Photograph 6. Persistent excavation can make the slope unstable resulting in a landslide.

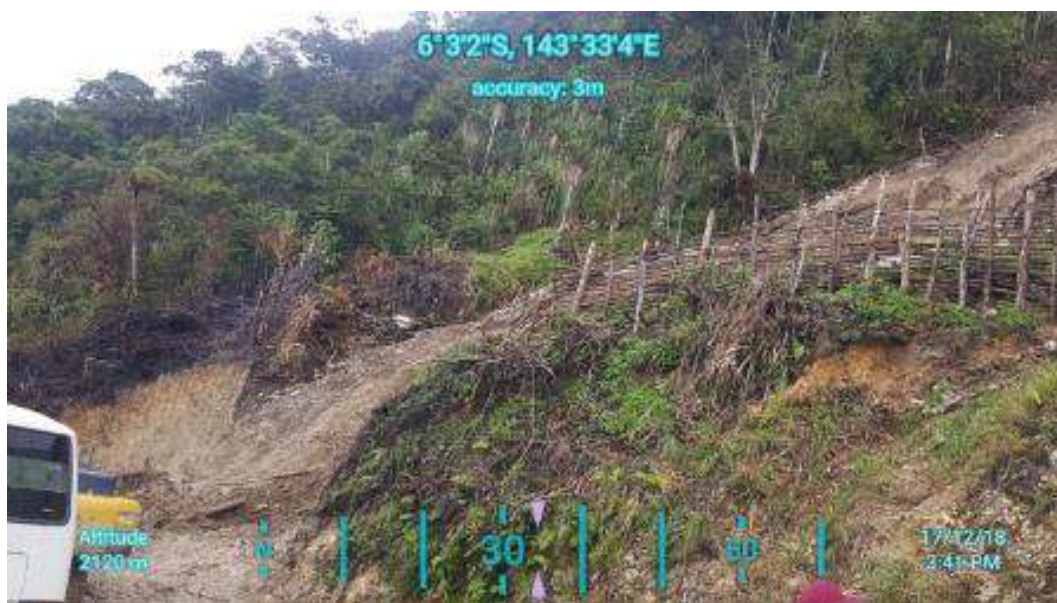
79. The risks to public safety in terms of accidents tragically resulted in death in the previous reporting period. The risks from erosion and sedimentation of water bodies and home gardens should also be assessed. In some cases even the road construction project is at risk from landslides (Photograph 10).

Photograph 10. Mudslide at Mt. Wiru of Mendi-Kandep road.

80. The Contingency Emergency Response Plan needs to be followed upon by the contractor to prevent such risks and hazards. ern and the attendant potential risks and hazards.

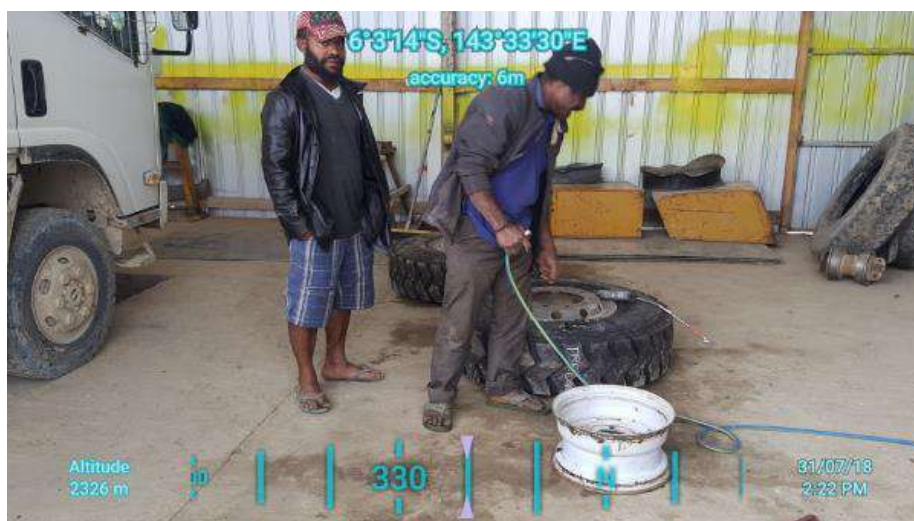
81. Despite repeated instructions, most of the workers in the site are not provided with PPEs. It is recommended that precautions should be taken by the Contractor to ensure the safety and protection against accidents of all staff and labor engaged in the works (Photograph 11).

Photograph 11. Workshop employees with no PPEs.

82. The Contractor should follow the approved Health and Safety Plan (HSP) which was approved by DOW-ESSU with operational details addressing health and safety concerns during his Works.

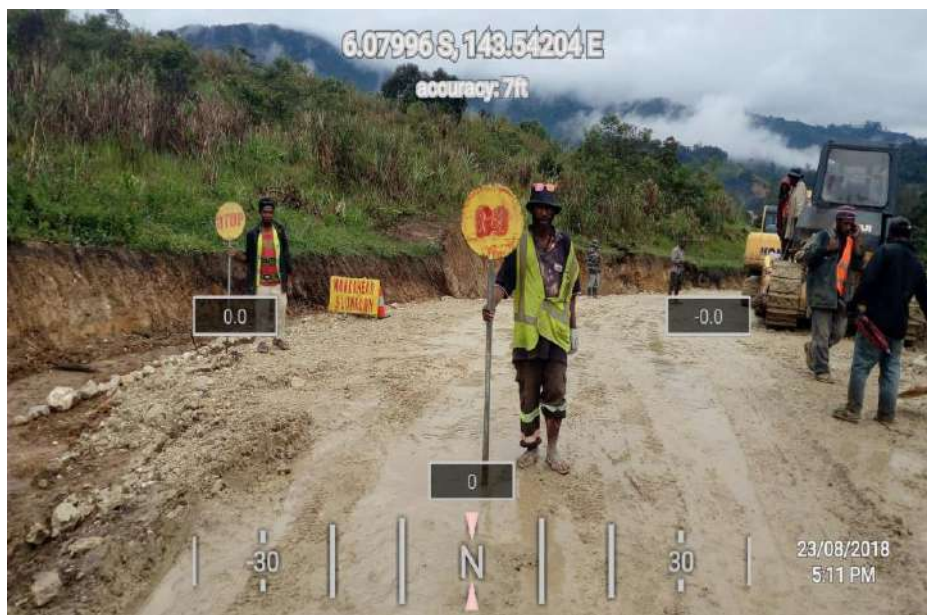
83. The Contractor has provided traffic signs or traffic aides for its project implementation in line with the requirements of the approved Traffic Management Plan (Photograph 12).

Photograph 12. Traffic aide providing signages.

84. The contractor has been advised to provide the required traffic management resources including standard traffic signages based on its stated TMP.

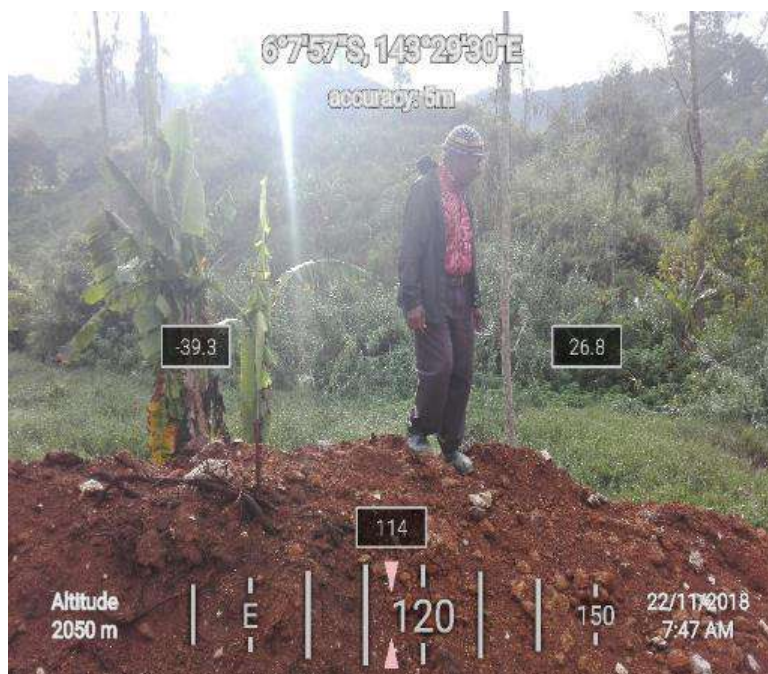
Photograph 13. Landowner complain of spoils dumped in his land without approval Ch 6+500.
