Semi-annual Report

PNG: HIGHLANDS REGION ROAD IMPROVEMENT INVESTMENT PROGRAM (TRANCHE 3)

Pangia-Wiru Road Sub-Project

Prepared by Highlands Road Management Group (HRMG) of the Department of Works for the Asian Development Bank

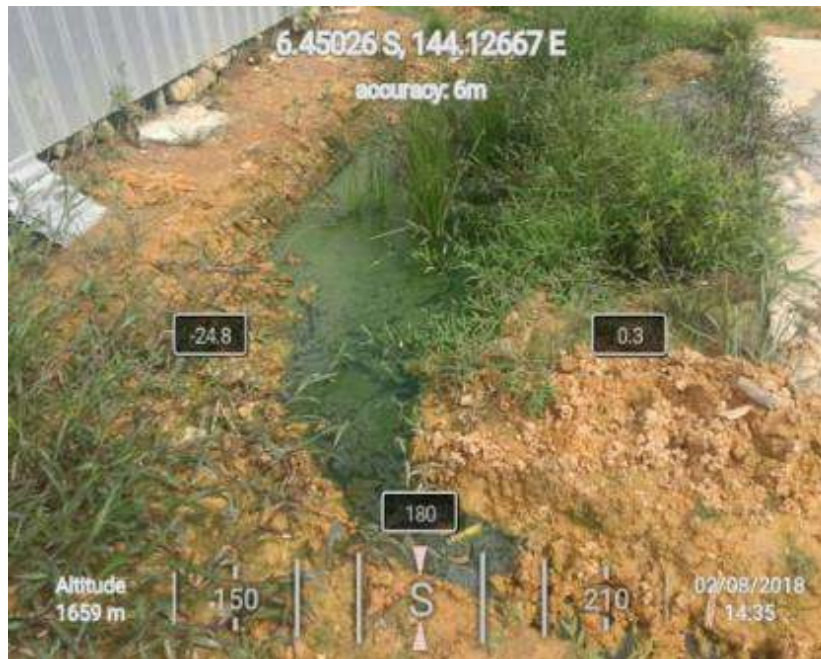
50. The Contractor has completed construction for all of its camp facilities. (Photograph 1). The environmental non compliance observed during the period is the leaking sewage facility (Photograph 1). The contractor needs to immediately mitigate this problem.

Photograph 1. Leaking sewage from the contractor's camp.

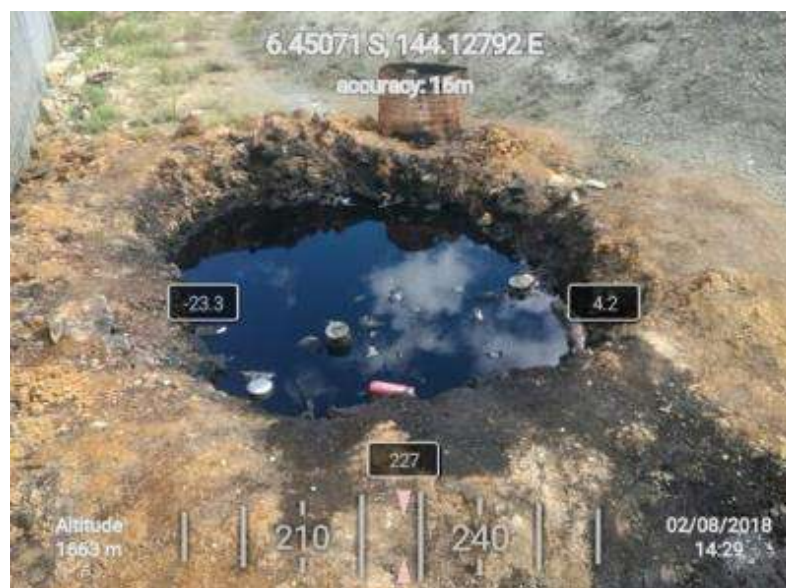
Photograph 2. Improper waste disposal of used oil.

51. The improper disposal of used oil should be remediated to prevent groundwater contamination (Photograph 2).

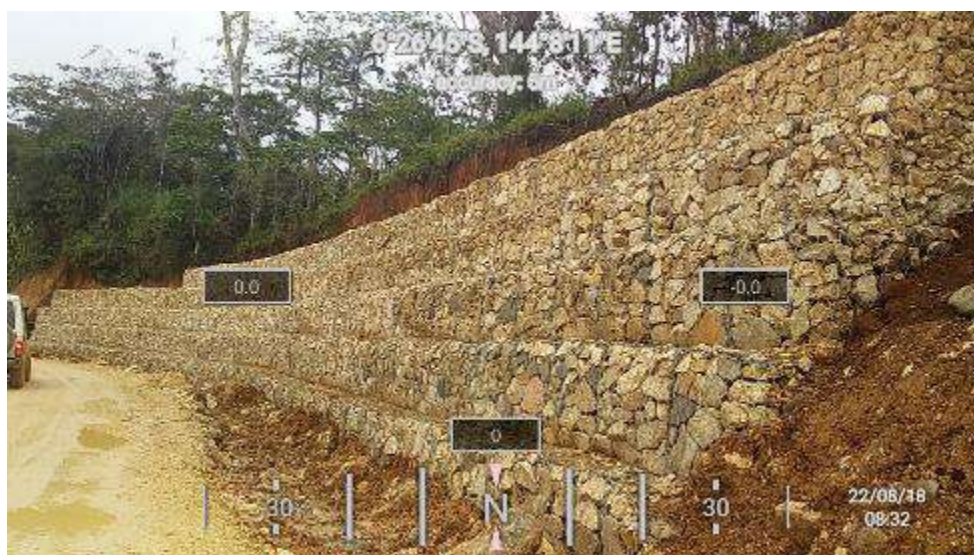
52. The contractor has carried out several erosion control engineering structures such as culvert headwalls and terraced gabions (Photograph 3). It was observed that the contractor has deposited its wastes in the designated sites.

Photograph 3. Terraced gabion to hold off erosion from steep slope.

53. As previously suggested, a helpful manual which was previously provided could be used, the “Erosion and Sediment Control Best Management Practices Manual”. Erosion control using trees, bamboos and other grasses was also recommended.

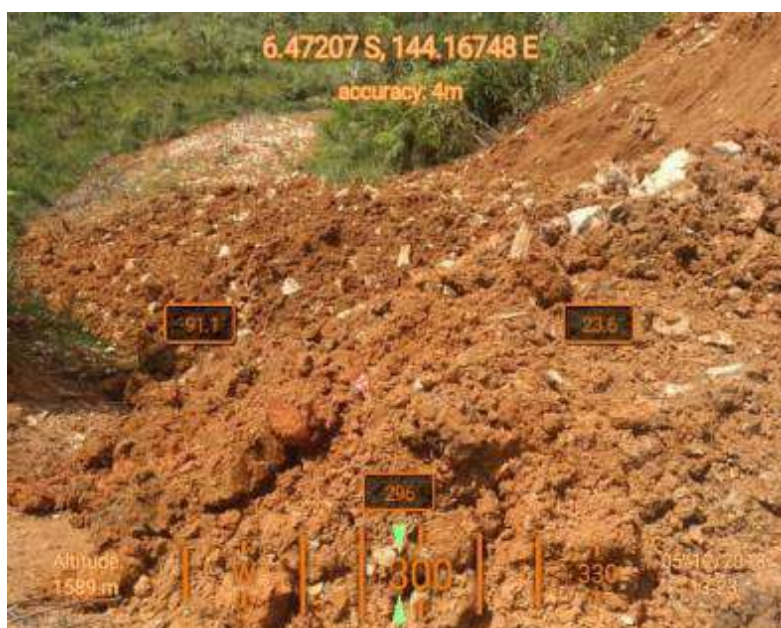
58. The proper disposal of construction wastes needs to be followed. The dumping of wastes along slopes has occurred (Photograph 4).

Photograph 4. Dumping of soil overburden along the road side.

59. A previous recommendation is for the Contractor with the cooperation of the PSC and HRMG review the various plans associated with wastes to ensure its compliance.

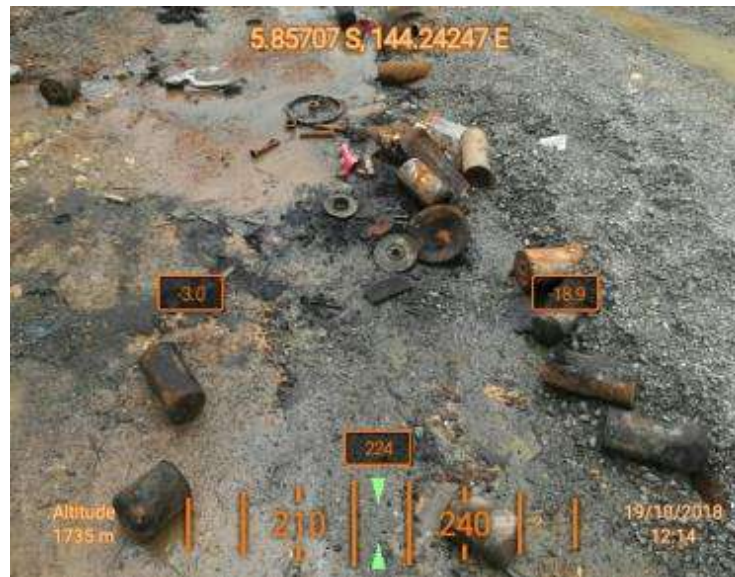
62. Discarding or burning fuel drums, filters and used oil waste fuel can pollute groundwater and pose air pollution hazards if improperly managed. Spent fuel filters should not be burned (Photograph 5) and needs to be disposed following its submitted HWMP.

Photograph 5. Burnt fuel filters are considered hazardous

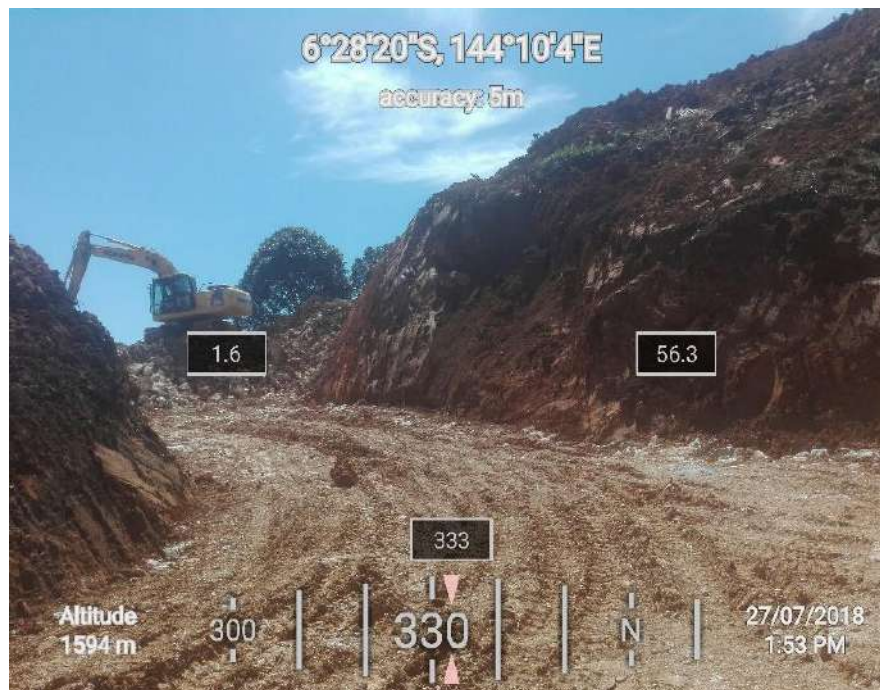
63. The quarry at Chainage 22 at Tomiare Village needs to submit its QMP due to its utilization following the clearing of access road (Photograph 6).

Photograph 6. Clearing at Tomiare Quarry Ch 22+200

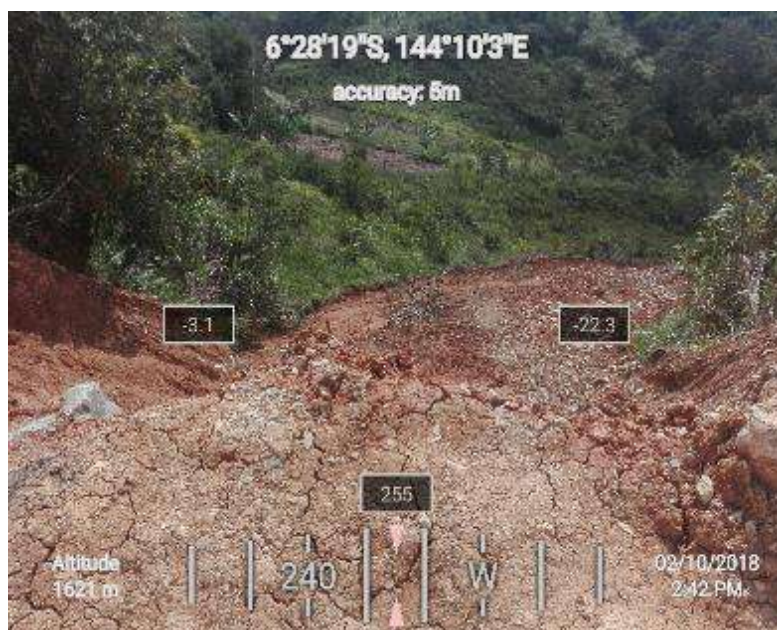
64. All the quarry sites need to have an approved Quarry Management Plan. In the case of the abovementioned quarry, spoils have been dumped along the slopes (Photograph 7).

Photograph 7. Erosion and sedimentation at the back of Tomiare Quarry.

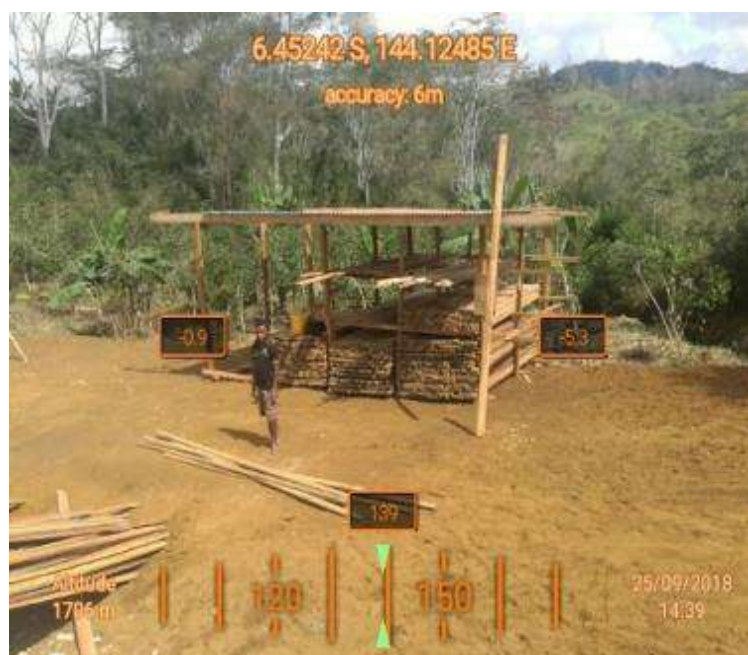
66. A negative consequence of the road would be easier access to markets for logging to produce timber and possible expansion of deforestation (Photograph 8). The implementation of the tree planting activities need to be implemented with stakeholder's participation.

Photograph 8. Lumber store along the road project.

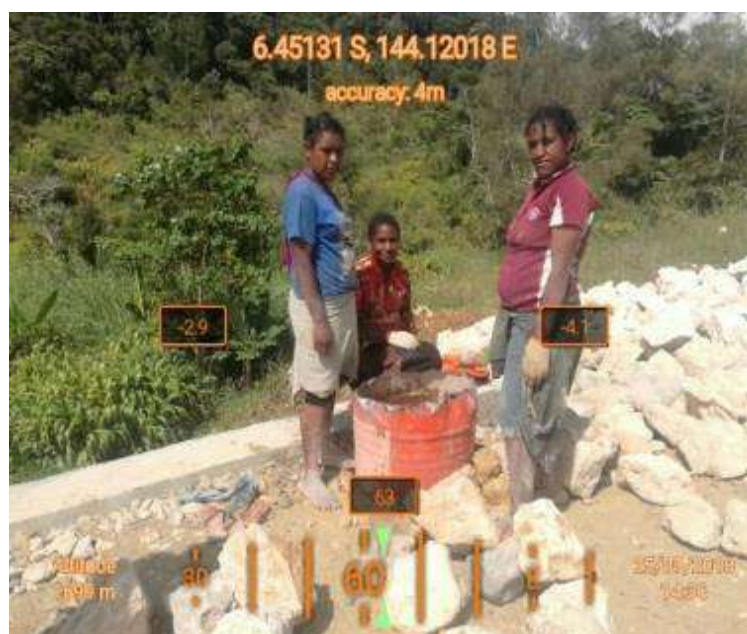
Photograph 9. Young women involved in rock wall construction.

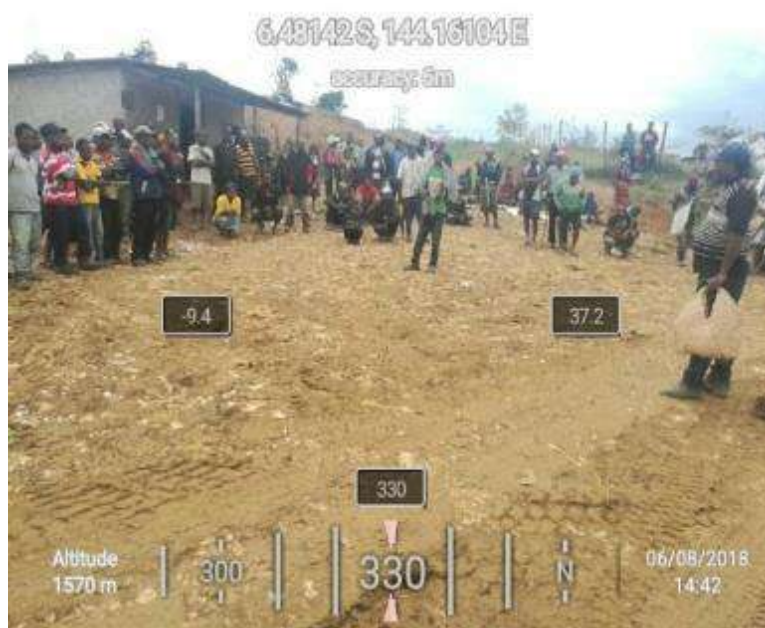
70. There is a lack of documentation on the socio economic issues being raised by the community. However, these are being conducted in response to issues that have been raised by the community and the need for resolution (Photograph 10).

Photograph 10. Public consultation at Tunda community.

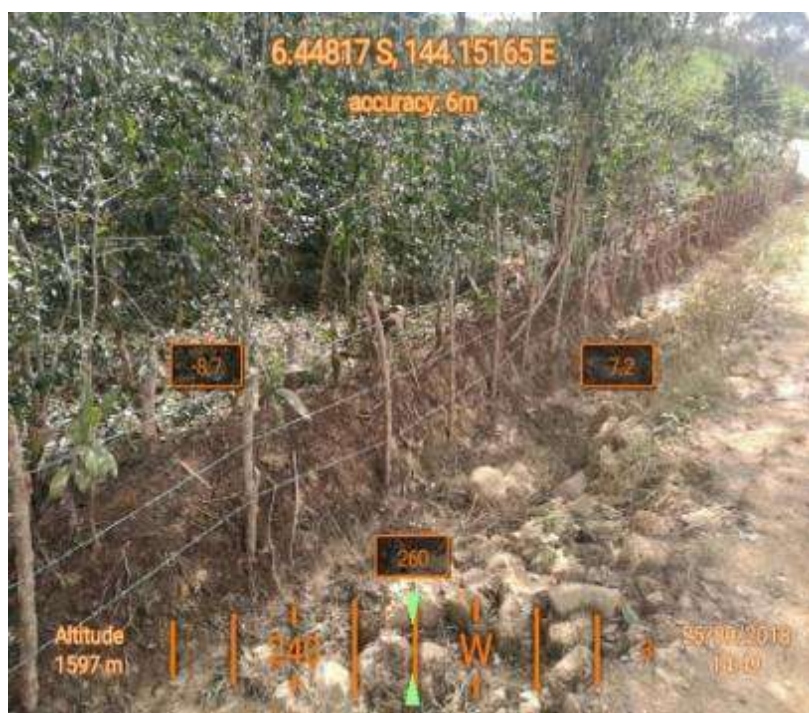
Photograph 11. Pruned coffee plants.

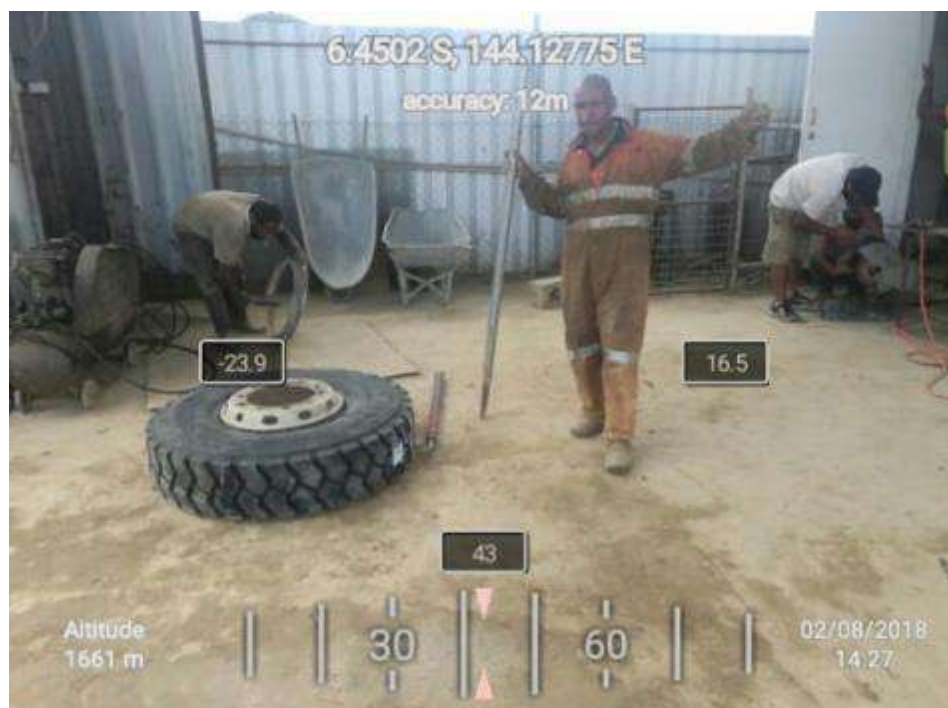
77. The Contractor has provided protective clothing and safety equipment to some of its staff (Photograph 12). However, the contractor has not complied with this requirement for its non-payroll workers who are mostly women.

Photograph 12. Workshop personnel with PPE.

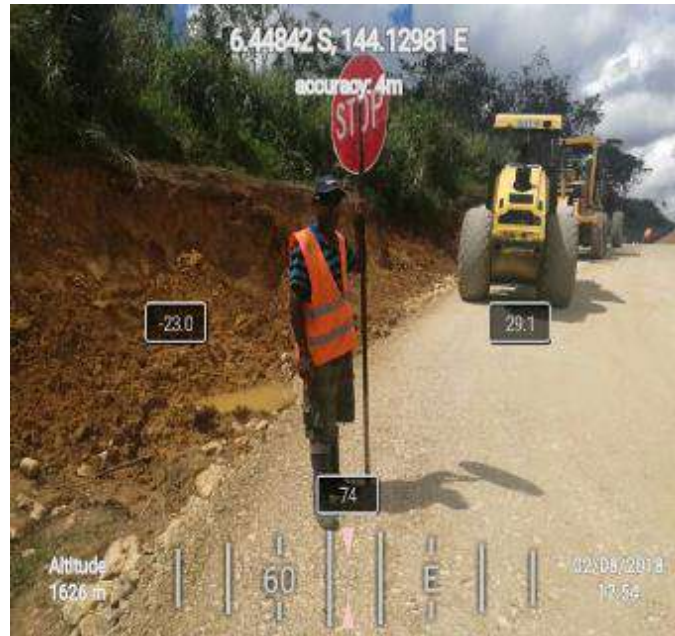
78. The Contractor has to follow its own Traffic Management Plan which has not yet been approved. The monitoring activities show that the contractor has provided traffic signs and traffic aides (Photograph 13). It is recommended that women traffic aides should be employed.

Photograph 13. Traffic aide worker with reflective vest.

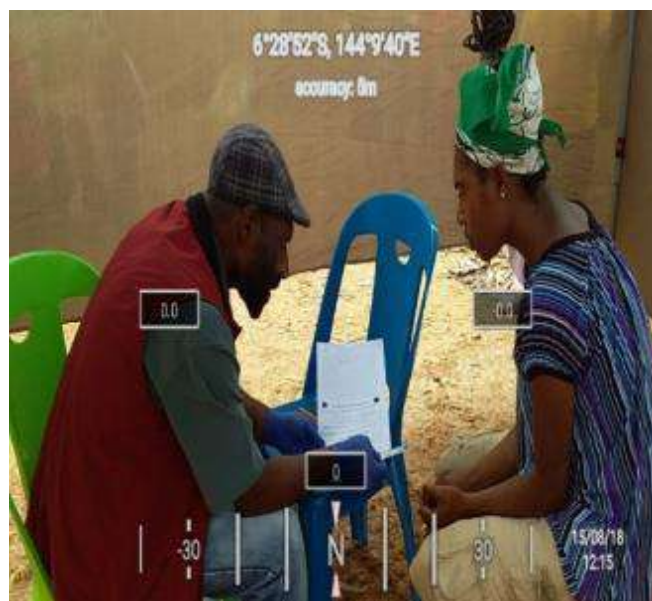
79. The HIV-AIDS provider, the Department of Health, Pangia Health Centre has provided counselling to its clients (Photograph 14).

Photograph 14. Health worker providing information on HIV-AIDS.

80. The HIV-AIDS provider has not provided a monthly activity report. The contractor needs to require the provider to submit such reports.

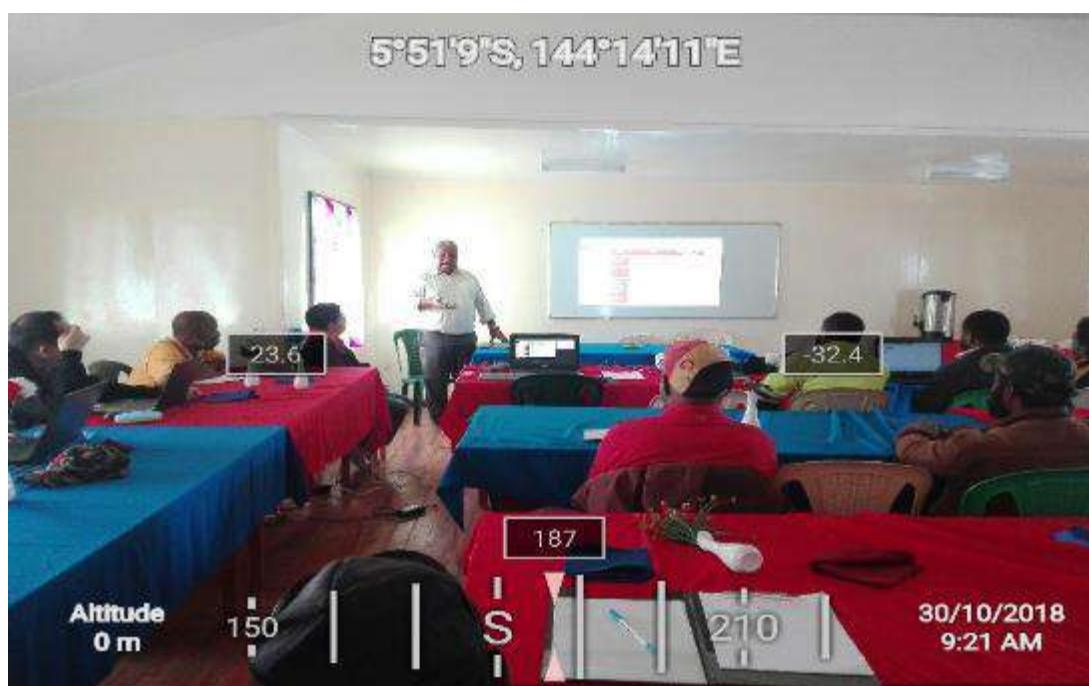
84. A seminar workshop Technical Report Writing was conducted last November 31 at Kuri Lodge and was participated in by all contractor's social and environmental safeguards officers, HRMG personnel and PSC (Photograph 15).

Photograph 15. HRMG officer providing pointers on technical writing.

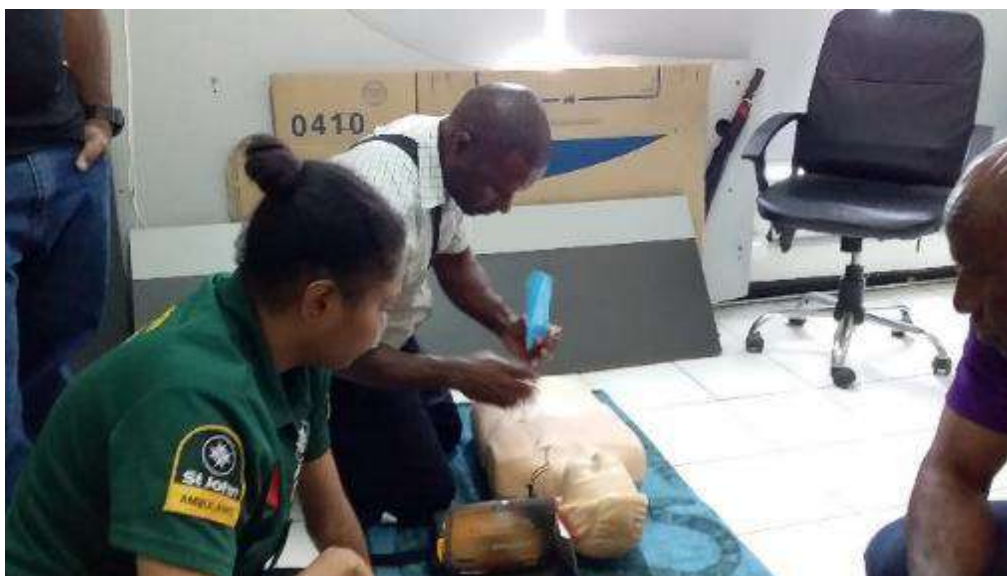
85. A training on First Aid was also conducted by St. John's Ambulance at Port Moresby for contractor's and HRMG personnel from July 18-20, 2018 (Photograph 16).

Photograph 16. Contractor's participant performing first aid activity.
