Semi-Annual Report

PNG: HIGHLANDS REGION ROAD IMPROVEMENT INVESTMENT PROGRAM (TRANCHE 3)

Gewa-Gembogl Road Sub-Project

(January-June 2019)

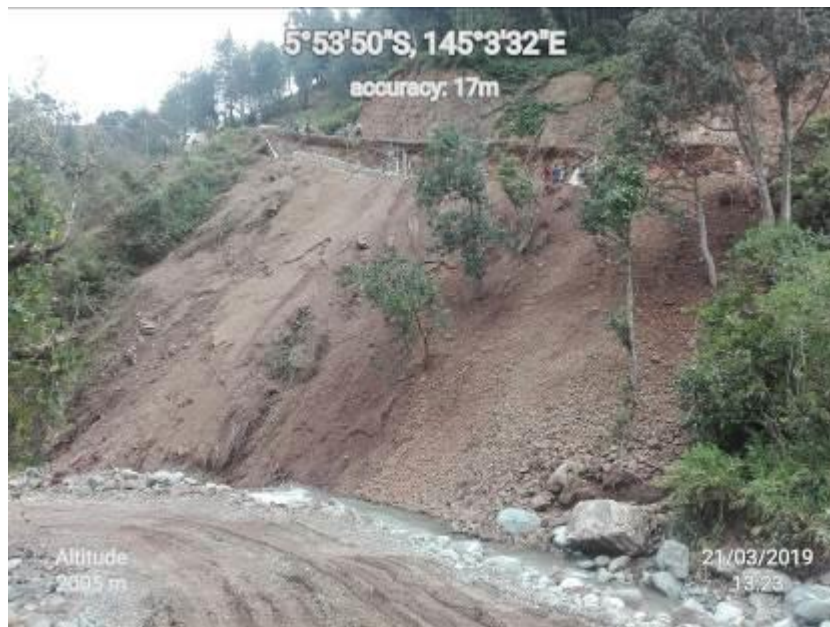
39. The major causes for the high erosion rates during this period are lack of mitigation measures during clearing and grubbing of spoils and vegetative materials over hill slopes.
40. There are high erosion and sedimentation incidences caused by the clearing and grubbing on steep hilly slopes. Sediments that were exposed to climatic conditions by civil works have been washed to lower elevations by heavy rain.
41. Because of the steep adjacent slopes and as a result of excavation activities have created so many critical slopes resulting to land slippage. The Grievances that are out of the ROW are entirely the sole responsibility of the contractor.

Photograph 1. Lack of mitigation measures to prevent erosion

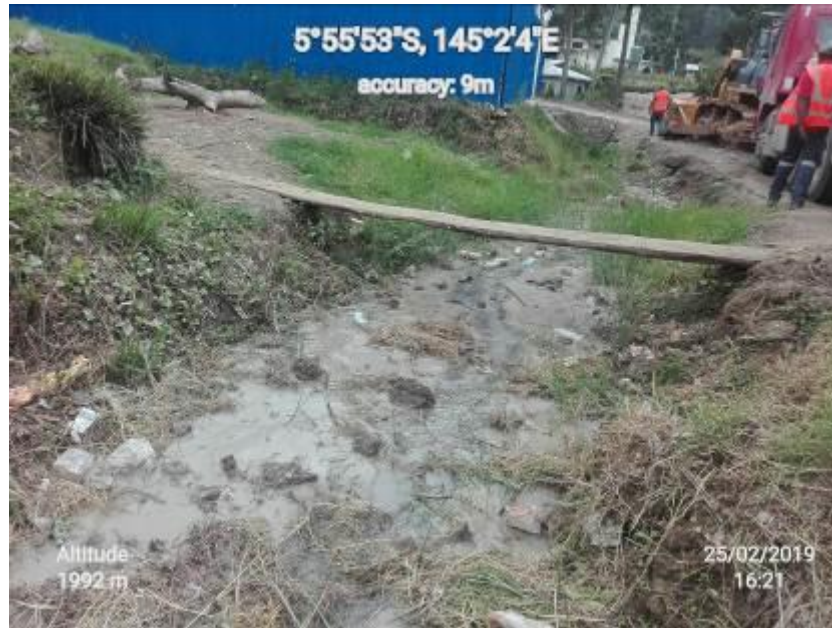
42. The major cause for the sediment laden river is the negligence of the contractor to institute soil erosion and sediment deposition mitigation measures. Chimbu River is murky as a result of sedimentation from civil works and partially due to the wet season.
43. The batching plant area is releasing raw hazardous wastewater into the natural stream that is flowing in between the Mission Station and the Local Community.

Photograph 2. Raw wastewater from the batching plant flowing into natural stream

65.The Batching Plant setup at Goglme is already being in use and is discharging considerable amount of hazardous waste water into the receiving stream at Goghme Station refer to Photograph 2 above.

Non-Compliance	Recommendations for Implementation	Corrective Actions Plan	In-Charge	Date of Implementation
Absence of waste treatment facility at batching plant site	Install at least two filtering ponds/sediment traps to treat	Contractor to install wastewater treatment plant.	CHEC	Immediate

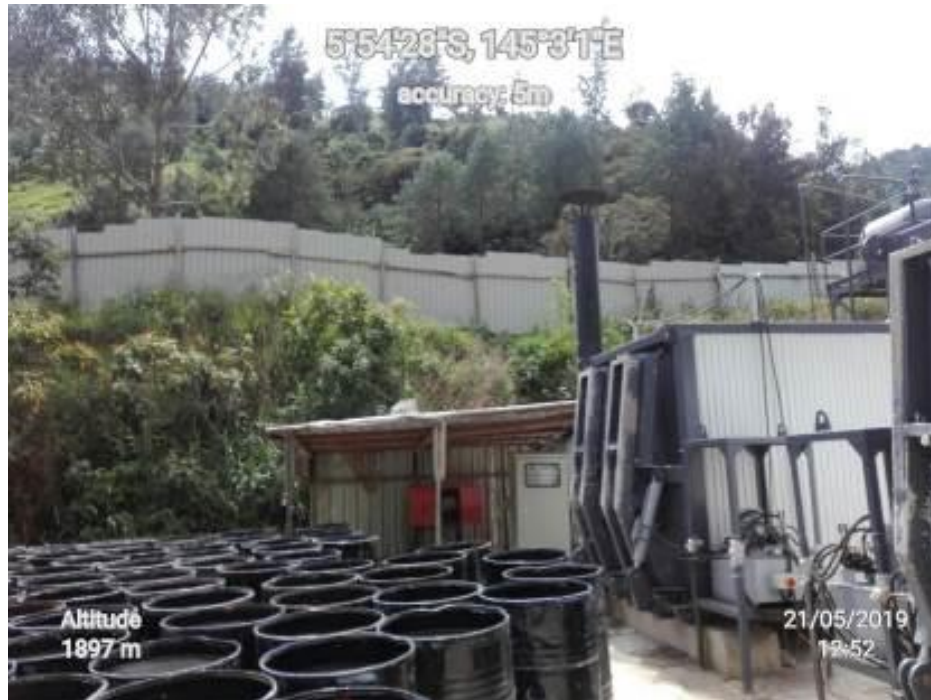
48. There are grievances from the local communities about the fumes coming out from the bitumen chimney. Recommendations have been made for extension of the current chimney to be extended or diverted away from the market area.

Photograph 3. Bitumen chimney needs to be adjusted in height or diverted away from the fence.

90. Grievances on the fumes from the bitumen plant's chimney. The fumes from the bitumen have caused the nearby locals to complain of the very strong smell refer to **Photograph 3** above.

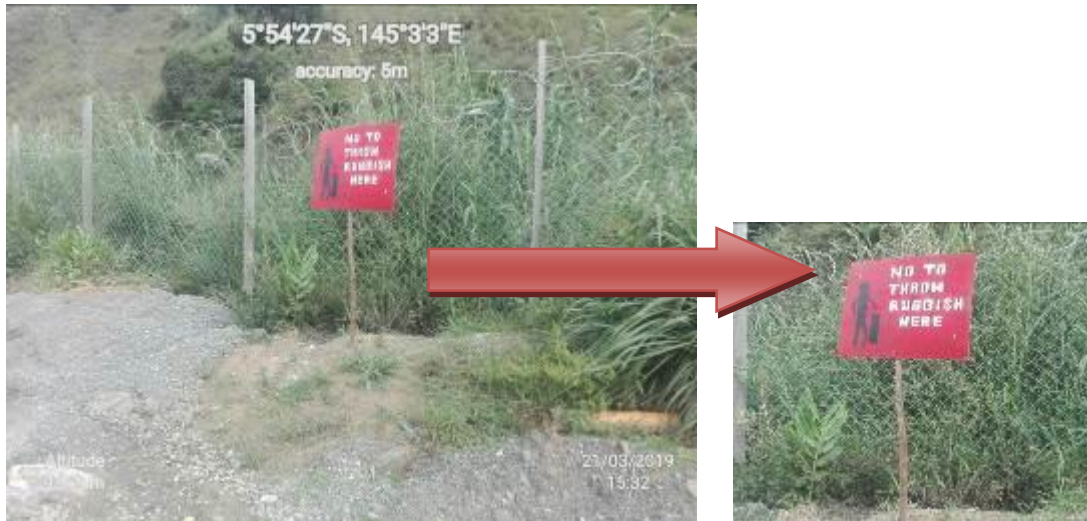
52. Because of the geographical setting of the project site, the disposal of spoils during clearing and grubbing has caused soil erosion into the water bodies and the associated vegetation. Despite agreements on spoils disposal sites, this is a recurring problem.
53. After the issuance of the NOV on 25 February 2019, the continuous no-compliance of storage and disposal of domestic waste at Sumburu Quarry have been managed following the recommendations stated in the NOV refer to Photograph 4. **Warning signage erected to prevent throw of rubbish at Sumburu quarry site..**
54. Old tyres are continuously being burnt near the workshop at Sumburu Quarry.

Photograph 4. Warning signage erected to prevent throw of rubbish at Sumburu quarry site.

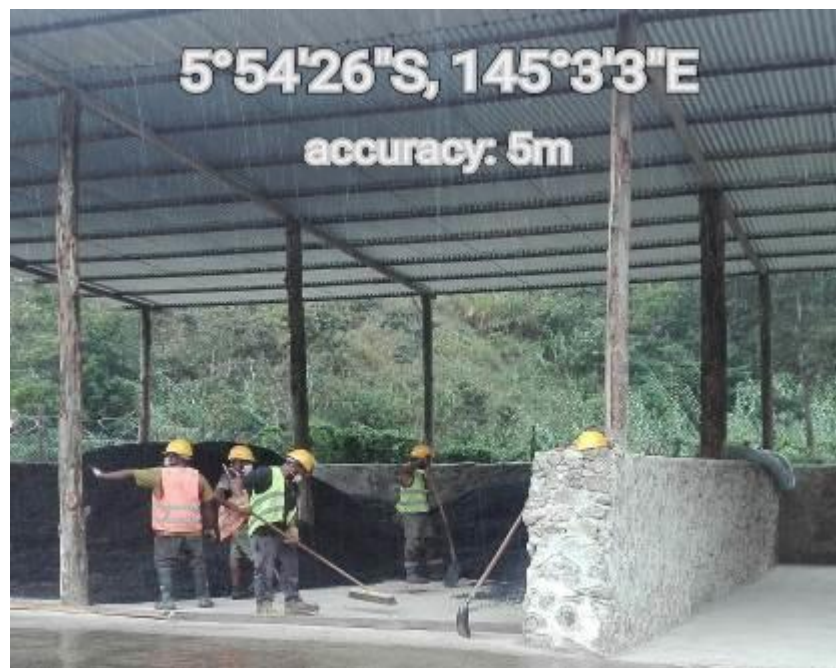
55. The fuel depot is at DoW Kundiawa, fuel is transported by tankers to refuel construction equipment and plants. There are no facilities to collect and dispose of hazardous chemicals including used oil and lubricants. HRMG and the PSC Environmental Safeguards Personnel will conduct an audit on safety procedures on storage, handling and disposal of fuels. There are less oil spill occurring after the issuance of NOV's for oil spill at Sumburu quarry site.
56. Contractor managed to issue specified PPEs for workers working at the bitumen plant. The workers are seen in nose mask, rubber boots, hand gloves, helmets and safety vest to prevent them from direct contact with bitumen.

Photograph 5. Workers at the bitumen plant with job specific PPEs

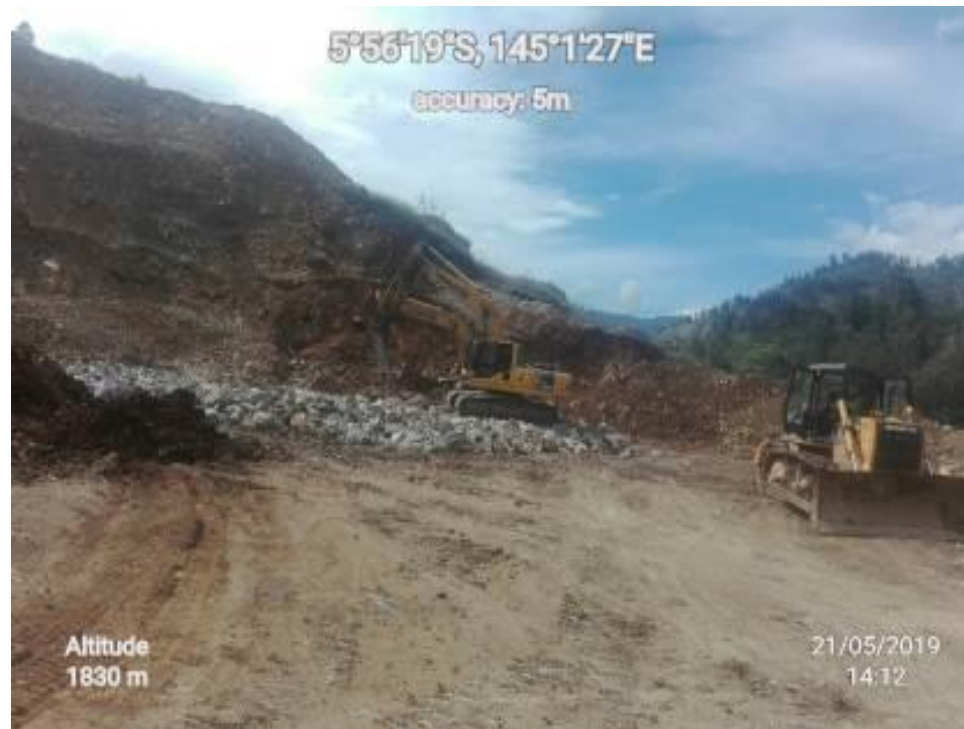
Photograph 6. Stone extractions at Banduma Quarry

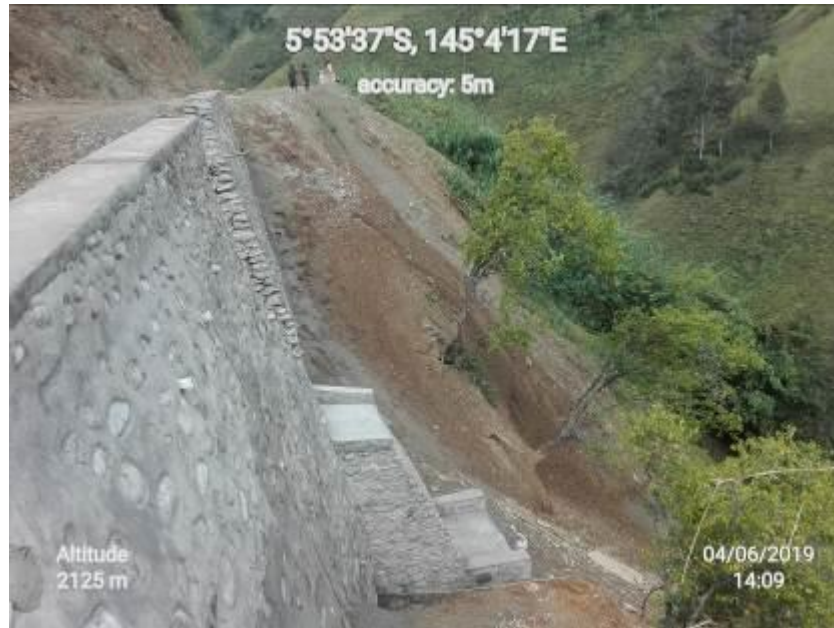
67.Sedimentation has been accelerated by the hilly rugged terrain of the project site. Hence, underlying vegetation's have been destroyed at certain sections of the project site.

Photograph 7. Rugged terrain couldn't resist disposal over the hillside on existing vegetations.

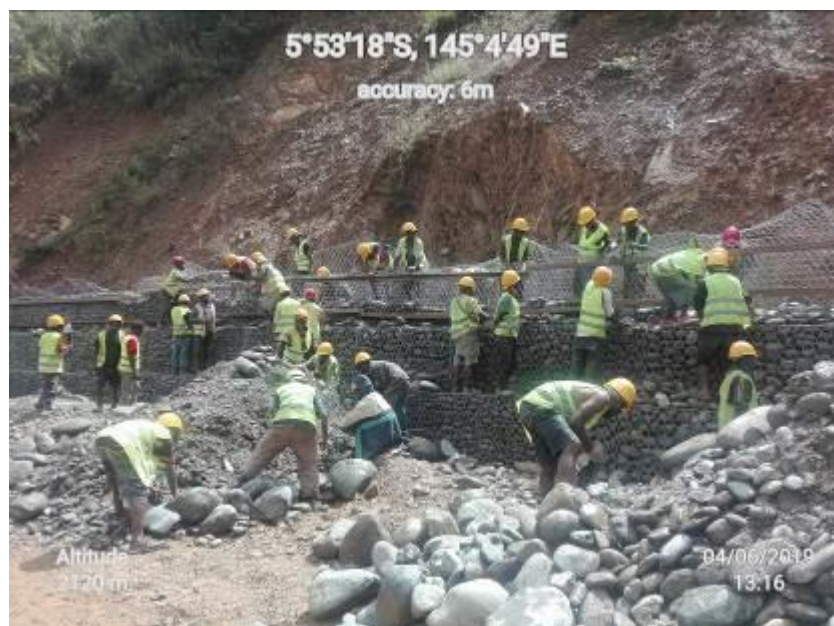
Photograph 8. Casual workers making gabion basket.

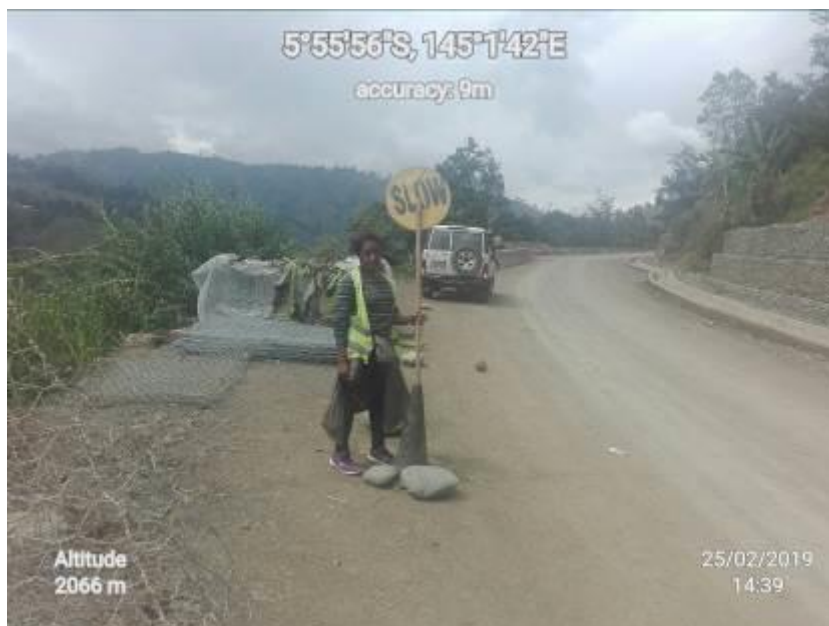
81. The Traffic controllers are stationed in areas where civil works are in progress to control the

flow of the passing traffic and the pedestrians. Almost all of the traffic controllers are females.

Photograph 9. Female traffic controller stationed after civil works in progress

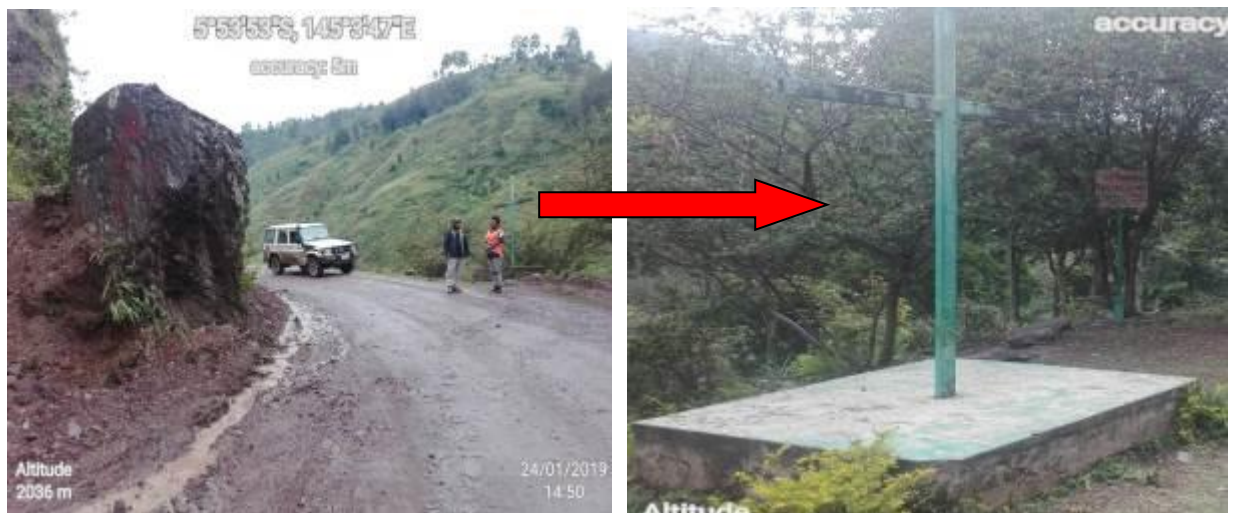
87. At Ch.27+ 850 there is a Physical Cultural Resource or Sacred Site that has Religious Significance. There was a Missionary who was killed by the locals there before independence. The missionary was killed by the locals on the Left-Hand Side (LHS) of the Road and a monument is placed on the (Right Hand Side) RHS of the road for that Missionary to be remembered.

Photograph 11. Physical Cultural Resource that has Religious Significance to be conserved

89. Proposed facelift will be given to the current monument for conservation.
