Semi-Annual
Report

PNG: HIGHLANDS REGION ROAD IMPROVEMENT INVESTMENT PROGRAM (TRANCHE 3)

Nipa-Munihu Road Sub-Project

(January to June 2019)

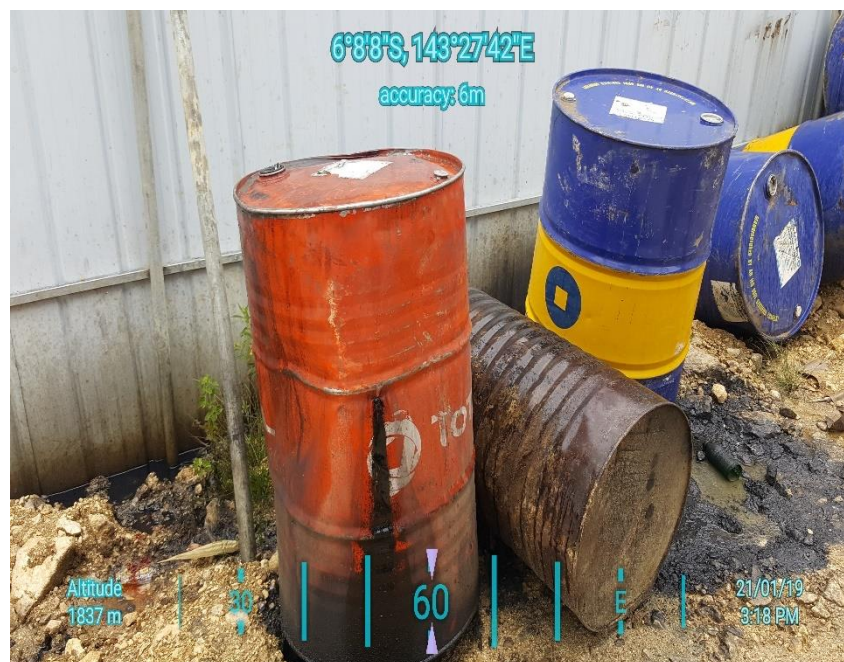
50. Furthermore, the River Nembi campsite needs proper drainage system, which was evident with stagnant water pools inside the campsite.
51. The proper containment of used oil and lubricants need to be followed and closely monitored due to a recurring problem of spillage and improper disposal which has been observed leaking from the storage drum (Photograph 1).

Photograph 1. Oil Leakage from damaged storage drum.

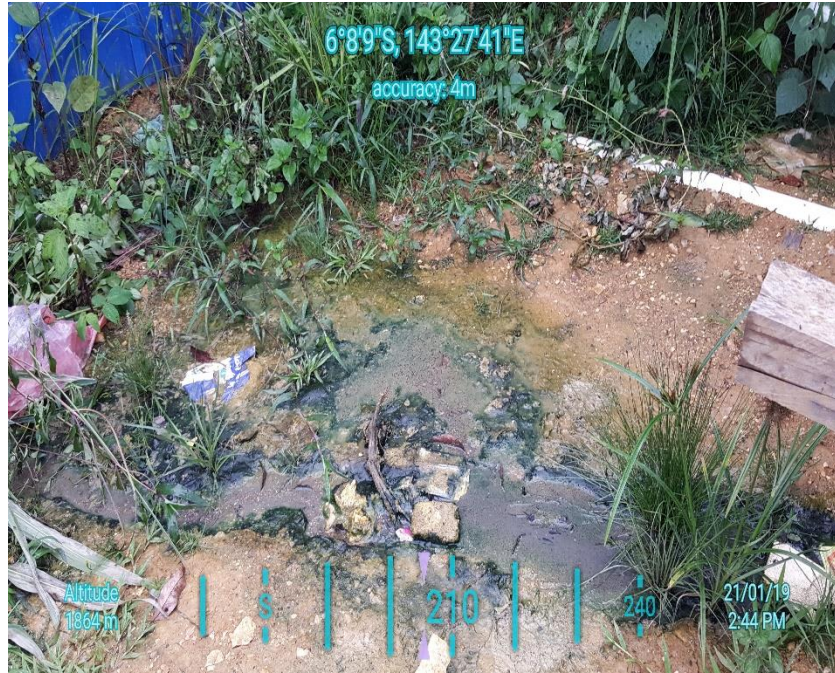
Photograph 2. No proper drainage system, evident with stagnant water pools inside the campsite.

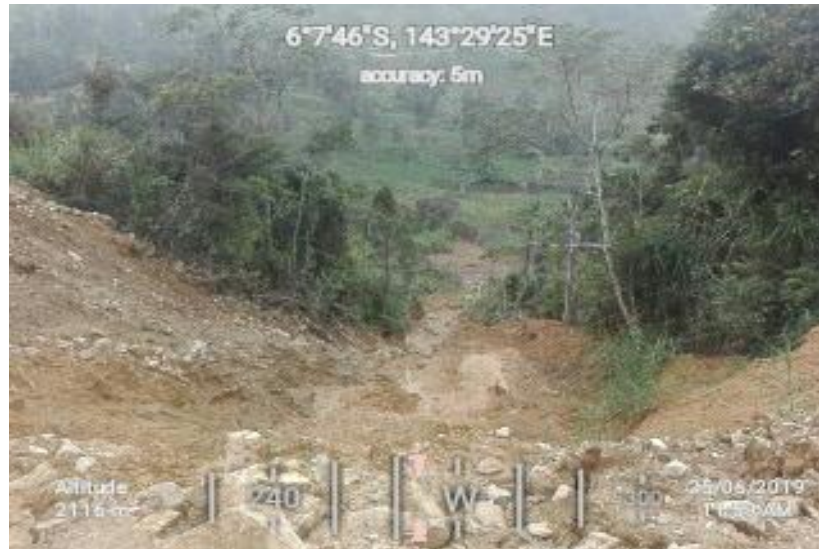
52. There are ongoing issues with improper spoils disposals. The operators were pushing spoils to the road side and dumped at some locations without the consent of the landowners.
53. Working at two fronts of the project proved to be difficult for the contractor's environmental officers to be present onsite during clearing and grubbing and major excavation works to ensure its CEMP is implemented.
54. There were several major slips at the Munihi end of the project, however these were not new areas; landslips have been occurring between these sections because of the unstable geological structures since clearing and grubbing commenced last year.
55. Recently there was a major slip at Ch:7+500 at the Nipa end of the project which showed a huge erosion which ended at the upstream of Boldom 2 creek). A culvert installed about 10m from the slip area also caused erosion problems. (Photograph 3

Photograph 3. Major erosion from the landslide at Ch:7+500 which ended at the upstream of Boldom 2 Creek.

106. All proposed spoils dump sites have to be inspected by the contractor's Environmental Officer to ensure the site is stable and will not affect any sensitive receptors including rivers and stream. A proper agreement has to be done with the respective landowners prior to dumping.

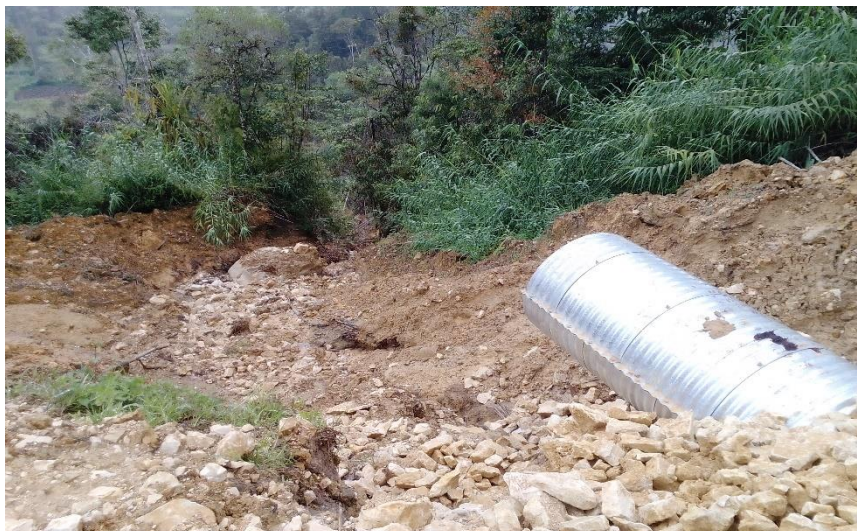
Photograph 4: Calvert at Ch:7+510 causing major erosion

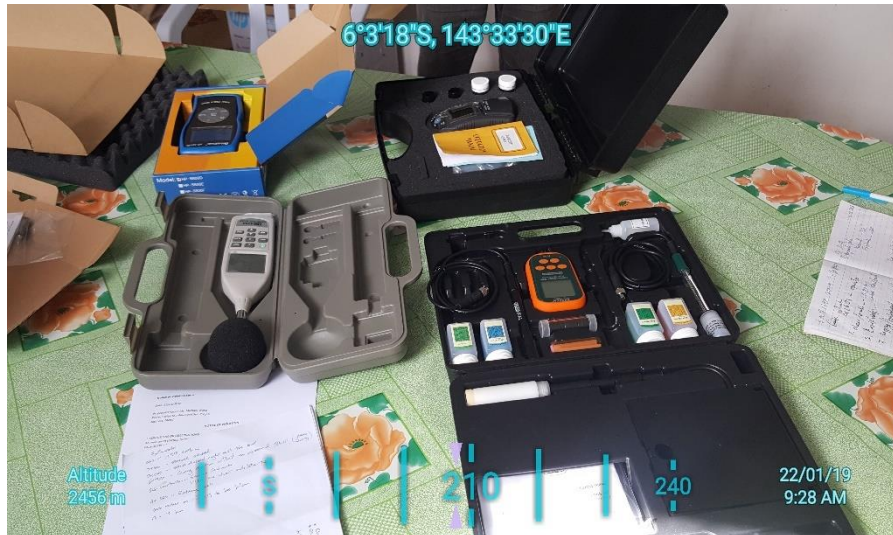
Photograph 5. Newly purchased monitoring in-situ equipment displaced by the contractor.

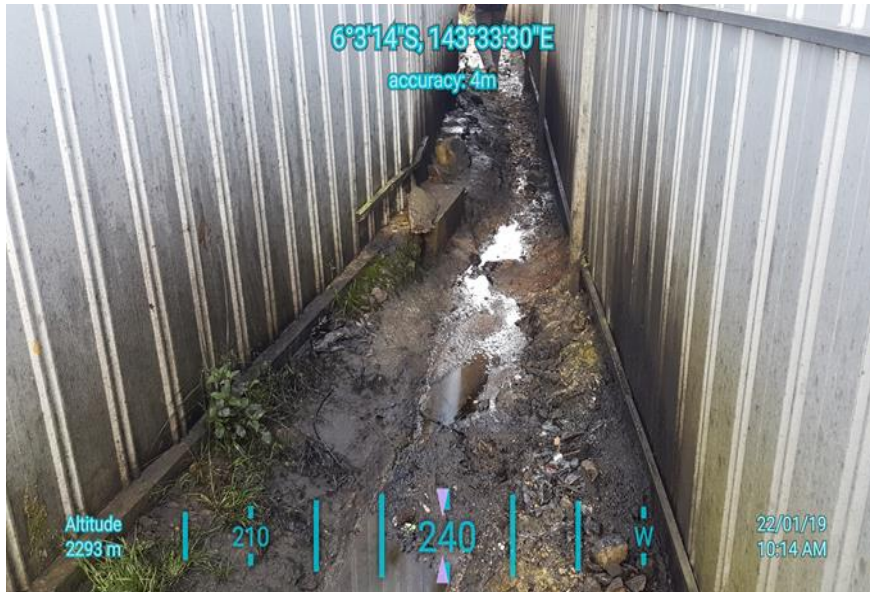
68. Proper inventory of hazardous materials such as fluorescent bulbs, computers and peripherals, printers, used batteries, battery fluids, oils, lubricants, and asphalt products are required so that proper monitoring can be carried.
69. Nevertheless, the wastes generated from the workshop need to be disposed properly because there was no proper disposal for waste like used oil, batteries, battery fluids, lubricants, and asphalt products.
70. Waste oil have been seen to be dumped on the drain at the back of the workshop. Used or waste oil should be stored properly for recycling or given to locals for timber treatment.
71. There are several instances of burning of used tires as well. There is a need for the implementation and monitoring of the contractor's Hazardous Materials Management Plan.

Photograph 6. Improper discharge of waste oil at Mt. Wiri Campsite into the drainage.

104. An inventory of all hazardous materials need to be provided by the contractor so that proper disposal and monitoring can be carried out.
105. Waste oil need to be properly disposed. All waste oil should be collected and stored in drums for recycle, re-sue or dispatched to local communities for timber treatment.

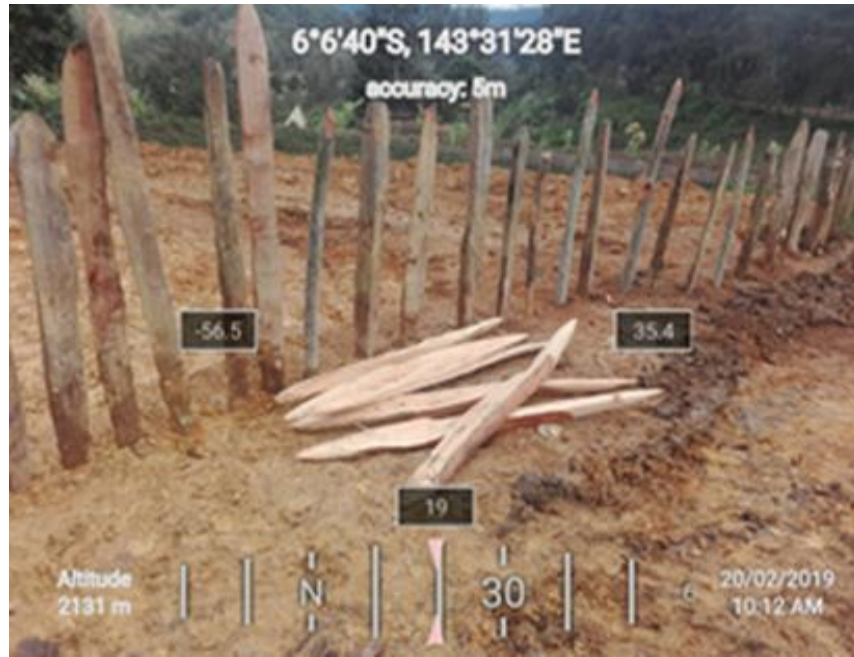
75. Trees felled were within the construction limits from clearing and grubbing works. The felled trees were given to the respective land owners which were then turned into lumber and sold along the road side or used for fencing (Photograph 7)

Photograph 7. Timber from felled trees used for fencing

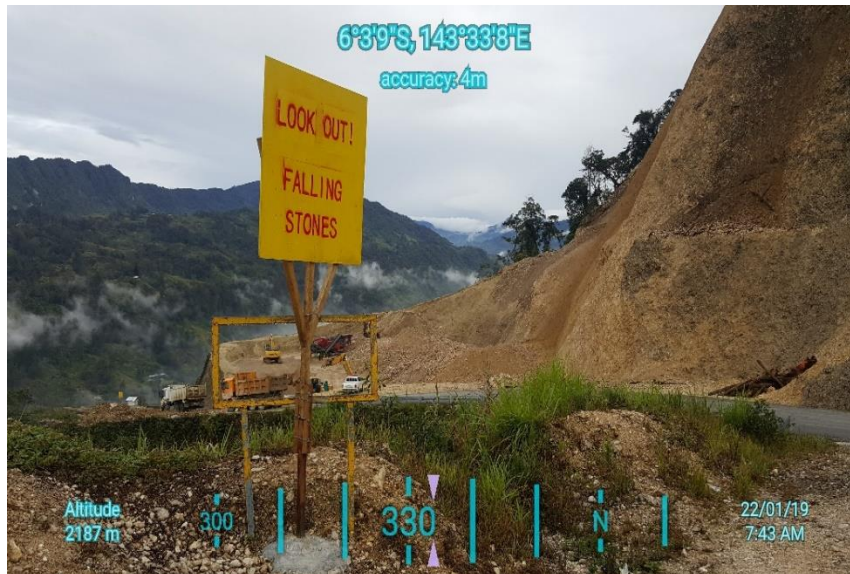
81. The extraction on the steep slopes at Wapun Su-oro quarry has caused landslips and rock falls (Photograph 8).

Photograph 8. Warning signage on the road side opposite Wapun Su-oro quarry- Mendi-Kandep road warning for falling stones.

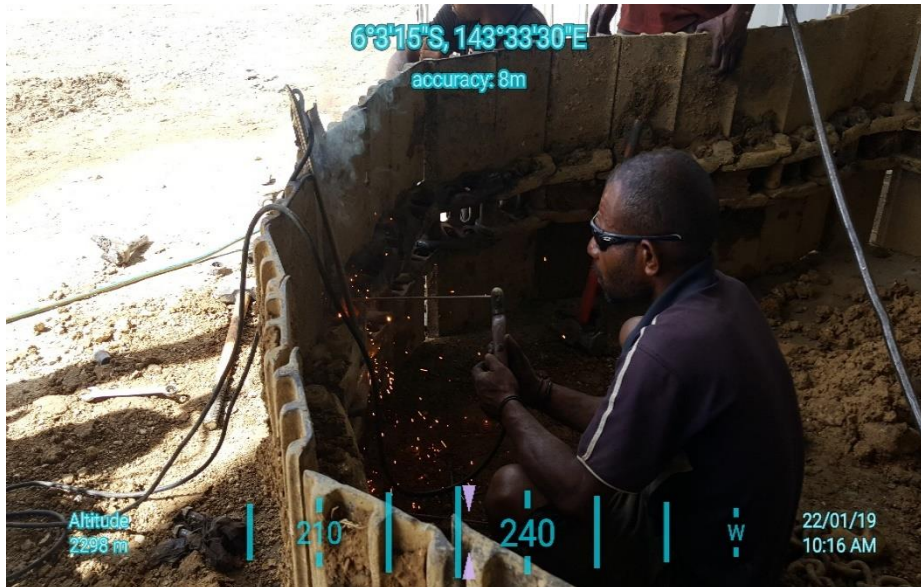
82. Despite repeated instructions, some of the workers on site were not provided with PPEs. It is recommended that precautions should be taken by the Contractor to ensure the safety and protection against accidents of all staff and labor engaged in the works (Photograph 11).
83. The Contractor should follow the approved Health and Safety Plan (HSP) which was approved by DOW-ESSU with operational details addressing health and safety concerns during his Works.

Photograph 9. Workshop employee without proper PPE.

107. The absence of soil erosion and sedimentation mitigation measures need to be addressed following identified best management practices.
108. The contractor has to provide its workers with appropriate PPEs for the various work requirements and working conditions.

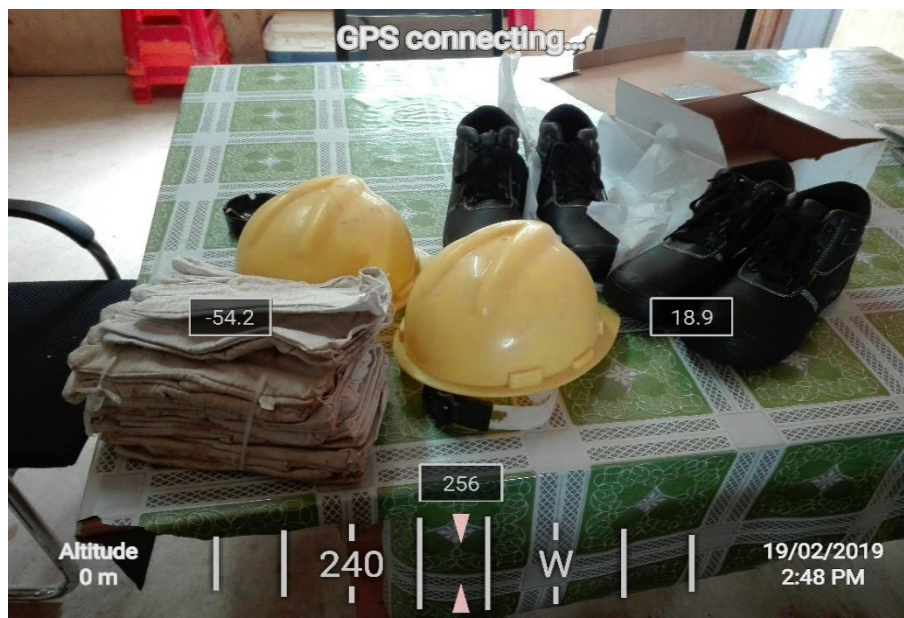
Photograph 10. Contractor displaced PPEs which should be given to the all workers

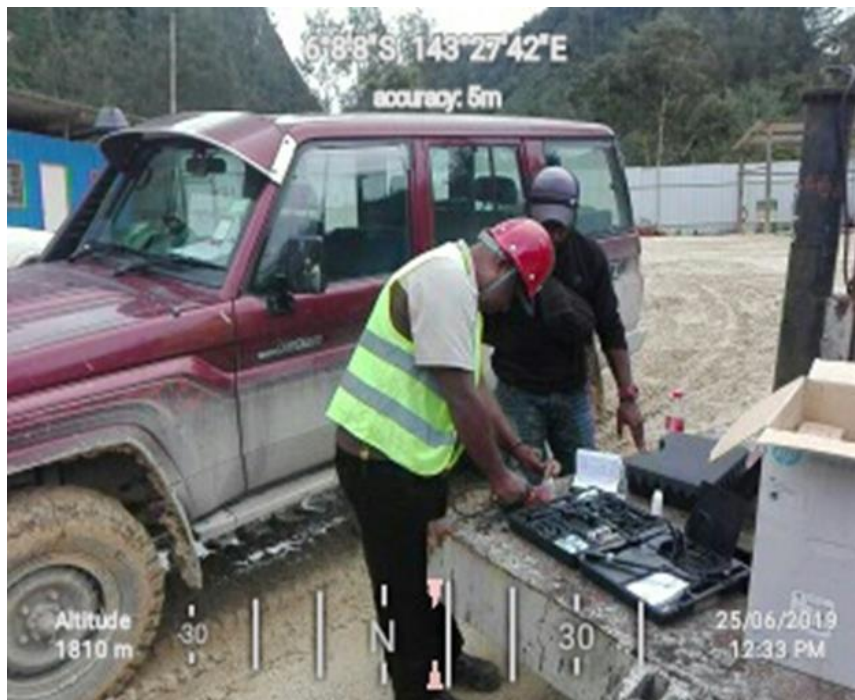
Photograph 13. PSC Environmental Specialist showing the contractor's EO how to calibrate the multi-parameter for testing DO, pH, TDS and temperature.
