Semi-Annual Report  
July – December, 2016

## **VIE: Greater Mekong Sub-region Flood And Drought Risk Management and Mitigation Project**

**SECOND SEMI-ANNUAL ENVIRONMENTAL MONITORING REPORT**

**VIETNAM WATER, SANITATION AND  
ENVIRONMENTAL JS COMPANY**

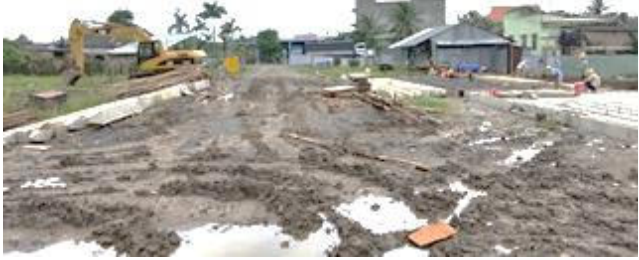
Subproject	Construction item	Environmental issue	Typical image
<b>3<sup>rd</sup> Quarterly:</b> 10 October - 20 October, 2016			
GMS – 2.6: Subproject “Upgrading saline control system of Go Cong region. Tien Giang province”	Nguyen Van Con sewer	- Runoff water would be polluted and impacted to construction process - Construction area is frequently inundated in rainy season by lack of management (no temporary road built for construction vehicles)

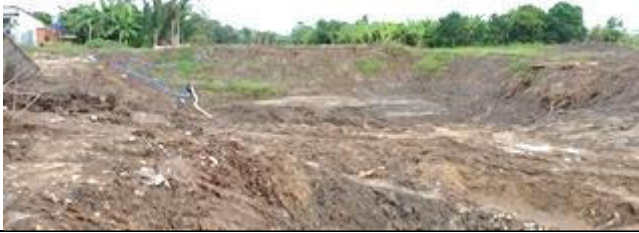
Salisete sewer	- The deep excavating pits may cause the dangerous for workers and local people in case of without fence and warning signs

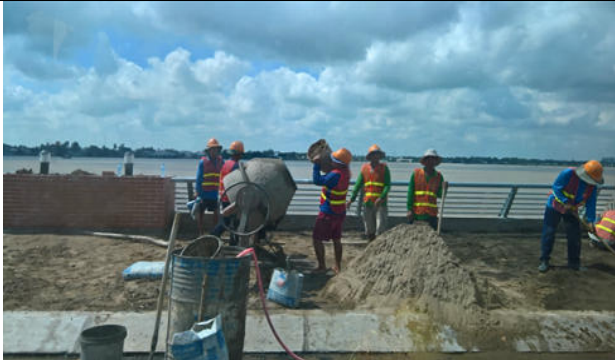
GMS 2.7. Construction of flood control system in Ba Rai – Phu An region, Tien		Not yet due	
GMS 2.8. Embankment erosion control in Thuong Thoi Tien Town, Dong Thap Province	Thuong Thoi Tien embankment	The concrete mixing station placed near Tien river may cause the Tien river water pollution in case liquid concrete falling down to the river

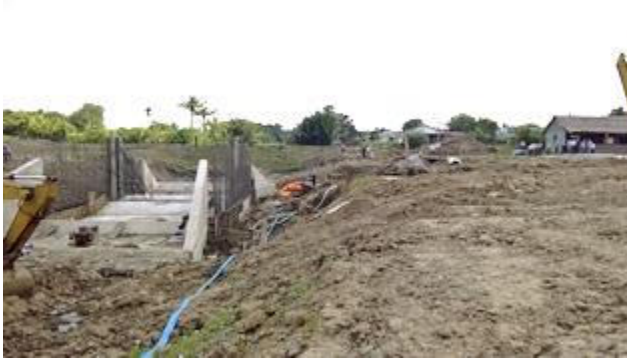
irrigation channels and supply irrigation water for Plain of Reeds			
<b>4<sup>th</sup> Quaterly:</b> 22 November – 3 December 2016			
GMS – 2.6: Subproject “Upgrading saline control system of Go Cong region. Tien Giang province”	Salisete sewer	Water pipe should be protected in technical box to avoid risks of broken, cracking thereby creating a volume of runoff water, which may affect the environment

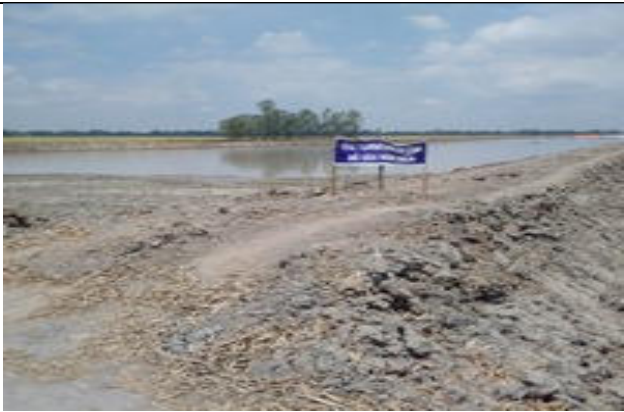
GMS 2.7. Construction of flood control system in Ba Rai – Phu An region, Tien	Not yet due		
GMS 2.8. Embankment erosion control in Thuong Thoi Tien Town, Dong Thap Province	Thuong Thoi Tien embankment	No potentially environmental issues arisen  Basically, Thuong Thoi Tien embankment has been done	
GMS 2.9. Improvement and upgrading irrigation channels and supply irrigation water for Plain of Reeds	Mud disposal cells	<ul style="list-style-type: none"> <li>- Mud disposal cells without fence will cause the dangerous for worker and local people.</li> <li>- The service roads should be gravelled to avoid risks of landslide in case of the big machines going back and forth</li> </ul>

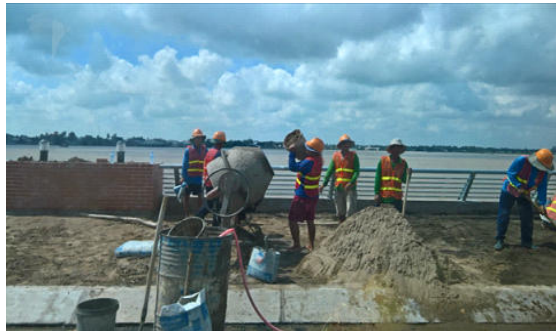
**H1. The concrete mixing station placed near Tien river**

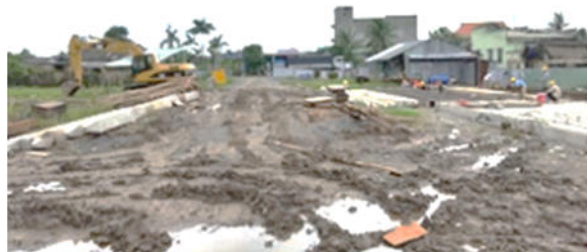
**H1. The runoff water, which appears on construction site of Nguyen Van Con sewer**

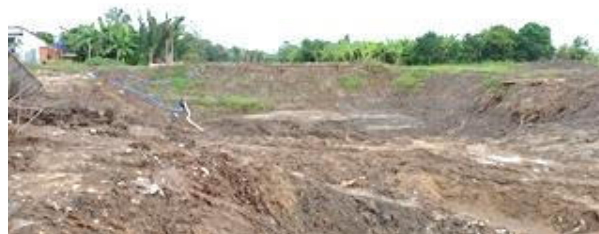
**H2. The deep excavating pits without fence and warning signs at construction site of Saliset sewer**

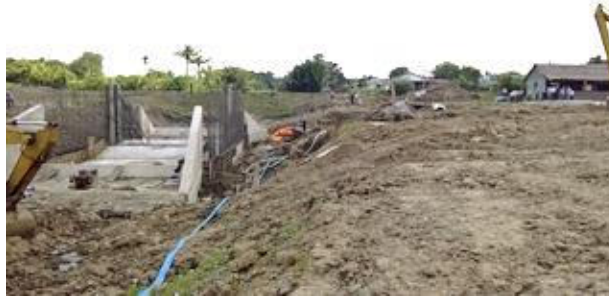
**H3. Water pipe with no protection by technical box**

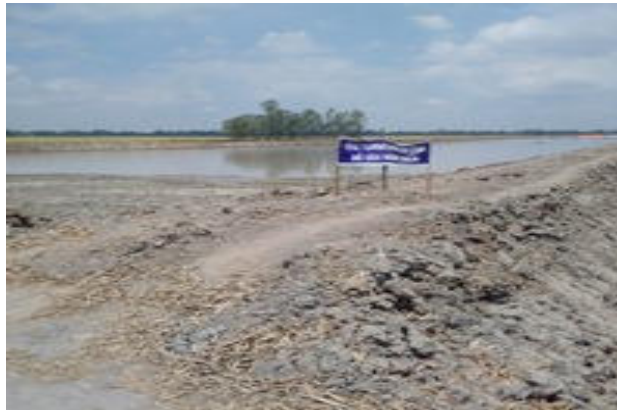
**H4. Mud disposal cells without fence**
