Semi-annual Environmental Monitoring Report

**Bangladesh: South Asia Subregional Economic Cooperation Dhaka-Northwest Corridor
Road Project, Phase 2 - Tranche 1**

**IMPROVEMENT OF ELENGA-HATIKAMRUL-RANGPUR ROAD TO A 4-LANE
HIGHWAY, ROADS AND HIGHWAYS DEPARTMENT (RHD)**

SEMI-ANNUAL ENVIRONMENTAL MONITORING REPORT

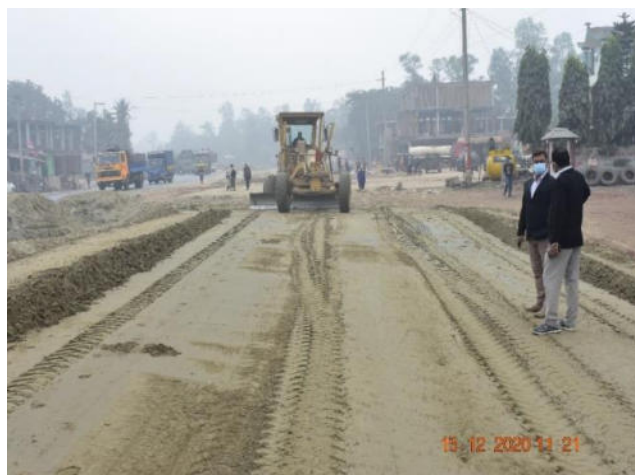
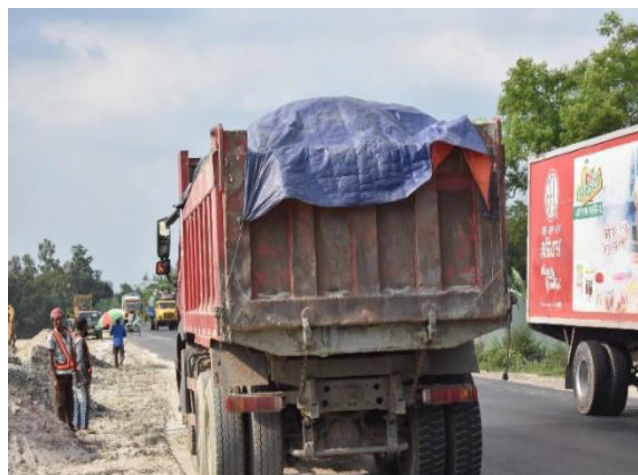
Figure 4.1 Air pollution and dust control at under construction road in wp-07

36. Air pollution is usually observed near batching point or mixing plants. However, air quality report suggests that the air pollution is within DOE standards. During the dry season dust around the project site is being produced due to on-going construction work. To control the dust nuisance during dry weather, the Contractors are spraying water three to four times in a day as per necessity. Dust Suppression is carried out by truck mounted water spray system. Workers involved in dust control have to put on proper PPE during water spray.

A. Water Spraying after Earth Filling

B. Covered Sand Transportation

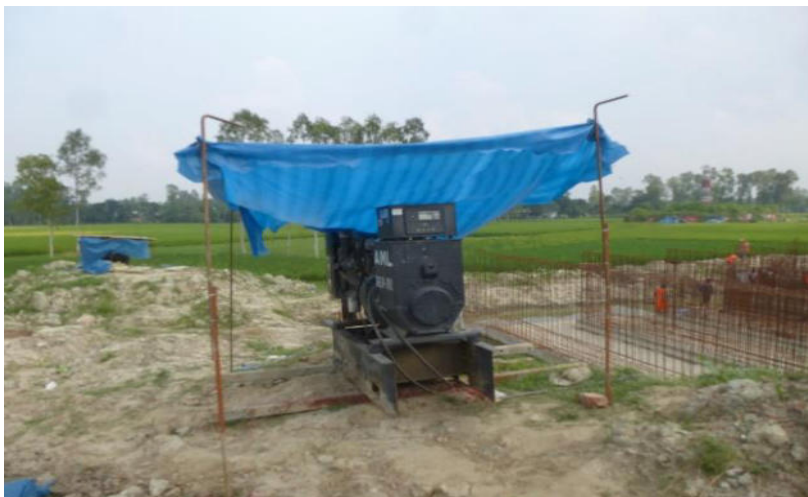
37. Prior to the selection and design of control measures, noise sources were identified and the noise produced was carefully evaluated. The Contractors have employed machineries and heavy earth moving equipments which is mostly latest. New equipment tends to be quieter than the old ones. Earplugs as an integral part of PPE along with other accessories have been provided to the labors and workers accordingly. The use of earplugs is made mandatory during heavy construction activities and its proper use is a part of orientation training also.

Figure 4.2 Generator with Silencer controlling noise in wp-07

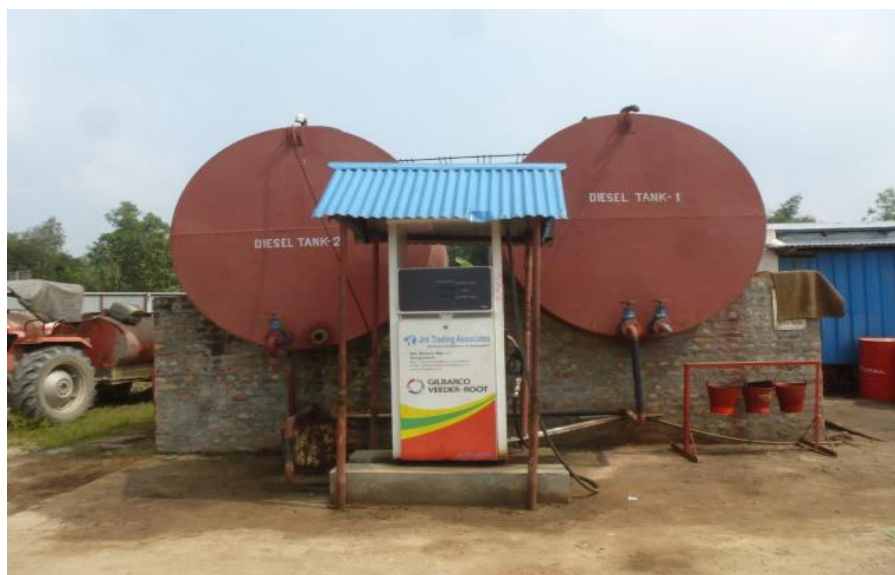
44. Petroleum products used in the site are stored in the respected tanker in the base camp. While fueling a vehicle or transferring to different medium, polybags are used to prevent spillage of oily substance on the ground. However, if somehow spillage occurs, shovels are used to separate that soil amount and transfer to the designated waste disposal area in the base camp for further disposal in the dumping yard. Air pollution has not been reported yet according to air quality tests so far.

Figure 4.3 Pavement surface at refueling station controlling oil pollution in wp-07

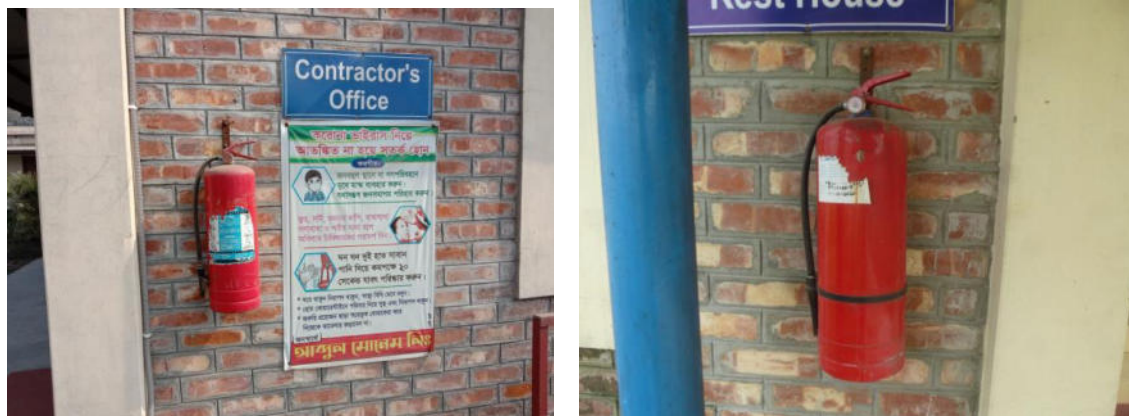
Figure 4.4 Site security through fire safety extinguisher system

46. The Contractors have already constructed site boundary fencing to isolate the base camp. Proper sign boards and pictorial sign have been used mentioning caution for the area of petroleum, spirit & highly flammable materials & general awareness prohibiting smoking inside the base camp. At camp site there are adequate fire extinguisher systems. It is suggested to ensure pavement surface of refueling station in base camps and secondary containments of lubricant chemicals. Fire safety signage, precautionary symbols and labeling are used at refueling station and base camp.

I. Fire Extinguisher Infront of Site Laboratory II. Fire Extinguisher Infront of Engineer's Office

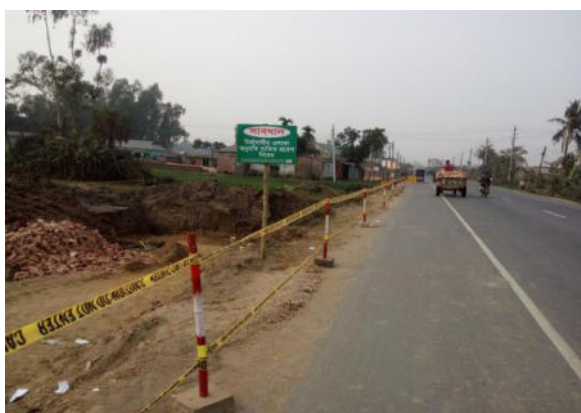
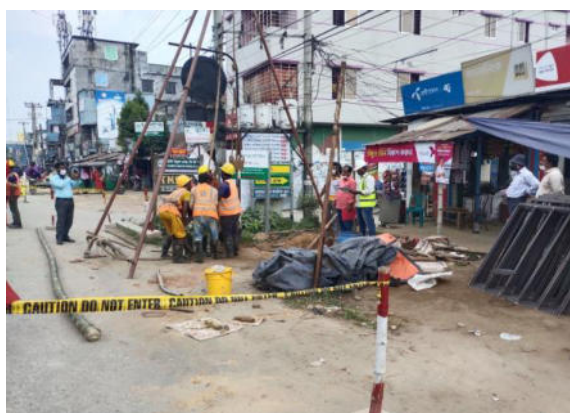
Figure 4.5 Site security with safety caution tape at under construction sites in wp-08

a. Under construction Road side safety

b. Bore Hole No. 02, B-Block Cantonment

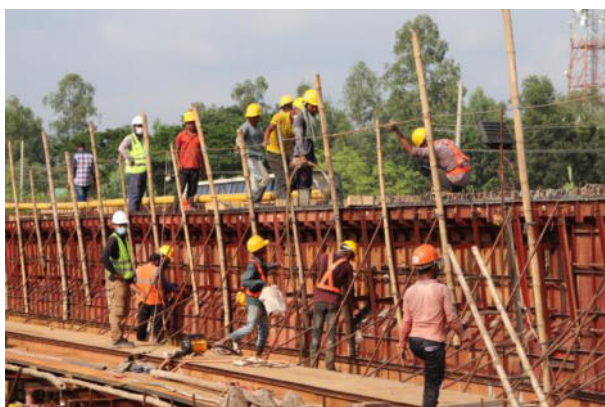
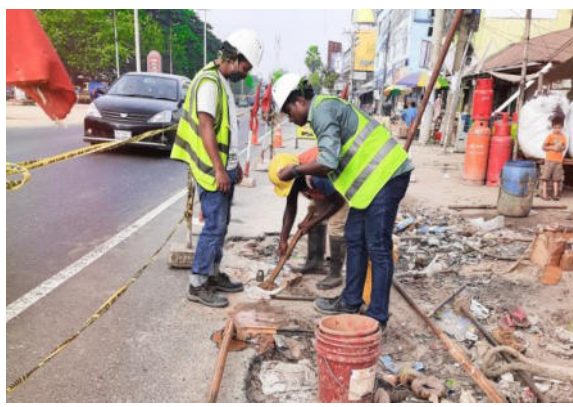
Figure 4.6 Workers are using PPE during construction work at wp-08

64. The working personnel involved in the construction activities have put on PPE properly. The workers were found with proper PPE, such as Safety Jacket, Safety Shoes, Helmet and Hand Gloves, Eye face protection etc. Due to COVID-19 outbreak all the workers, labors and other personnel involved in this project has been provided with respiratory masks to protect themselves while working. Social distance has been seen to be maintained by everyone as much as possible. General knowledge regarding self-protection against novel Corona Virus has been infused with orientation program and training properly.

A. PC Girder Concrete Casting, (Fotki Bridge)

B. Sub soil investigation work for underpass

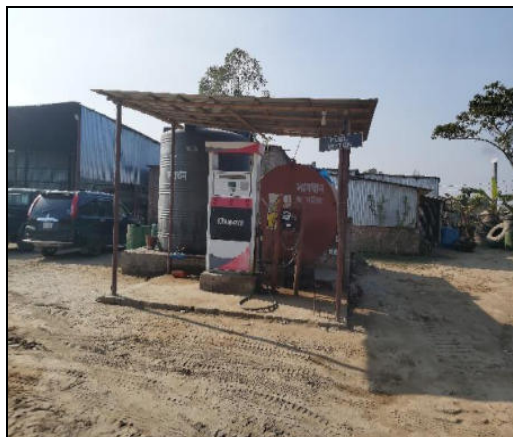
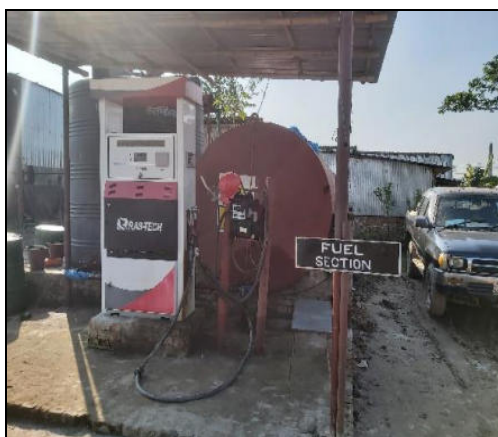
Figure 4.7 Controlling of petroleum products through using concrete surface in wp-09

76. Petroleum products used in the site are stored in the respected tanker in the base camp. While fueling a vehicle or transferring to different medium, polybags are used to prevent spillage of oily substance on the ground. However, if somehow spillage occurs, shovels are used to separate that soil amount and transfer to the designated waste disposal area in the base camp for further disposal in the dumping yard. Air pollution has not been reported yet according to air quality tests so far.

a. Refueling Station at Camp Site

b. Fuel Kept on concrete Place

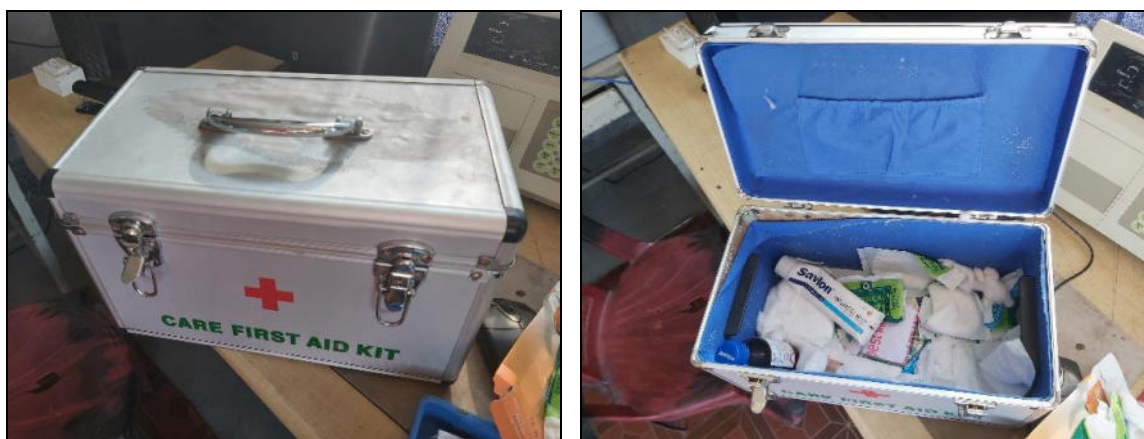
Figure 4.8 Workers primary health treatment by first aid kits in wp-09

A. First Aid Kits and medical services (closed) B. First Aid Kits and medical services (opened)

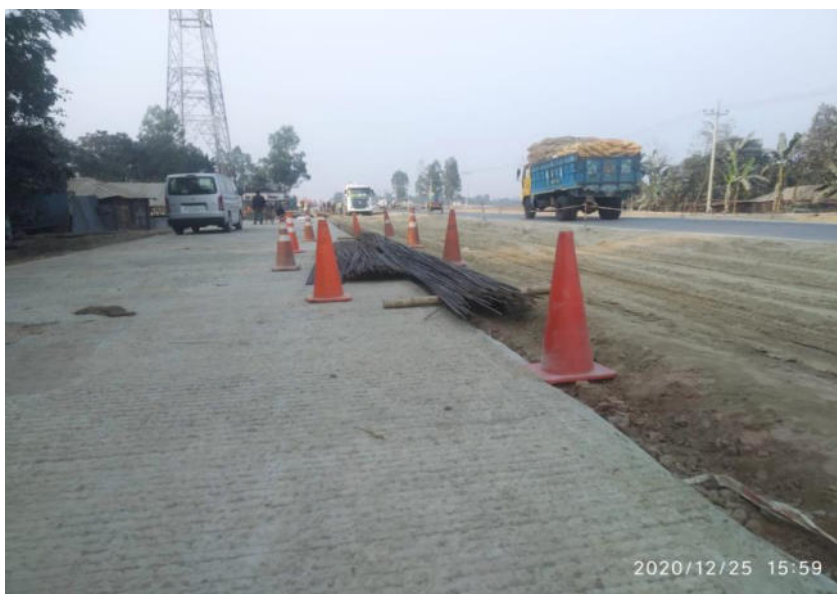
110. The Contractors have already constructed site boundary fencing to isolate the base camp. Proper sign boards and pictorial sign have been used mentioning caution for the area of petroleum, spirit & highly flammable materials & general awareness prohibiting smoking inside the base camp. At camp site there are adequate fire extinguisher systems. It is suggested to ensure pavement surface of refueling station in base camps and secondary containments of lubricant chemicals. Fire safety signage, precautionary symbols and labeling are used at refueling station and base camp.

Figure 4.9 Road safety by caution tape and plastic road cones in wp-11

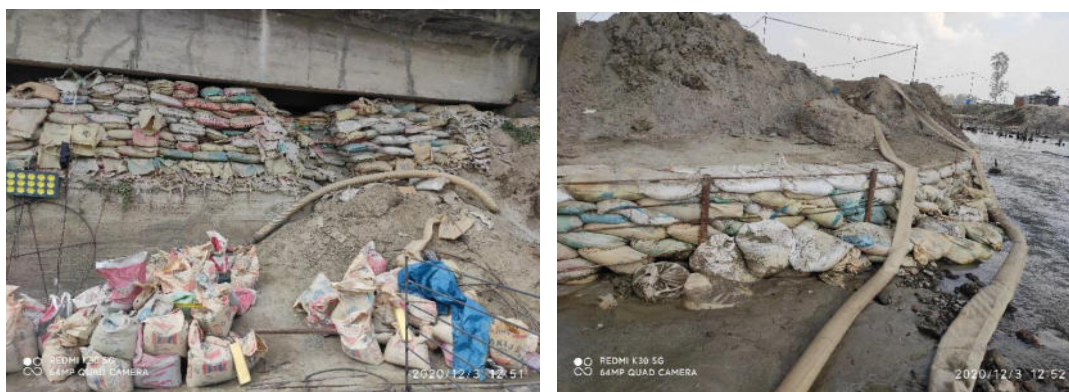
119. During dry season, flow of rivers along the project alignment is relatively low. As a result, running water is not a major cause of any soil erosion along the river banks. However, in the Bridge construction site visible soil erosion is observed due to heavy equipment use and construction works which is not that significant. Sandbags have been deployed near bridge and culvert construction area as a preventive measure.

Figure 4.10 Sandbags are deployed at bridge construction site for preventing soil erosion

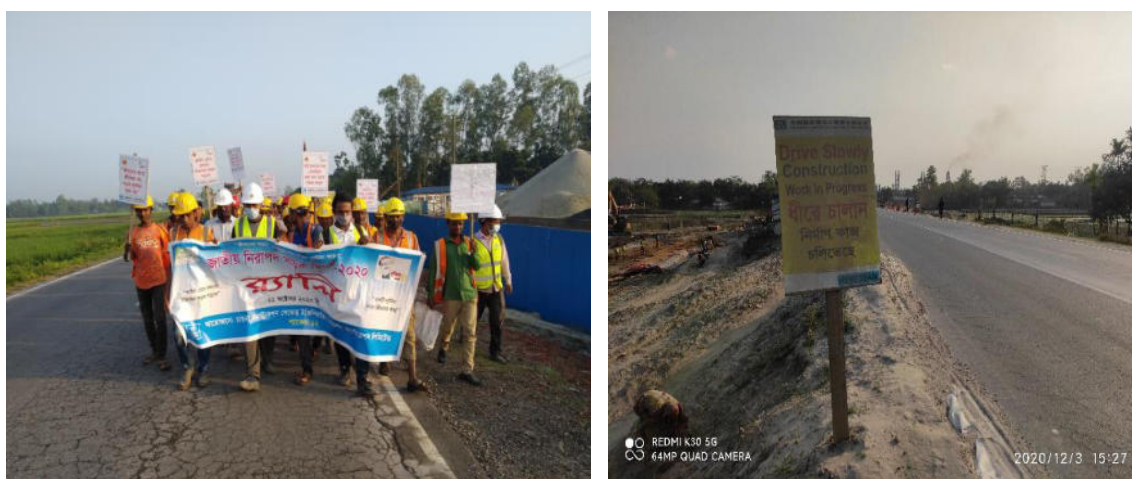
Figure 4.11 Road safety activities at under construction road in wp-12

A. Rally for safe road at under construction road B. Safety sign board at under construction road site

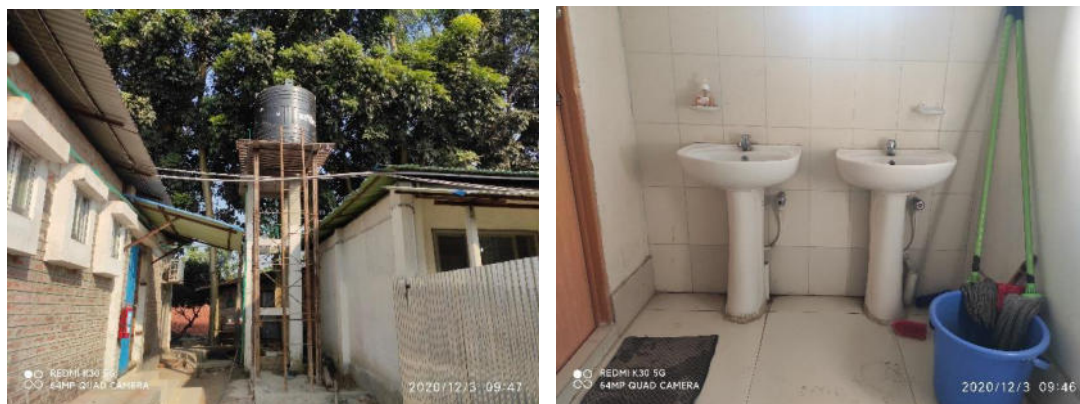
Figure 4.12 Drinking water facilities in the base camp in wp-12

130. Safe drinking water is being supplied through the arrangement of piping network in the base camp and water is available for the workers for the washing and toilet facilities. Adequate toilets for male and female workers have been constructed. It is recommended that washrooms & toilets have to be cleaned twice a day otherwise it will be unhygienic.

A. Source of drinking water for labours B. Wash basins available in the base camp

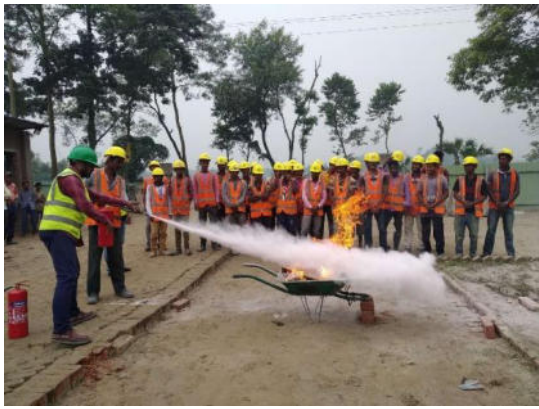
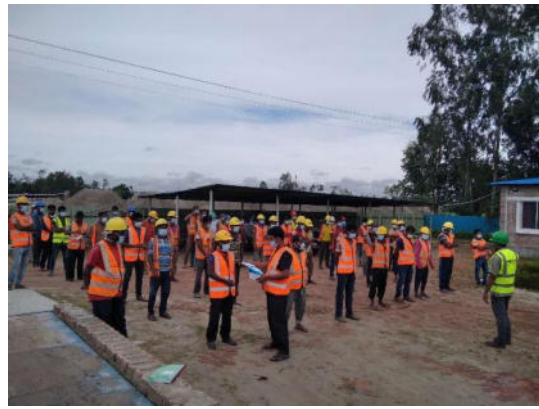
Figure 4.13 Safety orientation and training of workers in wp-12

I. Toolbox meetings are arranged

II. Fire drill is arranged on a monthly basis

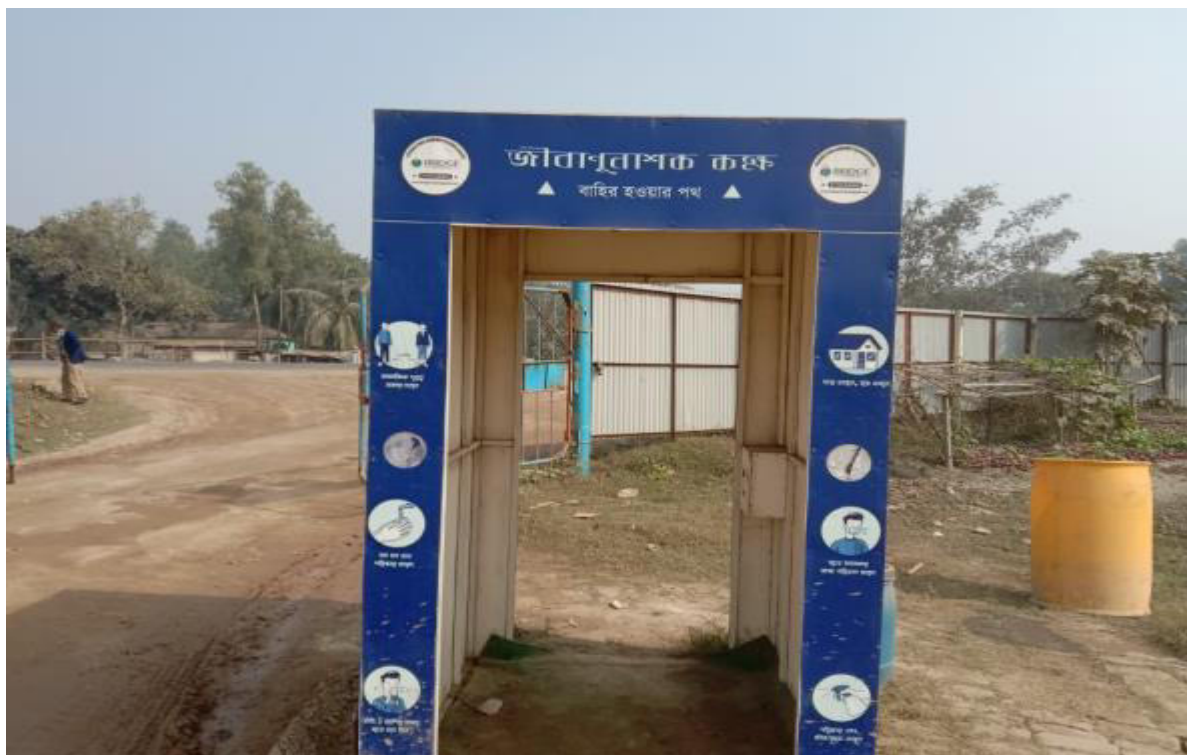
Figure 6.1 Disinfectant Safety Tunnel Facilities at the Camp Area

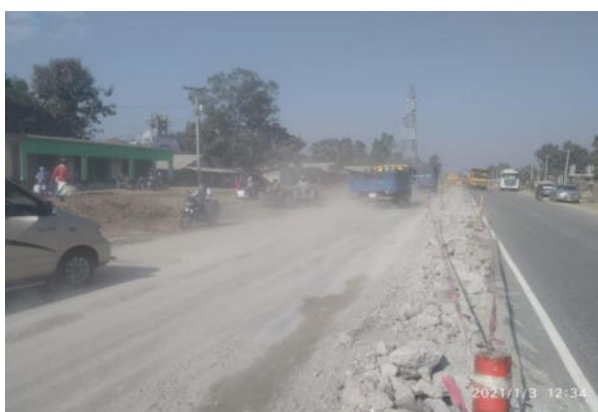
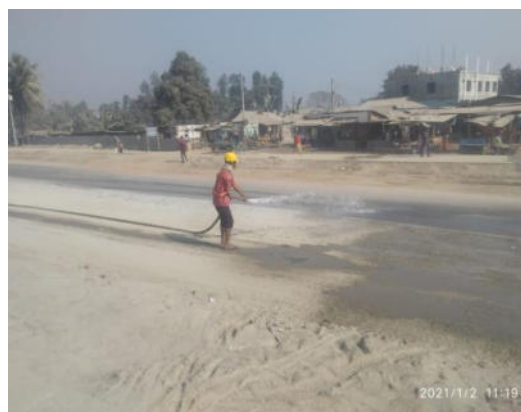
Figure 7.1 Dust control pre- and post-scenarios in wp-11

- Regular sprinkling of water is being done on open surface and dust grounds during construction phase;
- During school hour, sprinkling of water should be done around the school premises mentioned in Baseline survey.
- Transport of materials in tarpaulin- covered trucks
- The sand and other such dispersible material should be stored at site for minimum working period.
- Plantation of trees nears the road side after completion of construction phase.
- Project management and contractor should enforce strict use of personal protective clothing;
- Complaints of dust related ailments among employees and neighbors to be given attention by contractor.

a) Dust pollution pre-scenario condition

b) Dust control post scenario condition in wp-11

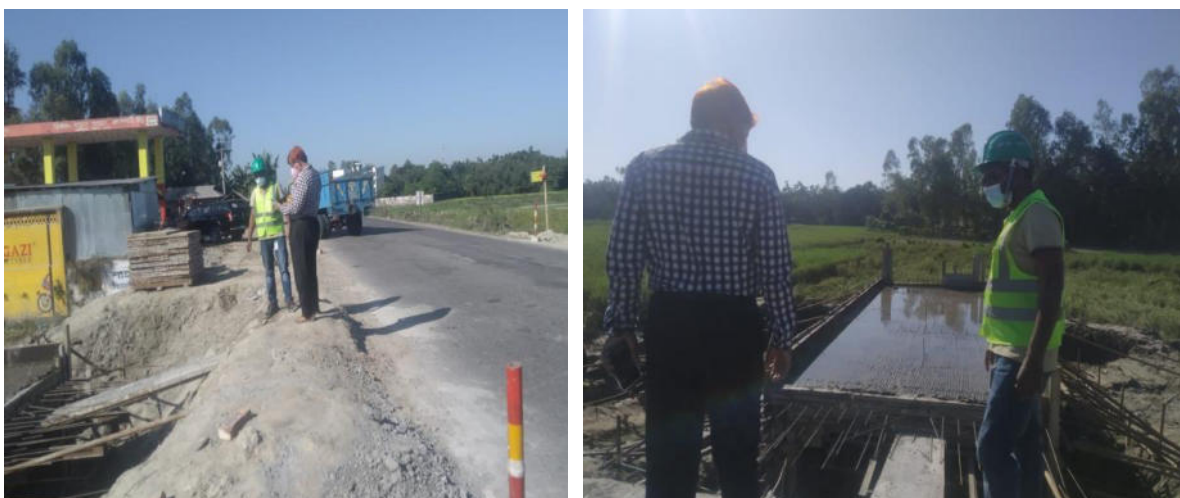
- Surface drainage have to be controlled to divert surface runoff away from the construction area;
- Laying barrier net;
- Undertaking construction work during dry seasons;
- Completed areas should be restored/re-vegetated as soon as practicable;
- Temporary silt-trap or digging of pond towardsiltation prevention
- Stockpiling of spoil soil at a safe distance from the drainage system

Figure 7.2 Culvert construction site visit by PIC Environment Specialist at wp-11

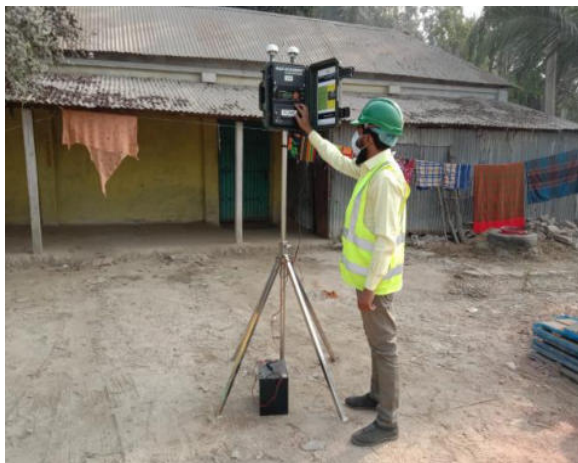
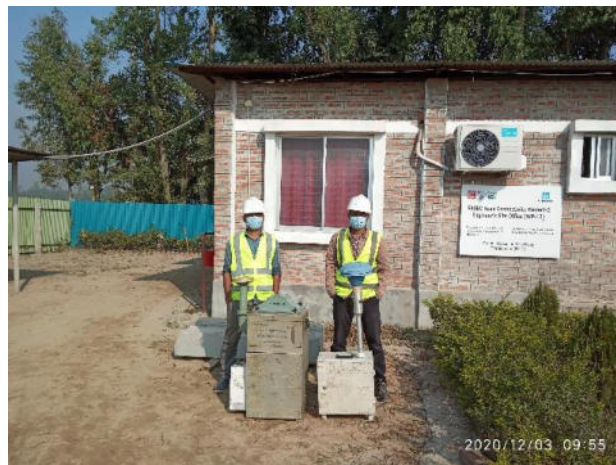
Figure 8.1 Air quality Sampling during the reporting period in WP 7 and WP 12

a. WP-7 Kurban's House, Hatikamrul

b. WP-12 Base Camp

Corrective Action Required: Contractor will control air pollution through dust suppression measure by January 2021.

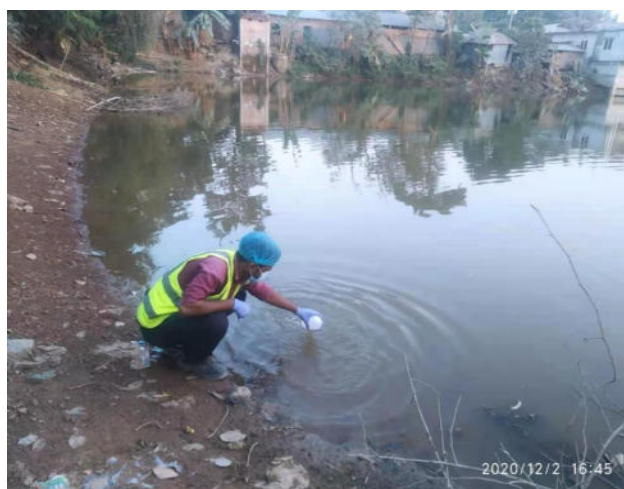
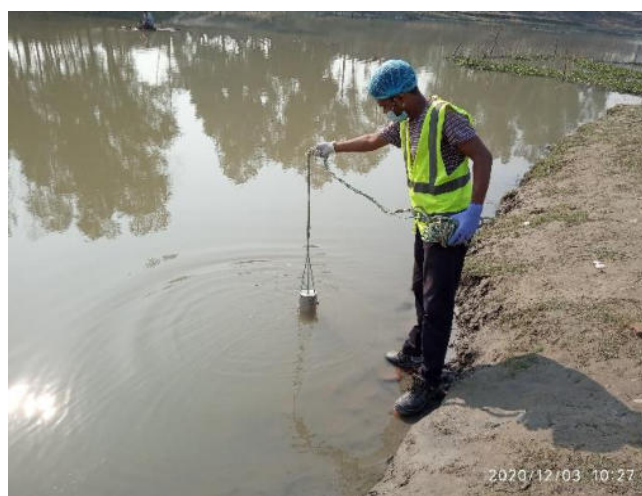
Figure 8.4 Surface water sampling during the reporting period in WP-11 and WP-12

a. Chainage 125+880 in wp-11

b. Ghaghot River in wp-12

Corrective Action Required: Contractor will pollution surface water pollution through preventing run off loose soil by January 2021.

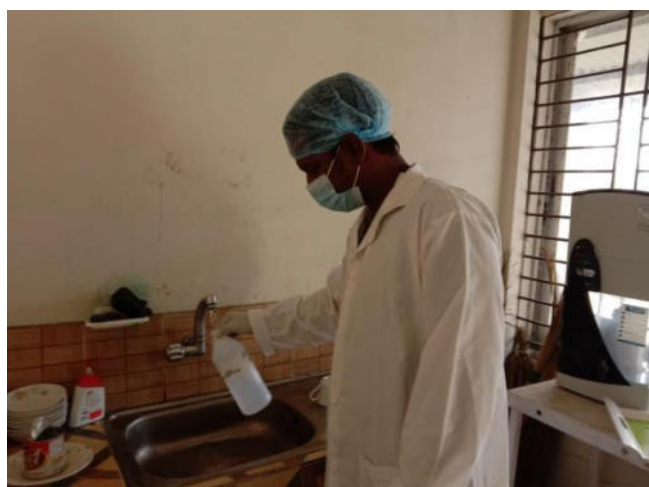
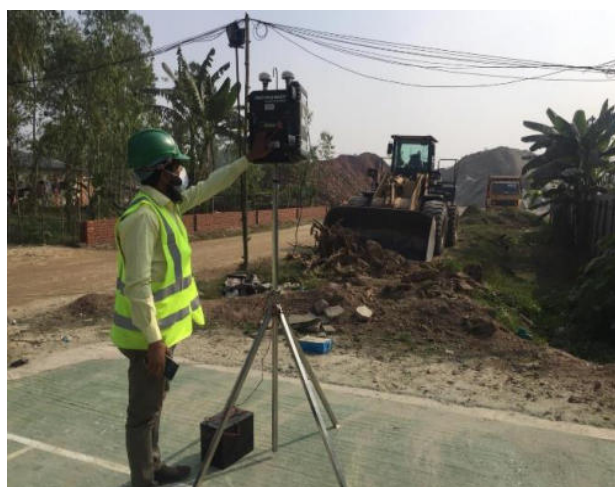
a. Ground water sampling at Construction Camp, wp-7

b. Ground water sampling at wp-8

Corrective Action Required: Contractor will advise the school authority to avoid using the water by January 2021.

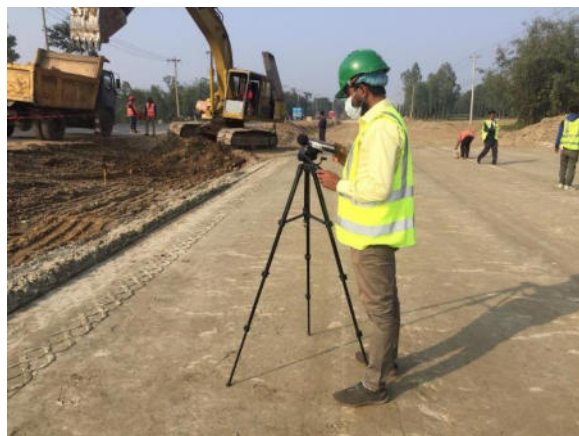
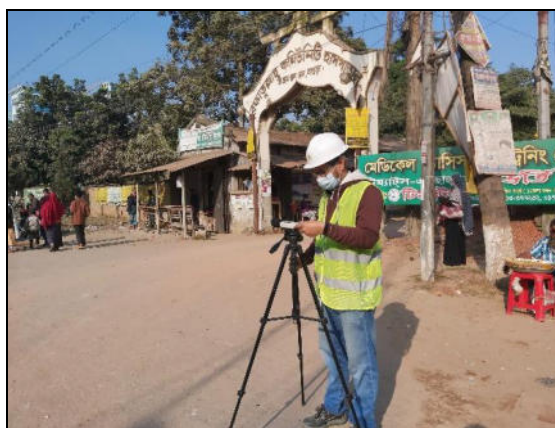
Figure 8.6 Noise Level monitoring during the reporting period in WP-8 and WP-9

Noise level: It is unsatisfactory that in WP-08 noise level found 67.39 dBA in mixed area and 71.45 dBA in commercial area which are higher than DOE value (mixed area 60 and commercial area 70 dBA). Noise level in all other five WPs is satisfactory.

a) Noise level monitoring in WP-8

b) Noise level monitoring in WP-9

Corrective Action Required: Contractor will take corrective action for mitigation or minimize the noise pollution by January 2021.
