Environmental Monitoring Report

Semi-Annual Report
September 2017

MON: Western Regional Road Corridor Investment Program, Tranche 2

Prepared by Project Management Unit (Ministry of Road and Transport Development) for the Government of Mongolia, Ministry of Environment and Tourism, and the Asian Development Bank.

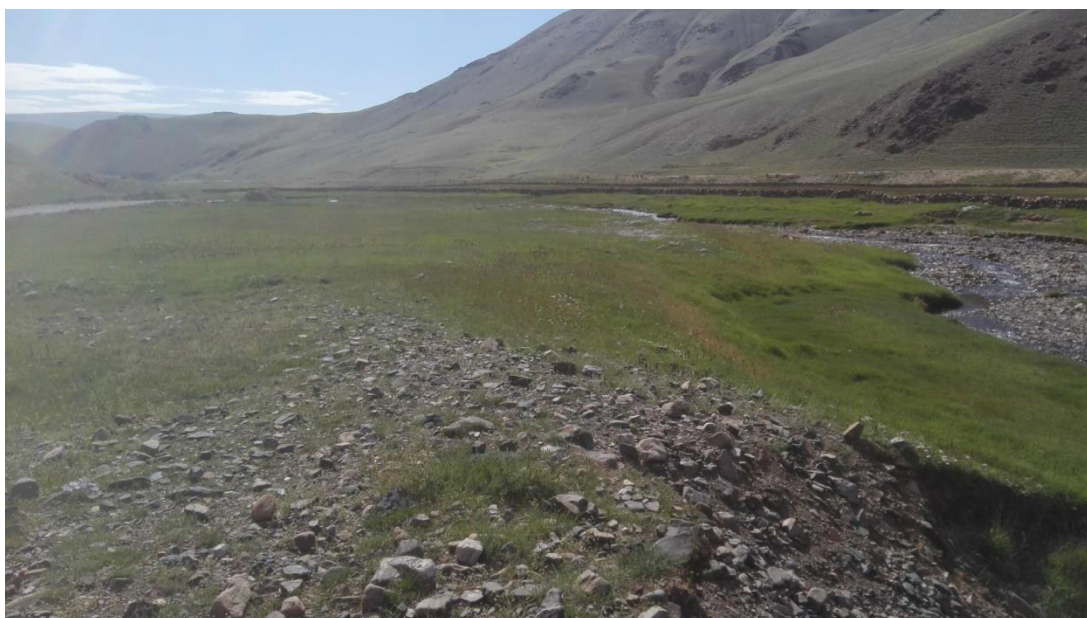
Figure 2: Buraat river valley, lot CW1-3.

1. **Buraat river valley:** is located in the CW1-3 section between STA.74 and STA.80. Buraat is a tight river valley (less than 1 km wide at some points) with much of the valley is covered by grassland and marshes. There are 3 permanently dwelling households and a fodder field in the valley.

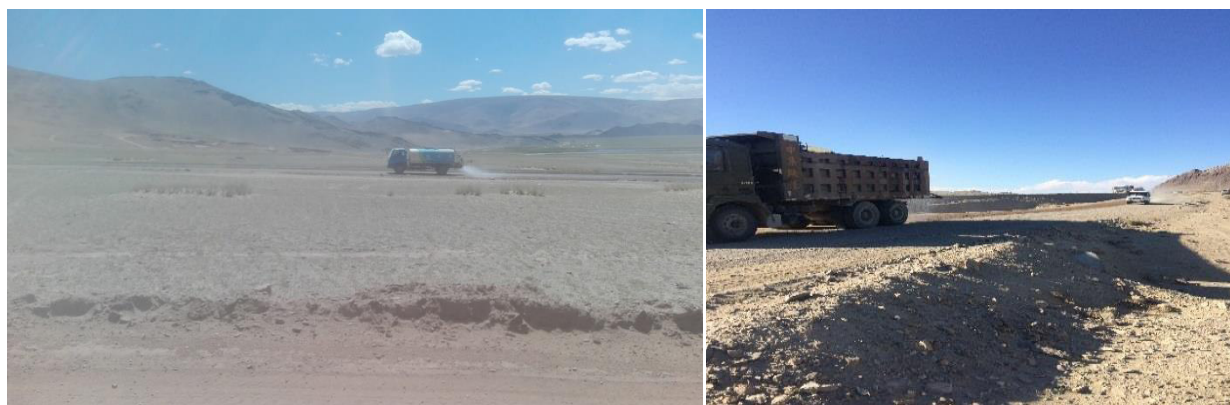
Figure 5. Water spray trucks

The contractors have employed water spray trucks to reduce dust generation. Each construction package is operating the 2 water spray trucks along the deviation road and construction sites and watering 4-5 times a day. However, dust generation has not been reduced to an expected level due to an extended drought and a dry weather this summer.

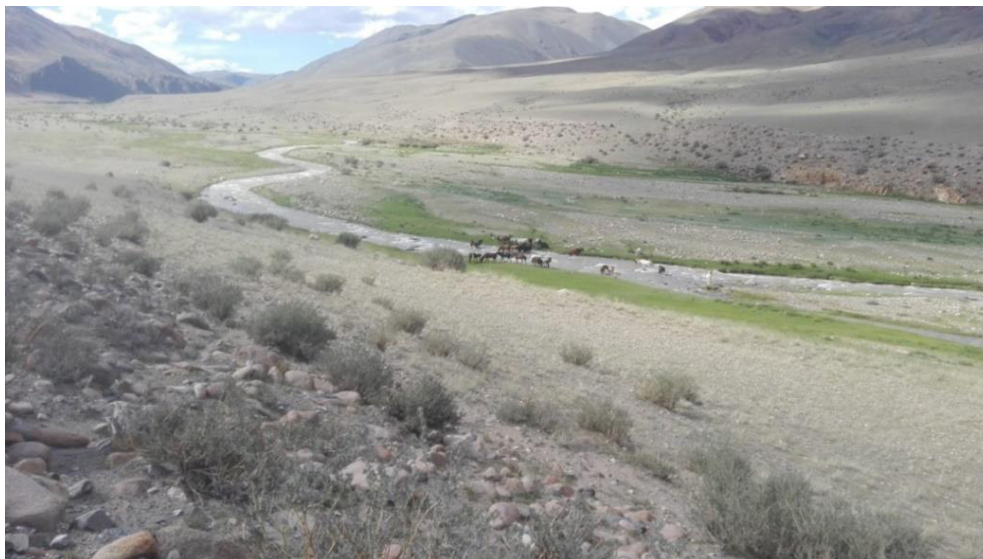
Figure 7: The point where Hongio river bank needs to be diverged

The CW1-1 road crosses Shurga and Hongio rivers and passes adjacent to the river in the Hongio valley. Protection of Hongio valley from potential pollution is important. There will be temporary limited access to pastureland for the herder families. The contractor will construct a new bridge on the crossing point of the Hongio river. At around STA.20, the space between the Hongio river and the mountain foot is very tiny, thus in order to allow a deviation road, the river bank shall be diverted. The contractor is planning to apply local administration for necessary permissions.

- ❖ Apply to Khar lake and Khovd river basin administration for permission on Hongio river diversion at STA.20.
- ❖ Create livestock crossings at the points that are recommended by Erdeneburen soum governor.
- ❖ Create wildlife crossings at 3 points in the Hongio river valley in accordance with the Mongolian standard MNS6515: 2015.

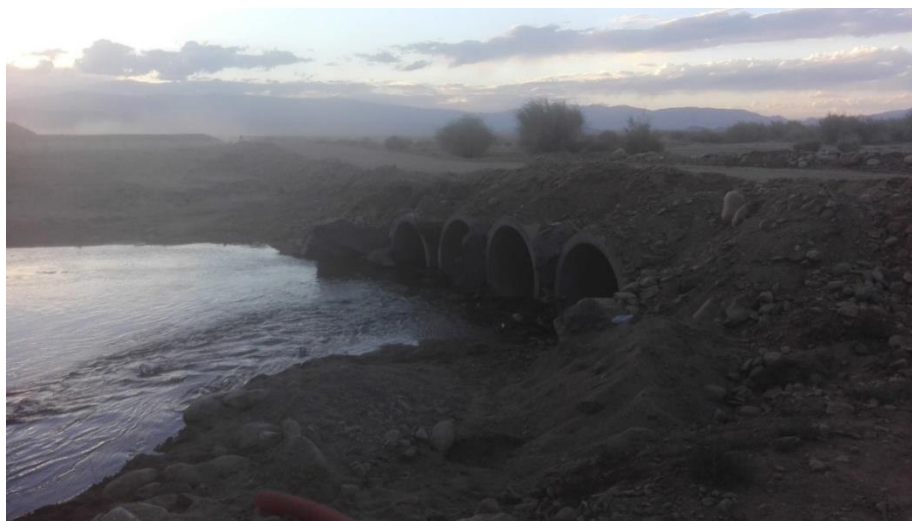
Figure 8. Deviation road embankment at the Shurga river

In order to prevent from oil spills, the contractor has constructed a deviation road embankment with culverts under it at the Shurga river in July.

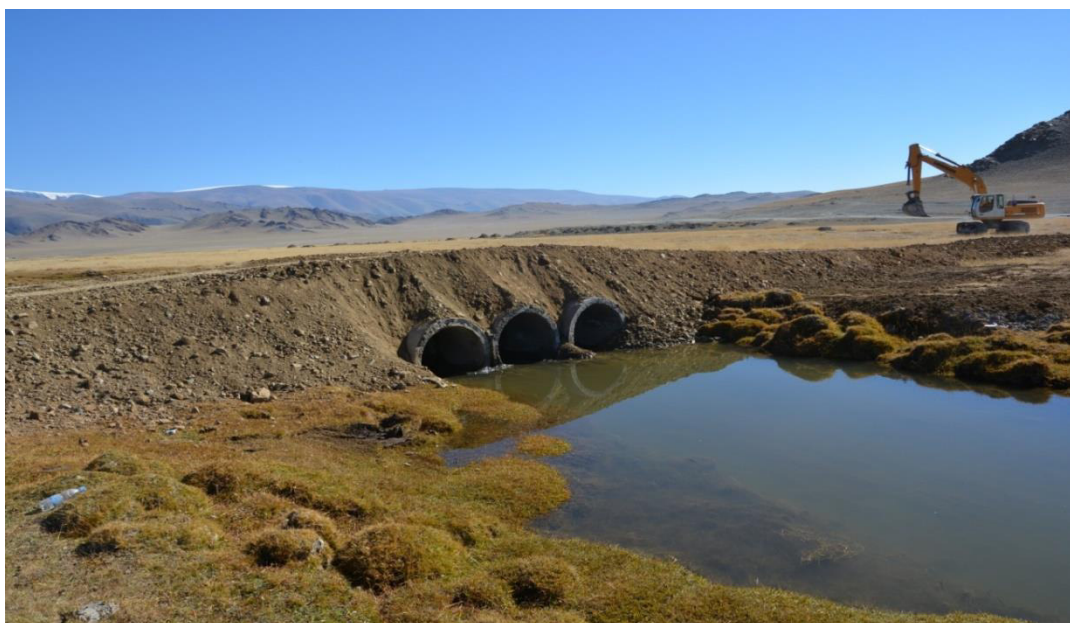
Figure 9. Deviation road embankment over the Hongor Ulun river. STA.100+700

CW1-3 team has constructed river crossing embankments for deviation roads at 3 points for Buraat and Hongor Ulun rivers, at STA.72+500, STA.75+800 and STA.100+700 respectively. Culverts are installed under the deviation which allows water flow.

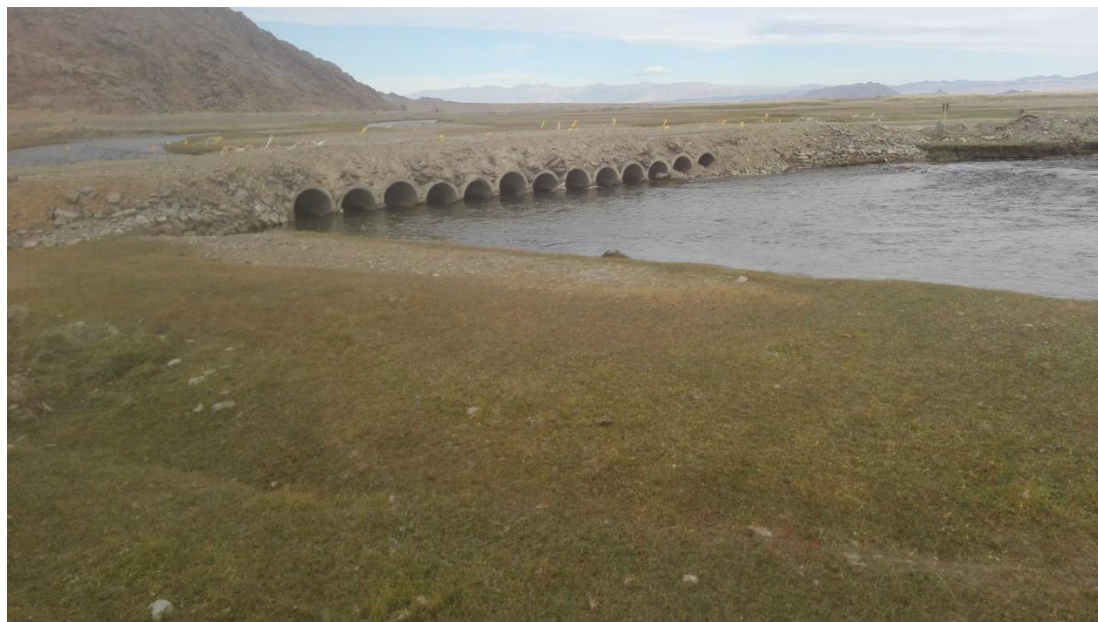
Figure 11: A deviation road embankment over the Buyant river

In order to prevent oil spillage which could pollute Buyant river, the contractor has constructed a deviation road embankments over 3 streams of the Buyant river. A total of 146 culverts are being installed along the deviation road. It was a well planned mitigation measure that meets EMP requirements.

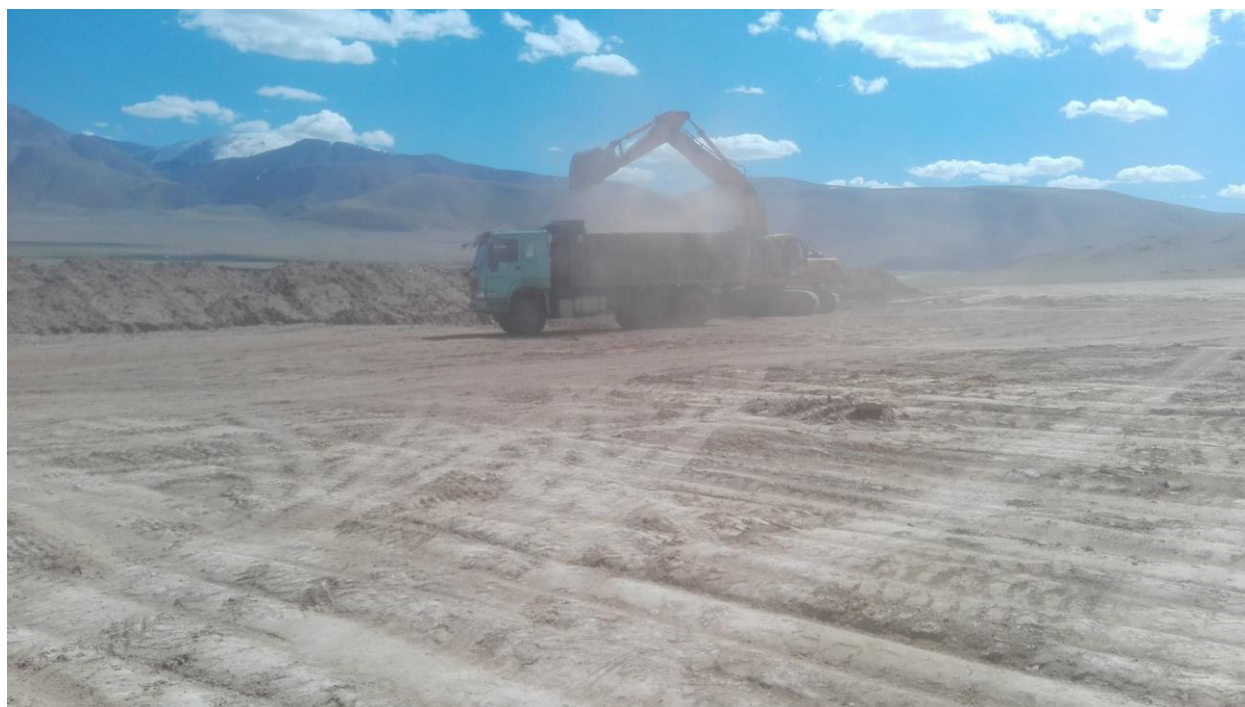
Figure 12. Borrow point at STA.96

The construction team has obtained permission to use 22 borrow pits from the Tolbo soum government. At present, 5 out of 22 borrow pits are in use. . The main quarry site locates nearby the main workers' camp at STA.65. Another quarry site planned for the CW1-3 section locates at STA.93.

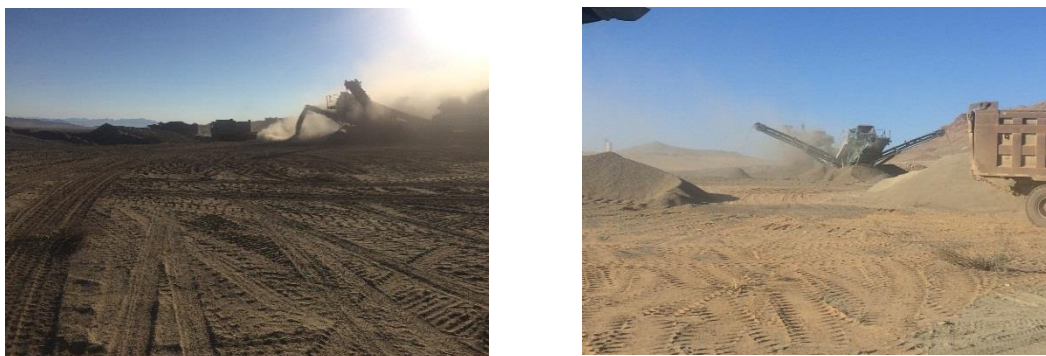
Figure 13. Newly installed crushers at the quarry site.

Crusher at the quarry site: In order to increase gravel material production, the contractor hired 2 new crushers. Relevant permission were obtained from the local government and environmental monitoring activities cover the crusher sites.

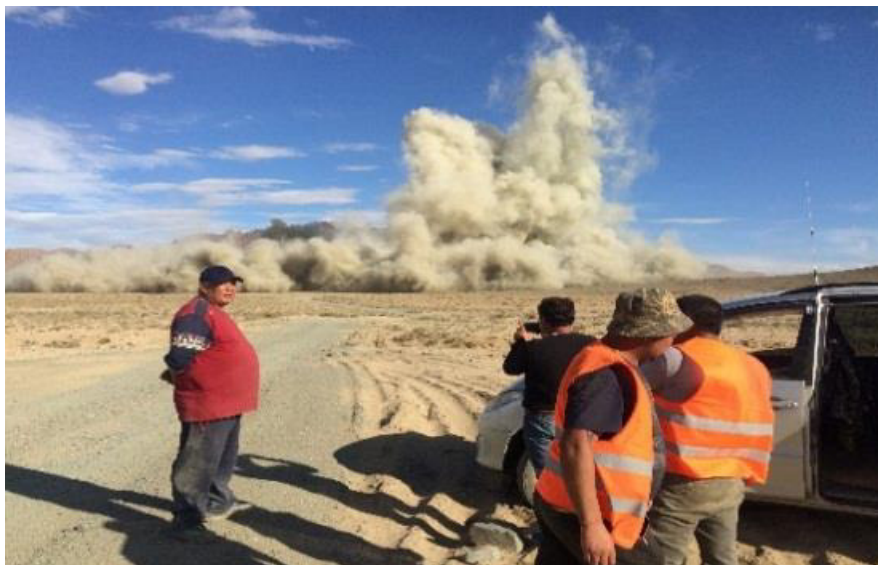
Figure 14. Blasting at the quarry site. 2017.07.03

The contractor has hired Davkhar Tesrelt LLC to conduct blasting works at the quarry site (STA.81+300) on 3 July 2017. The blasting team consists of 4 professionals has conducted blasting works under supervision by ICT Sain LLC engineers, Khovd province police department, Professional Inspection Agency and Environmental Department. Environmental and safety staffs of the contractor met with the local administration and herdspeople to inform the upcoming blasting works 3 days prior to the blasting action. There are no any herder household is residing in the vicinity of the blasting site (in 10km radius).

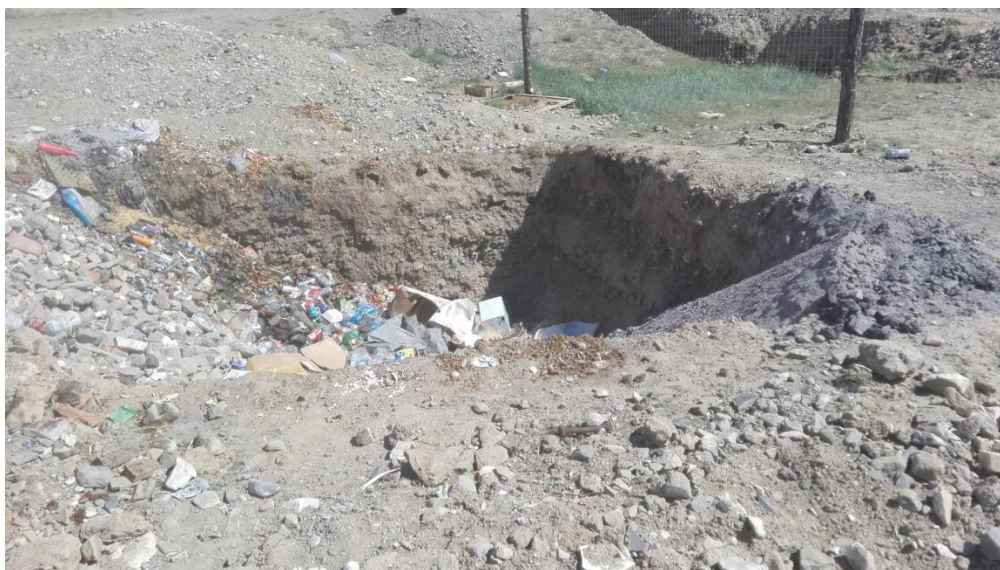
Figure 16. Waste collection point at main camp, CW1-3

The contractor collects domestic waste generated from the camp site and waste ash in an open pit which could be taken to the surrounding environment with wind during windy days. PIU Environmental specialist has visited the camp site in July and instructed to have protection fence around the waste collection point and make some cleaning works. Also, the contractor was instructed to collect waste ash from the kitchen in a designated box.

The vehicle washing point at the camp site does have a concrete basis but lacks protection stages around it which would prevent waste water to run-off. The contractor is instructed to improve the condition.

Waste water of the main camp site is disposed to designated pit with concrete base. However, it might cause a bacterial pollution to surrounding soil cover, the contractor was instructed to choose one of the following 2 options to properly dispose its waste water:

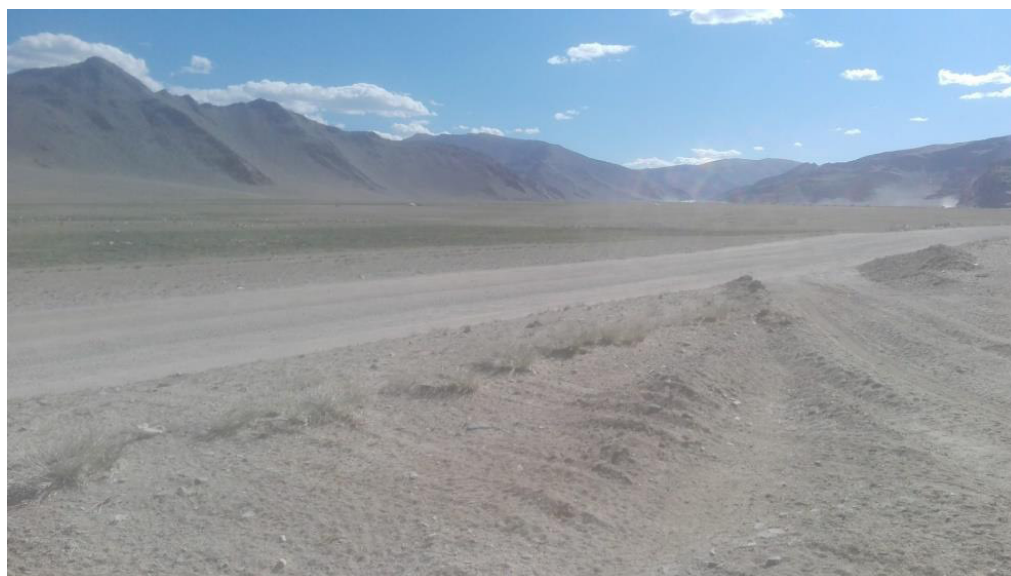
Figure 17. Proposed wildlife crossing at 6+520, CW1-1.

The PIU environmental monitoring consultant and ICT supervising engineer had a joint visit at the proposed wildlife crossing points to check implementation possibility. Depending on the height of the road embankment and landscape condition for wildlife movement, they propose to a slight change in the previously recommended locations for the wildlife crossing. Now, the agreed locations are at STA.6+520, STA.7+956 and STA.13+425 at CW1-1 and 85+040 at CW1-3, which are better for crossing as the road embankment is lower at the proposed spots..

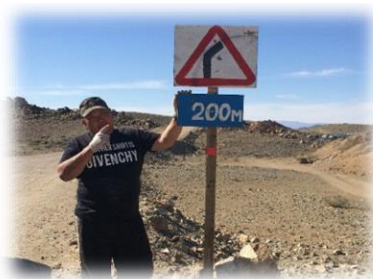
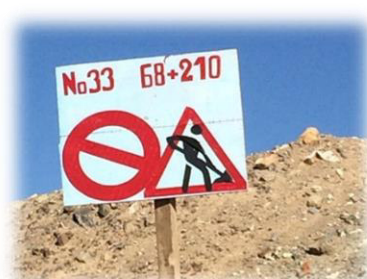
Warning signages were place at deviation roads and active construction sites

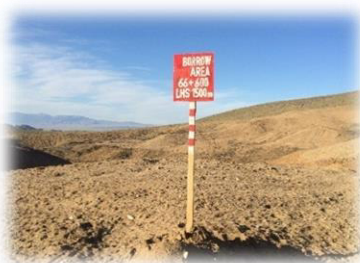
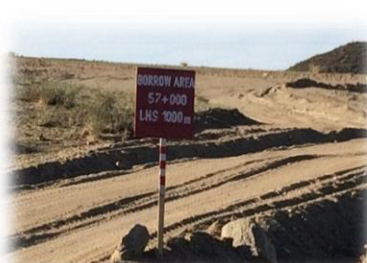
Warning signages were placed at the jungles and nearby borrow pits

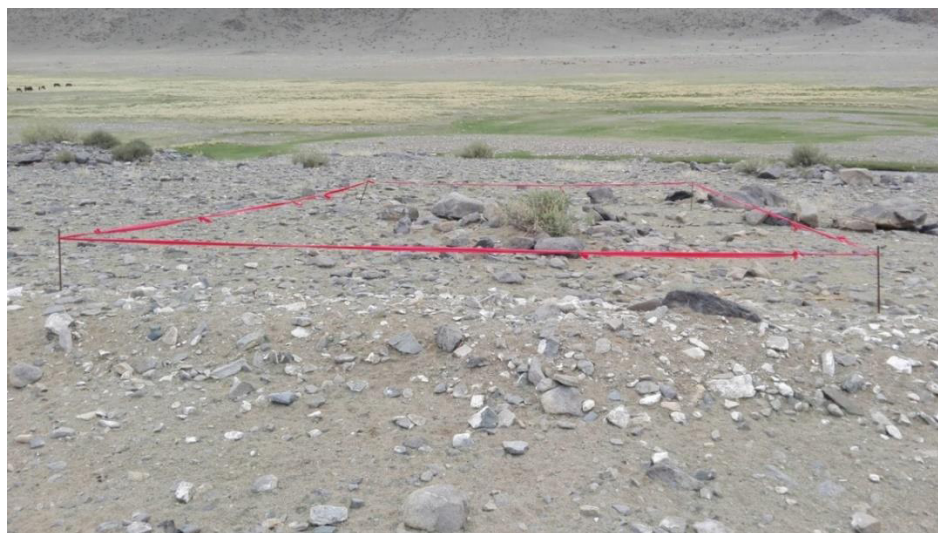
Figure 22. An ancient tomb protected in Hongio river valley

There are 23 ancient tombs existed within 20m distance of the road alignment in the Hongio river valley. Of which, 13 tombs were located under or very close to the road alignment, thus removed by professional organization in October 2016. The other 10 tombs that locate in 50-100m distance from the road alignment have been protected with visibility fencing.

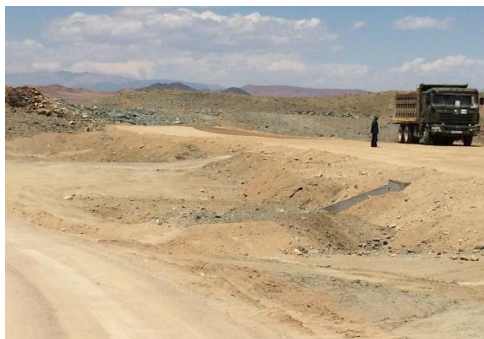
Figure 23. The planned blasting

There is a definite need to make blasting works nearby the rock paintings at STA.68+950, which is considered as a cultural heritage. The rock painting is located in 6 meter distance from the planned blasting site, thus which could be affected. Thus, the contractor is closely having dialogues with and applied for a permission to Khovd province government for rescue excavation of the rock paintings.

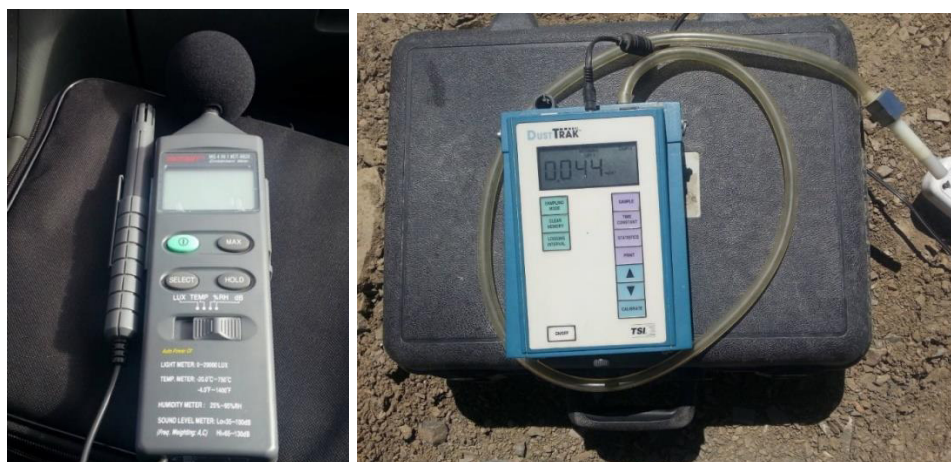
Figure 25: Noise dust measurement devices used for monitoring

level measurements using devices Dust Trak and VoltCraft, taken soil and water samples. Test analysis for soil and water samples were conducted at the Laboratory of National Geographic Academy in Ulaanbaatar and at the Laboratory of Khovd province Institute of Meteorology.

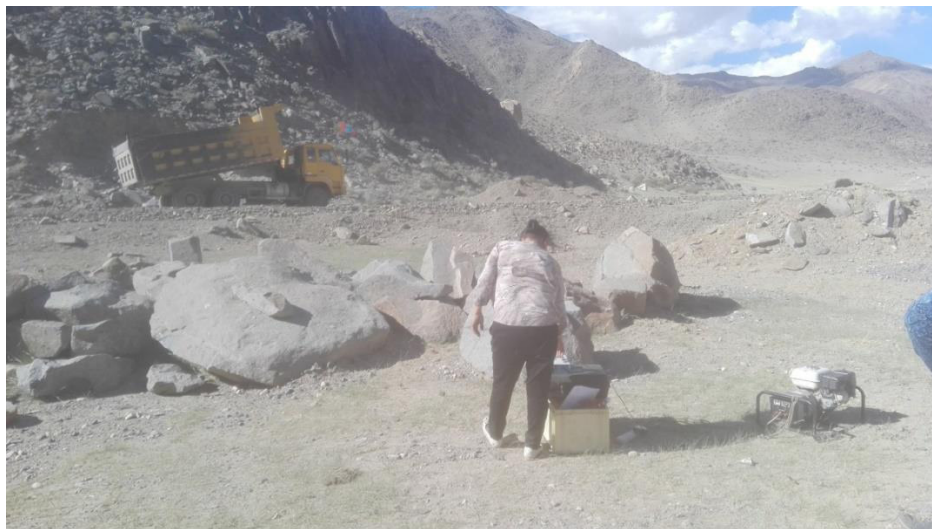
Figure 26. Dust measurement activity in July, CW1-1.

Measured dust concentration level exceeded the standard level all quarry sites and a couple of active construction spots in July. Each construction package is operating 2 water spray vehicles along the deviation road and construction sites on daily basis. However, due to an extended drought season and an unusually dry weather this year, the dry soil absorbs sprayed water in just a few minutes and dries up again quickly. Dust level was reduced with frequent water spraying, but not to an expected level. The contractors are planning to intensify watering along the deviation road and the borrow points. The workers are provided with protection masks and goggles. Herder households does not reside in close distance to active construction sites. Thus, there is no significant dust impacts to workers nor nearby communities.

Since measured dust levels exceeded the maximum allowed level at the active construction sites following measures are recommended to the contractor to reduce dust level:

- ❖ All trucks transporting earth materials shall be covered with tarpauling
- ❖ Fine particle stockpiles nearby the crusher need to be covered with tarpaulin.
- ❖ Intensify water spray along the deviation roads.
