# Environmental Monitoring Report

Project Number: 41193-019  
Semiannual Report  
December 2017

## Mongolia: Western Regional Road Corridor Investment Program - Tranche 2

## SEMIANNUAL ENVIRONMENTAL MONITORING REPORT

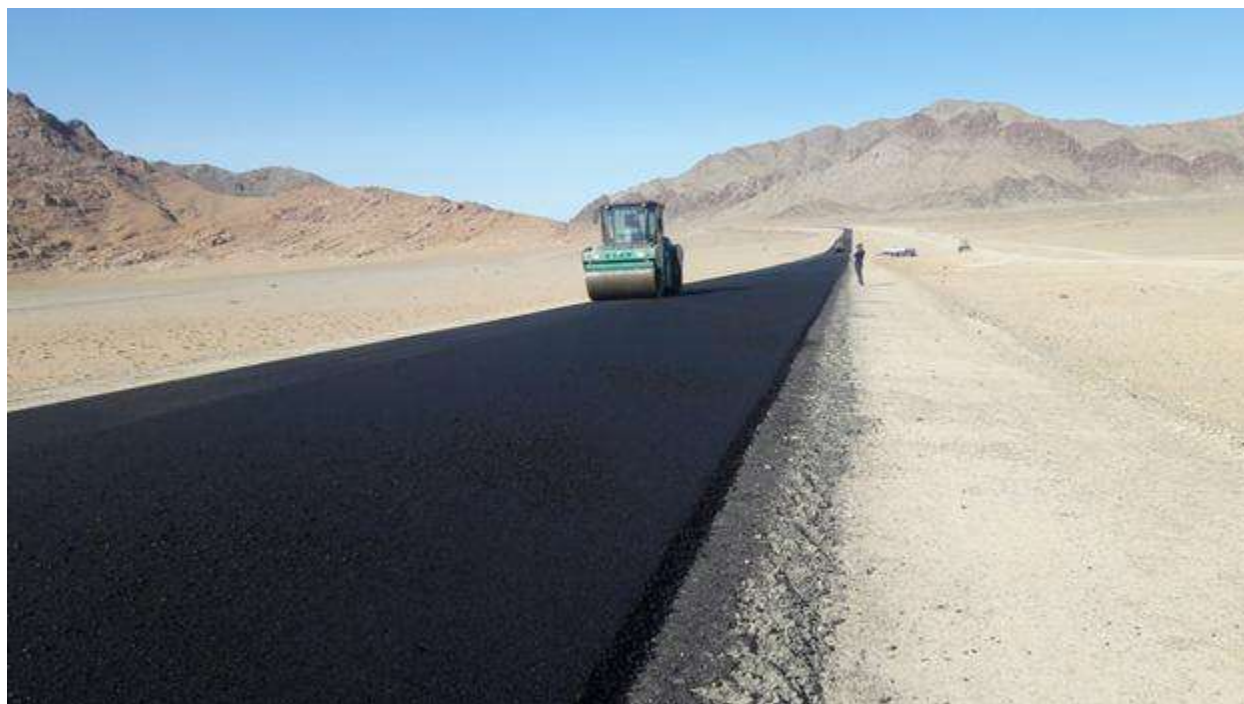
*Figure 2. Construction of asphalt concrete surfacing at the lot CW1-1. September 25, 2017*

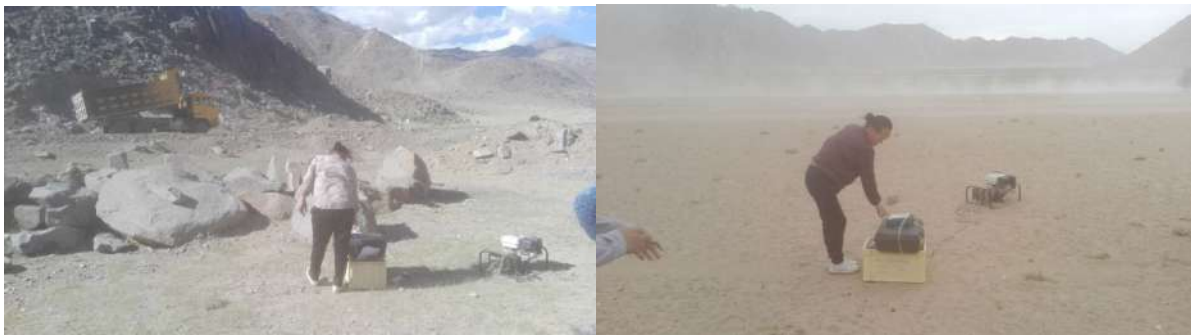
- ❖ Asphalt plants and concrete batching plants is located at least 1000 m downwind from the nearest dwellings in order to reduce the impact of fumes on humans and to be fitted with necessary equipment such as bag house filters to reduce fugitive dust emissions.
- ❖ The location of the stockpile is on downwind of sensitive receptors.
- ❖ Dust monitoring is undertaken at the selected monitoring spots on monthly basis to ensure dust level is within the maximum allowed level.

***Figure 3. Dust measurement at active construction sites, July 2017***

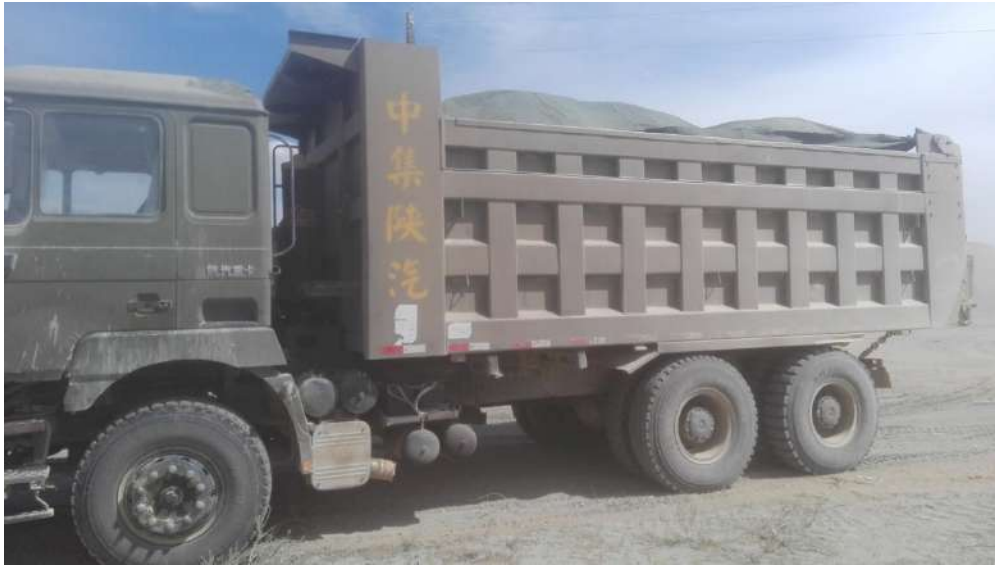
- ❖ Earth material transporting vehicles started used blankets to prevent dust spread

*Figure 4. Earth material transporting vehicles use designated blanket to prevent from dust spread, July 2017*

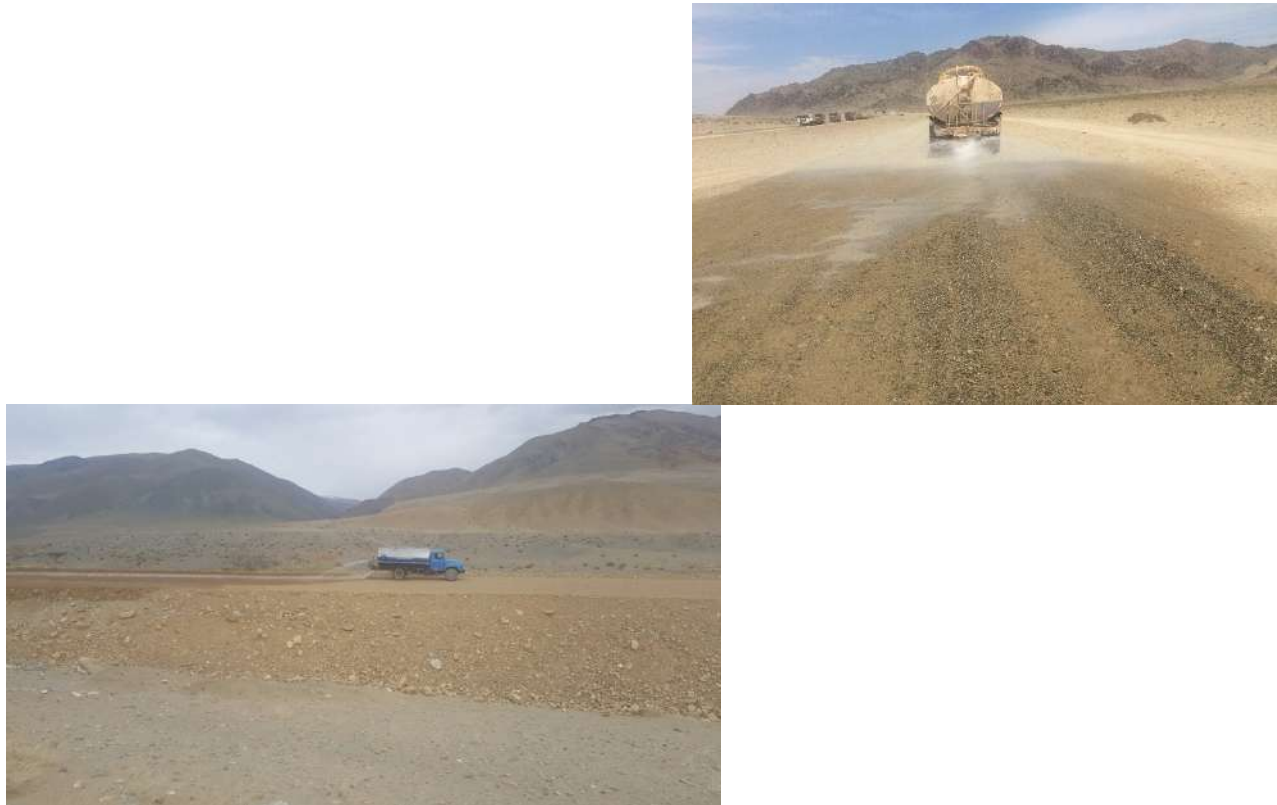
The CW1-1 construction team had 7, CW1-2 team had 6 and CW1-3 team had 8 water spray trucks respectively that had been deployed for watering the temporary roads, embankment construction sites, borrow points and quarry sites to reduce dust generation. However, dust generation has not been reduced to an expected level due to dry weather this summer.

*Figure 5. The contractors employed water spray trucks, August 2017*

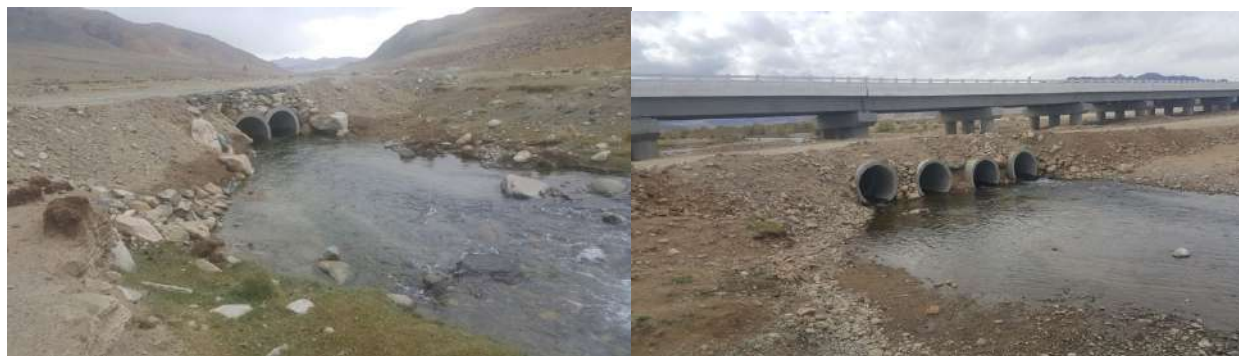
In order to prevent from oil spills, the contractor has constructed a deviation road embankment with culverts under it at the Shurga river in July.

***Figure 6: Temporary road embankments over Hongio and Shurga rivers, August 2017***

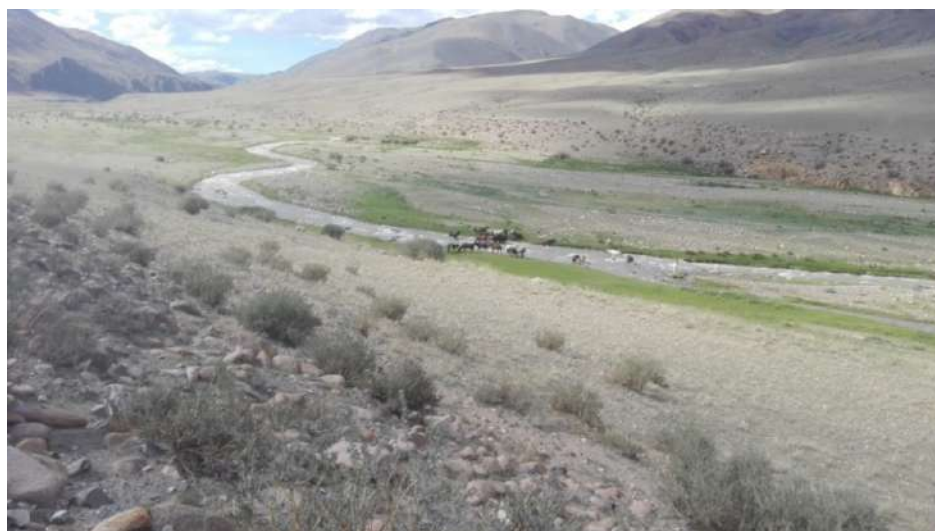
At around STA.20, the space between the Hongio river and the mountain foot is very tiny, thus in order to allow a deviation road, the river bank shall be diverted.

***Figure 7: The point where Hongio river bank will be diverged, July 2017***

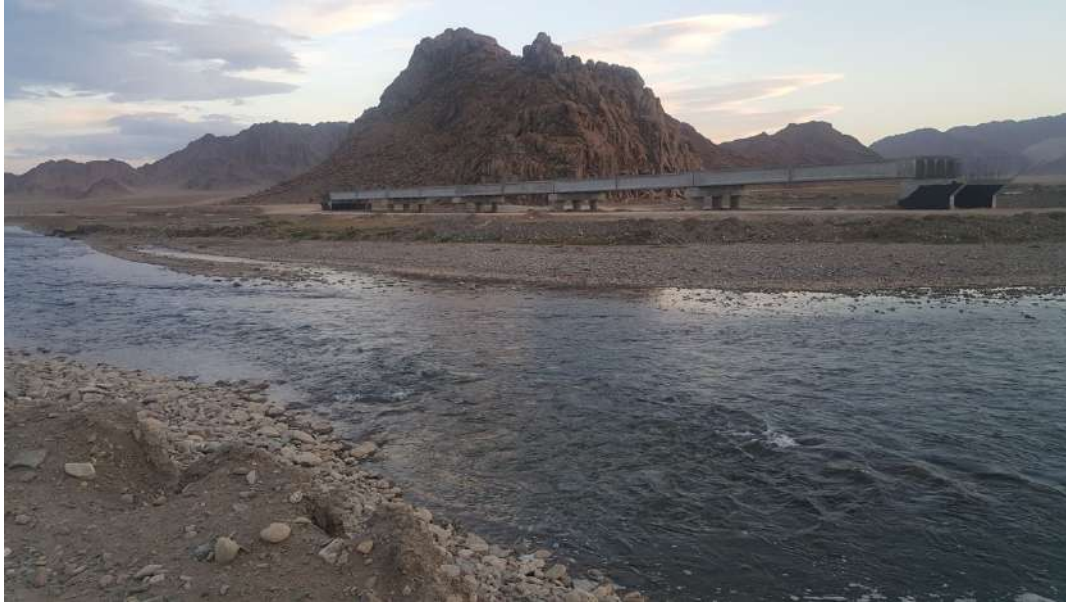
The project road crosses 3 streams of the Buyant river in the delta. 2 bridges with length of 150 will be built over the stream No.1 and 2. At the stream No.3, the culverts will be installed under the road embankment.

***Figure 8. Bridge construction over the Buyant river. CW1-2. September, 2017.***

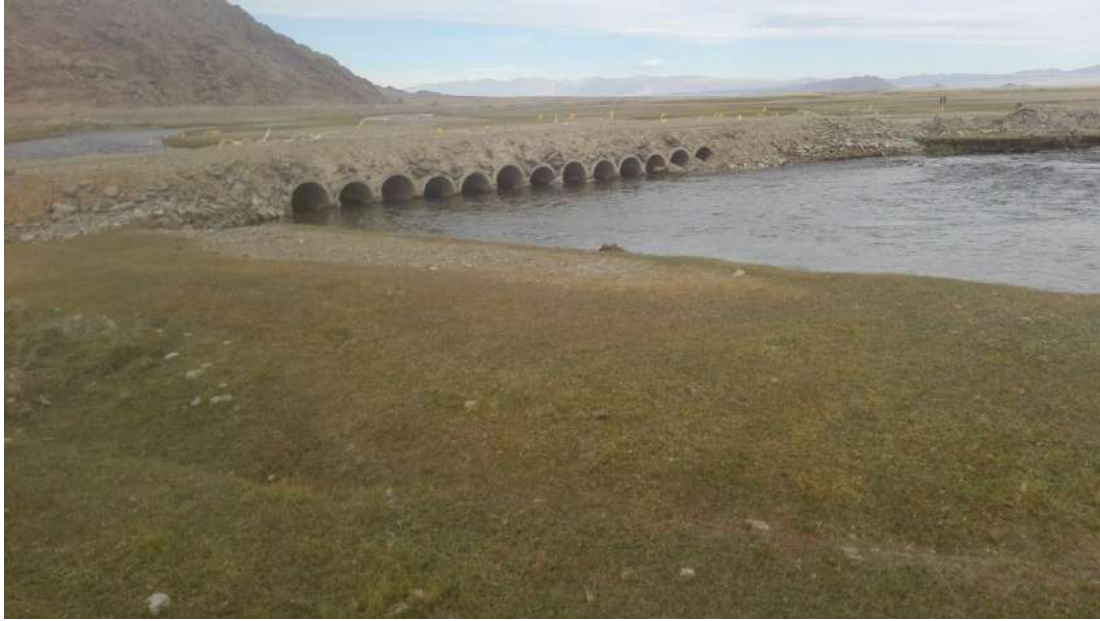
Preventing from pollution of Buyant river water is very important because there are about 1800 families are residing and planting watermelon down the stream of Buyant river, as per Buyant soum governor. In order to prevent oil spill from construction trucks, the contractor has constructed embankments at 3 points where the temporary deviation road crosses the river streams in 2016.

***Figure 9: A deviation road embankment over the Buyant river, July 2017.***

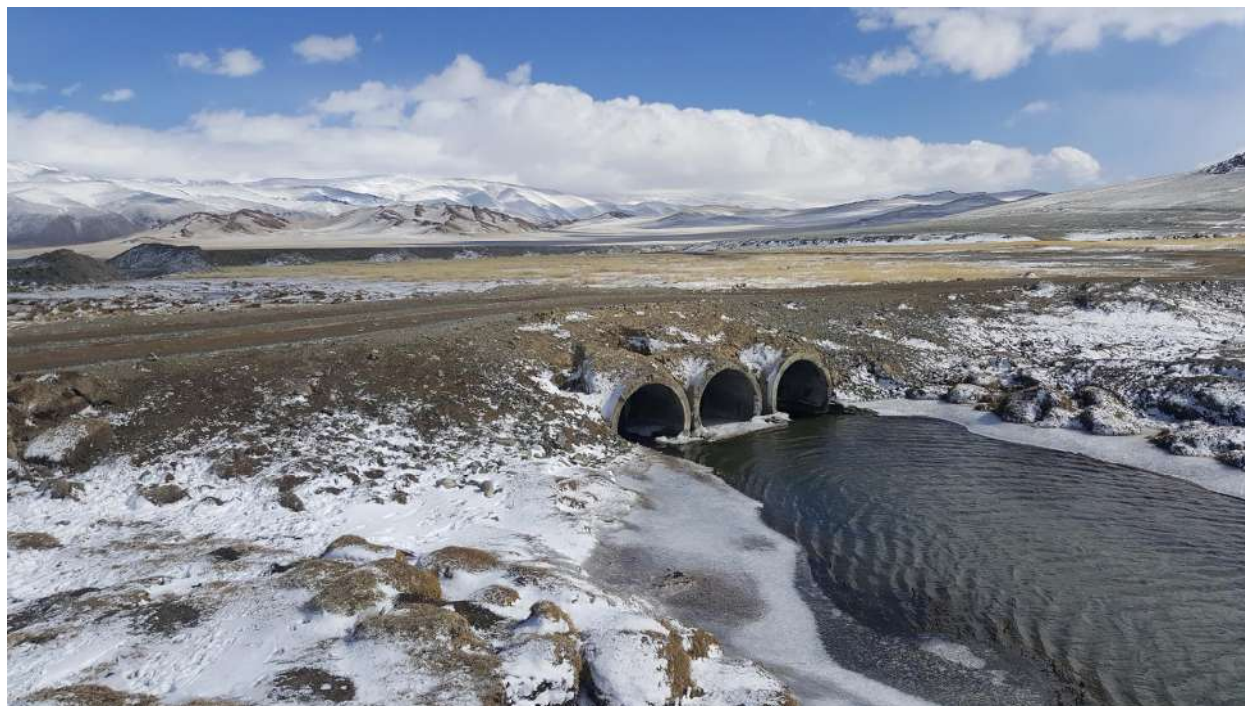
The road alignment crosses Buraat and Hongor Ulun rivers and there will be new bridges constructed on both rivers. Protection of the surface water resources from pollution is a critical task for the contractor. In order to prevent from oil spill, CW1-3 team has constructed river crossing embankments for deviation roads at 3 points for Buraat and Hongor Ulun rivers, at STA.72+500, STA.75+800 and STA.100+700 respectively. Culverts are installed under the deviation which allows water flow.

*Figure 10. Deviation road embankment over the Hongor Ulun river. STA.100+700, September 26, 2017.*

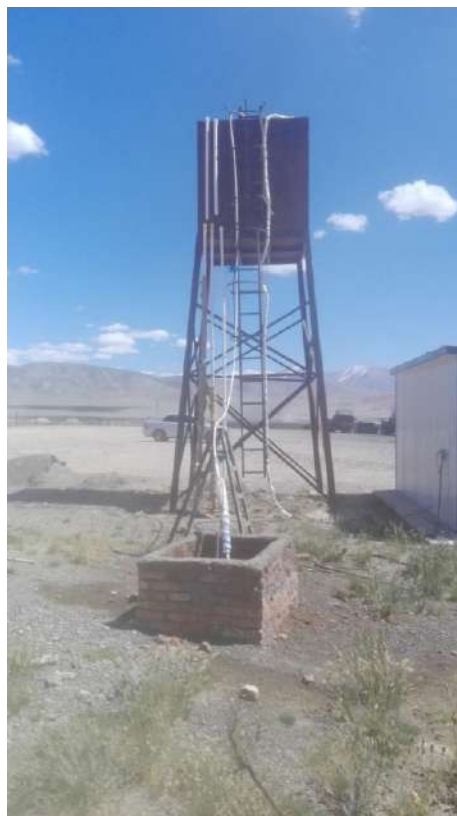
The contractor has obtained permission from the Tolbo soum administration on drilling of water wells at 1 spot: nearby the workers camp site (STA.65). The approval was given to well drilling at 3 spots, However only one water well has been created because water table at the other 2 spots were too deep. Drinking water for the main camp site is supplied from a well where the water table is about 60m.

***Figure 11: Water supply well at the main camp site, lot CW1-3, July 2017.***

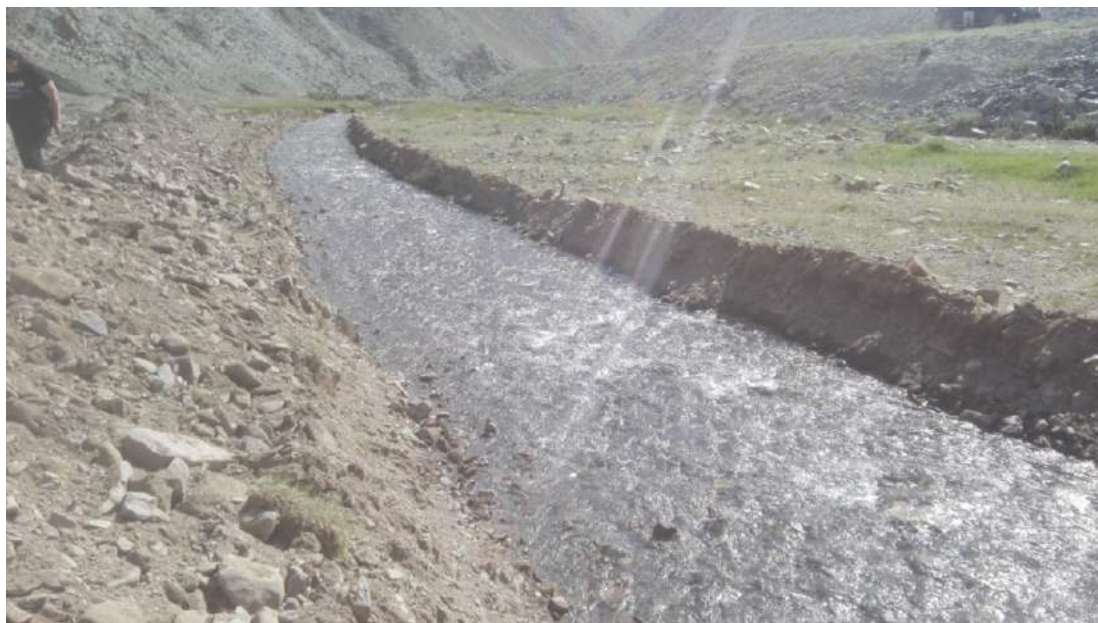
According to the road design, 100 meters long section of the Buraat river was diverted at STA.74+500 to enable construction of the embankment.

***Figure 12. The point where the Buraat river has been diverted. STA.74+500, August 2017.***

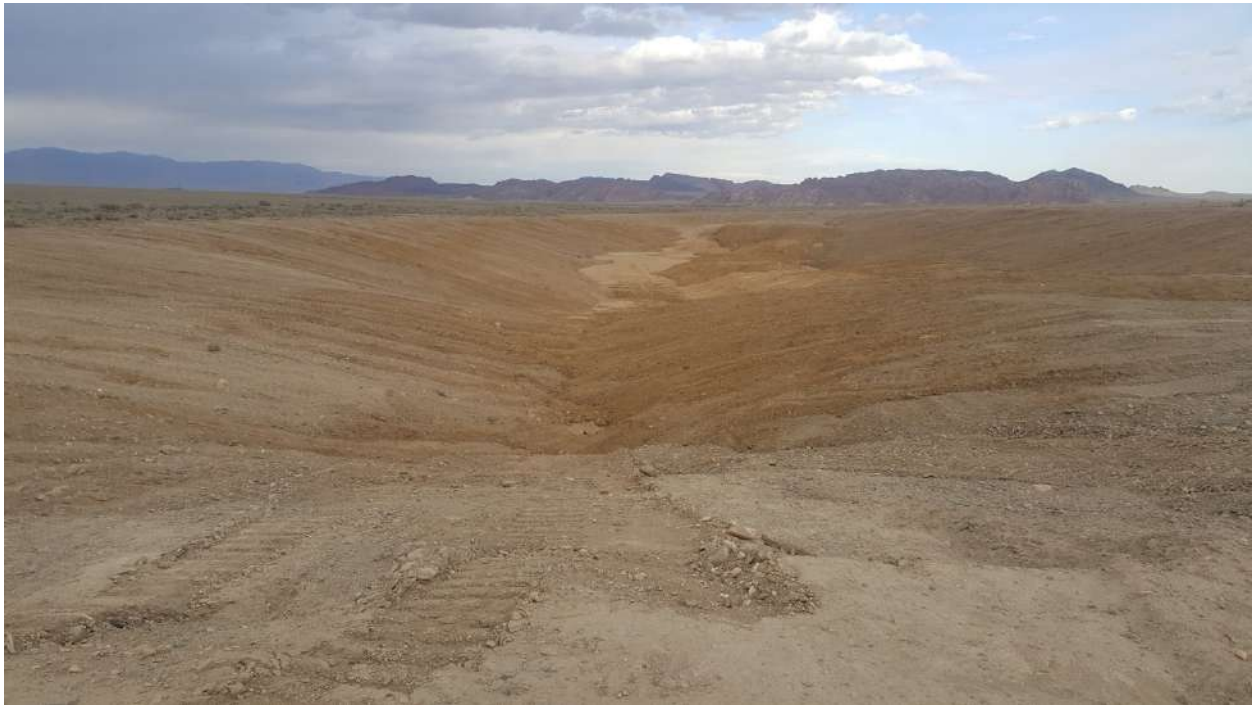
The CW1-1 construction team has obtained permission on 14 borrow pits and exploited 13 pits in 2017. The contractor has executed technical rehabilitation at 4 borrow pits which meets the requirements of the Mongolian standard on technical rehabilitation at damaged land sites: MNS 5917-2008.

***Figure 13. Rehabilitation of borrow pit at STA.32, September 25, 2017.***

1. Execute technical rehabilitation works at the borrow pits where the exploitation works are over. Strictly comply to Mongolian National Standard on rehabilitation and ensure the slope degrees are less than 30 at the rehabilitated borrow pits.
2. Create livestock crossings at 15 points that are recommended by Erdeneburen soum governor.

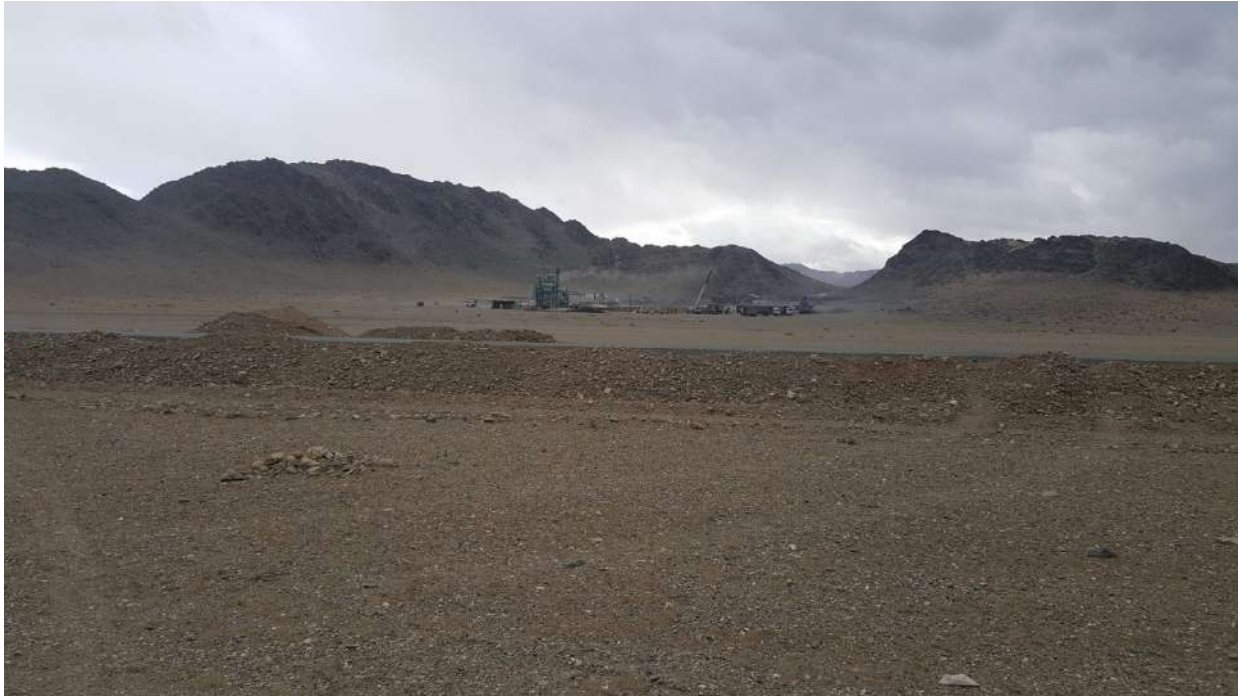
The quarry site for the CW1-1 section is located nearby the main camp where the contractor produces aggregates for cement and asphalt concrete, graded crushed stone base course material located. All the necessary permissions and approvals were obtained for the quarry site. There is no herder households residing in 5 km radius of the quarry site, thus any noise and vibration impacts were minimal.

***Figure 14. Quarry site for the CW1-1 lot. September 24, 2017.***

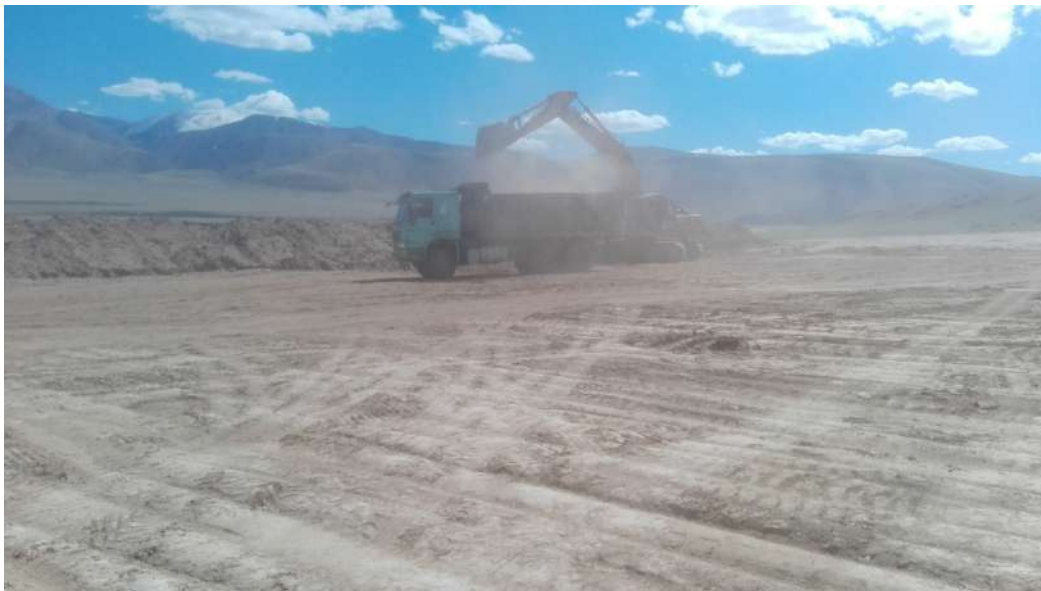
The construction team has obtained permission to use 22 borrow pits from the Tolbo soum government.

***Figure 15. Borrow point at STA.96, CW1-3, July 2017.***

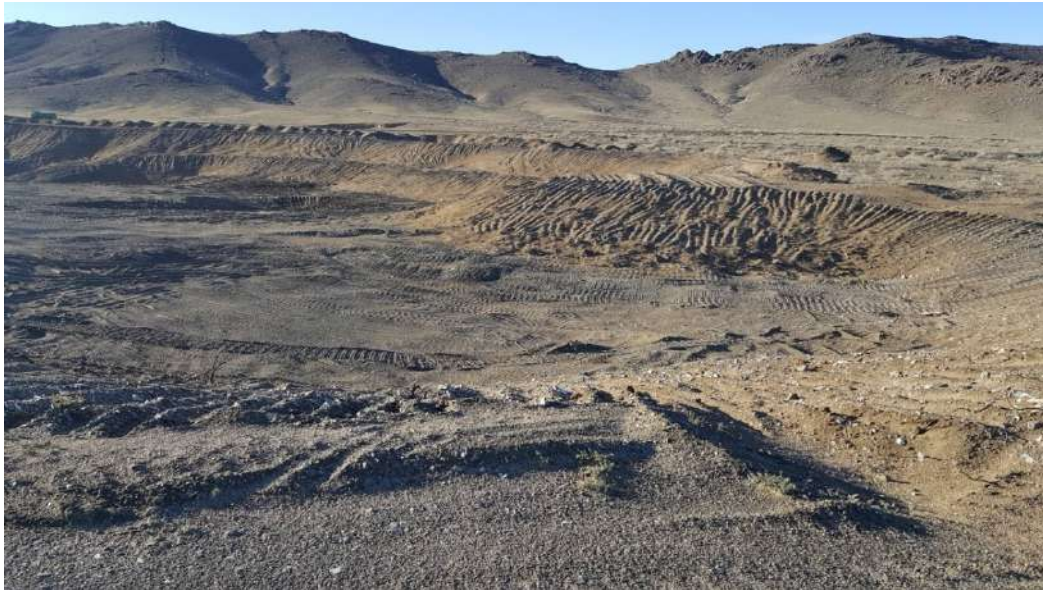
The contractor has obtained the permission from the local government for 20 borrow sites in 2017. Additionally, the contractors have used 2 old borrow pits along the 2.7km road to Modon Ovoo that were previously used by local road repair teams.

***Figure 16. Rehabilitation of borrow pit along the 2.7km road to Modon Ovoo, September 24, 2017.***

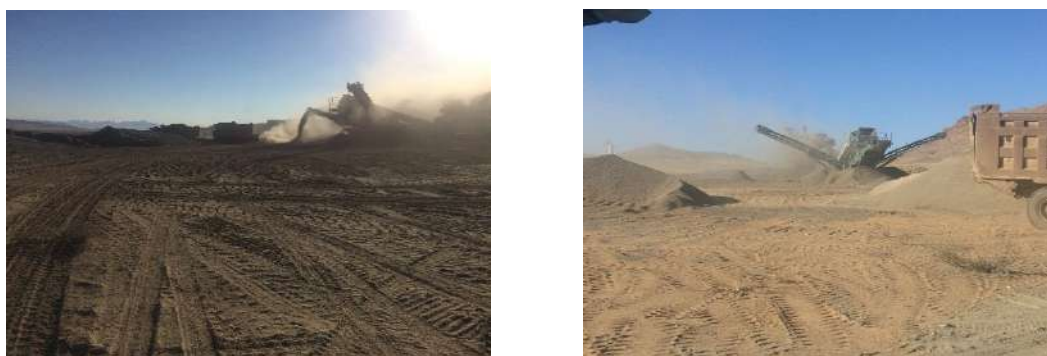
**Crusher at the quarry site:** In order to increase gravel material production, the contractor hired 2 new crushers. Relevant permits were obtained from the local government and environmental monitoring activities cover the crusher sites.

*Figure 17. Crusher at the quarry site, August, 2017.*

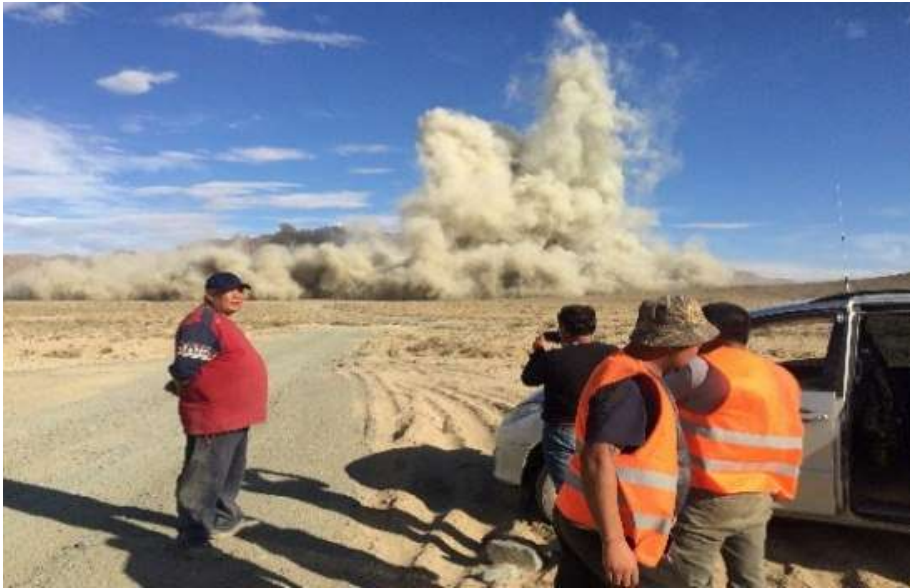
*Figure 18. Blasting at the quarry site. CW1-2, July, 2017.*

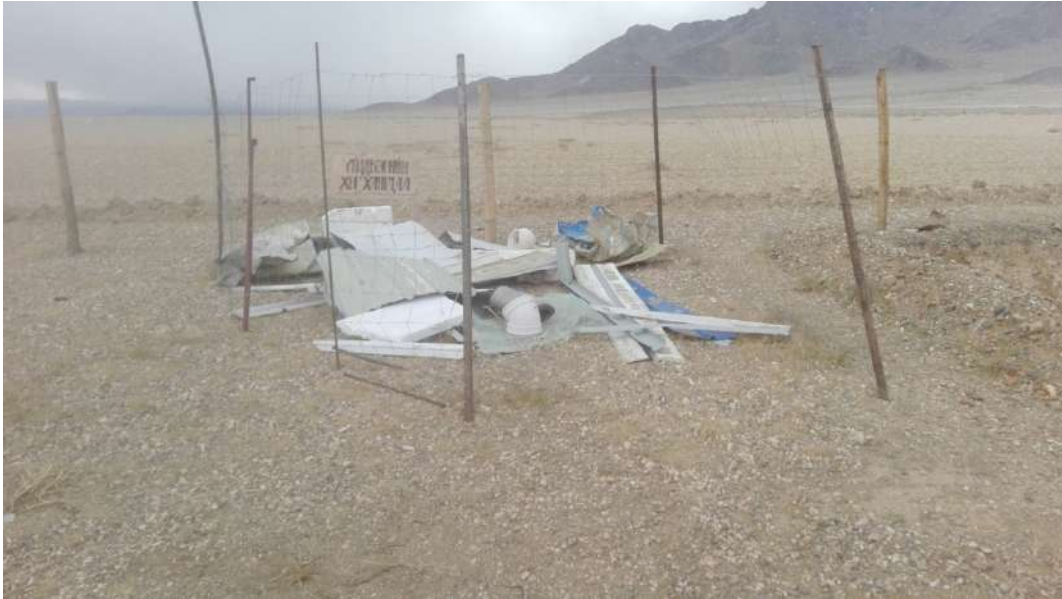
***Figure 19. Waste collection point at the main camp site, CW1-1, May 2017.***

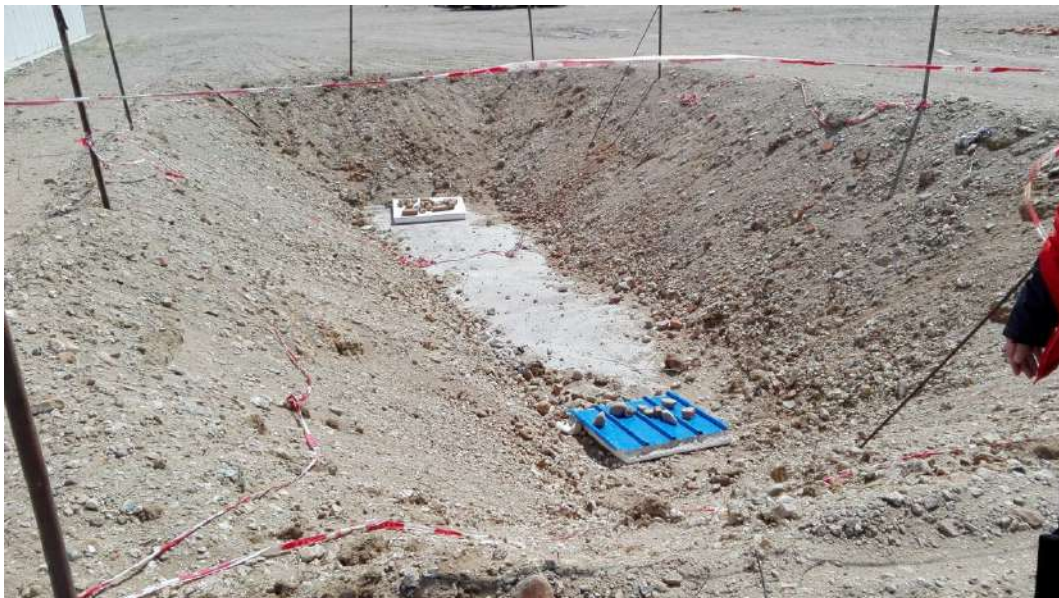
Sewage generated by camp sites are collected in septic tank or designated pits. Kitchen and toilets at the workers camp sites are connected to the steel septic tanks with underneath pipelines. Once the septic tank get full, the wastewater is disposed to the Khovd city Waste Water Treatment Plant.

***Figure 20: Designated wastewater collection facility, May, 2017.***

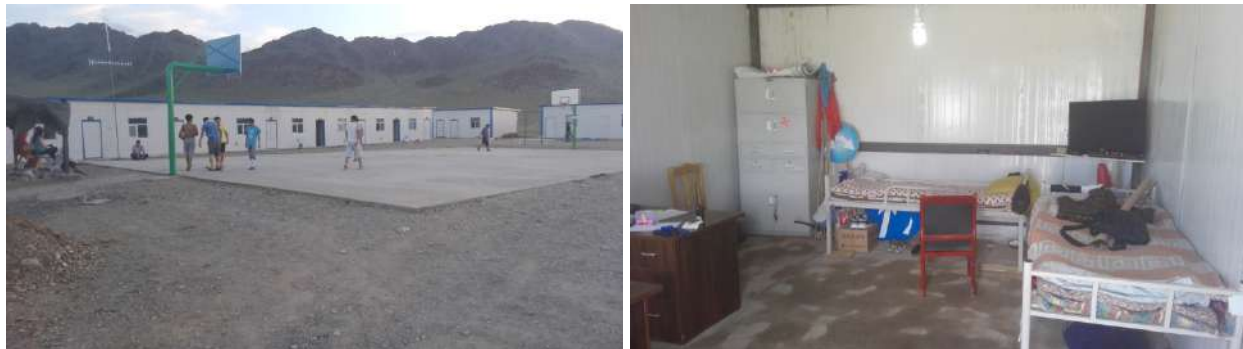
The main camp of the lot CW1-1 which covers 2.8 hectares of area is located on the right side of the road alignment at STA.31+400 while the sub camp which covers 0.3 hectares of area is located on the left side of the road alignment at STA.9+100.

***Figure 21. The main camp for the lot CW1-1, July 2017.***

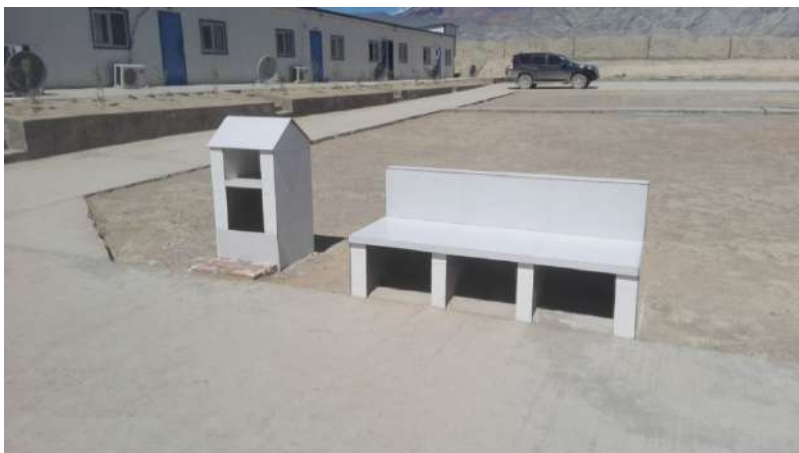
*Figure 22. Main campsite environment, CW1-3, May 2017.*

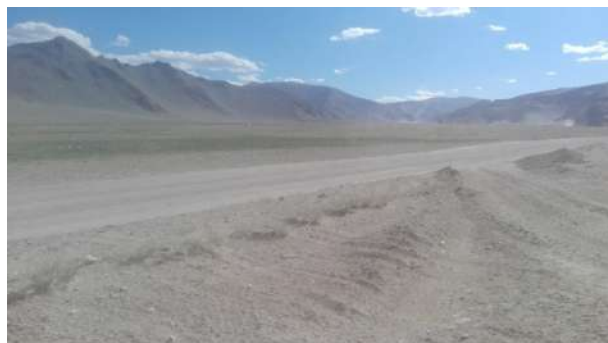
The PIU environmental monitoring specialist and ICT supervising engineer had a joint visit at the proposed wildlife crossing points to determine implementation possibility. Depending on the height of the road embankment and landscape condition for wildlife movement, they agreed on wildlife crossing locations at STA.6+520, STA.7+956 and STA.13+425.

**Figure 23. Wildlife crossing at 6+520**

These wildlife crossing will be constructed in 2018 once the pavement works are completed. In accordance with domestic standard, there will be slopes with angles less than 30 degrees on both sides of road embankment, warning signs for drivers on both side of the road and 3 speed bumps at each crossing point.

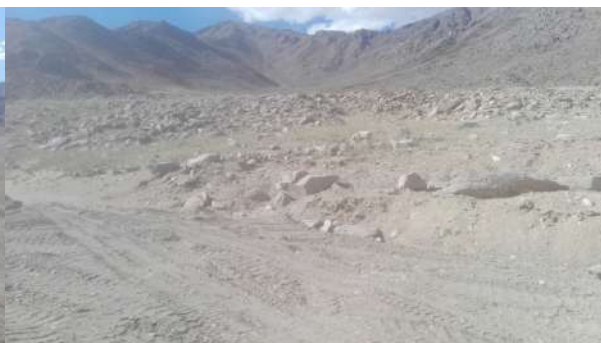
**Wildlife crossing at STA.13+425, July, 2017.**

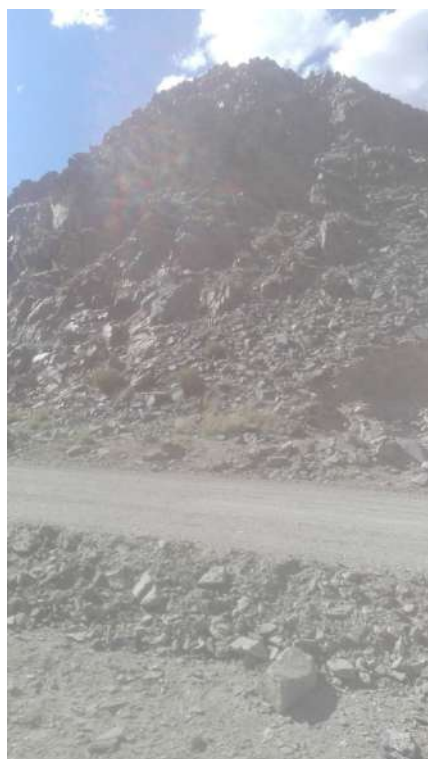
**Figure 24. Wildlife crossing at STA.7+956**

**July 2017.**

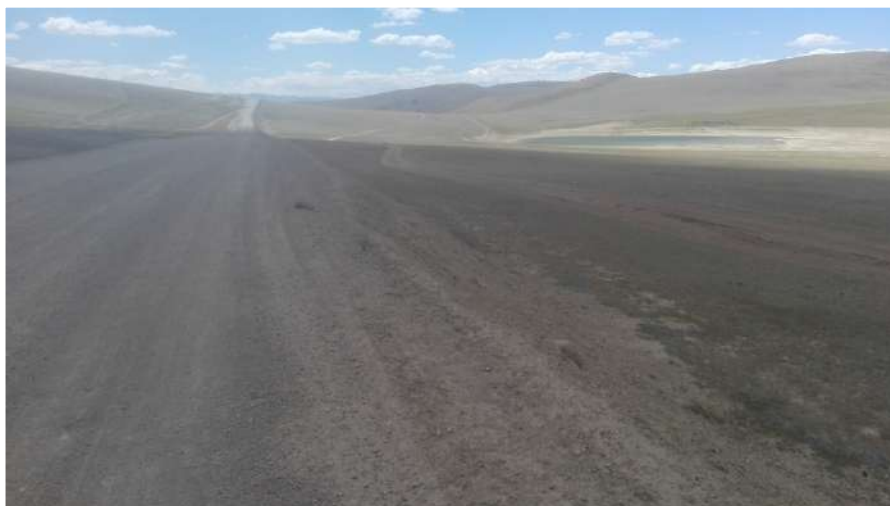
**Wildlife crossing at Buraat pass, STA.85+040,**

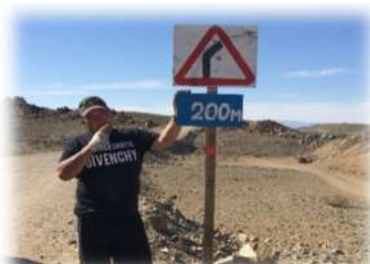
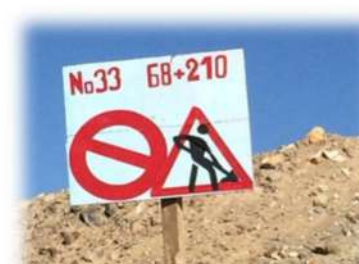
*Warning signages were place at deviation roads and active construction sites*

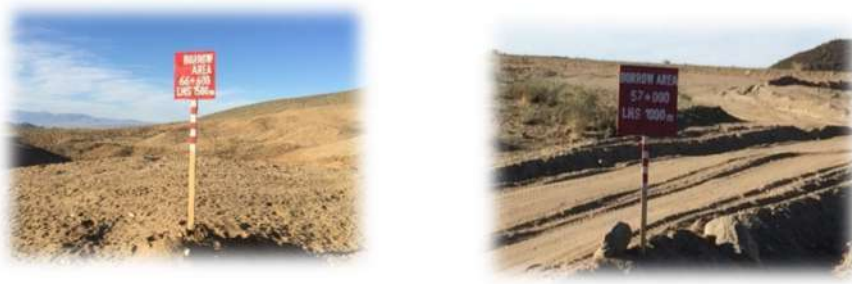
*Warning signages were placed at the jungles and nearby borrow pits*

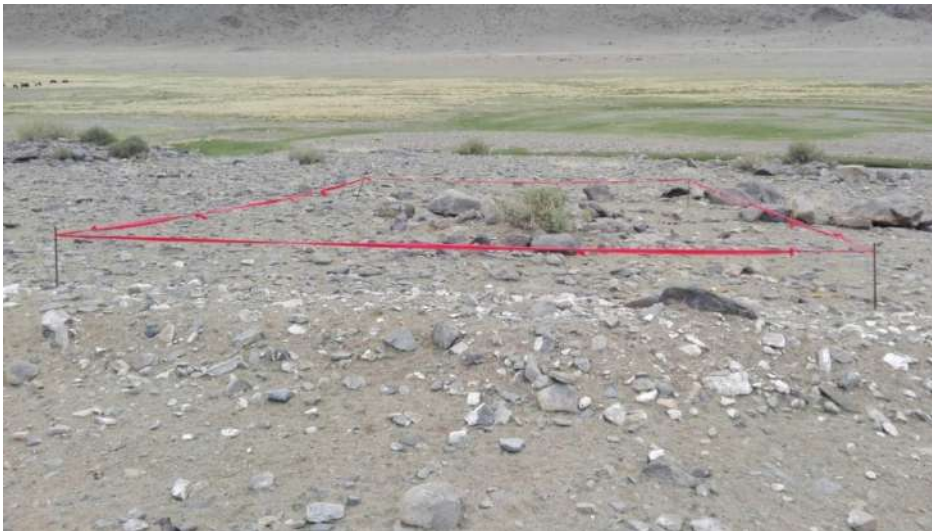
There were 23 ancient tombs existed within 20m distance of the road alignment in the Hongio river valley. Of which, 13 tombs were located under or very close to the road alignment, thus removed by professional organization in October 2016. The remaining 10 tombs that locate in 50-100m distance from the road alignment have been protected with visibility fencing.

*Figure 26. An ancient tomb protected in Hongio river valley, July, 2017.*

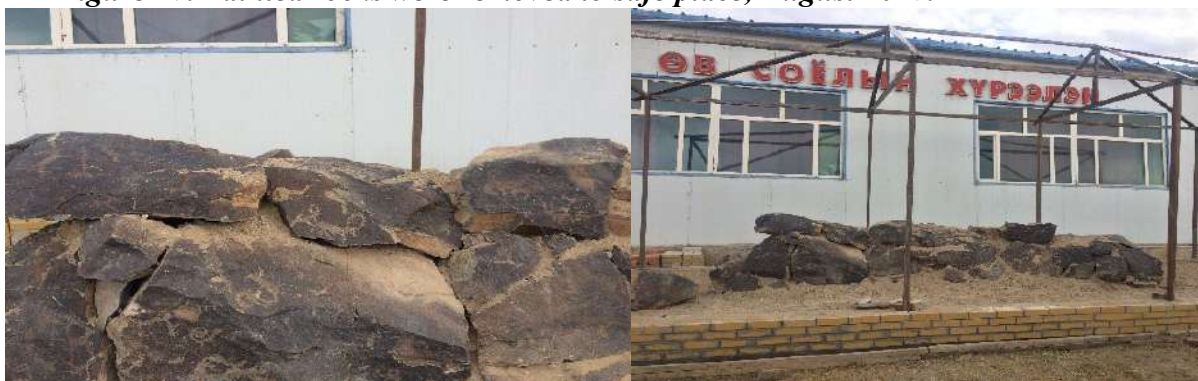
*Figure 27. Painted rocks were removed to safe place, August 2017.*

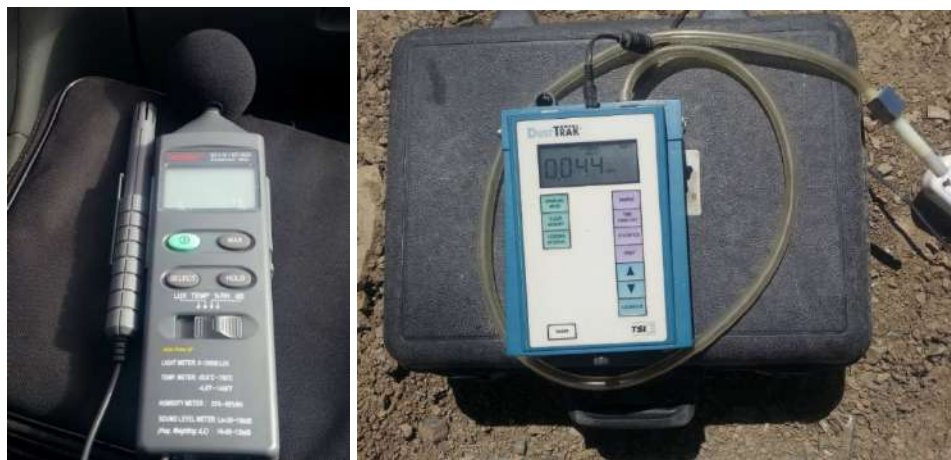
- ❖ Dust concentration level (m<sup>3</sup>/mg)
- ❖ Noise emission level (decibel)
- ❖ Water chemical contents: turbidity, mineralization, hardness and contents of other chemicals
- ❖ Water contamination: contents of Pb, Zn, Cd, Cr and Ni.
- ❖ Soil contamination: contents of Pb, Zn, Cd, Cr and Ni.
- ❖ Hygiene inspection: inspection on waste and sewage removal, physical condition of camp sites, hygiene condition of kitchen and canteen, drinking water standards.

*Figure 28: Noise and dust measurement devices used for monitoring*
