Safeguards Monitoring Report

Semi-Annual Report
December 2017

Viet Nam: Water Sector Investment Program – Periodic Financing Request 3

Cua Lo Subproject: Upgrading and Expanding Cua Lo Water Supply System, Cua Lo Town, Nghe An Province

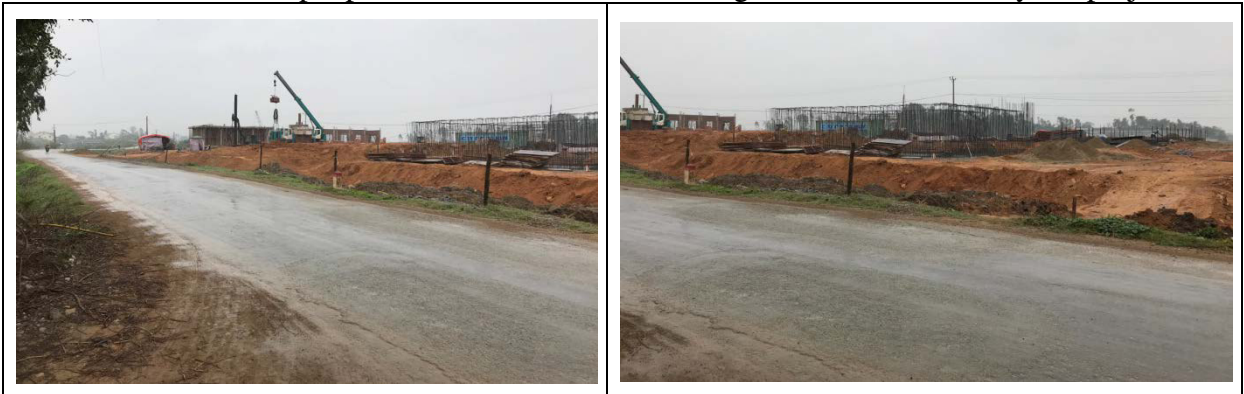
- Construction site located near traffic road with low density traffic. There are no nearby residential areas. Thus, socio-environmental impacts affecting people are assessed as low or insignificant.

- Construction site is huge. Construction material are gathered neatly and safely. Transportation vehicles are cleaned up before going out construction site. Traffic route used for material transportation is being watered daily.

Conditions of Nghi Hoa construction site (Taken on 30/01/2018).

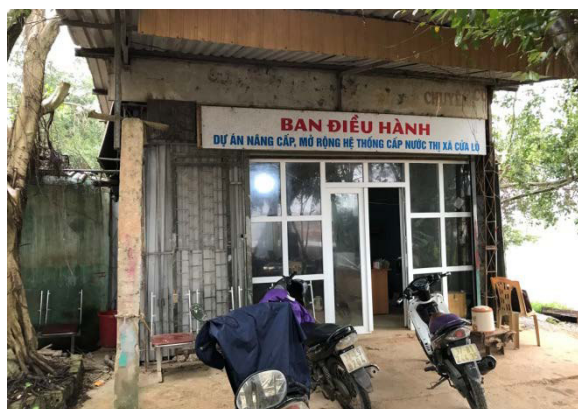
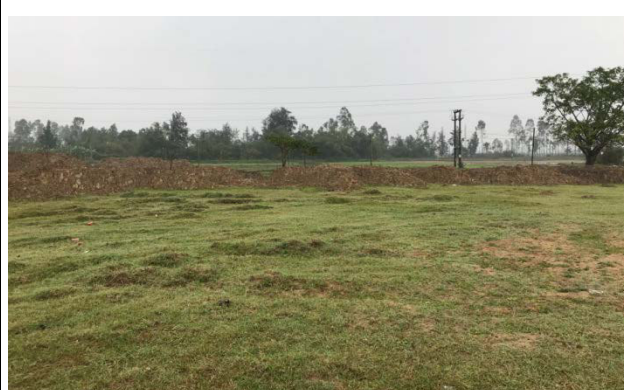
- Amount of organic sludge of the bottom lake is pumped out, dries naturally before transporting to the disposal site. The old stadium area identified as disposal site of the project, far away 2km of distance from construction area of the project, managed by Nghi Hoa CPCs. These area had been approved by Nghi Hoa CPCs for dumping dredged mud. With low foundation level, the disposal site need an amount of soil/sludge to increase foundation level of stadium area. Organic soil dumped and gathered neatly thereby didn't affect environment

Site office of the contractor and organic soil disposal site of the Nghi Hoa's WTP (Taken on 30/01/2018).

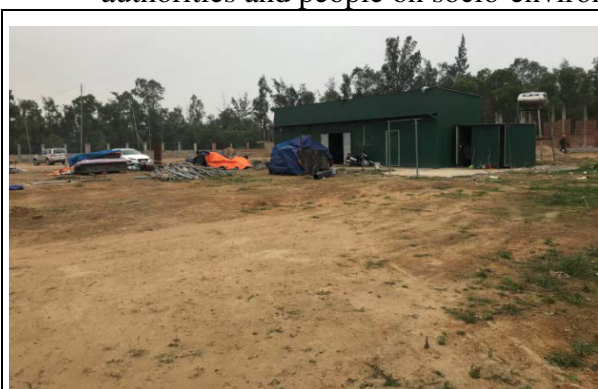
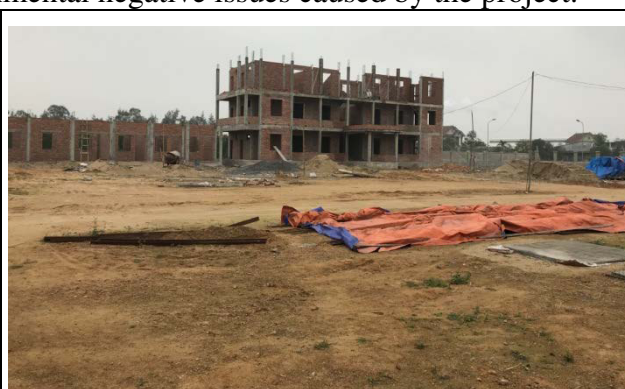
- Construction site located near traffic road with low density traffic. Construction activities carried out within site's fence. Thus, socio-environmental impacts affecting people are assessed as low or insignificant

- Construction site is huge. Construction material are gathered neatly and safely.
- The number of workers daily working on construction site varies from 20 to 40 persons. Those persons mainly are local people, owned houses or rented houses near construction site, usually back to their home at the end of working day. Some security guards are arranged to stay overnight at construction site.

Conditions of the construction site and workers' camp at the booster station and office in Nghi Huong ward (Taken on 30/01/2018).
