Safeguards Monitoring Report

Viet Nam: Water Sector Investment Program – Tranche 3

Cua Lo Subproject: Upgrading and Expanding Cua Lo Water Supply System, Cua Lo Town, Nghe An Province

REPORT ON PERIODIC SOCIO-ENVIRONMENTAL MONITORING

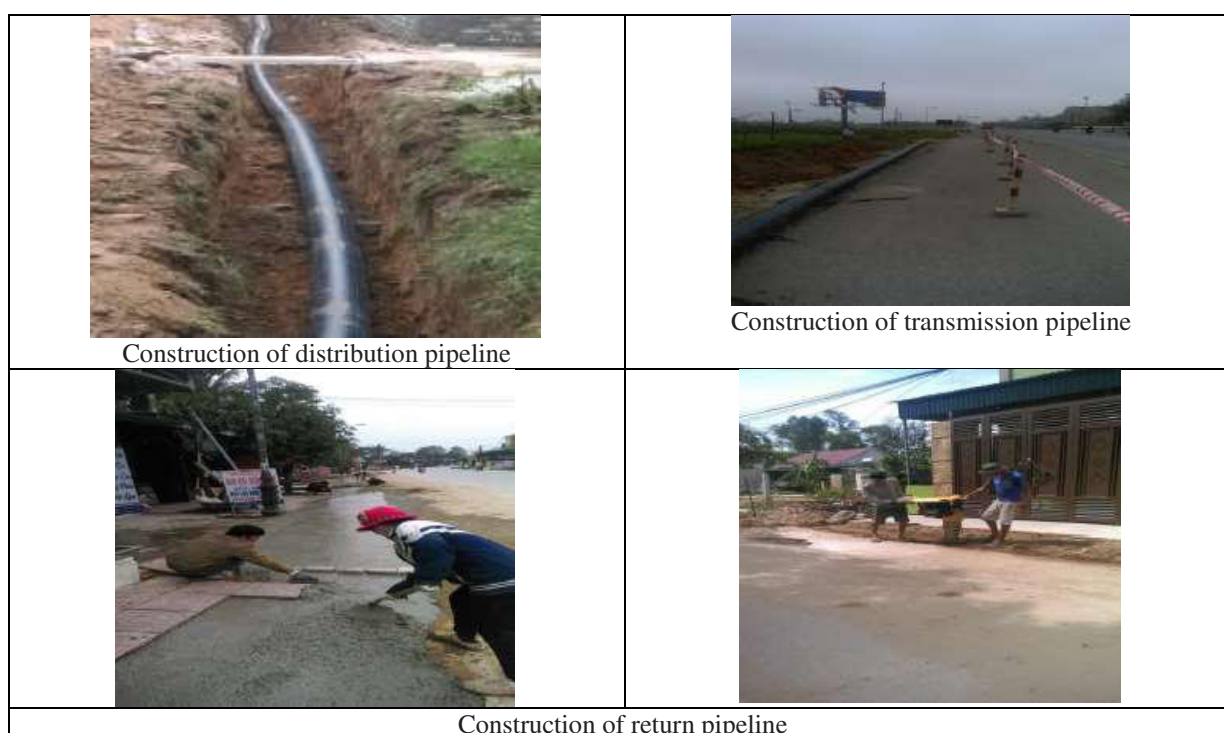
Figure 2.Photos of Construction Sites (taken in June 2018)

- Workers are equipped with adequate labor protection as prescribed;
- The construction and installation of water pipelines along the roads shall be carried out by rolling, completing and returning the road immediately after the completion of each short section. Plumbing materials and building materials are neatly assembled, safe in the location of the land on both sides of the road.

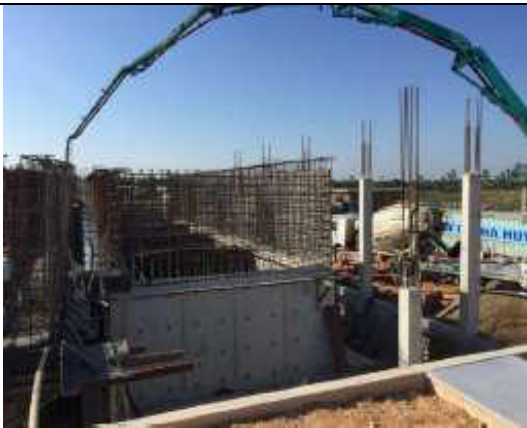
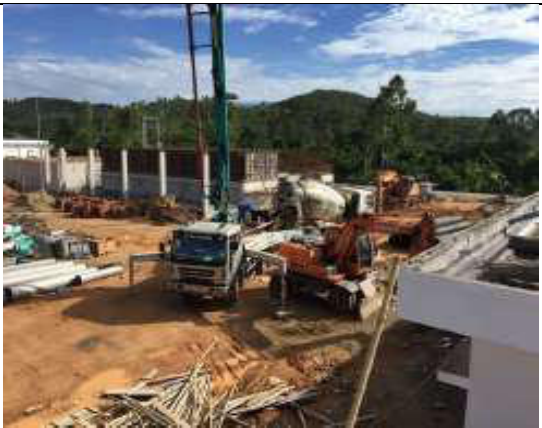
<p>Concrete pumping of Nghi Hoa water treatment plant</p>

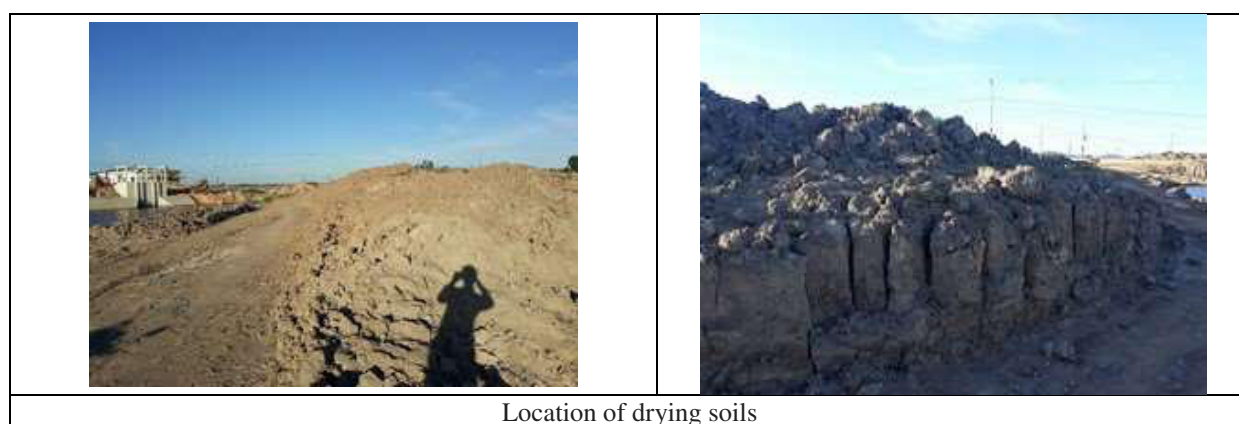
Figure 4. Photos of Nghi Hoa Water Treatment Plant (taken in June 2018).

- The construction site is huge. Construction materials are gathered neatly and safely. Transportation vehicles are cleaned up before going out the construction site. Traffic route used for material transportation is being watered daily.

Location of drying soils

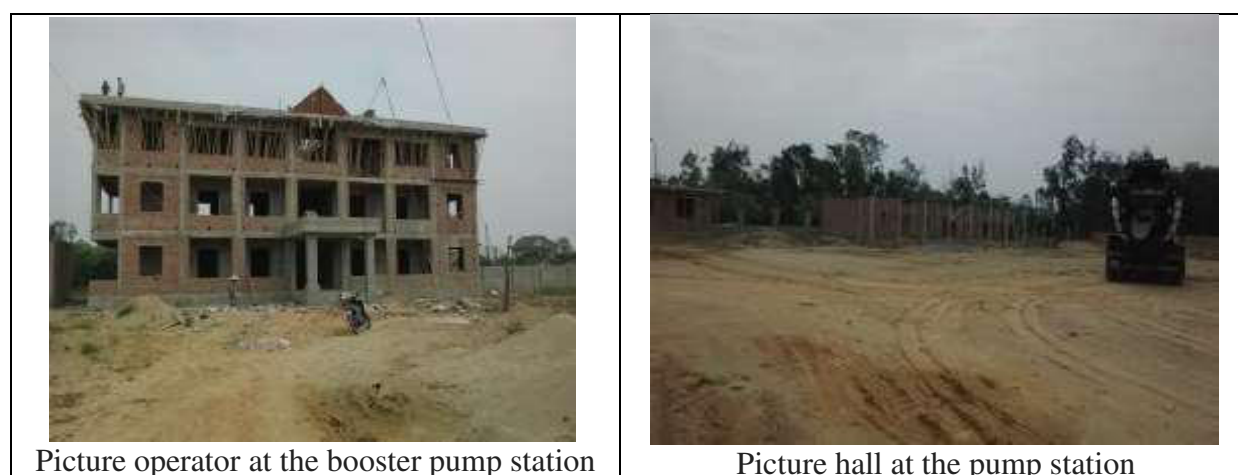
Figure 5. Photos of Pumping Station and Office Building (taken in June 2018).

- Construction site located near traffic road with low-density traffic. Construction activities carried out within site's fence. Thus, socio-environmental impacts affecting people are assessed as low or insignificant.

- The construction site is huge. Construction materials are gathered neatly and safely.
- The number of workers daily working on construction site varies from 20 to 40 persons. Those persons mainly are local people, own houses or rented houses near construction site, usually back to their home at the end of working day. Some security guards are arranged to stay overnight at construction site.

2.1	Minimizing dust/exhaust fumes		
-	Watering sprinkling at specific locations in dry season.	No. Watering activities have not been conducted	The contractor is requested to water daily (when dry weather) on the construction site to keep a reasonable humidity to reduce dust dispersion.

2.4	Pollution of surface water caused by construction activities and camps of workers	Yes	
-	There is gutter collecting wastewater/stormwater at the site leading to the main sewer of the district	No (Domestic wastewater was discharged into a dug drain for self-infiltration into the ground)	To request construction contractors to discharge domestic daily-life wastewater or connect it to the common waste water-drainage system.

- Although there is some improvement in equipping safety clothing for workers, the workers who are exposed to loud noise are not equipped with noise-canceling ear plugs (Pump Station site)). It is recommended that the contractor need to equip with noise-canceling ear plugs for their workers who are exposed to loud noise.
- The activities of watering sprinkling at specific locations in dry season were not conducted properly by the contractors during the construction. It is recommended that the contractor is requested to water daily (when dry weather) on the construction site to keep a reasonable humidity to reduce dust dispersion.
- There is gutter collecting wastewater/stormwater at the site leading to the main sewers of the district. The contractor is requested to collect domestic wastewater and connect it to the common wastewater drainage system.
