Environmental and Social Monitoring Report

**CUA LO TOWN WATER SUPPLY SYSTEM ENHANCEMENT AND
EXPANSION PROJECT, NGHE AN PROVINCE**

REPORT ON PERIODIC SOCIO-ENVIRONMENTAL MONITORING

Phase: from July 1st, 2018 to December 31st, 2018

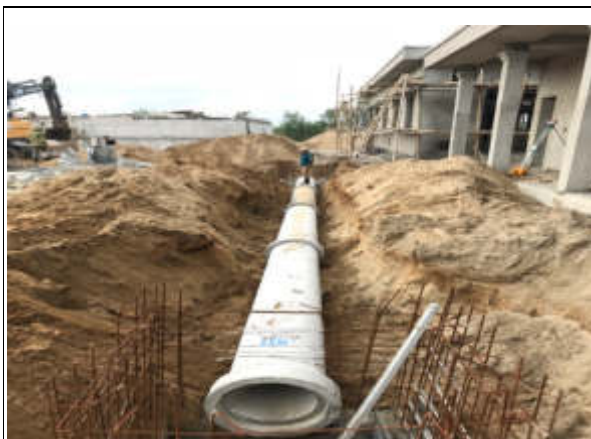
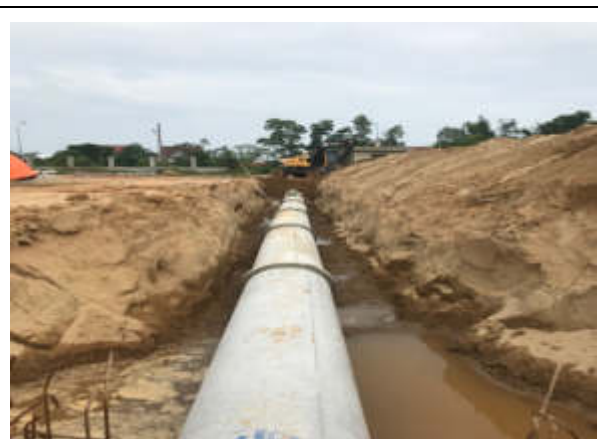
Figure 3. Photos of Pumping Station and Office Building (taken in December 2018).

Construction of drainage system at the booster pump station (the construction site is located within the surrounding fence of the whole site area, the local people could not access to the construction site, thus an additional guarding fence is no longer necessary. The water in the dug pit was shallow groundwater)

- It is necessary to install sufficiently safety warning signs on the construction site;
- The contractor is required to spray water onsite more regularly to reduce dust dispersion when windy weather;
- Some workers have been working without person protection equipment PPE (shoes, safety helmets), thus the contractor should supervise and remind more regularly.

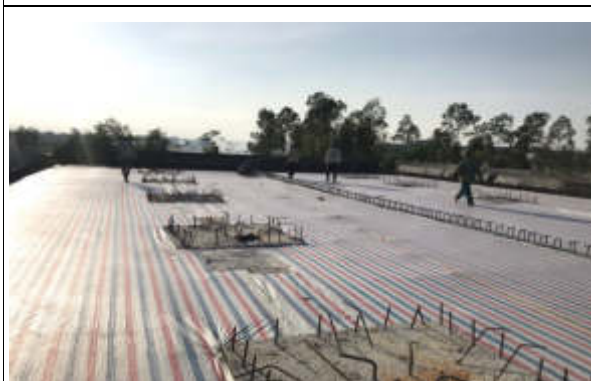
Execute clean water tank cover at booster pump station
