Environmental and Social Monitoring Report

Semi-Annual Report (July to December 2019)

VIE: WATER SECTOR INVESTMENT PROGRAM – TRANCHE 3

CUA LO TOWN WATER SUPPLY SYSTEM ENHANCEMENT AND EXPANSION PROJECT, NGHE AN PROVINCE

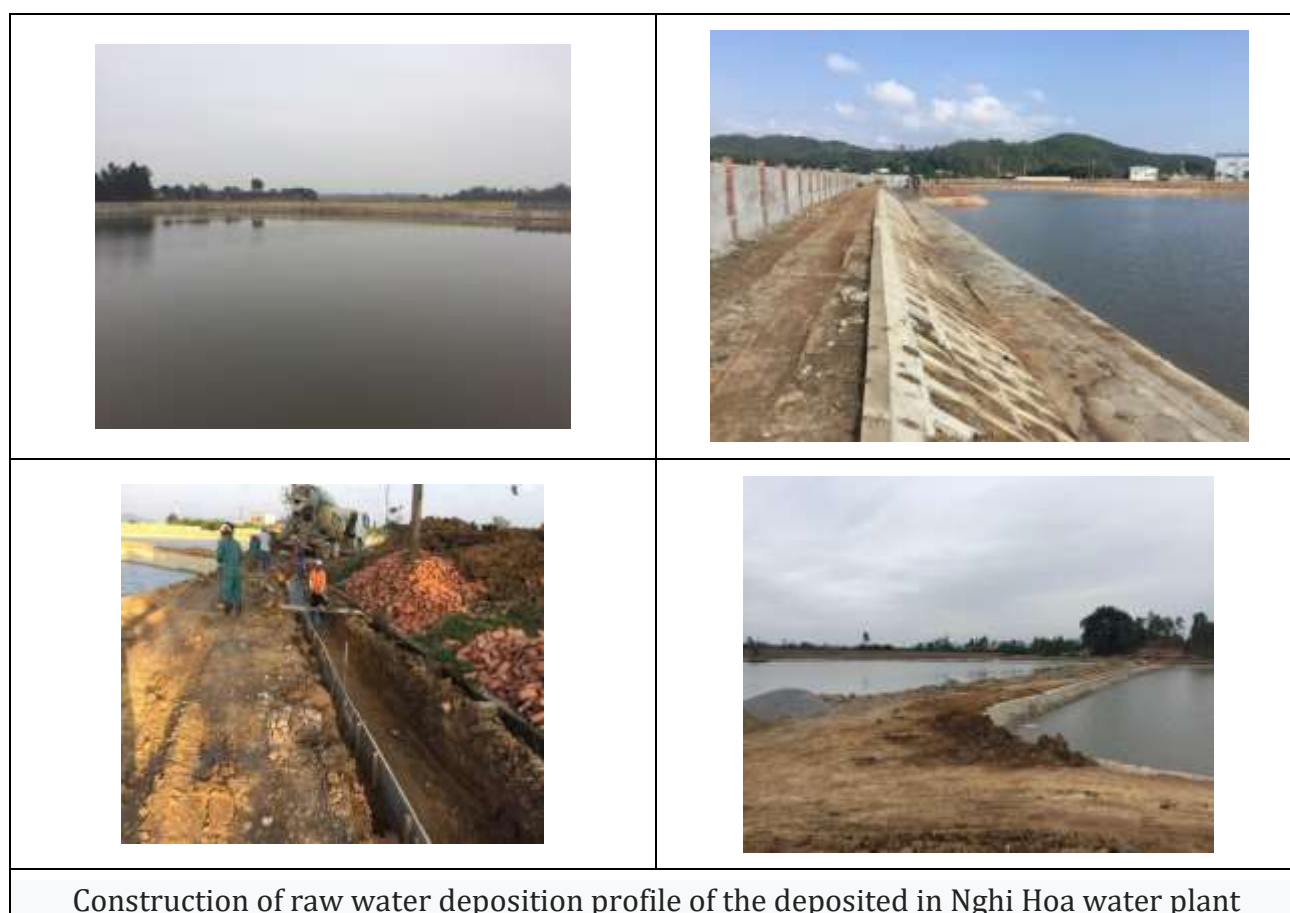
Figure 2. Photos of Nghi Hoa Water Treatment Plant (taken in Dec 2019)

9. In the last 6 months of 2019, at the time of visiting the construction site (at the end of December 2019), Nghi Hoa water plant site has basically completed nearly all construction activities and is conducting a trial run. internal. The rest is only (i) Building raw water sedimentation records; (ii) construction of fences (20% of the remaining volume), complete the sedimentation profile and landscape of the plant.

11. The Construction site area is large. Construction materials are gathered neatly and safely. Transportation vehicles are cleaned up before going out the construction site. Traffic route used for material transportation is being watered daily.

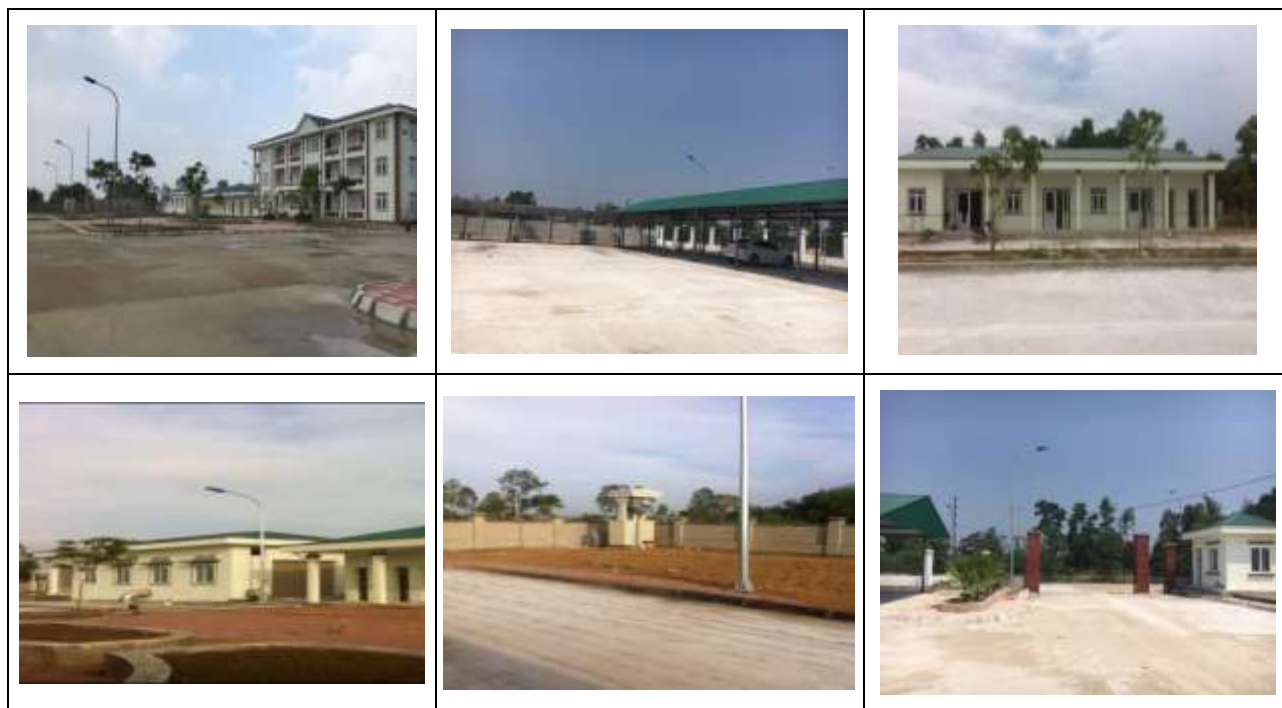
Figure 3. Photos of Pumping Station and Office Building (taken in Dec 2019).

19. As of the time of reporting, there have been no recorded complaints from local authorities and people on socio-environmental negative issues caused by the project.

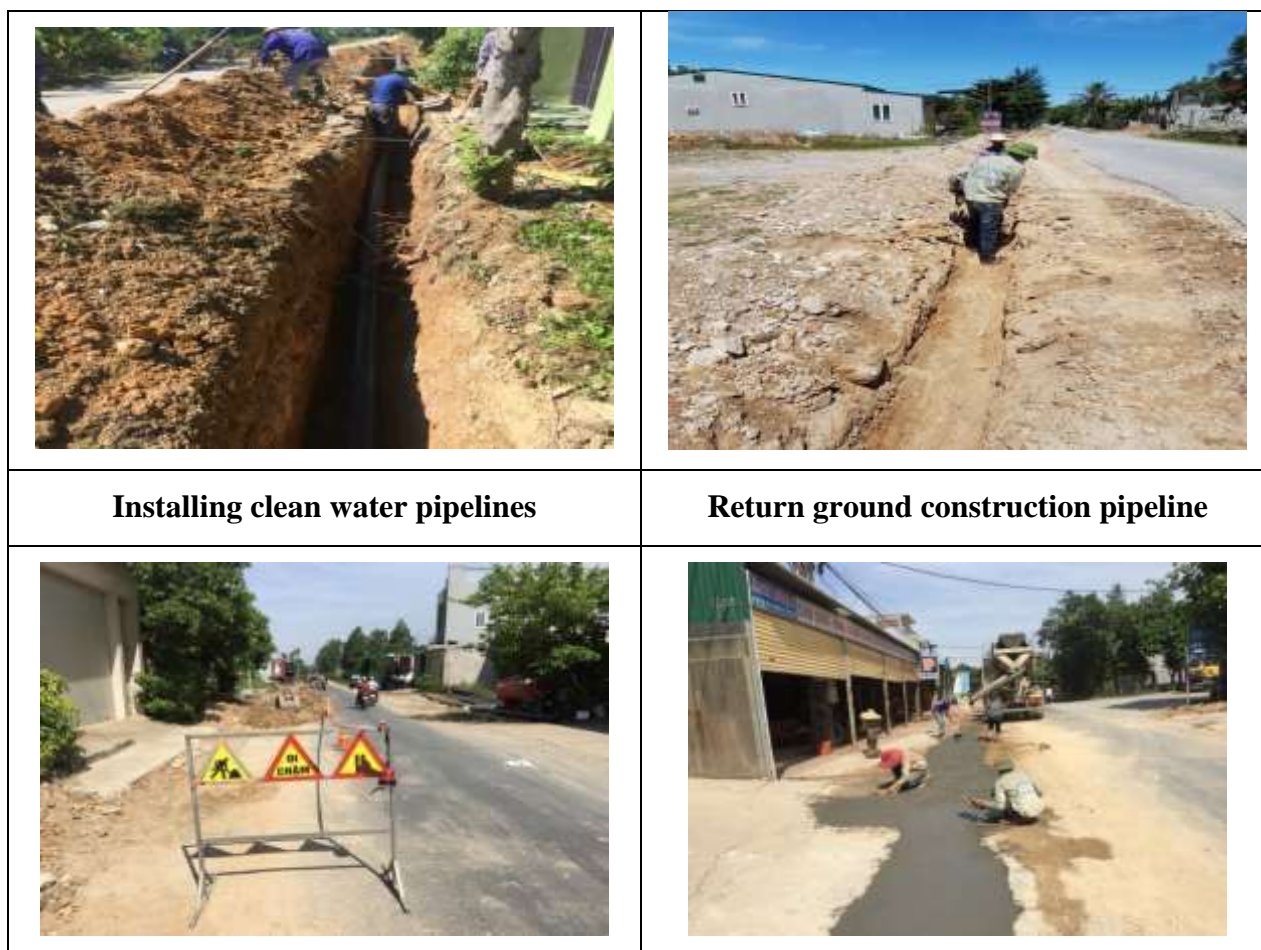
Figure 4: Construction of distribution pipeline²

22. Since the pipelines are all relatively small, the construction and installation were implemented by rolling, completing and returning the road immediately after the completion of each short section, pipe materials had been arranged tidily along the roadsides waiting for the installation, thus the impacts on transportation have been mitigated sufficiently.

23. Construction transmission pipeline has progressed, the contractor has enlisted to have the construction site right there. Basically, the pipeline has been installed 100% in volume.
