VIE: WATER SECTOR INVESTMENT PROGRAM – TRANCHE 3

**CUA LO TOWN WATER SUPPLY SYSTEM ENHANCEMENT AND
EXPANSION PROJECT, NGHE AN PROVINCE**

REPORT ON PERIODIC SOCIO-ENVIRONMENTAL MONITORING

Phase: from 01st January 2019 to 30st June 2019

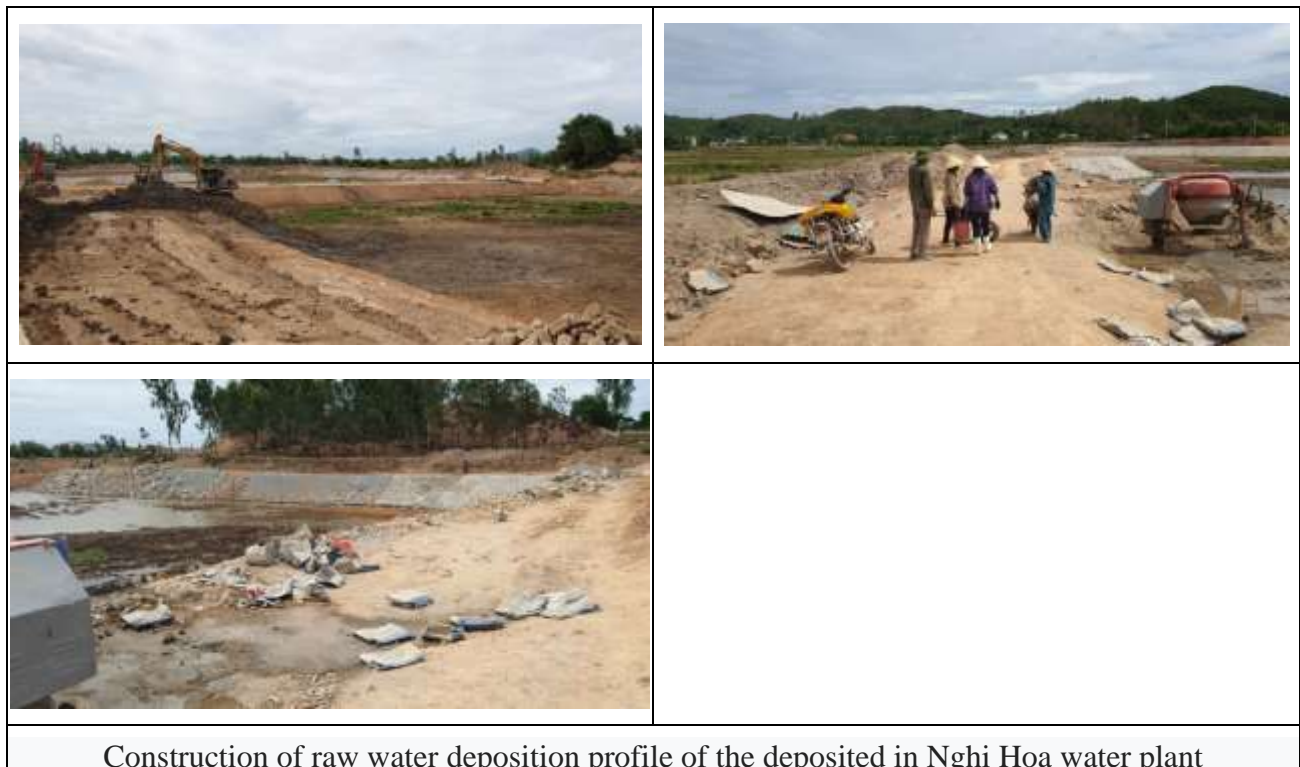
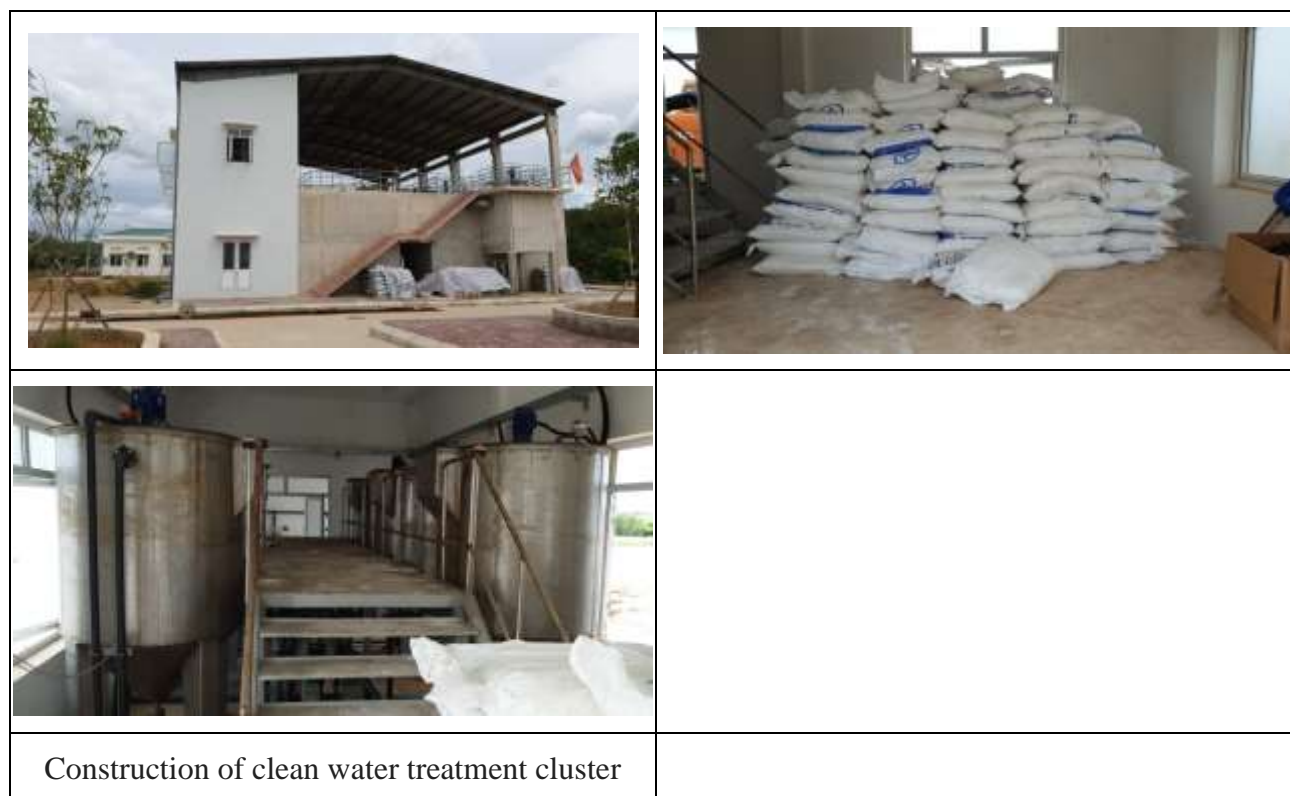
Figure 2. Photos of Nghi Hoa Water Treatment Plant (taken in June 2019)

16. In general, the construction contractor, Ha Huy Joint Stock Company, has fully complied with the requirements and measures to minimize environmental impact and occupational safety in the EMP. However, there are some issues that need to be complied with, improved and maintained at Nghi Hoa water plant construction site:

- Workers who operate and maintain the pump station should be equipped with noise-canceling earplugs.
- Regularly collect construction wastes on the construction site after each working session, gather them in the prescribed dump.

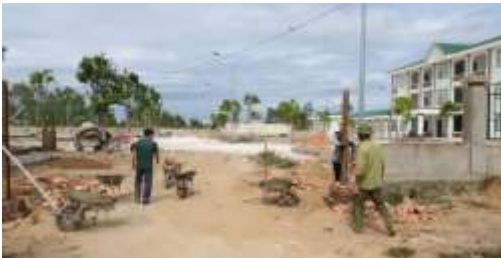
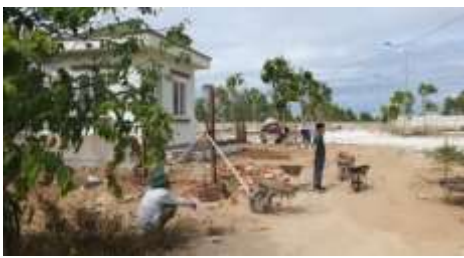
| Building entrance gate at booster pump station | |

| The main items have been completed at booster pump station | |

- The contractor is required to spray water onsite more regularly to reduce dust dispersion when windy weather;
- Some workers have been working without person protection equipment PPE (shoes, safety helmets), thus the contractor should supervise and remind more regularly.

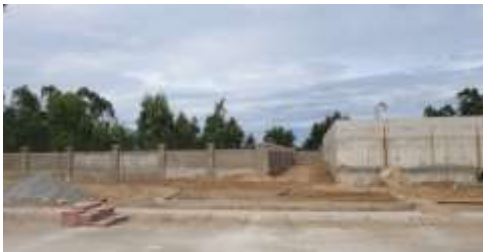
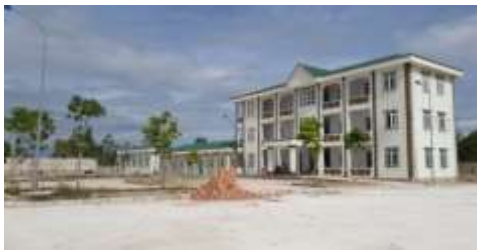
| Storage tanks and fences | Administrative buildings |

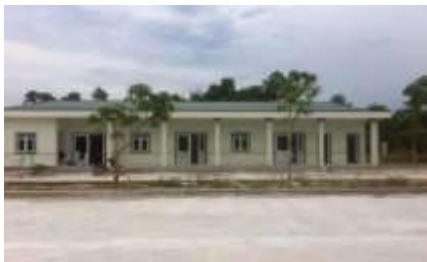
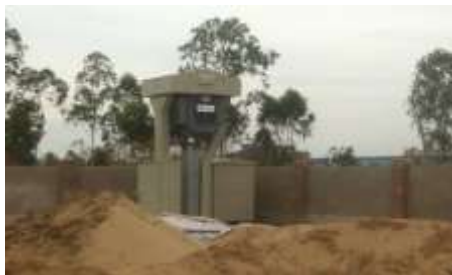
| Hall house | Substation |

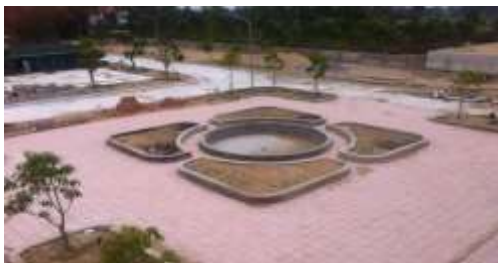
| Courtyard | |
