VIE: Strengthening water management and irrigation systems rehabilitation project (ADB5)

**Six - month environment monitoring report
From May to October 2013**

COMPONENTS 1: CONSTRUCTION OF NEW EDUCATION FACILITIES FOR WATER RESOURCES UNIVERSITY

Prepared by Southeast Asia Institute for Water Resources and Environment for the Central Project
Office (CPO) – MARD and the Asian Development Bank

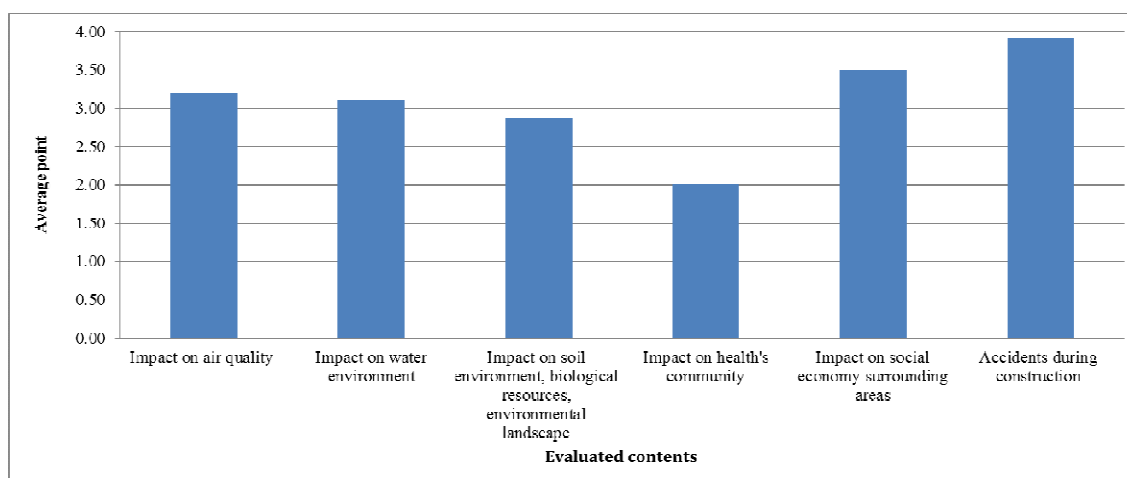
Figure 3. 1: Chart of average evaluating score on environment at construction site Package No. 11 – Water Resources University (average score monitoring 2nd period)

No.	Evaluation contents	Evaluation score		
		Max		
1	Impacts on air quality	3	2	2.7
2	Impacts on water environment	4	1	3.0
3	Impacts on soil environment, biological resource, environmental landscape	3	2	2.5
4	Impacts on worker health	3	1	2.6
5	Impacts on social economy both inside and outside surrounding areas	4	2	3.0
6	Breakdowns during construction	3	2	2.1

Systhezie the environmental monitoring ouputs CSCs as in Table 3.1 and Firgure 3.1 as following:

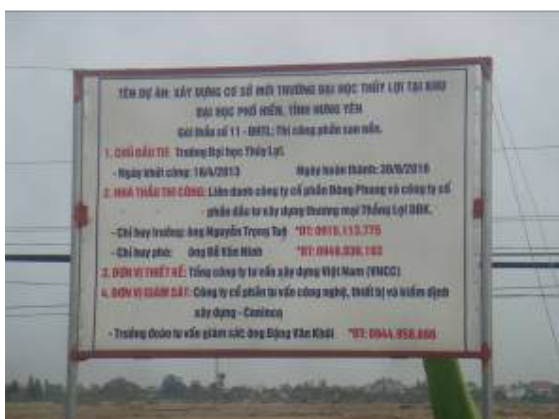
Project's information board

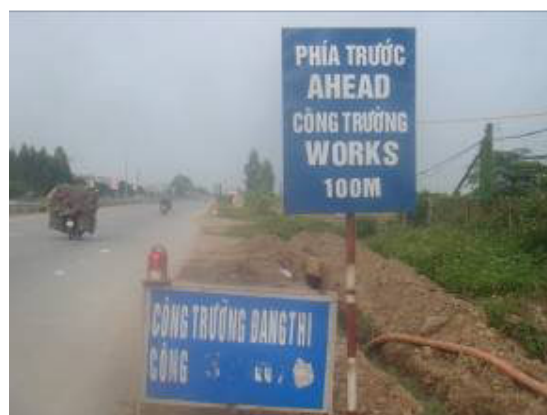
Sign boards at construction site

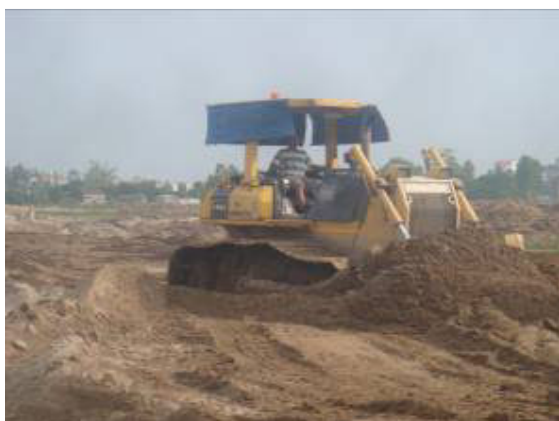
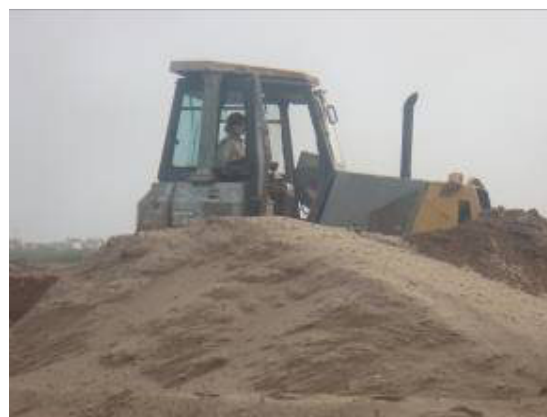
- Workers did not wear the protective clothes during construction

Bulldozer's drivers were working without labour protection

- Fully equip the protective clothes for workers during construction period;
- Fully equip the medicine cabinet, the first-aid tools, and necessary medicines in case of accidents.
- Workers who work in the difficult conditions, who needs to be checked for health periodically.
- Contractor needs to be responsible for training on the occupational safety before and during construction time.
- Contractor needs to assign workers more regularly to instruct the traffic at the places with many vehicles
- It implement water-spraying practice to reduce dust and cover the material-carrying vehicles to prevent the spillage that obstructs the traffic and affect the local environmental sanitation
- Arrange and maintain the red light at the entrance of the construction site at night.
