Bi-annual Environmental Monitoring Report

Loan 2993-ARM
July - December 2017

Armenia: North-South Road Corridor Investment Program, Tranche 3

Prepared by the “Transport Project Implementation Organization” State Non-Commercial Organization based on the monthly Environmental Monitoring Reports of the Project Management Consultant

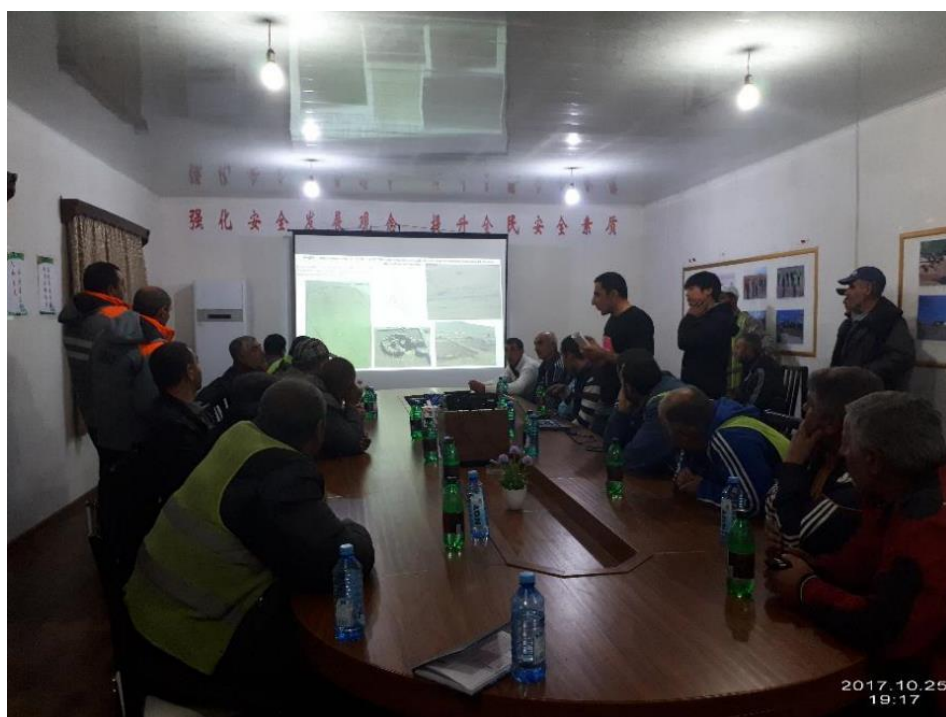
3.7.1.2 The training about archaeological component and chance finds procedure was conducted on 25 of October 2017 in Contractor's Maralik Camp (office).
