Semi-Annual Report
June-December 2016

VIE: Renewable Energy Development and
Network Expansion and Rehabilitation for Remote
Communes Sector Project
(Nam Nghe Hydropower Project)

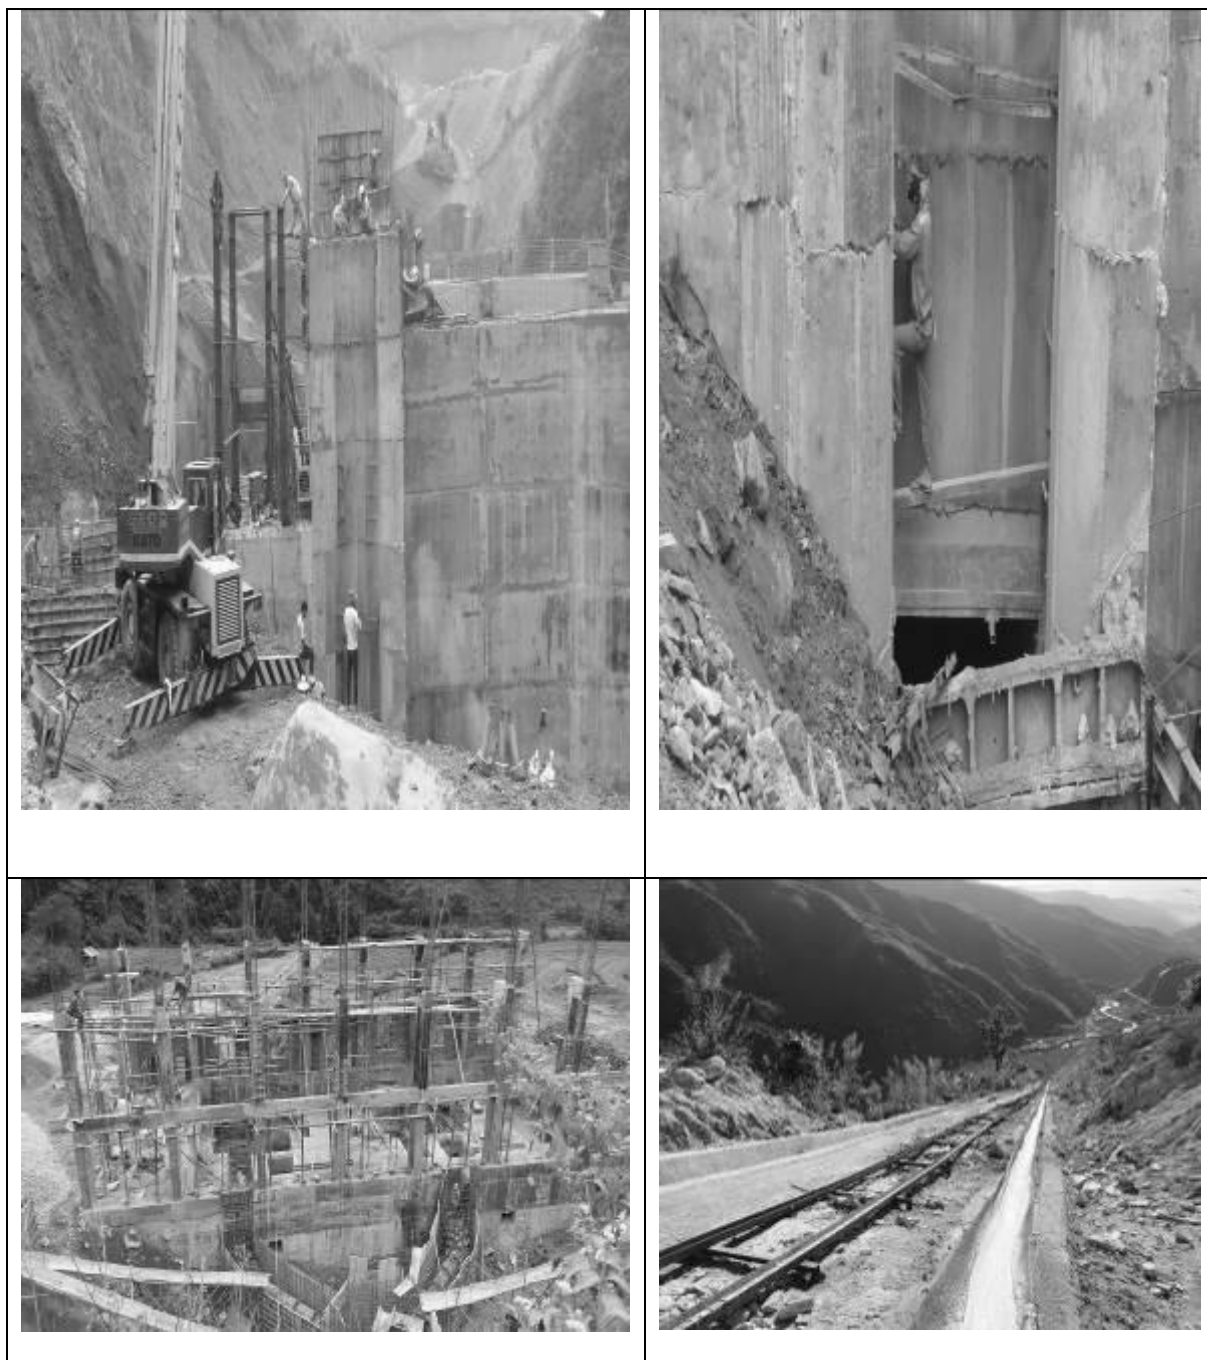
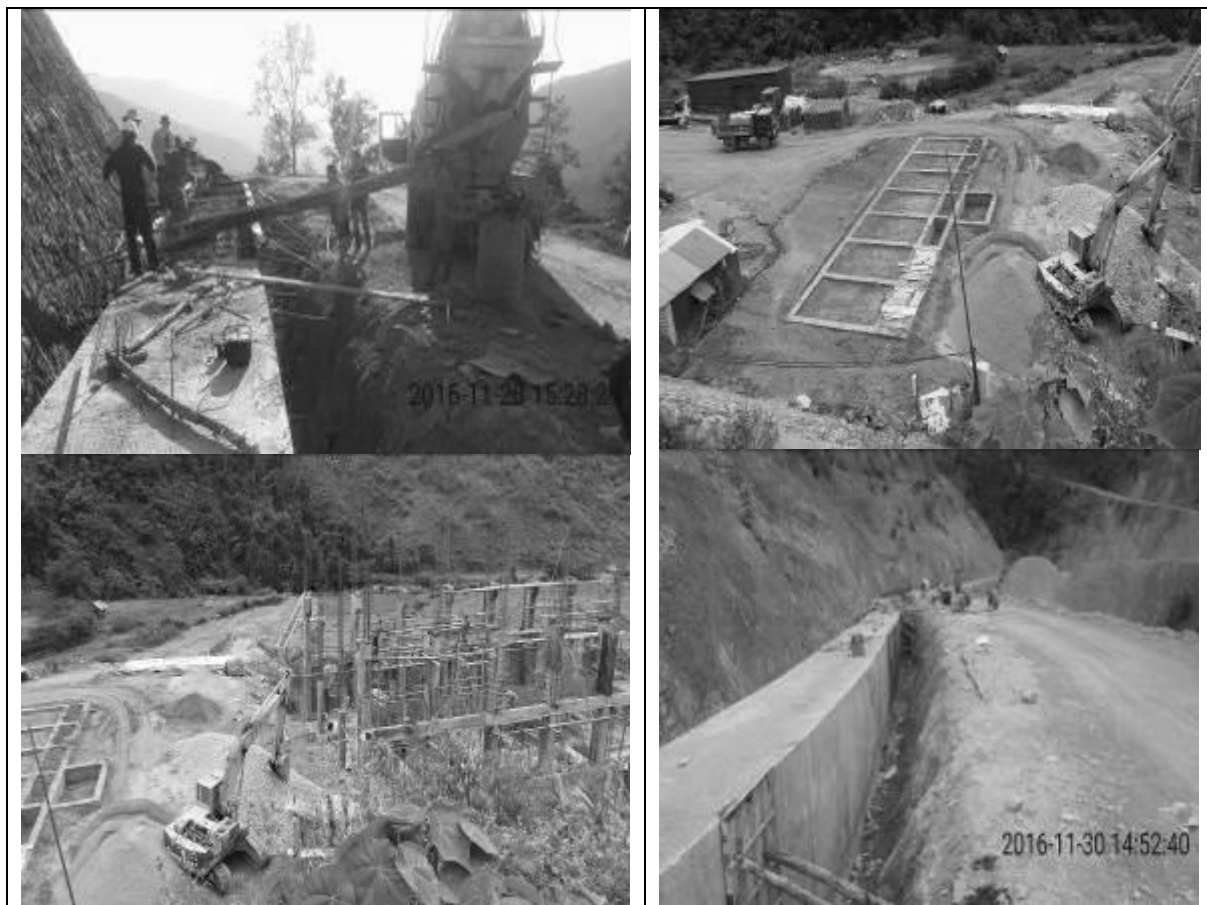
Appendix 1: Photos of the Nam Nghe project site

- **Excavated soil Management:** The mission found that a large amount excavated soil has been dumped on to the river below in the W04 construction site. The excavated soil has been dumped at the assigned spoil area, but no method had been applied to control soil leakage since the trucks unload the solids from high elevation and soil has been overtopped the cofferdam at the foot of the hill and leaked to the Nam Nghe River. The mission requested LC-PC to ensure contractors stop dumping soil on to the Nam Nghe River, and remove the dumped soil out of the stream. At the spoil site, the contractor has to level the soil to provide more space for dumping and apply adequate methods to prevent soil being leaked to the stream. These actions need to be done before 31 January 2017.

- **Fuel management:** Some fuel drums are left open without caring about oil spill. The signs of oil spill were found at the drilling machine around the section K14. The Mission urged LC-PC to request contractor to apply adequate methods for controlling the risk of oil spill immediately.

- **Worker camp:** The Mission found some worker camps in very poor conditions that do not meet even with the lowest living standard; the tents consist of thin canvas, there is no first aid medicine box and sanitation facilities are poor. On such notable site at the subcontractor in penstock construction work. The Mission requested LC-PC to work with all contractors to improve worker camps facilities within December 2016.

- Contractor to stop dumping soil on to the Nam Nghe River, and remove the dumped soil out of the stream. At the spoil site, the contractor have to level the soil to provide more space for dumping and apply adequate methods to prevent soil being leaked to the stream.	Before 31 January, 2017	Lung Lo corporations build JSC, Sub Contractors .	Construction Supervision Office, NPC/PMU
