Integrated Environmental and Social Safeguards Monitoring Report

Semi-Annual Report (July-December 2019)
June 2020

CAM: Rural Roads Improvement Project III

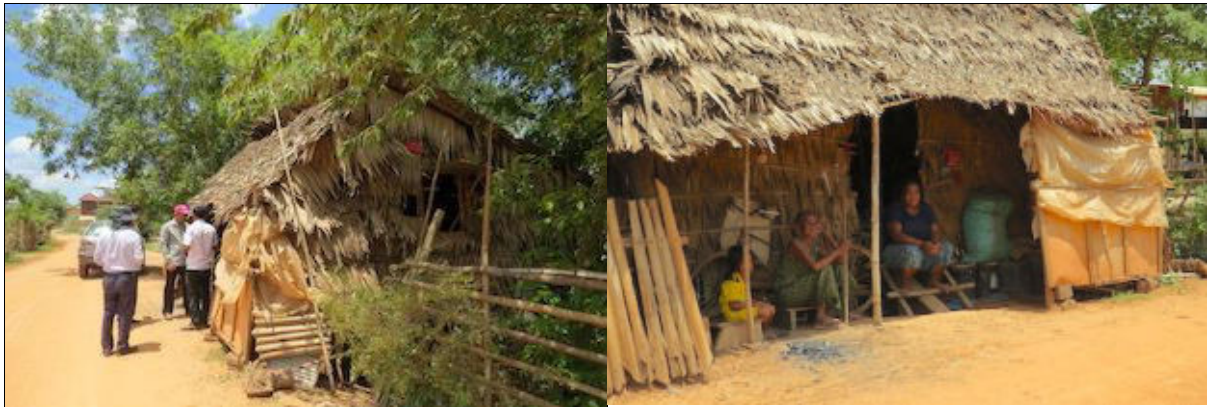
Figure 5-1 Photos of Old and New House of Ms. Sorn

The old house of Ms Sorn along the KC2 road identified 5 July 2019 during transect walk.

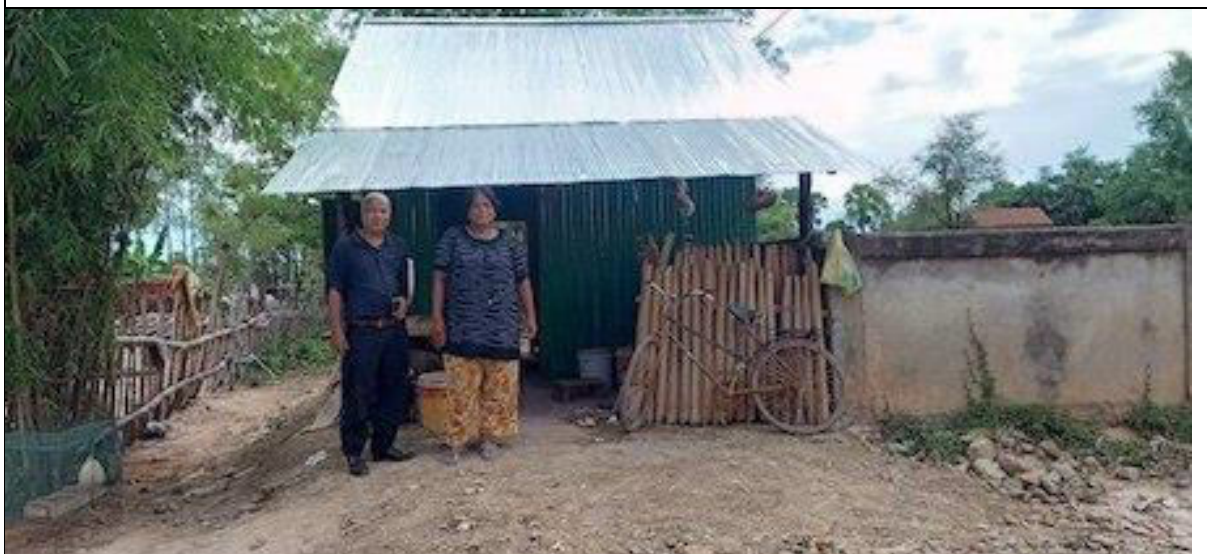
Ms Sorn in front of her new house with DDIS national environmental specialist who paid a monitoring visit on 6 August 2019

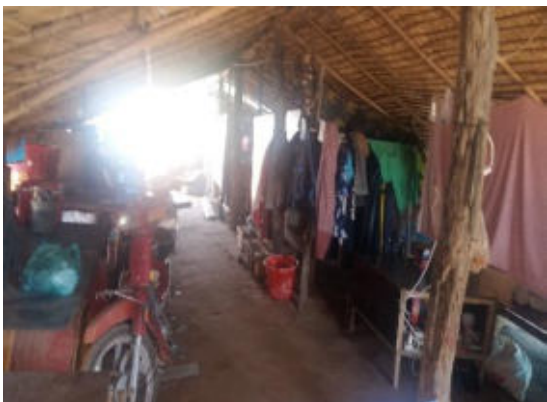
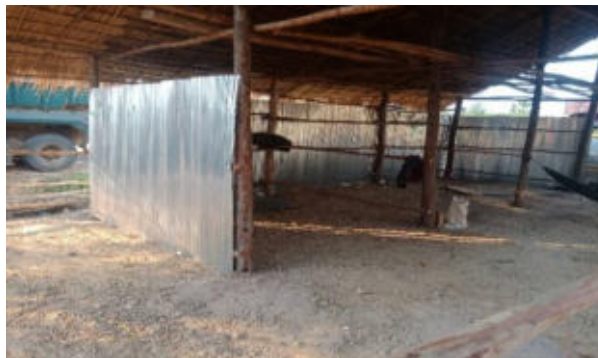
<p>-Not conducive and healthy quarters. No privacy and congested for workers living in long period.</p>	<p>-This condition calls for further improvement. And the contractor has to construct additional unit is recommended.</p> <p>-The worker sleeping on equipment machines, it causes to affected workers health. Therefore, the contractor has to build one more Quarter for male workers staying.</p>	<p>The contractor built one more tent for labors</p>

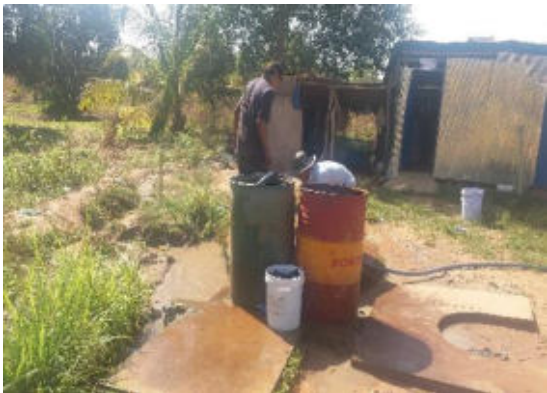
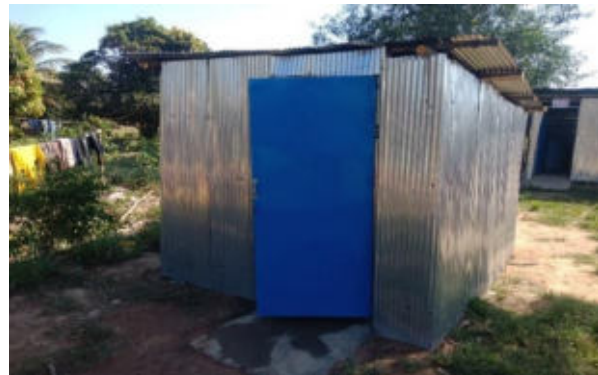
<p>There is only one bathroom for labor.</p>	<p>The contractor should build another bathroom in the camp site, one for male workers and other one for female workers.</p>	<p>The contractor built another bathroom.</p>

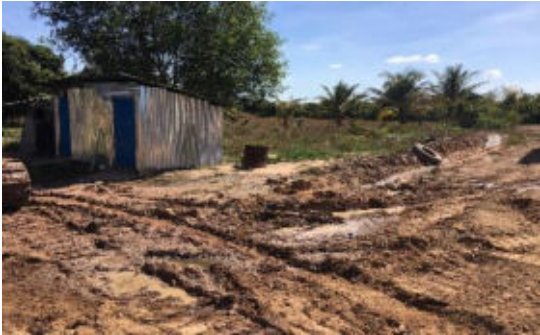
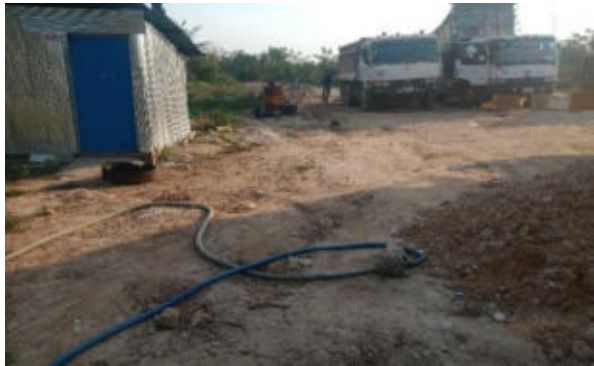
<p>The camp has a 2-door toilet, sealed latrine with 2 labels to distinguish between what if for male and for female, but still poor condition with muddy close to the toilets house without construct drainage properly.</p>	<p>Provide proper drainage around toilet and filled with soil to make flat.</p>	<p>Drained out water and filled with soil.</p>

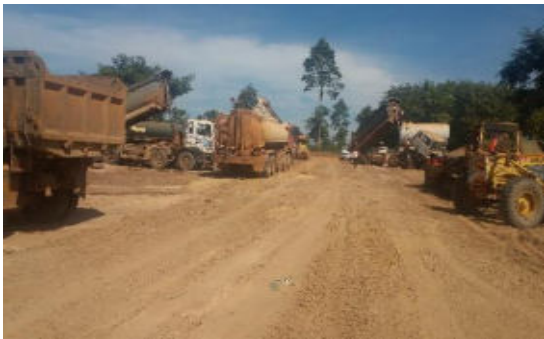
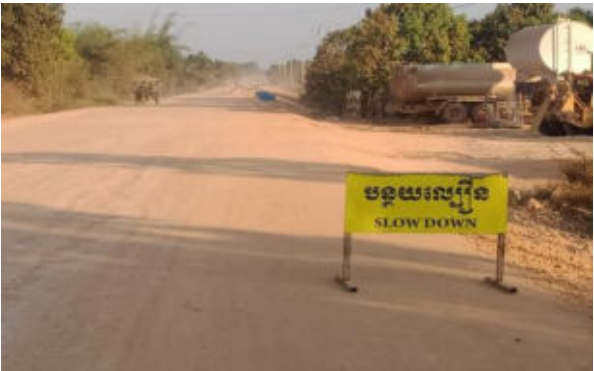
<p>No warning traffic signs installed in front of the entrance into the site camp. And no board information in the site camp.</p>	<p>The contractor should install signboard in front of camp.</p>	<p>The contractor installed signboard.</p>

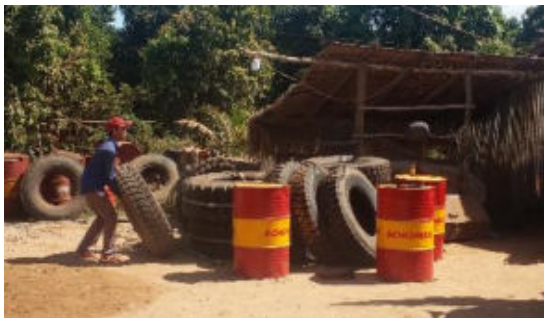
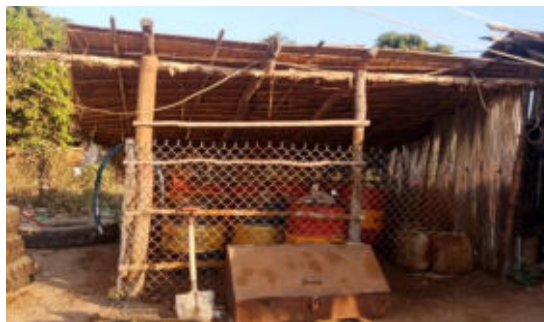
<p>It has no separate stockroom for tires and oil drums, and all kept outside room without cover.</p>	<p>The contractor should keep tire and oils inside warehouse.</p>	<p>Contractor kept tires and oils inside the warehouse.</p>

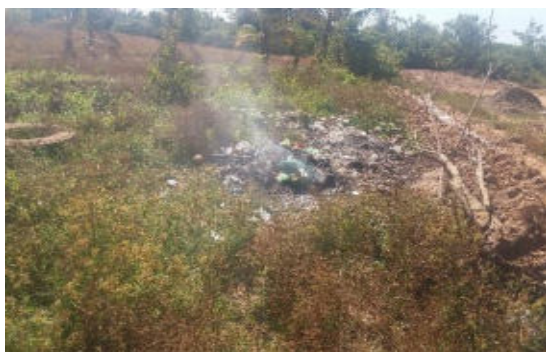
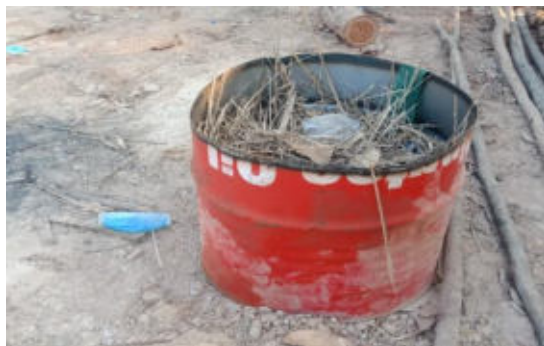
<p>Rubbishes and other discarded items are put in one place for burning.</p>	<p>Rubbishes should be collected at one place for disposal.</p>	<p>The contractor provided a trash container to collect rubbishes.</p>

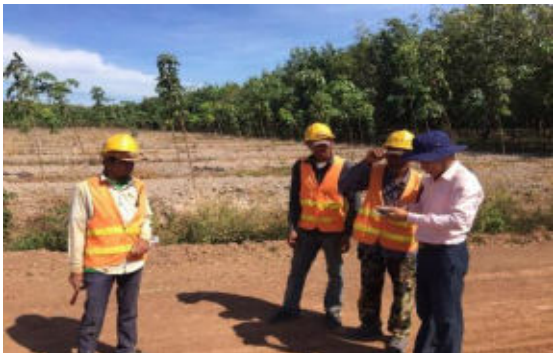
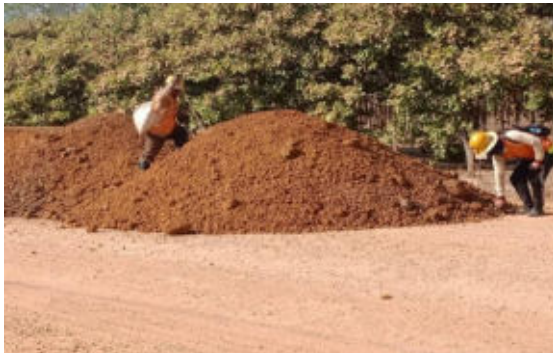
Most workers are wearing helmets, but not in full working gears	The contractor shall supply a full set of personal gear for safety operation.	<p>All field workers are equipped with proper personal gears in the site.</p>

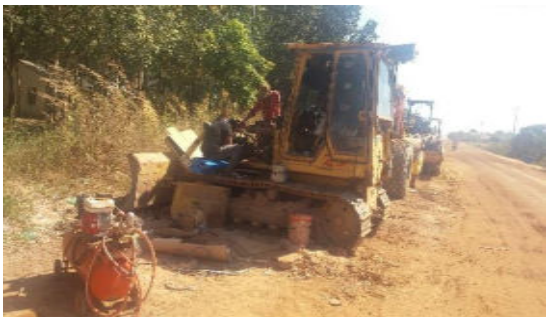
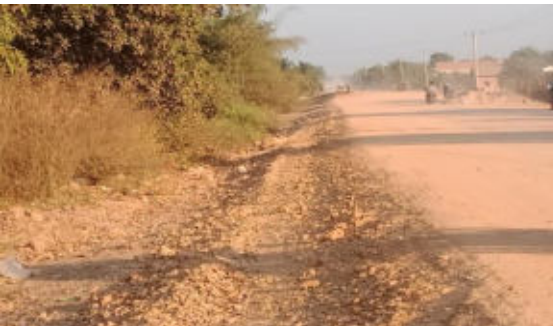
Broken heavy equipments are placed at the project road side.	Contractor has to move Broken equipment machines parked in site the camp.	<p>The contractor moved the broken equipment to the camp for repair.</p>

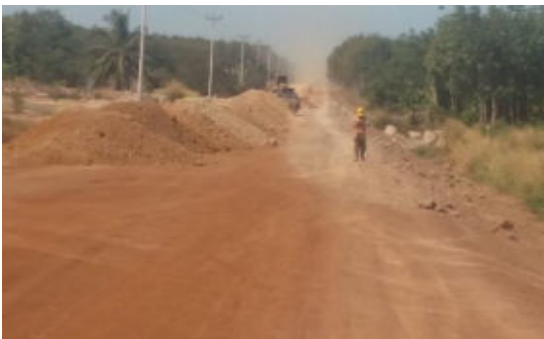
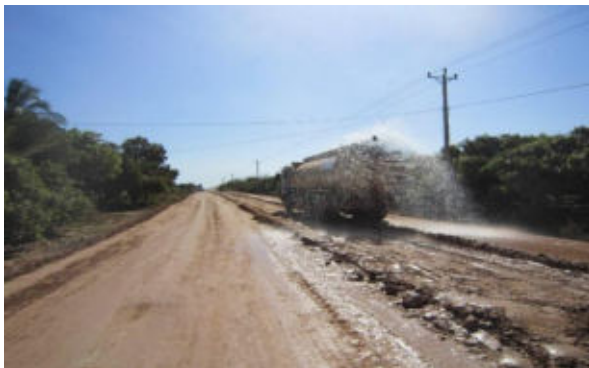
There is dust caused by contractor's dump trucks.	The contractor should spray water more frequently during dry season.	<p>The contractor spray water using water trucks.</p>

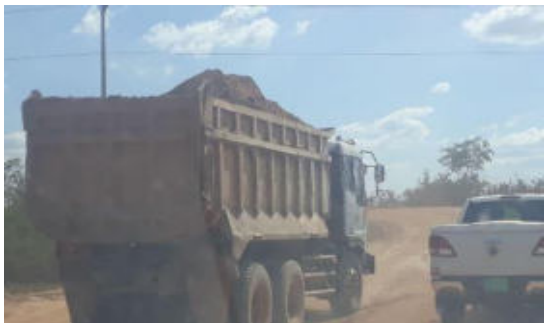
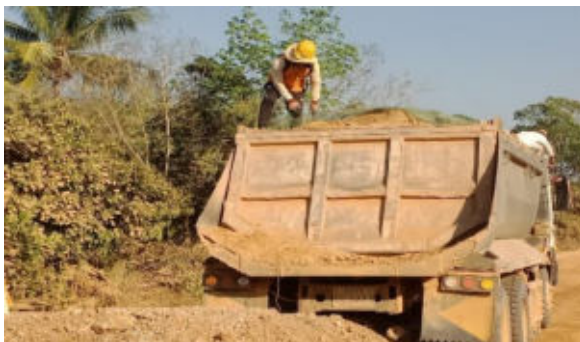
Some trucks do not use cover on top of soil in the loading box.	The contractor should use cover during transportation of soil.	<p>Use cover when transporting soil in the site.</p>

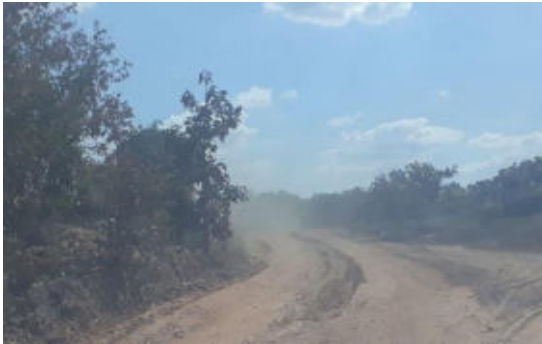
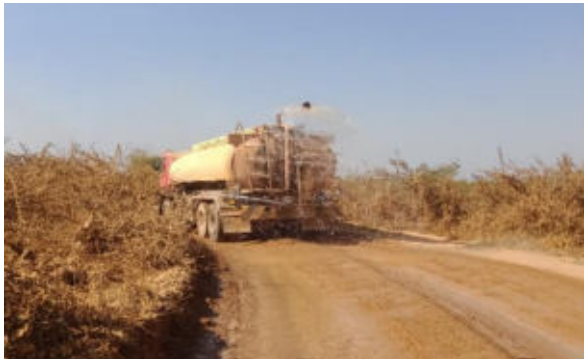
<p>The way entrances the borrow pit is not clearing, no watering and no warning traffic signs installation.</p>	<p>-The contractor has to clearing and watering on the way entrance the borrow pit with warning traffic signs installation to prevent traffic accident.</p>	<p>The contractor spray water at access to borrow pits and installed warning signboard.</p>

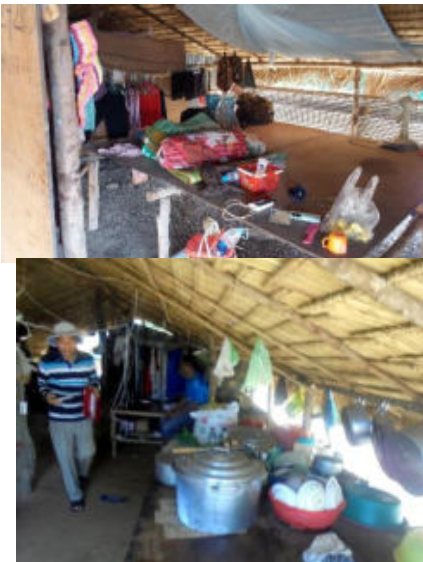
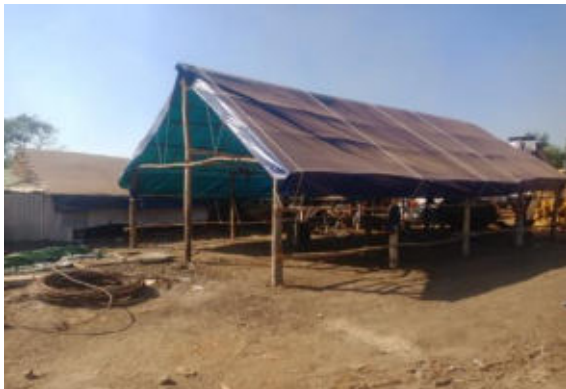
<p>-Bedroom and kitchen are all in one common room.</p>	<p>-This condition calls for further improvement. And the contractor has to construct separate Bedroom and kitchen room.</p> <p>-Construct Quarter one more for male workers sleeping</p>	<p>Contractor built one more tent for labors.</p>

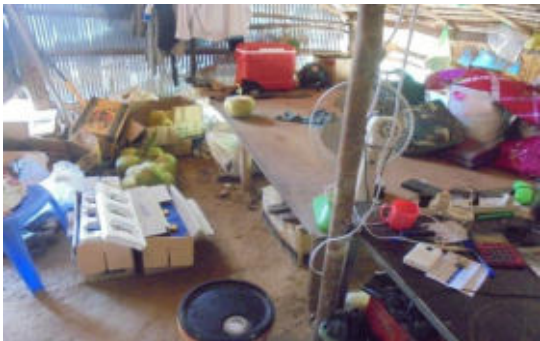
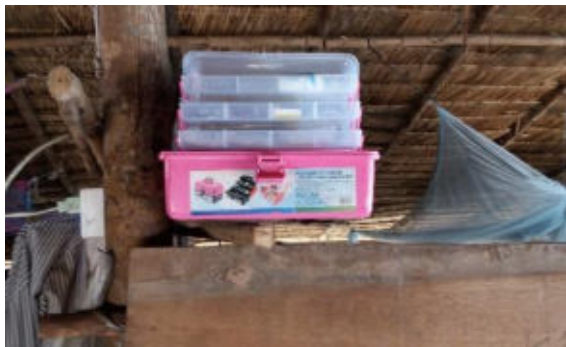
<p>First AIDs kit keeps on the wooden shelter in the open space without medical cup-board.</p>	<p>-The contractor has to keep first Aids kit in medical cup-board in the cool place to keep quality medicines.</p>	<p>First AID kit was provided in the camp.</p>

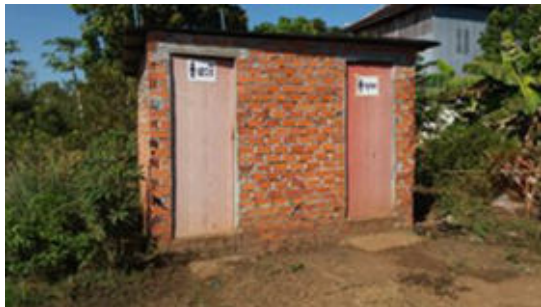
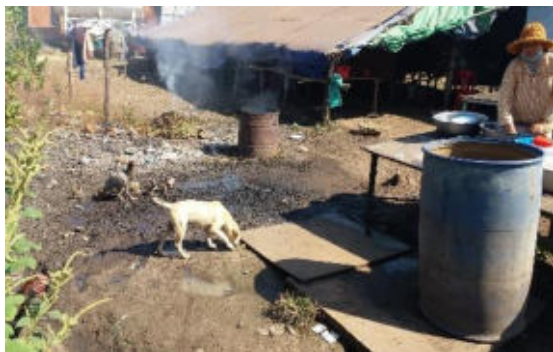
<p>-The camp has a 2-door toilet, sealed latrine with 2 labels to distinguish between what if for male and for female</p>	<p>-This is considered a good practice. But still poor sanitary. The contractor has to clearing small brush around toilet house to reduce mosquitos.</p>	<p>Keep maintained.</p>

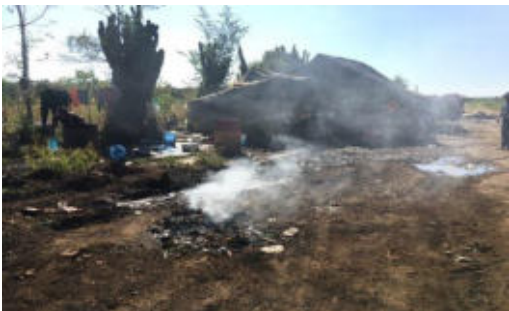
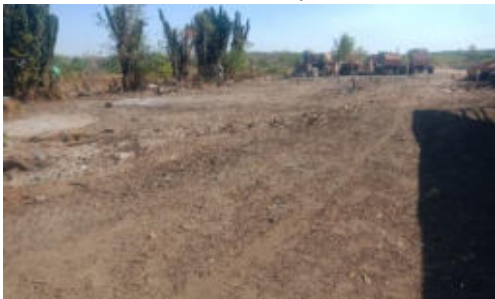
-No garbage bin in the camp site, the contractor collects solid waste & discard items to burn in the camp site. No drainage and discharge water run-off in the premise cause to have standing water, muddy and mosquitos could be spreading.	-The contractor has to construct the drainage to discharge water from the camp site and collect rubbishes, discard items to dispose at the dump site which approved by local authorities.	The contractor cleaned up the site.

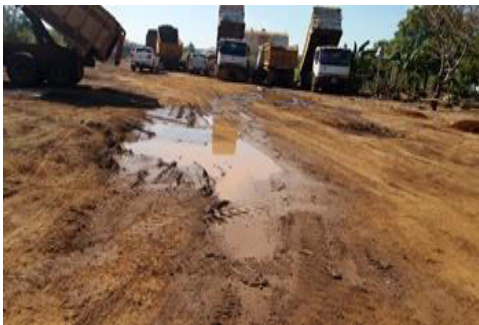
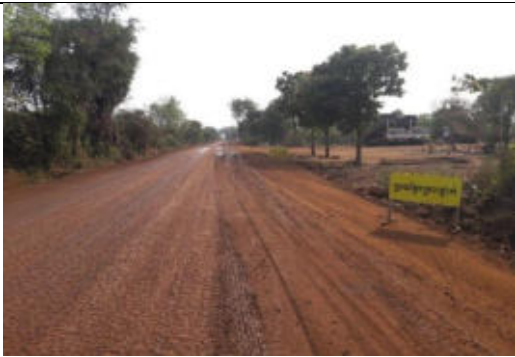
-No traffic signs board installed in front of the entrance into the site camp. And no board information in the site camp.	-To keep traffic safety, the contractor has to installed traffic sign board in front of the entrance in to the site camp. And inside the camp has to install board information to disclose all information of project activities and Grievance Redress Mechanism paper.

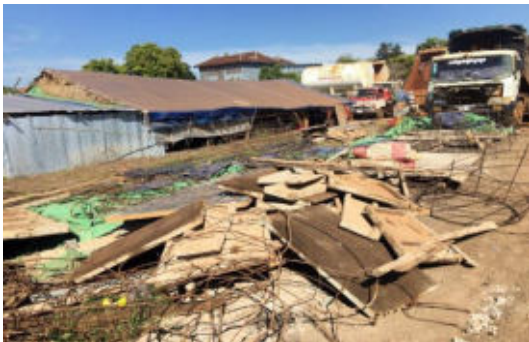
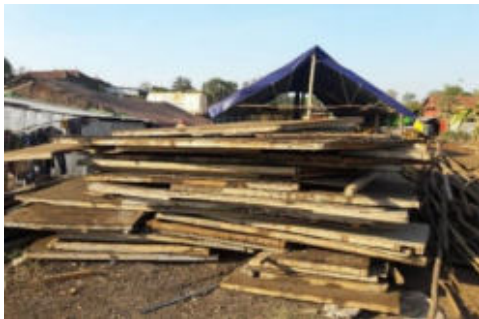
-disorder keeping materials in the camp site, it causes narrow space and congesting during movement equipment machines.	- The contractor has to rearrange in the camp site premise	Rearranged used materials in order.
