## Cambodia: Rural Roads Improvement Project III

**ADB LOAN 3678-CAM (COL)/GRANT 0581-CAM (SF)  
RURAL ROADS IMPROVEMENT PROJECT III**

# **SEMI-ANNUAL INTEGRATED ENVIRONMENTAL AND SOCIAL SAFEGUARDS MONITORING REPORT**

**(Period of Monitoring: July ~ December 2020)**

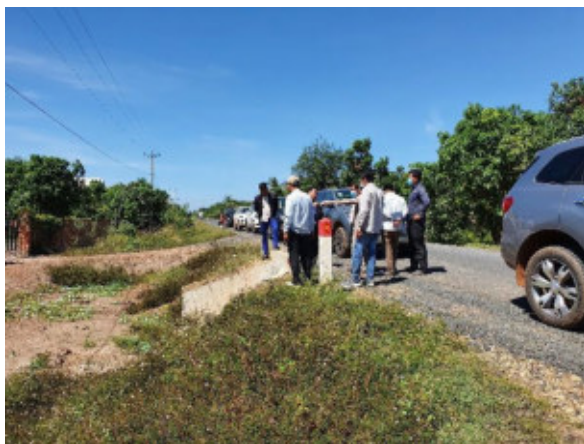
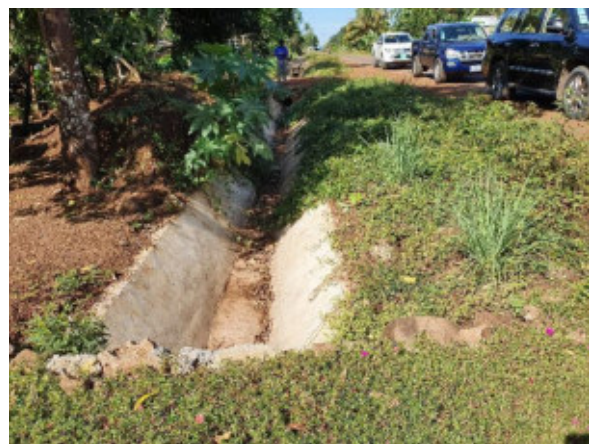
19. The contract CW-B2 has been completed and no environment issues were observed during inspection. The slopes of roads were covered by block sodding to avoid erosion as shown below.

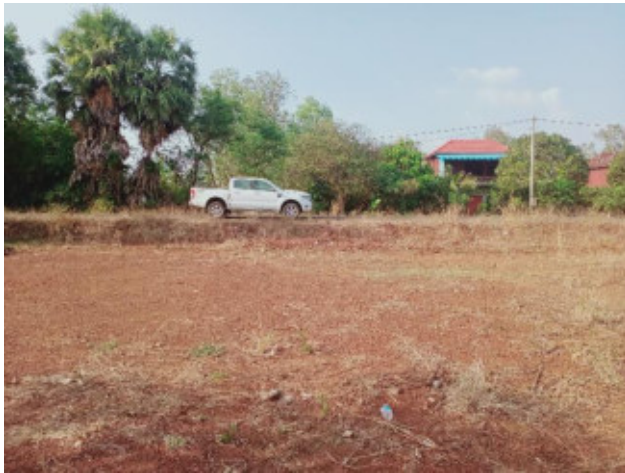
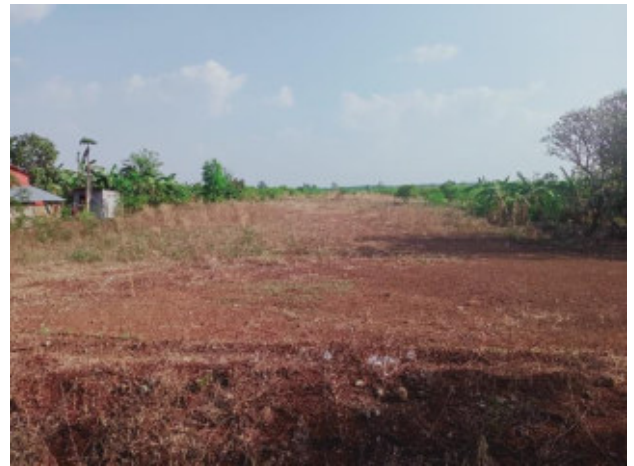
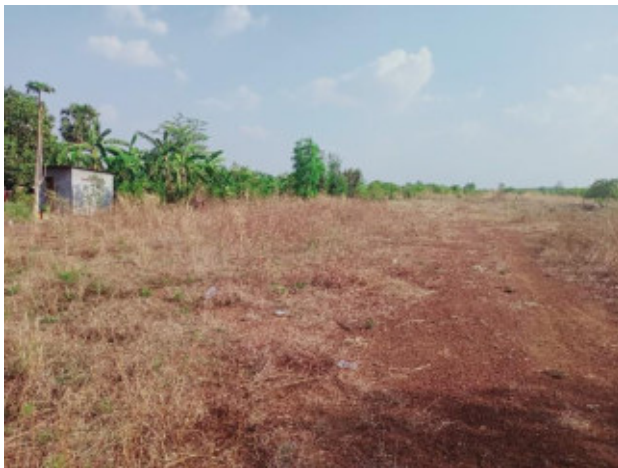
### Closed Site Camp on TBK1

21. All debris in the site camps have been removed and the rented lands have been returned to the owners by the contractor. There is no water stagnation and environment impact on water channel. The pictures of two closed camps are shown below.

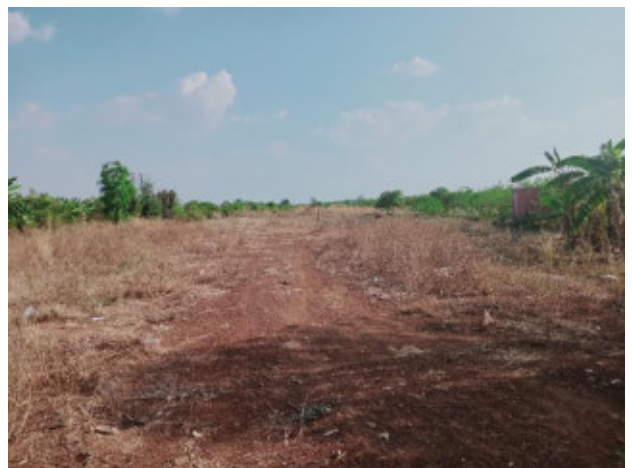
20. The two camp sites had been emptied and closed right after the completion of physical works. The location of the two camp site locations are as follows:

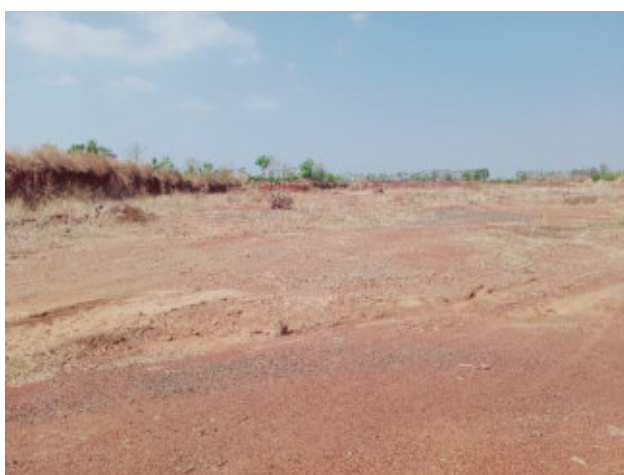
Borrow Pit at PK PK6+400 TBK1

23. The contractor graded the used borrow pits and installed warning signs to prohibit local people from approaching to the borrow pits. Photos of borrow pit and warning signs are shown below.

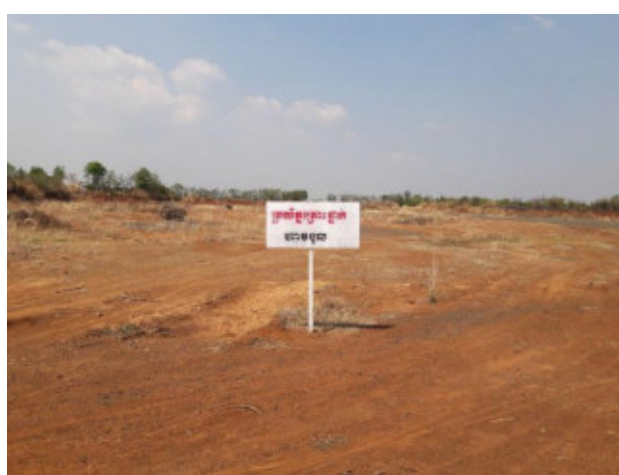
22. The contractor took material of embankment, subgrade and subbase from the previously used borrow pits for the contract CW-B2. The list of borrow pits used by the contractor is as follows:

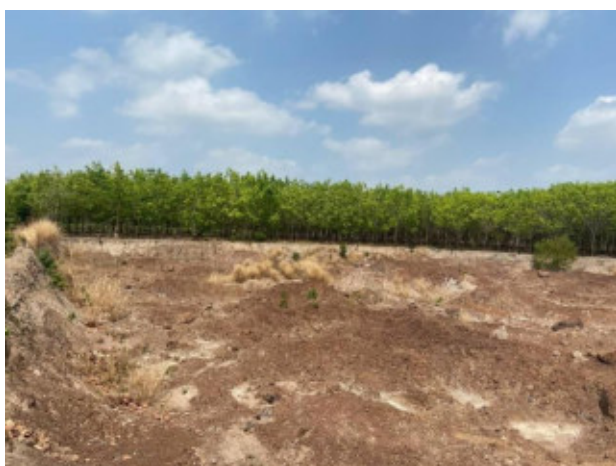
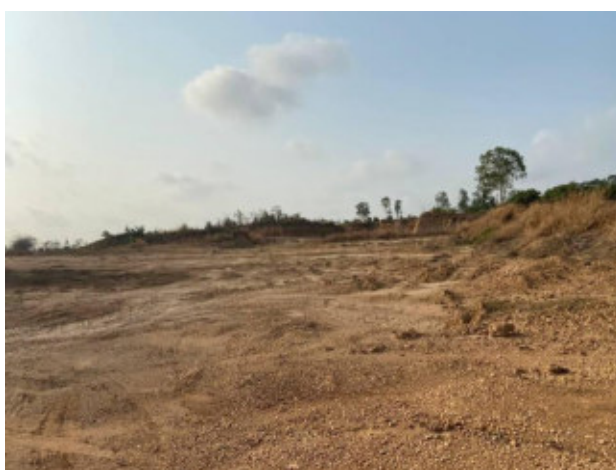
Installed warning signs at the borrow pits

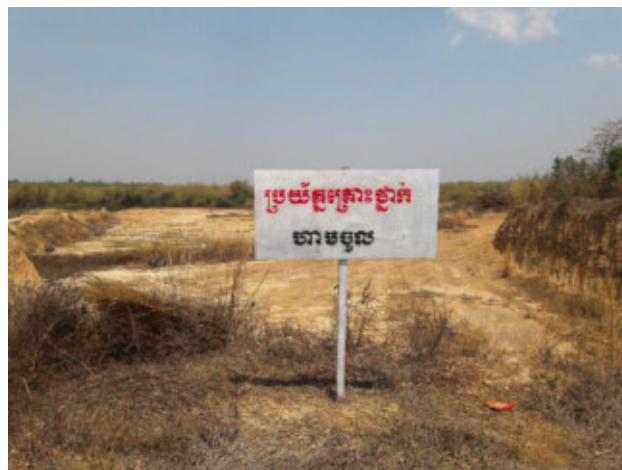
Borrow Pit at PK14+500 in TBK3

Installed warning signs at the borrow pits

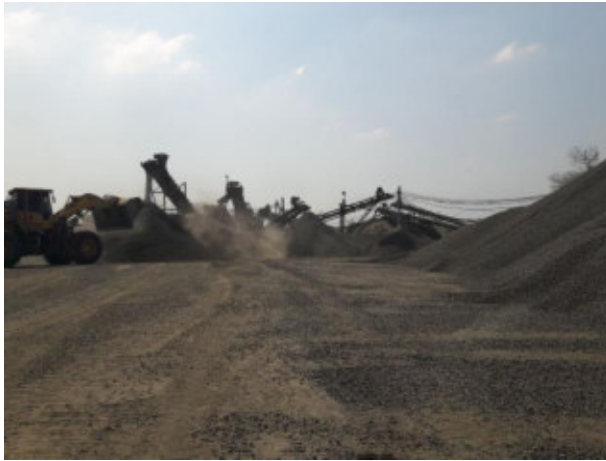
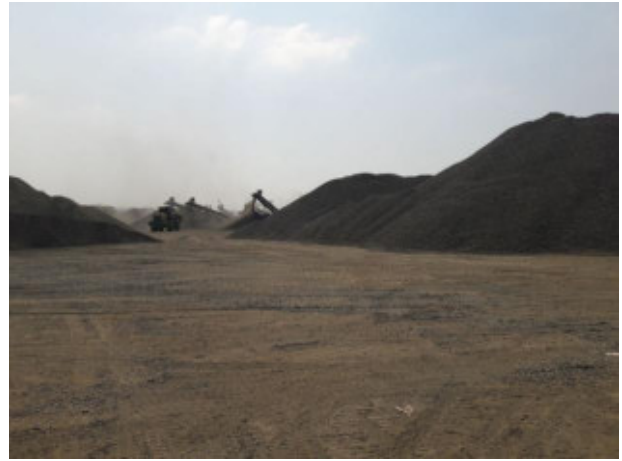
24. The photos of commercial quarry and license are shown below.

View of Commercial quarry operated By Uthy

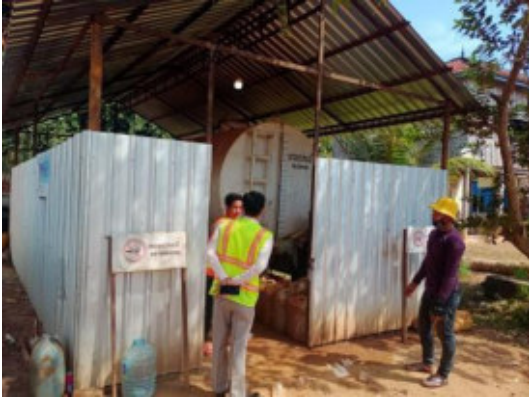
- Contractor should provide proper drainage to avoid water stagnant which cause mosquito breeding.
6	<b>Hazardous waste/materials storage</b>  (Required Action) Oils and hazardous materials should be stored in separate location and oil leaks should be cleaned.	-Oil tank and hazardous waste/material storage has been built separately with roof

-Keep maintenance as clean.

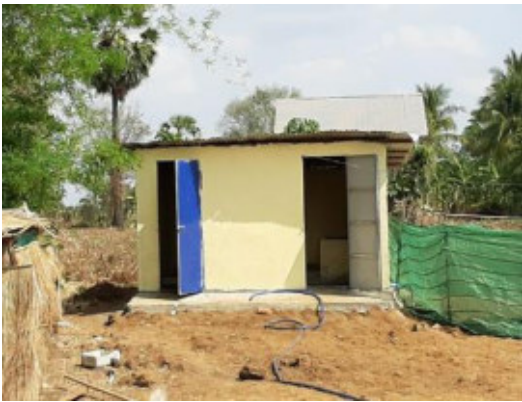
<p>-Contractor should install more signs at construction site and install warning signs at the entrance of camp site.</p>
9	<p><b>Toilet facilities</b></p> <p>(Required Action) Install at least 2 toilets for the separate use of men and women.</p>	<p>-Contractor installed 2 toilets.</p>

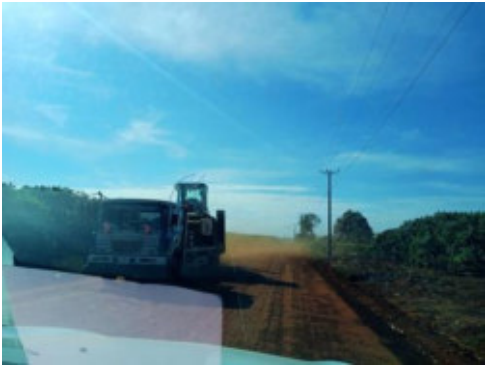
3	<p><b>Dust control at construction site</b></p> <p>(Required Action) Regular and frequent Repair road sprinklers and control dust at construction site</p>	<p>-Frequency of sprinkling water is not enough to control dust.</p>

<p>-Contractor should sprinkling water more frequently during dry season and transporting trucks should be equipped with cover sheet.</p>

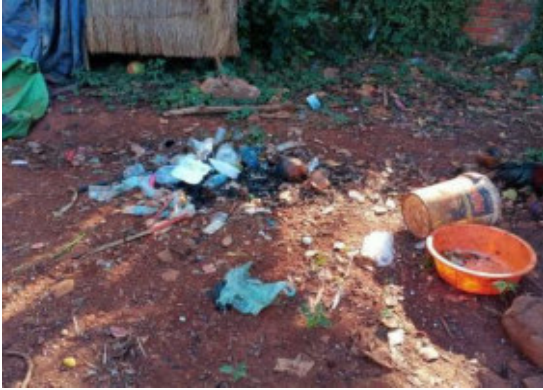
No	Items Checked and Required Action	Status	Action to be Taken
4	<b>Proper garbage bins and solid waste management</b>  (Required Action)	<p>-No garbage bin in the camp site.</p>

<p>-Contractor should put large size dust bin with plastic garbage collecting bags. Collected wastes should be transported and dumped at garbage disposal site operated by local authorities.</p>
5	<b>Wastewater control at camps and water stagnant</b>  (Required Action)	<p>-There is water stagnant area in the camp site.</p>

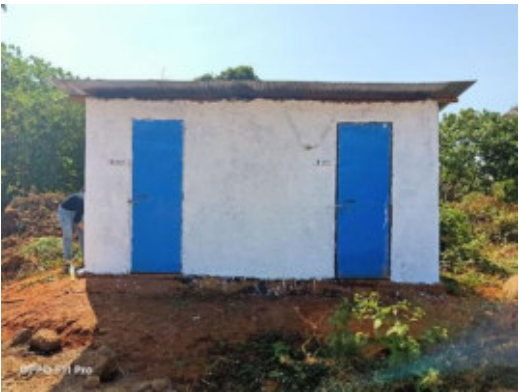
<p>-Contractor should install proper signs at construction site and install warning signs at the entrance of camp site.</p>
9	<p><b>Toilet facilities</b></p> <p>(Required Action) Install at least 2 toilets for the separate use of men and women.</p>	<p>-Contractor installed 2 toilets</p>

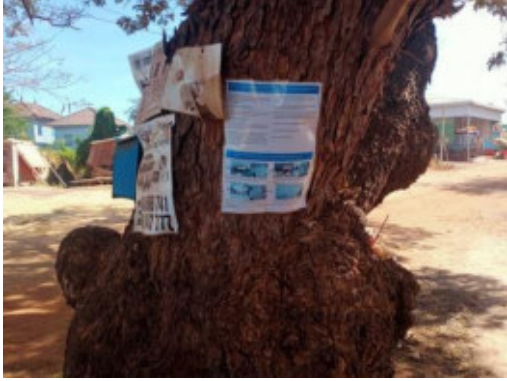
No	Items Checked and Required Action	Status	Action to be Taken
1	<p><b>Put Public Information Booklet (PIB) at Commune Office.</b></p> <p>(Required Action) Public information Booklet should be in every commune office in the project area</p>	<p>-One GRM leaflet attached at the Camp site and commune office but no Public Information Booklet(PIB)</p>

<p>- Public Information Booklet (PIB) should be kept in every commune office in the project area.</p>
2	<p><b>Project Information board locations to be shown with contact number and organization</b></p> <p>(Required Action) Project information board should be installed at the starting point and included contact number and organization (MRD).</p>	<p>- Project information board has not yet installed.</p>	<p>-Contractor should install project information board at the beginning point of the project road. The project information board should include contact number and organization (MRD).</p>

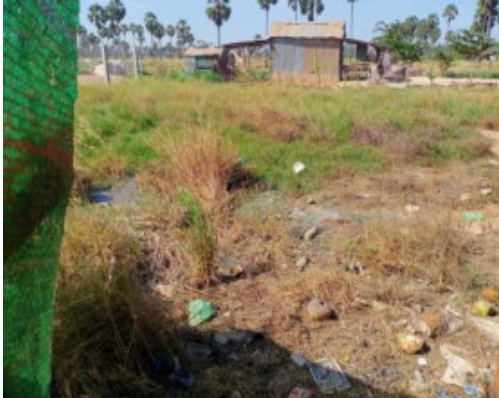
No	Items Checked and Required Action	Status	Action to be Taken
4	<b>Proper garbage bins and solid waste management</b>  (Required Action)	-No garbage bin in the camp site.

-Contractor should put large size dust bin with plastic garbage collecting bags. Collected wastes should be transported and dumped at garbage disposal site operated by local authorities.
5	<b>Wastewater control at camps and water stagnant</b>  (Required Action)	-There is water stagnant area in the camp site.

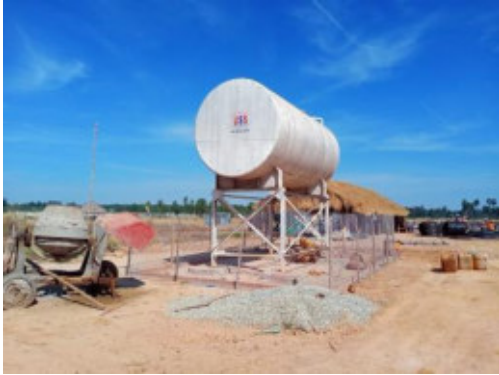
- Contractor should provide proper drainage to avoid water stagnant which cause mosquito breeding.
6	<b>Hazardous waste/materials storage</b>  (Required Action) Oils and hazardous materials should be stored in separate location and oil leaks should be cleaned.	-Oil tank and hazardous waste/material storage has been built separately with roof

-Keep maintenance as clean.

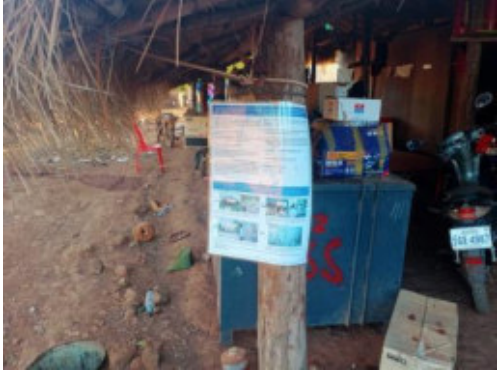
No	Items Checked and Required Action	Status	Action to be Taken
1	<p><b>Put Public Information Booklet (PIB) at Commune Office.</b></p> <p>(Required Action) Public information Booklet should be in every commune office in the project area</p>	<p>-One GRM leaflet attached at the Camp site and commune office but no Public Information Booklet(PIB)</p>

<p>- Public Information Booklet (PIB) should be kept in every commune office in the project area.</p>
2	<p><b>Project Information board locations to be shown with contact number and organization</b></p> <p>(Required Action) Project information board should be installed at the starting point and included contact number and organization (MRD).</p>	<p>- Project information board has not yet installed.</p>	<p>-Contractor should install project information board at the beginning point of the project road. The project information board should include contact number and organization (MRD).</p>

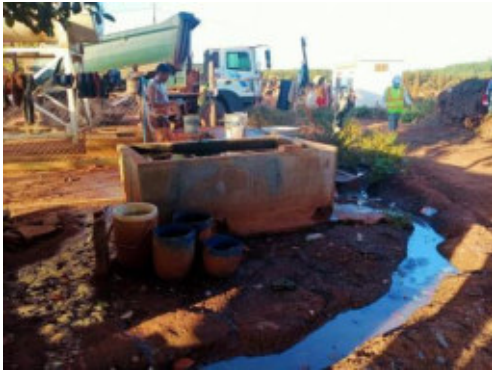
No	Items Checked and Required Action	Status	Action to be Taken
4	<b>Proper garbage bins and solid waste management</b>  (Required Action)	-No garbage bin in the camp site.   	-Contractor should put large size dust bin with plastic garbage collecting bags. Collected wastes should be transported and dumped at garbage disposal site operated by local authorities.
5	<b>Wastewater control at camps and water stagnant</b>  (Required Action)	-There is water stagnant area in the camp site.

- Contractor should provide proper drainage to avoid water stagnant which cause mosquito breeding.
6	<b>Hazardous waste/materials storage</b>  (Required Action) Oils and hazardous materials should be stored in separate location and oil leaks should be cleaned.	-Oil tank and hazardous waste/material storage has been built separately with roof	-Keep maintenance as clean.

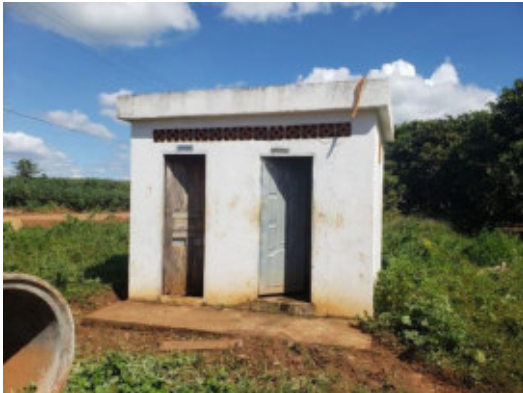
<p>-Contractor should install more signs at construction site and install warning signs at the entrance of camp site.</p>
9	<p><b>Toilet facilities</b></p> <p>(Required Action) Install at least 2 toilets for the separate use of men and women.</p>

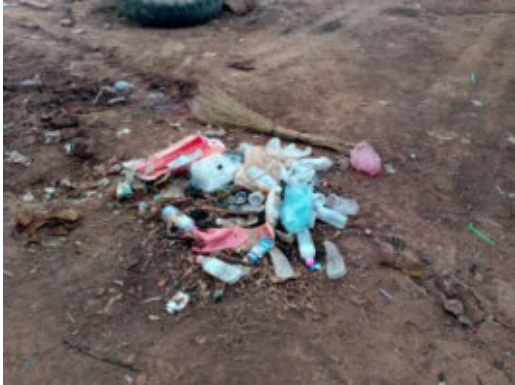
No	Items Checked and Required Action	Status	Action to be Taken
4	<b>Proper garbage bins and solid waste management</b>  (Required Action)	-No garbage bin in the camp site.

-Contractor should put large size dust bin with plastic garbage collecting bags. Collected wastes should be transported and dumped at garbage disposal site operated by local authorities.
5	<b>Wastewater control at camps and water stagnant</b>  (Required Action)	-There is water stagnant area in the camp site.

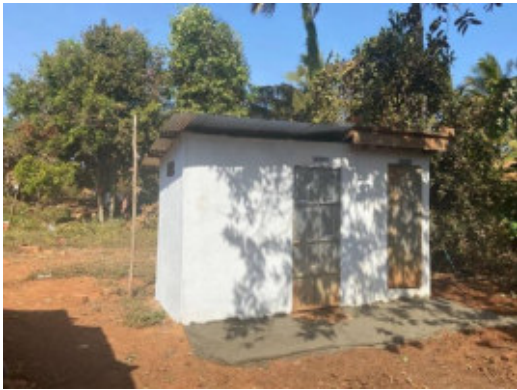
<p>-Contractor should install more signs at construction site and install warning signs at the entrance of camp site.</p>
9	<p><b>Toilet facilities</b></p> <p>(Required Action) Install at least 2 toilets for the separate use of men and women.</p>	<p>-Contractor installed 2 toilets</p>

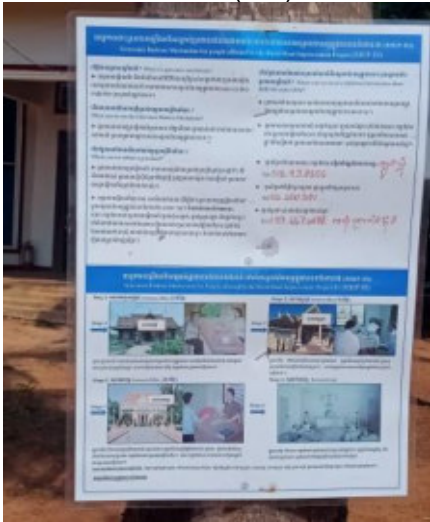
No	Items Checked and Required Action	Status	Action to be Taken
1	<p><b>Put Public Information Booklet (PIB) at Commune Office.</b></p> <p>(Required Action) Public information Booklet should be in every commune office in the project area</p>	<p>-One GRM leaflet attached at the Camp site and commune office but no Public Information Booklet(PIB)</p>

<p>- Public Information Booklet (PIB) should be kept in every commune office in the project area.</p>
2	<p><b>Project Information board locations to be shown with contact number and organization</b></p> <p>(Required Action) Project information board should be installed at the starting point and included contact number and organization (MRD).</p>	<p>- Contractor installed project information board at the end point.</p>	<p>-Contractor should move project information board at the end beginning point of the project road.</p>
3	<p><b>Dust control at construction site</b></p> <p>(Required Action) Regular and frequent Repair road sprinklers and control dust at construction site</p>	<p>-Frequency of sprinkling water is not enough to control dust.</p>

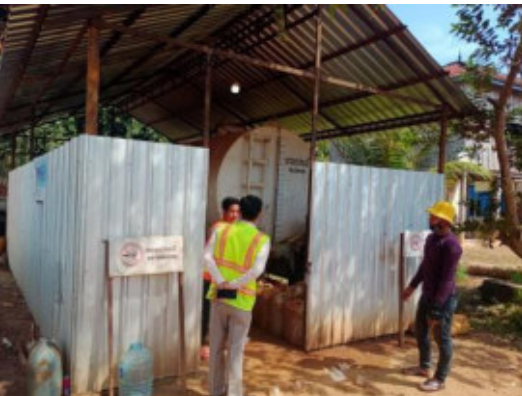
<p>- Contractor should construct septic tank for waste water control.</p>
6	<p><b>Hazardous waste/materials storage</b></p> <p>(Required Action) Oils and hazardous materials should be stored in separate location and oil leaks should be cleaned.</p>	<p>-Oil tank and hazardous waste/material storage has been built separately with roof</p>

<p>-Keep clean.</p>

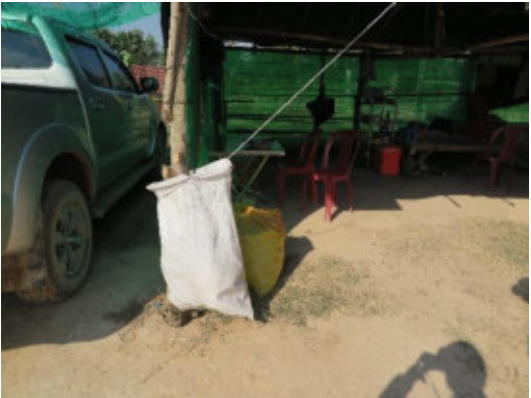
No	Items Checked and Required Action	Status	Action to be Taken
4	<b>Proper garbage bins and solid waste management</b>  (Required Action)	-No garbage bin in the camp site.

-Contractor should put large size dust bin with black plastic garbage bags. Collected wastes should be transported and dumped at garbage disposal site operated by local authorities.
5	<b>Wastewater control at camps and water stagnant</b>  (Required Action)	-No septic tank for waste water control

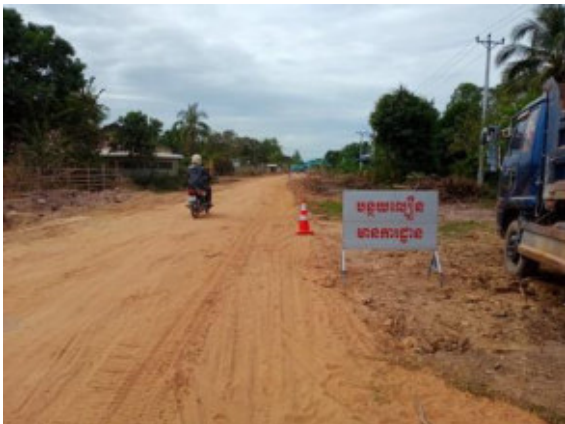
<p>-Warning sign in front of site camp is movable sign.</p>

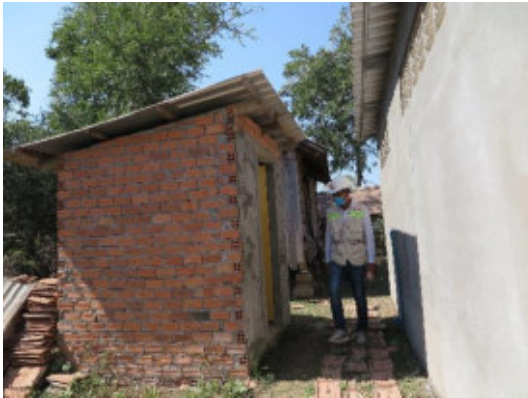
<p>-Contractor should install more warning signs and barriers, and install warning signs in front of the camp site.</p> <p>A fixed warning sign should be installed with information warding.</p>
9	<p><b>Toilet facilities</b></p> <p>(Required Action) Install at least 2 toilets for the separate use of men and women.</p>	<p>Only one toilet was built.</p>

<p>- The contractor should provide at least 2 toilets at each site camp for the use of men and women separately.</p>

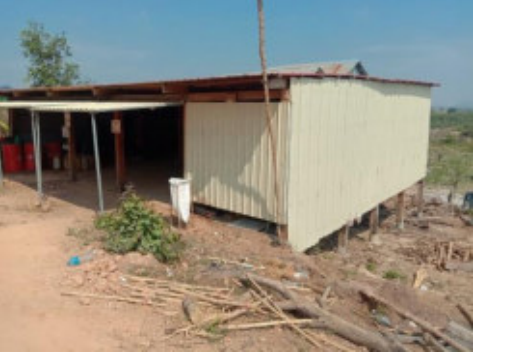
<p>Oil tank was not covered with roof and spill control platform was not provided.</p>	<p>-Keep clean near the warehouse.</p>

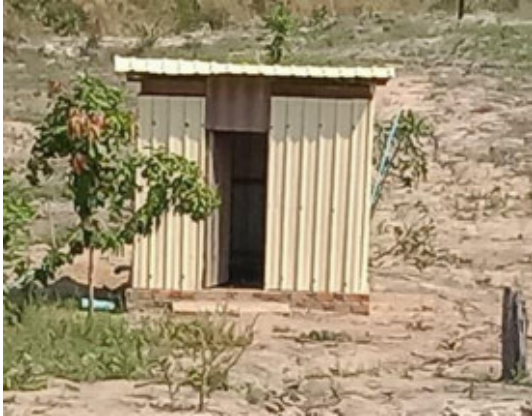
No	Items Checked and Required Action	Status	Action to be Taken
		<p>-Warning sign in front of site camp is movable sign.</p>  	<p>A fixed warning sign should be installed with information warding.</p>
9	<p><b>Toilet facilities</b></p> <p>(Required Action) Install at least 2 toilets for the separate use of men and women.</p>	<p>Only one toilet was built.</p>

<p>- The contractor should provide at least 2 toilets at each site camp for the use of men and women separately.</p>

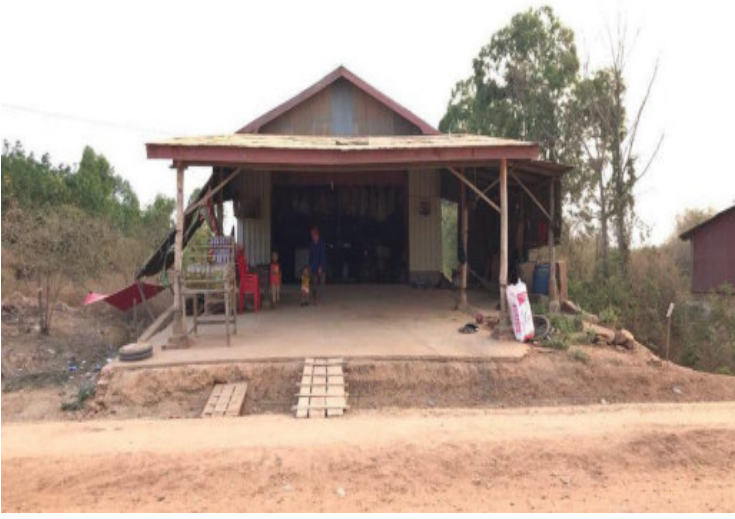
<p>(Owner: Mr. Sles Man) Front view of house before construction</p>
2

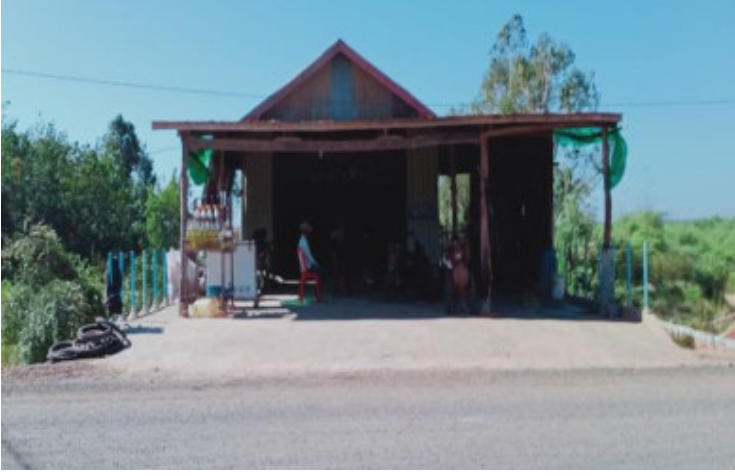
<p>(Owner: Mr. Sles Man) Front view of raised house to the new road level. No impact on the roof structure.</p>
3

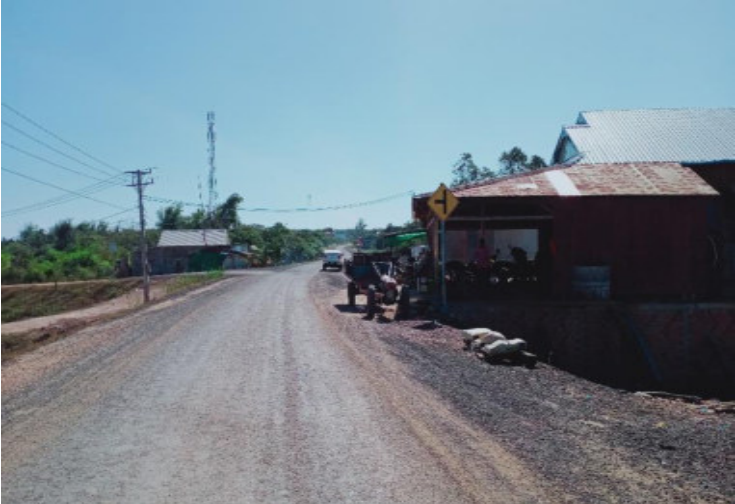
<p>(Owner: Mr. Sles Man) Side view after raising of house. (Zinc roof is outside of road)</p>

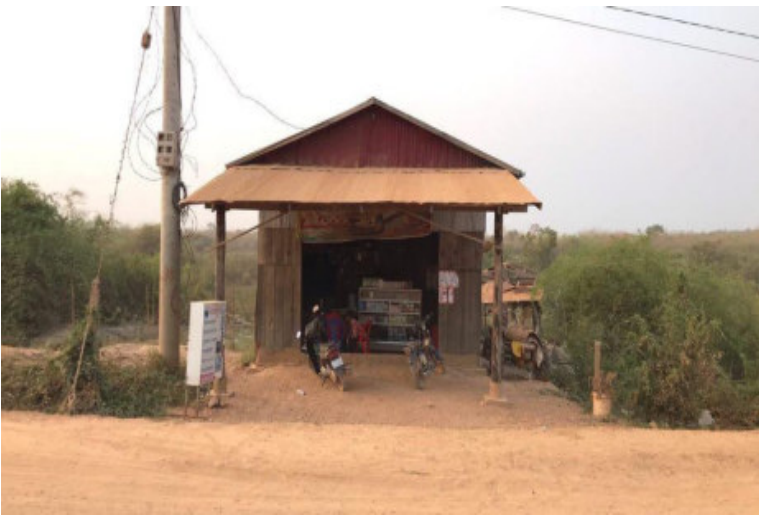
<p>(Owner: Ms. Meng Laisreang) Front view of shop (house) before construction</p>
2

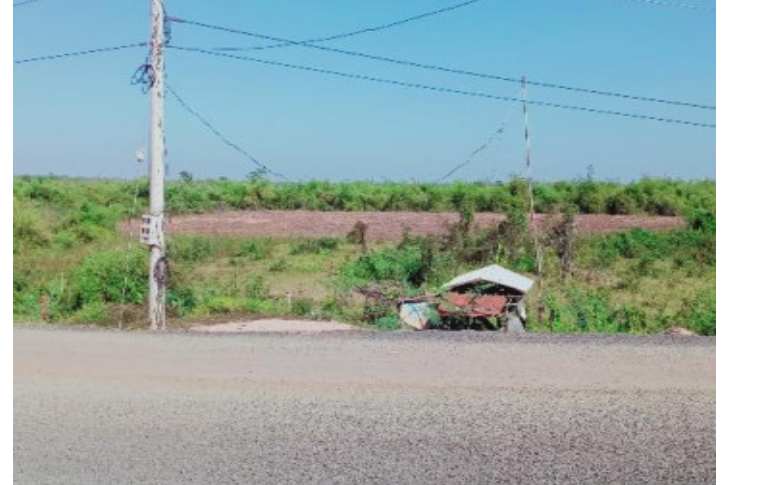
<p>(Owner: Ms. Meng Laisreang) Front view after construction. Owner demolished the shop to rebuild. The house in the back is the main house where the owner lives.</p>
3

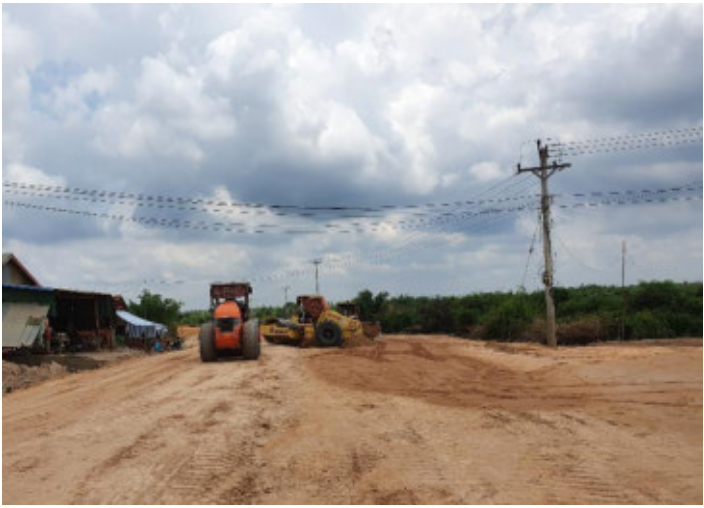
<p>(Owner: Ms. Meng Laisreang)          Raised road at the old hose location</p>
5

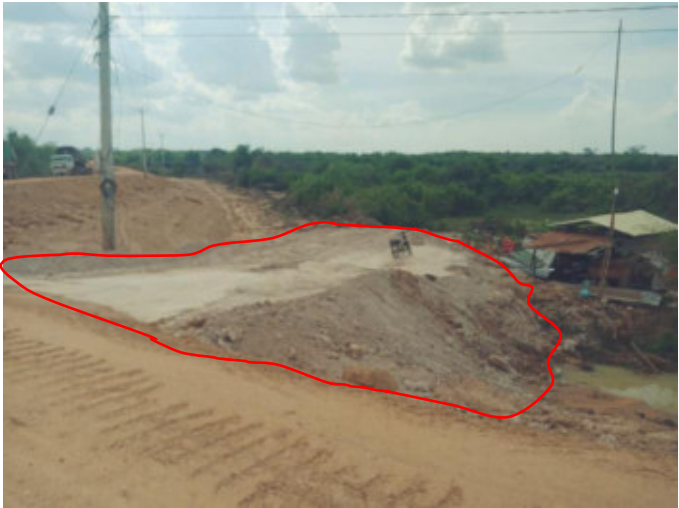
<p>(Owner: Ms. Meng Laisreang)          The contractor raised the ground of old house for rebuilding house without any cost.(Side view)          The house in the back is the owner's another house.</p>
6

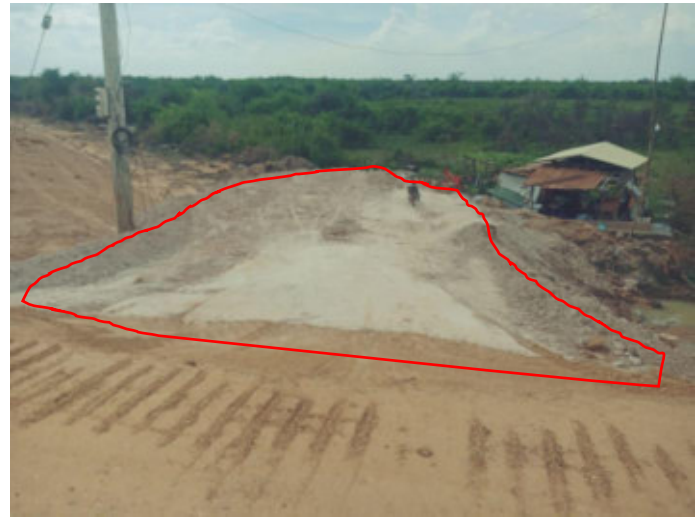
<p>(Owner: Ms. Meng Laisreang)          The contractor raised the ground of old house for rebuilding house without any cost. (Front view)          The house in the back is the owner's another house.</p>

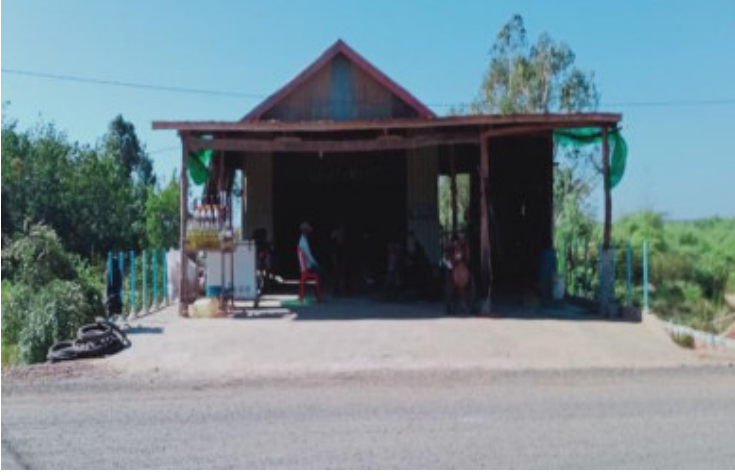
<p>(Owner: Mr. Dim Darith) Front view of raised house to the new road level. No impact on the roof structure.</p>
3

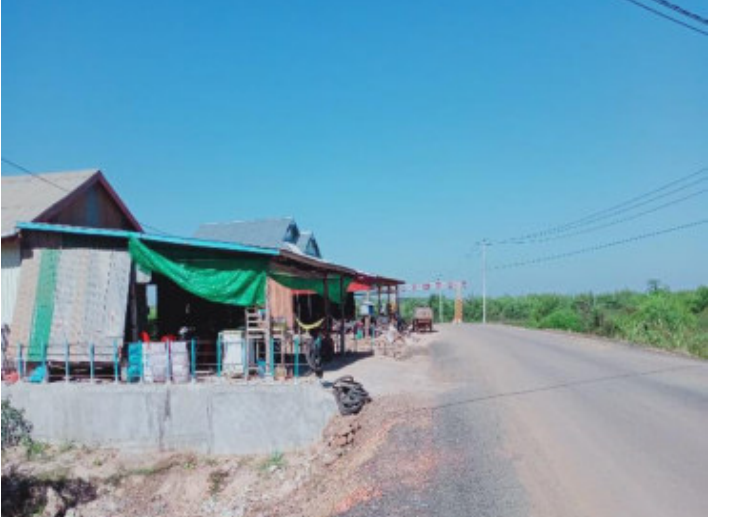
<p>(Owner: Mr. Dim Drith) Side view after raising of house. (Zinc roof is outside of road)</p>

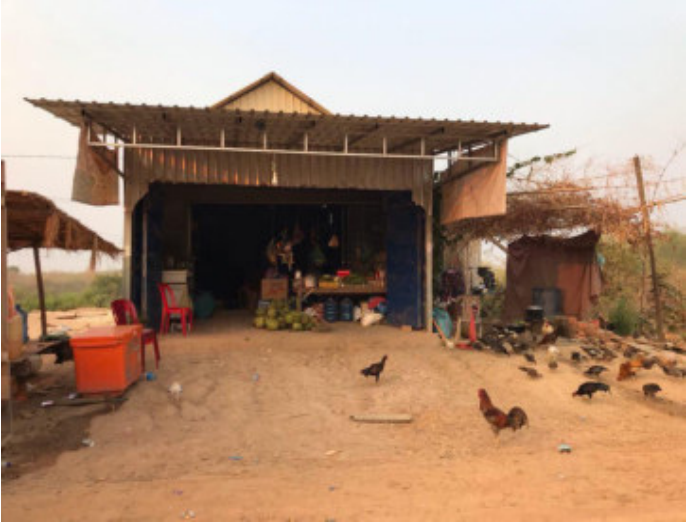
<p>(Owner: Ms. Nhor Sithan) Front view of house before construction</p>
2

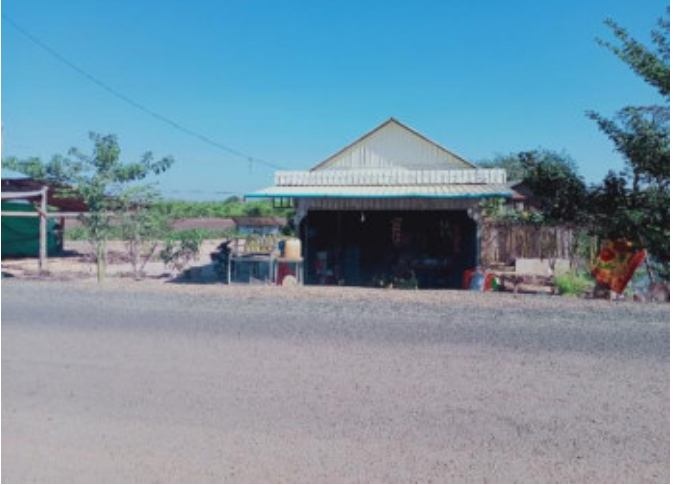
<p>(Owner: Ms. Nhor Sithan) Front view of house after construction. (No change in the zinc roof)</p>
3

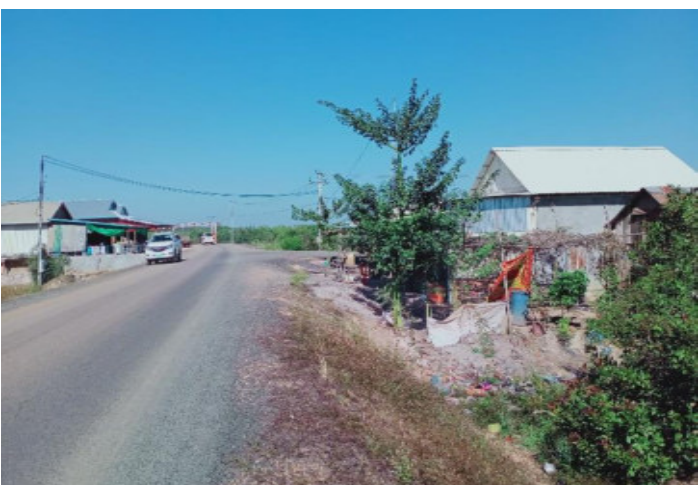
<p>(Owner: Ms. Nhor Sithan) Side view after Construction. (No change in the zinc roof)</p>

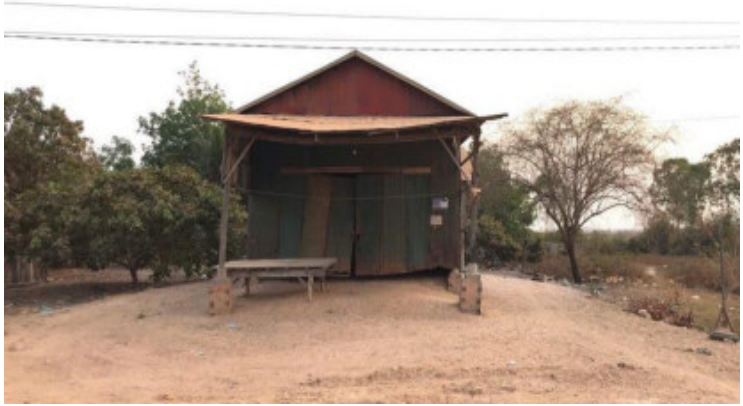
<p>A photograph showing the front view of a small, simple wooden structure with a gabled roof, situated on a dirt path. The structure appears to be under construction or is a basic frame. There are trees and a clear sky in the background.</p>	<p>(Owner: Ms. Nhor Sreymak) Front view of house before construction</p>
2

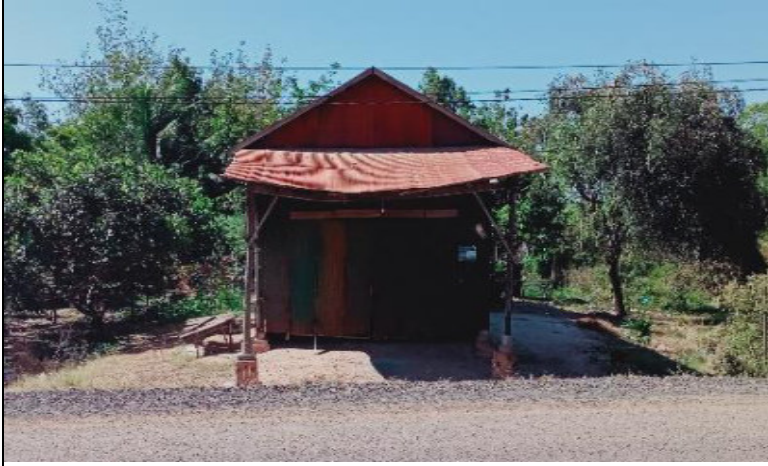
<p>A photograph showing the front view of the same structure after construction. It now has a more complete appearance with a red-painted roof and walls. The structure is still on the dirt path, surrounded by trees.</p>	<p>(Owner: Ms. Nhor Sreymak) Front view of house after construction. (No change in the zinc roof)</p>
3

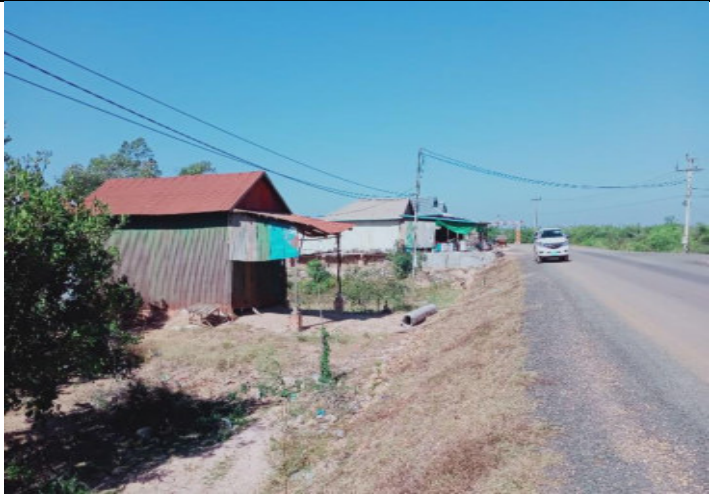
<p>A photograph showing the side view of the structure after construction. It is located next to a paved road. The structure has a red roof and is surrounded by trees and a clear sky.</p>	<p>(Owner: Ms. Nhor Sreymak) Side view after construction. (No change in the zinc roof)</p>
