Environmental and/or Social Monitoring Report

Semi-Annual Report
December 2018

VAN: Port Vila Urban Development Project

Semi-Annual Environmental and Social Safeguards Monitoring Report

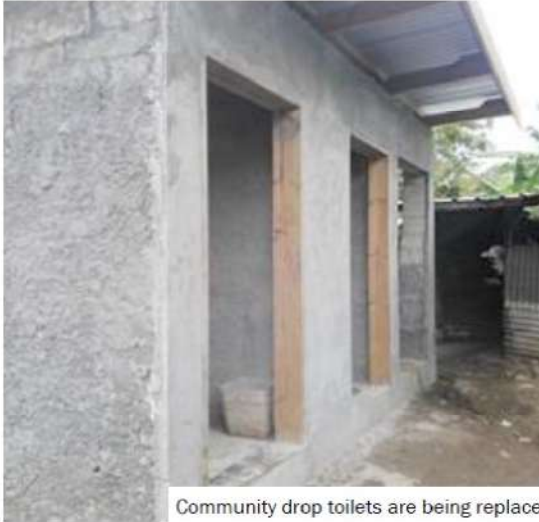
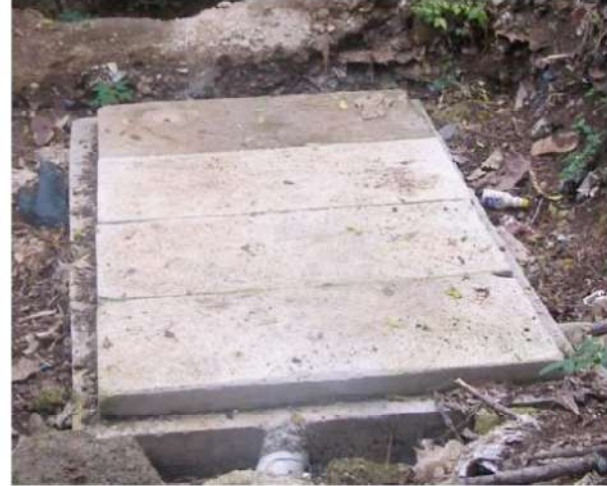
Community drop toilets are being replaced with new facilities and septic systems (under construction above)

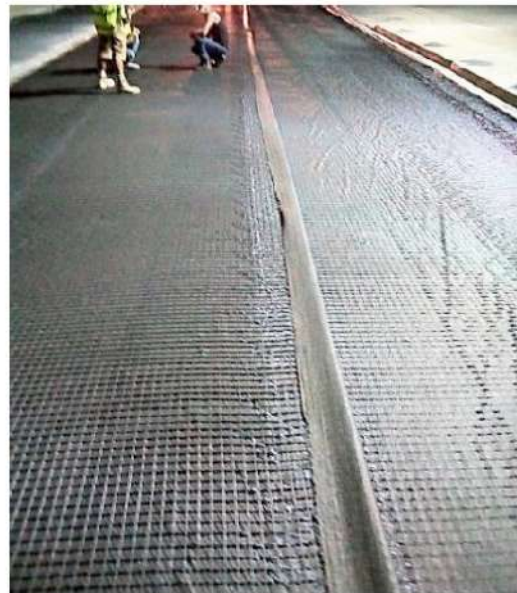
strengthen the road surface.

The grid will be applied to 6.5 km's of Port Vila's road receiving asphaltic concrete. This process will create a long-lasting, water-resistant road surface and improved drainage.
