Environmental Monitoring Report

Project Number 42459-014
Loan 3431
Semestral Report
July to December 2018

Sri Lanka: Local Government Enhancement Sector Project Additional Financing (LGESP-AF)

**Semi-Annual
Environmental Safeguards
Monitoring Report
(As on 31/12/2018)**

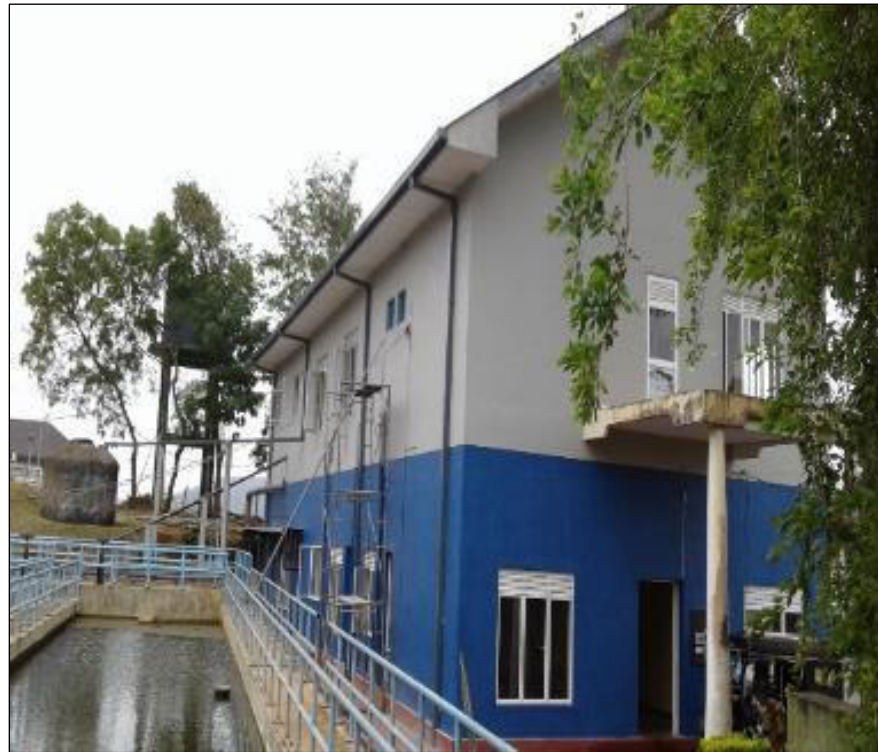
1) Renovation of existing Treatment Plant at Dambulla / Package No - CP-AF-WS-CKD-11

Photo 1 – Renovated Treatment Plant and building.

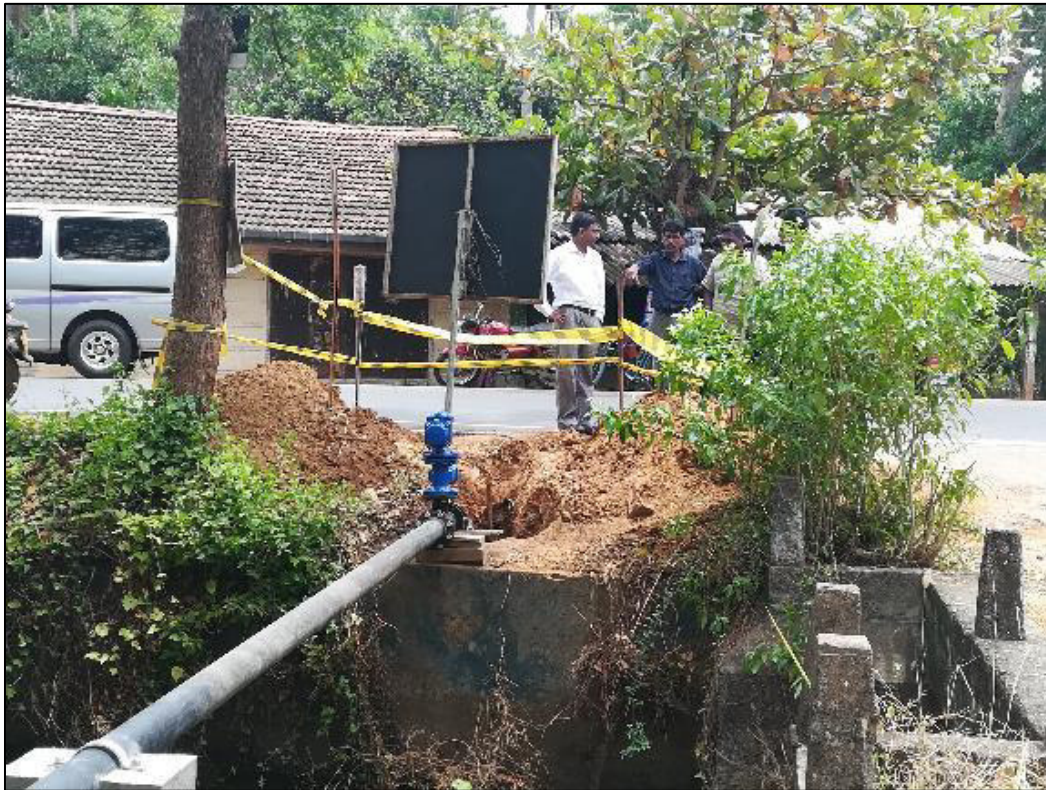
4) Water Supply Extensions to Bendiwewa (from Polonnaruwa water supply scheme)-NCP-AF-WS-CKD-21

and outside the site.		(ii) Signs of environmental degradation such as soil erosion, pollution in nearby area.					
4.G) Damages to natural water bodies, drainage pattern and surrounding rainwater drains	Natural drainage shall not be disturbed.	i) Signs of alternation or devastation or added changes in natural water ways. (ii) Quality changes in natural drains. iii) Undisturbed water way.	Physical Observation	Not required	-	Project area and surrounding	No natural drainage or water bodies disturbed during pipe laying. Photo 2- DI pipe laid on concrete pillars across a water way as a mitigation .

Photo 2 – DI pipe laid over a Water Way not disturbed.

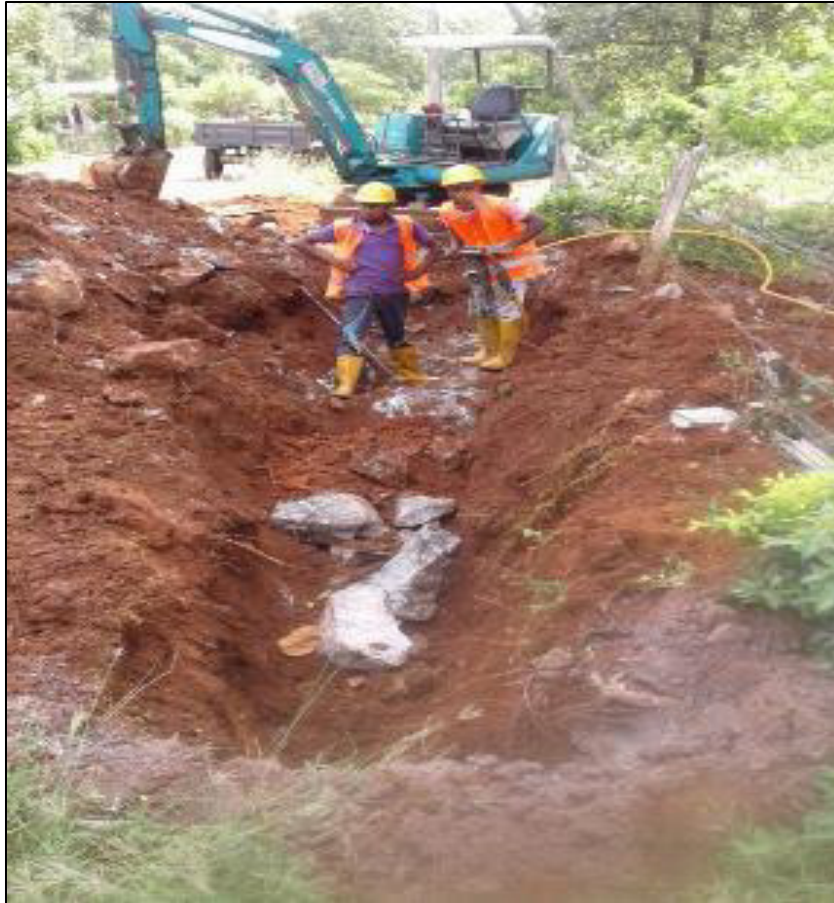
5) Water Supply Extensions to (i) Mahailuppallama & (ii) Thirappane area from Kekirawa water supply scheme-**NCP-AF-WS-CKD-02.**

complaints from sensitive receptors.					Photo No 3- Rock excavation by workers with PPEs.
5.J)Community health and safety.	(i) Provide walkways and metal sheets where required to maintain access for people and vehicles. ii) The contractor will ensure that there is provision of alternate access to business establishments during the construction, so that there is no closure of these shops or any loss of clientage. Iii) The contractor will ensure that any damage to properties and utilities will be restored or compensated to pre-work conditions iv) Safety signs will be established when and where necessary.	i) Availability of safety measures at the construction site. (ii) Contact numbers and information mentioned on the notice boards. (iii) Recordings of complaints from sensitive receptors.	Physical Observation	Above Average	PM was advised to provide safety signs and barricades at vulnerable locations such as near roads and ensure safety of road users.	Project area	This issue too taken up at the Provincial progress meeting.

Photo No 3-Rock Excavation- Workers with PPEs

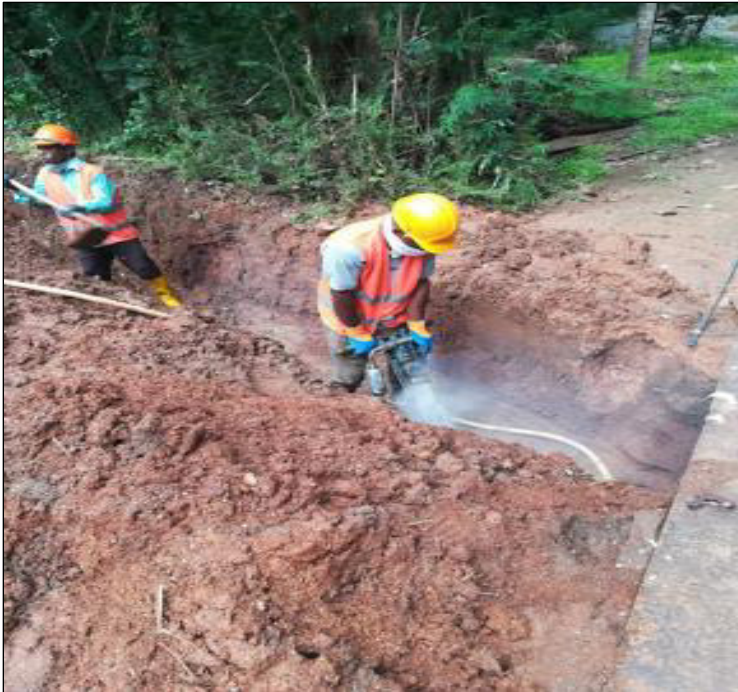
Photo No 4- Rock Excavation- Water Supply Extension Elagamuwa – Main and distribution lines (from Dhambulla water Supply Scheme)-**NCP-AF-WS-CKD-03**

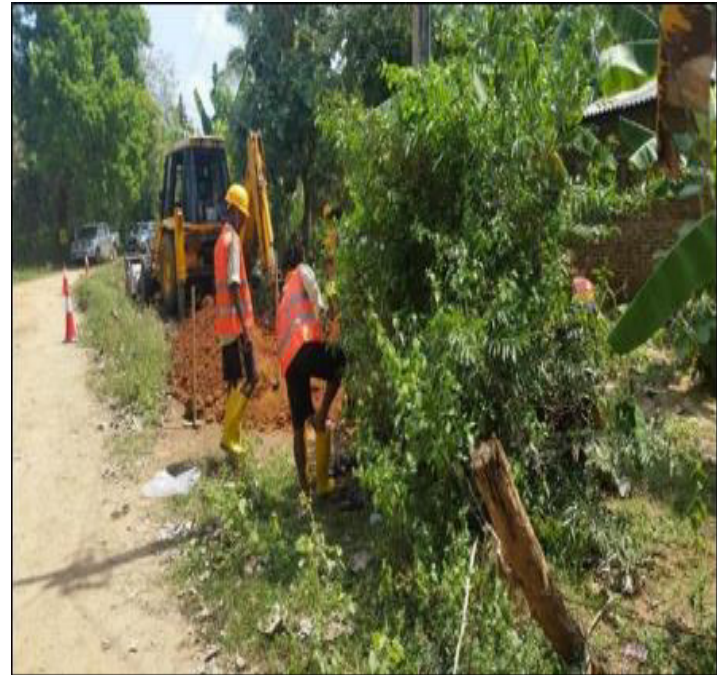
Photo No 5- Lack of safety warnings (no sign boards) at road side. Rock Excavation- Water Supply Extension Elagamuwa.-**NCP-AF-WS-CKD-03.**

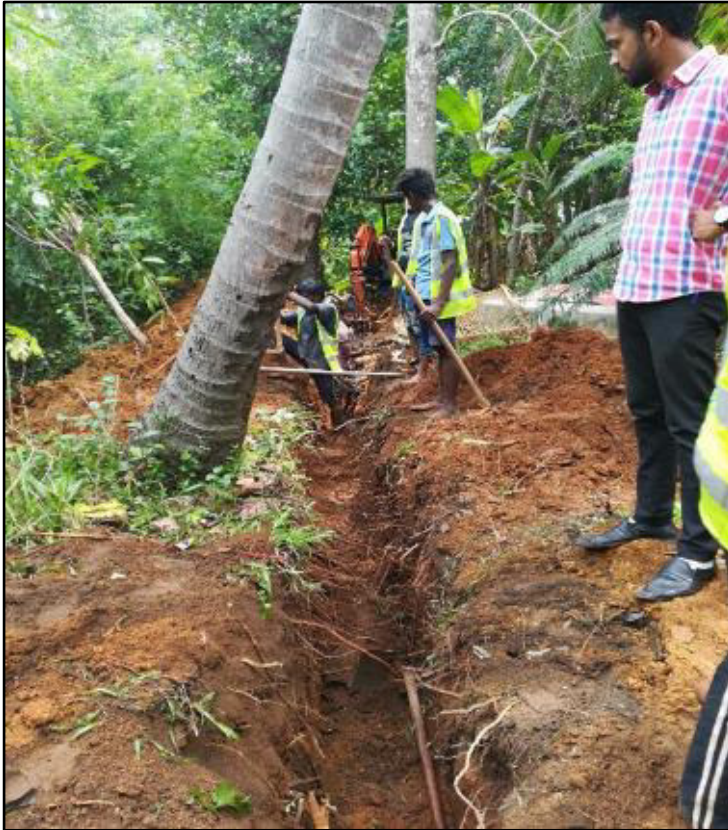
7) Sewagama Canal 3 - NCP-AF-WS-CKD-07

Photo 6 - Trench excavated by using man power to save trees. Only safety jackets.

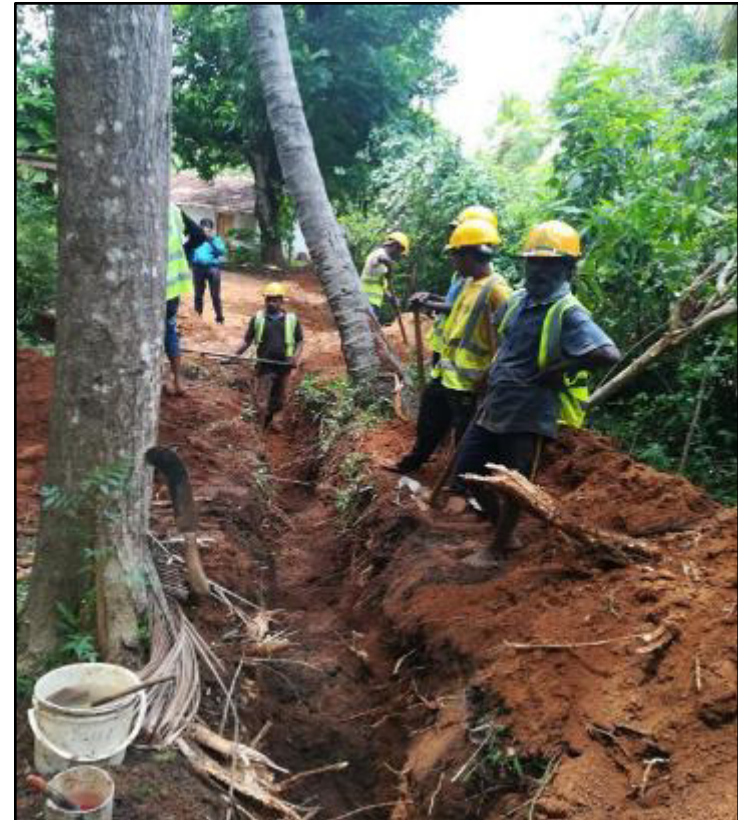
Photo No 7 -Workers with no Boots , trees saved by excavating trench manually..

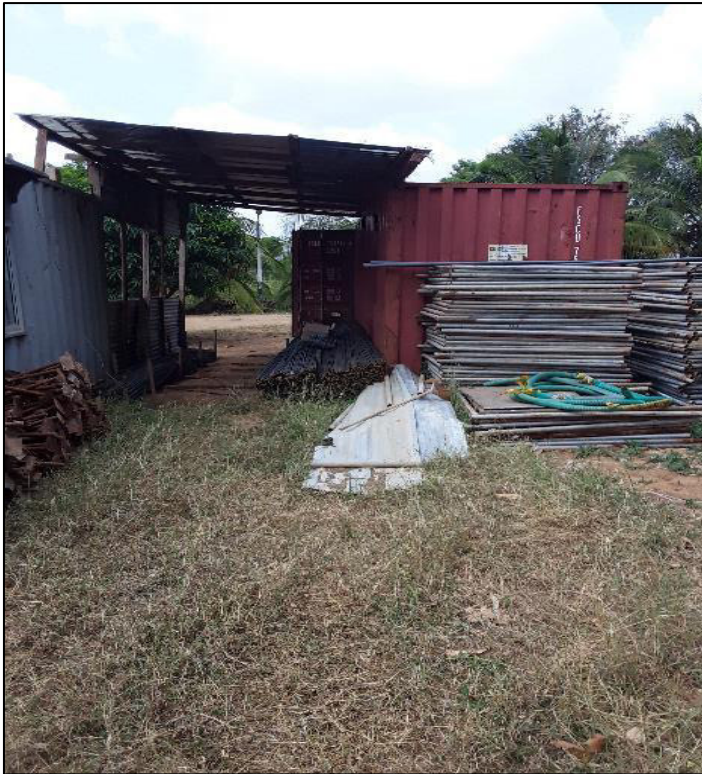
**8) Improvement to Kalawewa Treatment Plant at Ihalagama - (from Kekirarwa Water Supply Scheme).
-NCP-AF-WS-CKD-06.**

Photo 8- The place where material are stored.

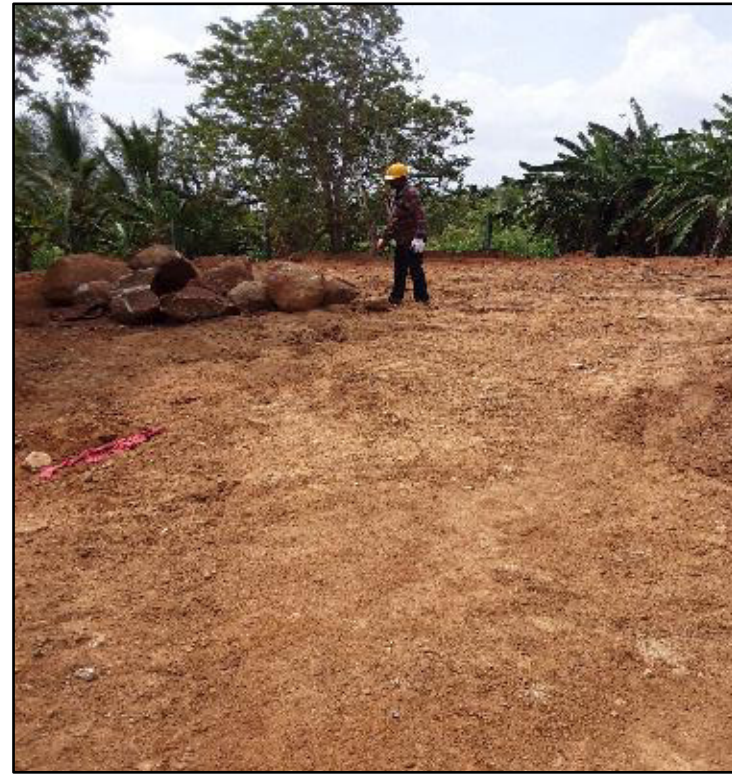
Photo 9- NWS&DB land filled with excavated soil and worker handling rocks without safety Boots.

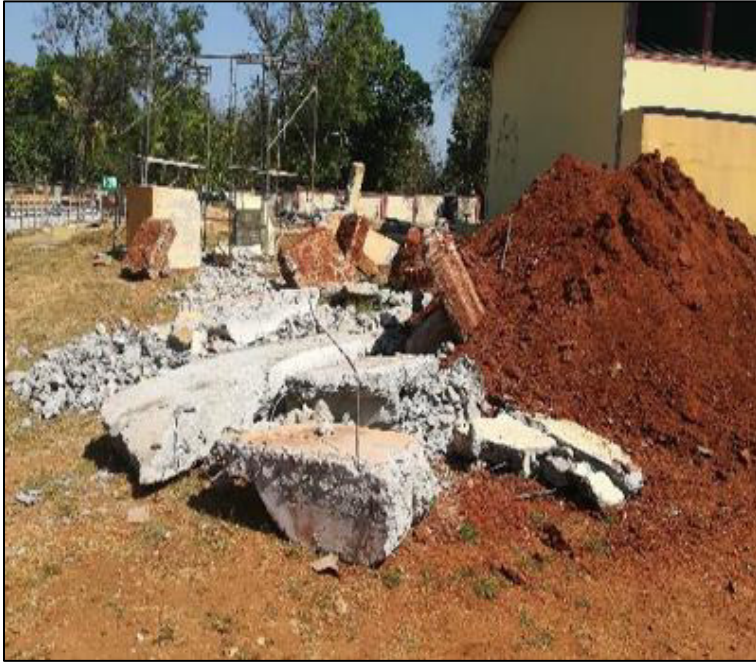
9) Capacity Improvement to Nuwerawewa Water Treatment Plant. (from Dhambulla water Supply Scheme)-NCP-AF-WS-KD-04

Photo No 10- Construction Waste dumped in the site.

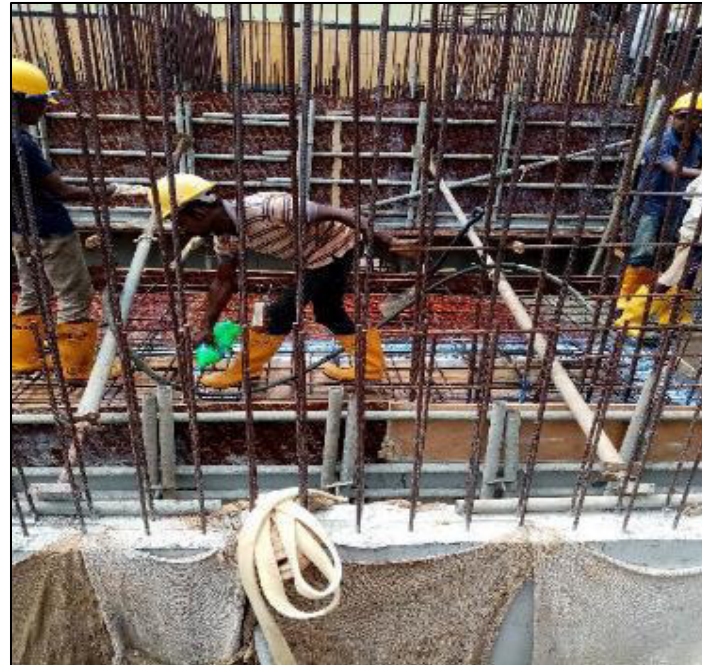
Photo 11-- Workers not wearing safety Jackets and Gloves.

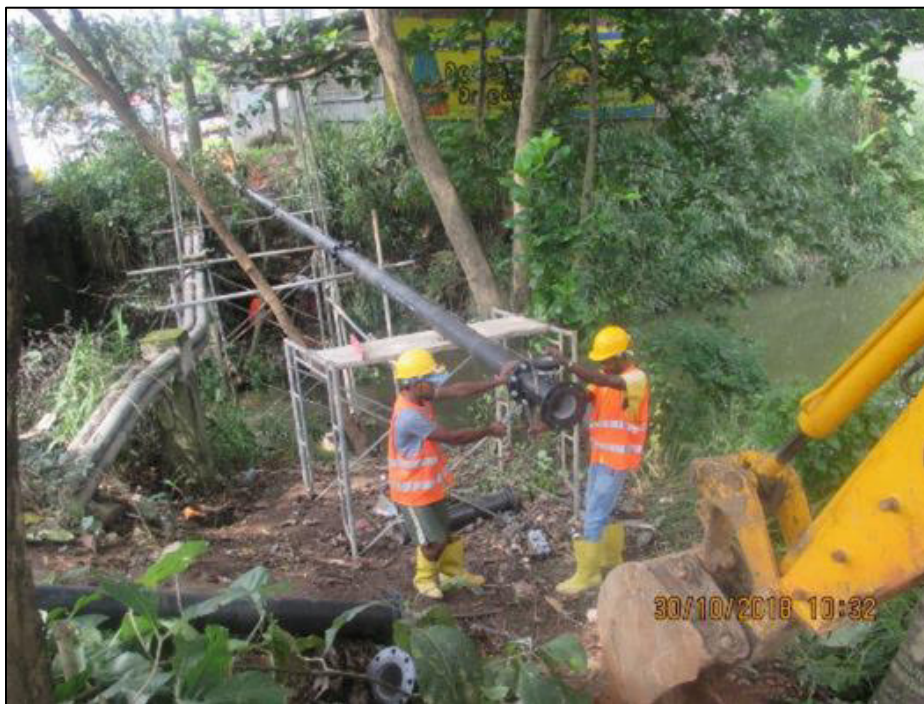
10) Water supply extension to Ibbagomuwa –NWP-AF-WS-CKD-05A

Photo 12 - A Pipe being laid over a stream. No gloves

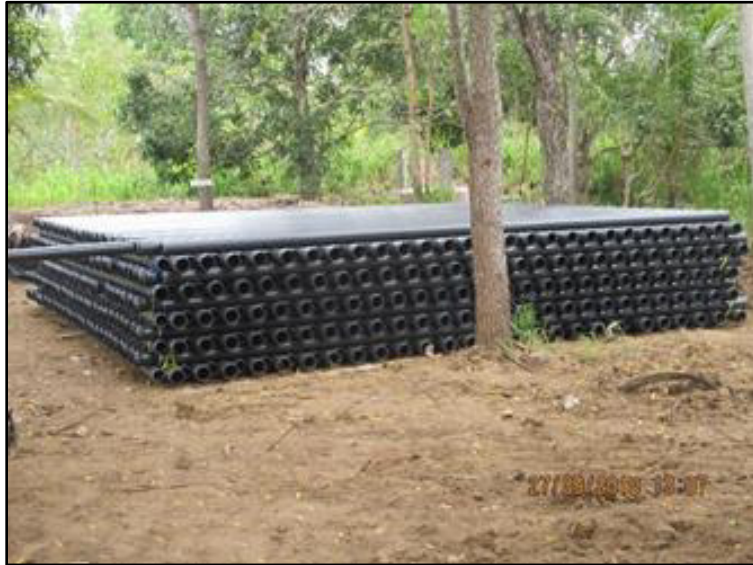
11) Extension of Water Supply Scheme of Nikaweratiya/ Ambampola/ Maho.-NCP-AF-WS-CKD-14A

Photo no 13-Uncovered pipes stored in site office premises

11.K)Waste generation and camping around	The solid wastes generated need to be removed to appropriate disposal yards	i) Checking of waste dump in site and camps (ii) Number of waste collecting baskets available in the site (iii) Recordings of periodic removal of solid waste (iv) Approved disposal yard. (v) Waste freeness of camping sites.	Physical Observation	Above average	Instructed Project Manager to remove debris currently stored at temporary sites to a LA approved site.	Project area	This issue was discussed at monthly progress meeting and contractor had agreed to resolve it.

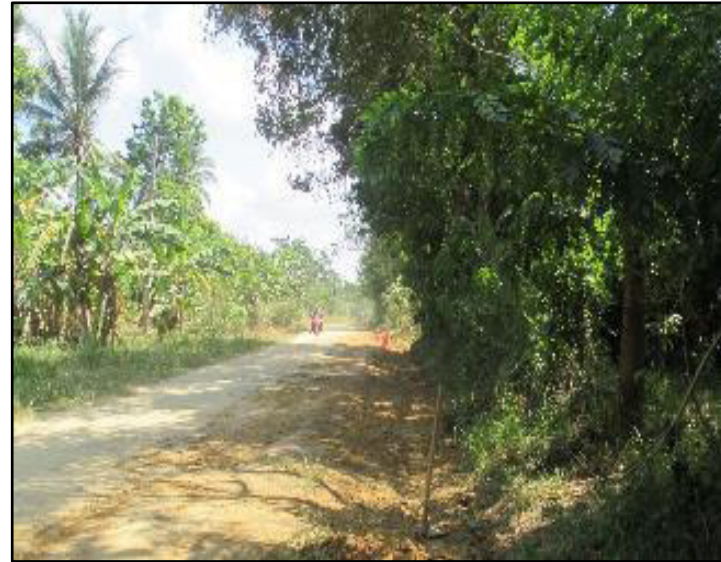
Photo 14 – Typical landscape where excavation done for pipe laying by the side of the road.

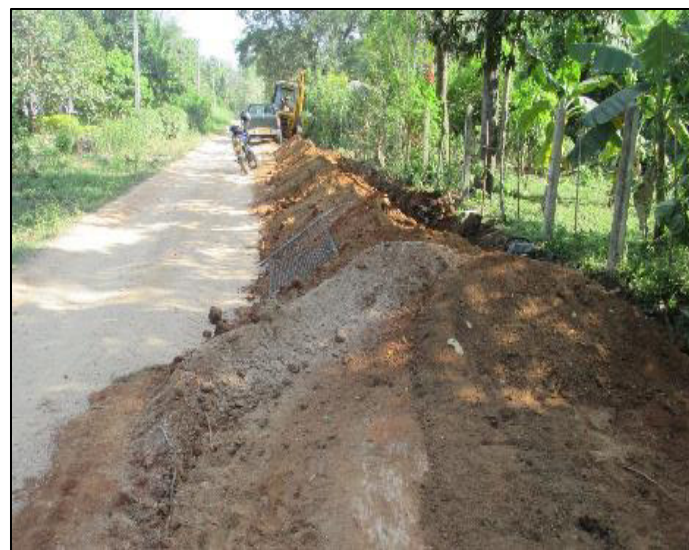
Photo 16- No safety signs placed at road side.

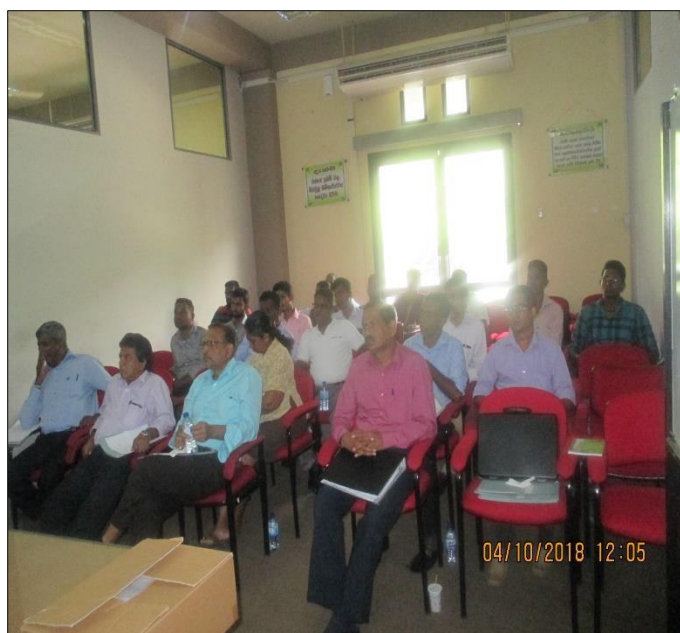
Photo No 17-One day work shop on ADB Safeguard policies and Principals to Contractor and Project field staff on 04th Oct.2018.

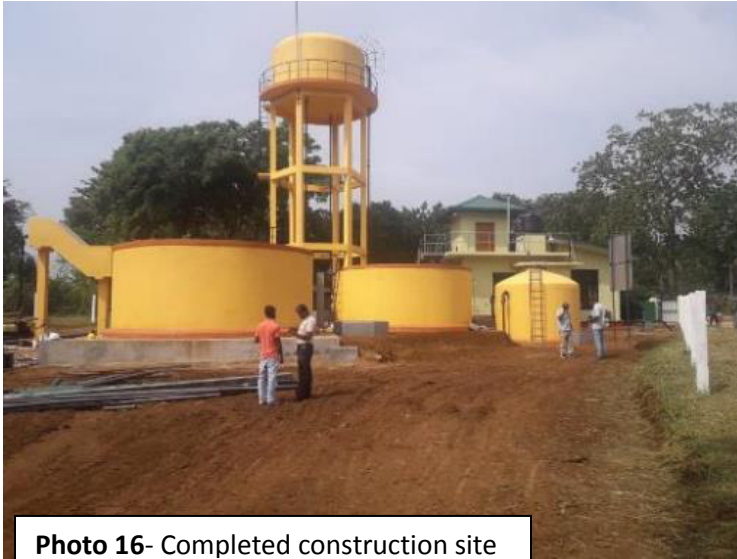
12) Water Supply Scheme for Rideemaliyadda - (Part 1 - Kuralewela Water Supply Subproject-UVA-AF-WS-CKD-16.

Photo 16- Completed construction site

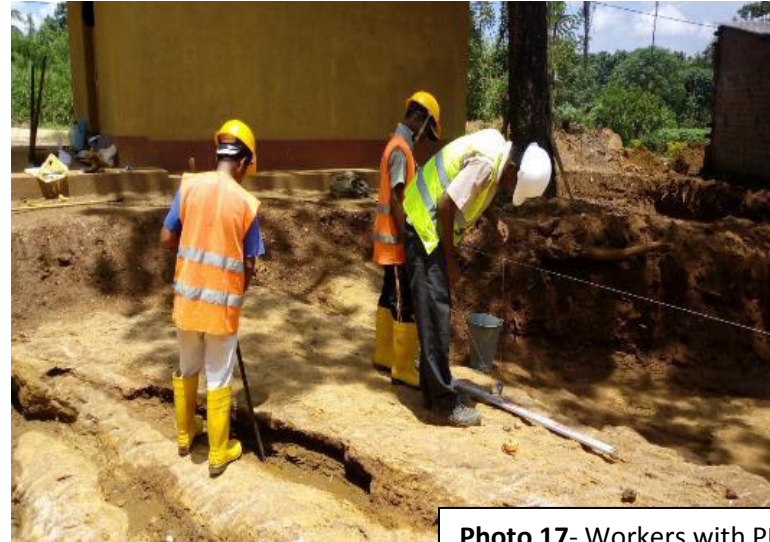
Photo 17- Workers with PPEs.

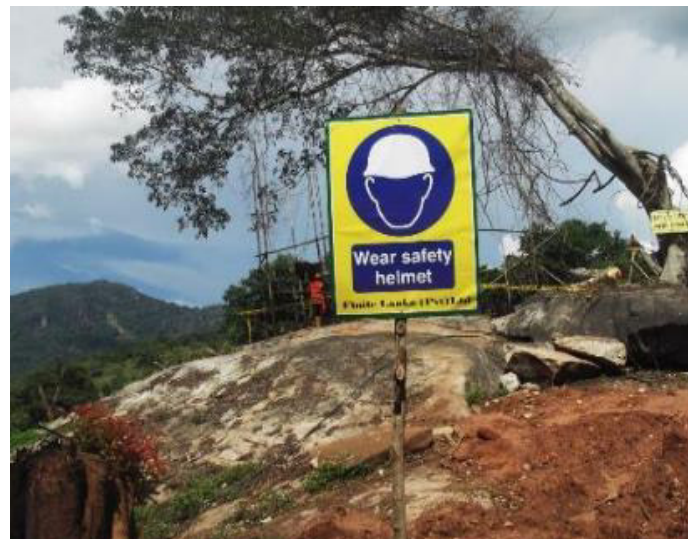
Photo 18 – Safety sign board.

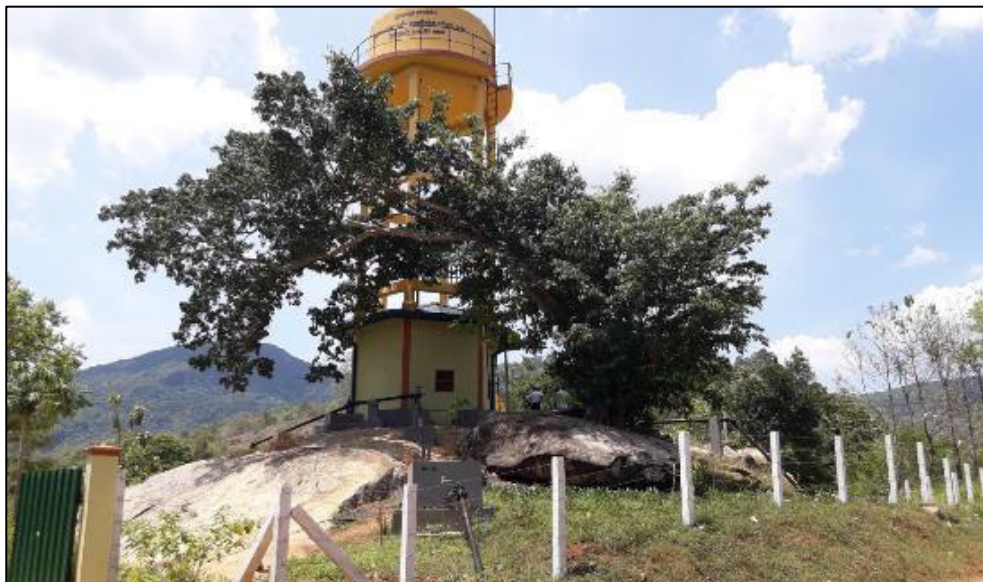
13- Water Supply Scheme for Rideemaliyadda (Part 2 - Ekiriuankumbura Water Supply Subproject)-UVA-AF-WS-CKD-16

control soil erosion, plant more trees in the project area and the neighborhood .	ii)Area planted with trees					Photo 19- A Large tree saved.
13.G)Damages to natural drainage pattern.	No impact for drainage flow as drainage flows down along roads and surrounding areas.	Undisturbed drainage flows.	Physical Observation	Not required	-	Project area.	Natural drainage not disturbed by construction work.
13.H)Waste generated .	The solid wastes generated need to be removed to appropriate disposal yards.	The solid wastes generated need to be removed to appropriate disposal yards.	i) Waste free site. ii)Disposal of waste into the approved site.	Fully completed.	-	Project site/ Disposal site.	Solid waste issue was resolved during this period.

Photo 19 – Construction done without removing a Large tree .
