Environmental Monitoring Report

Project No. 42466-017
Semi-annual Report (July-December 2021)
January 2022

Bangladesh: Skills for Employment Investment Program - Tranche 3

Semi-annual Environmental Monitoring Report (July to December 2021)

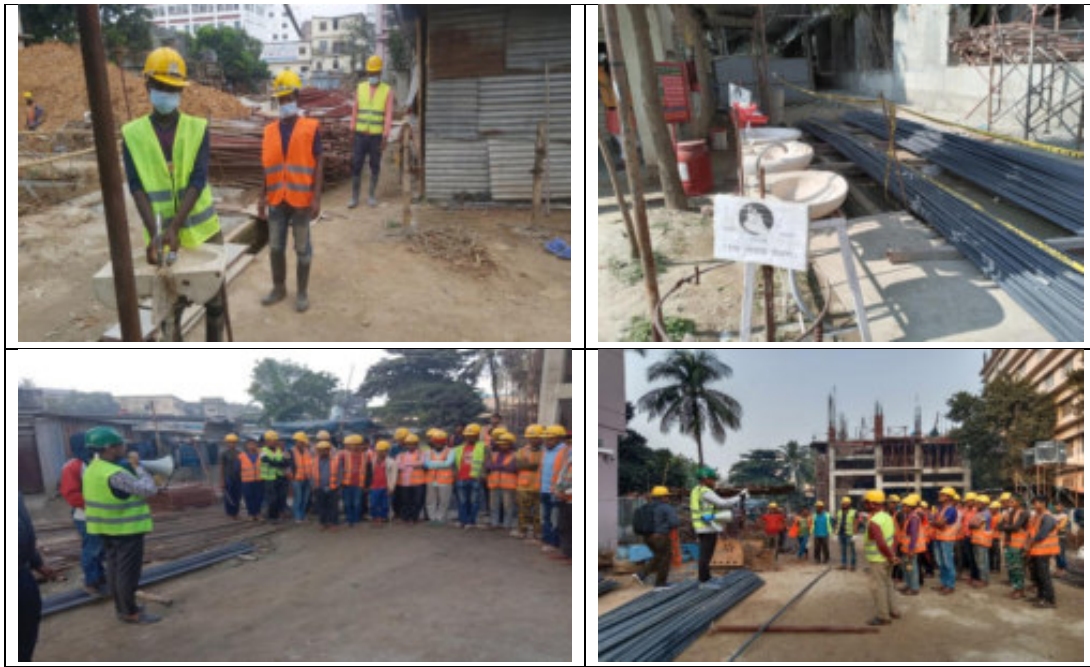
Figure 2: COVID-19 Precaution measures taken in BITAC site

~~34.~~ In order to protect workers form COVID-19 pandemic situation, musk and hand sanitizer is provided in the site for workers and labors for further abatement of COVID-19 virus. The workers keep safe distance between themselves when work in group.

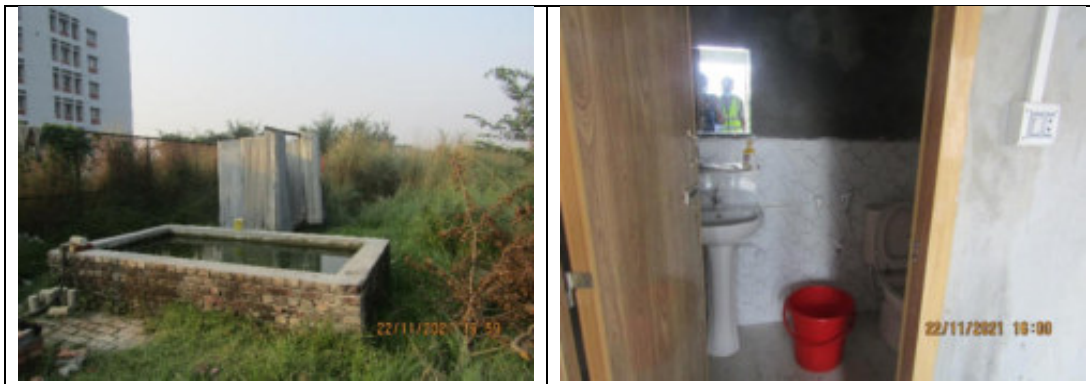
Figure 3 : Sanitation and hygiene status in the BACI site

42. Several sanitation facilities are developed in the subproject site both for labors and engineers for maintain proper sanitation in the area. Available water supply and handwashing facilities are also added to maintain hygiene. Regular cleaning and maintenance are done through responsible authority.

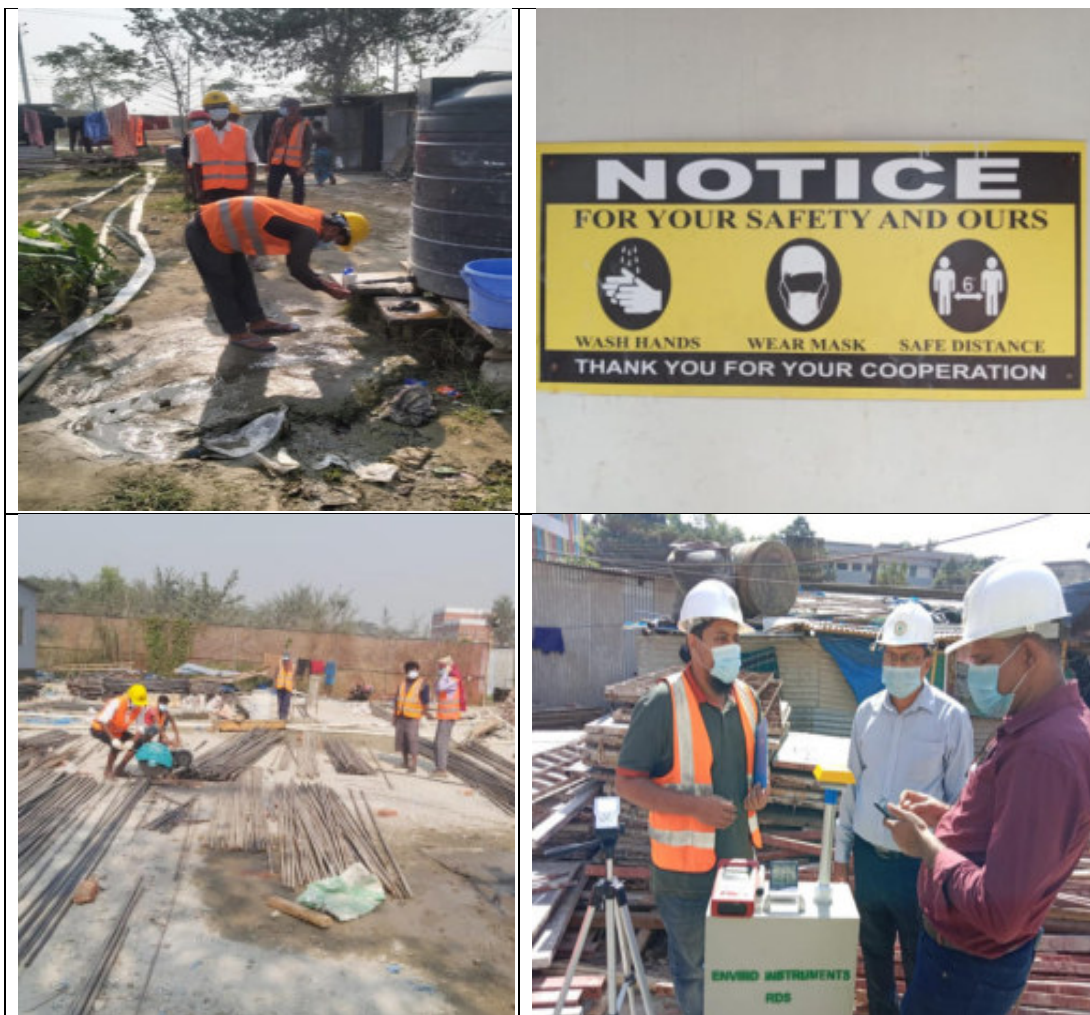
Figure 4: COVID-19 Precautions Measures taken in BACI site

45. Mask, sanitizer and hand gloves are provided to the workers in order to minimize spread of COVID-19 pandemic. Beside every one of the working site is in process to be vaccinated as soon as possible.

Two labour sheds have been constructed at BACI site. Piling work is continuing. A toilet has been constructed at the north-east corner of the site. Water extracting by submergible pump and storing into the GAZI tank. The water is using for both domestic and drinking purpose. Construction materials of the shed are moderate. Labours from BACI was participated in the Occupational Health Safety and COVID-19 safety practice orientation session which was organized by SEIP.
