Environmental and Social Monitoring Report

January - June, 2015

Kiribati: South Tarawa Sanitation Improvement Sector Project

Semi Annual Safeguards Monitoring Report
Period: January to June 2015

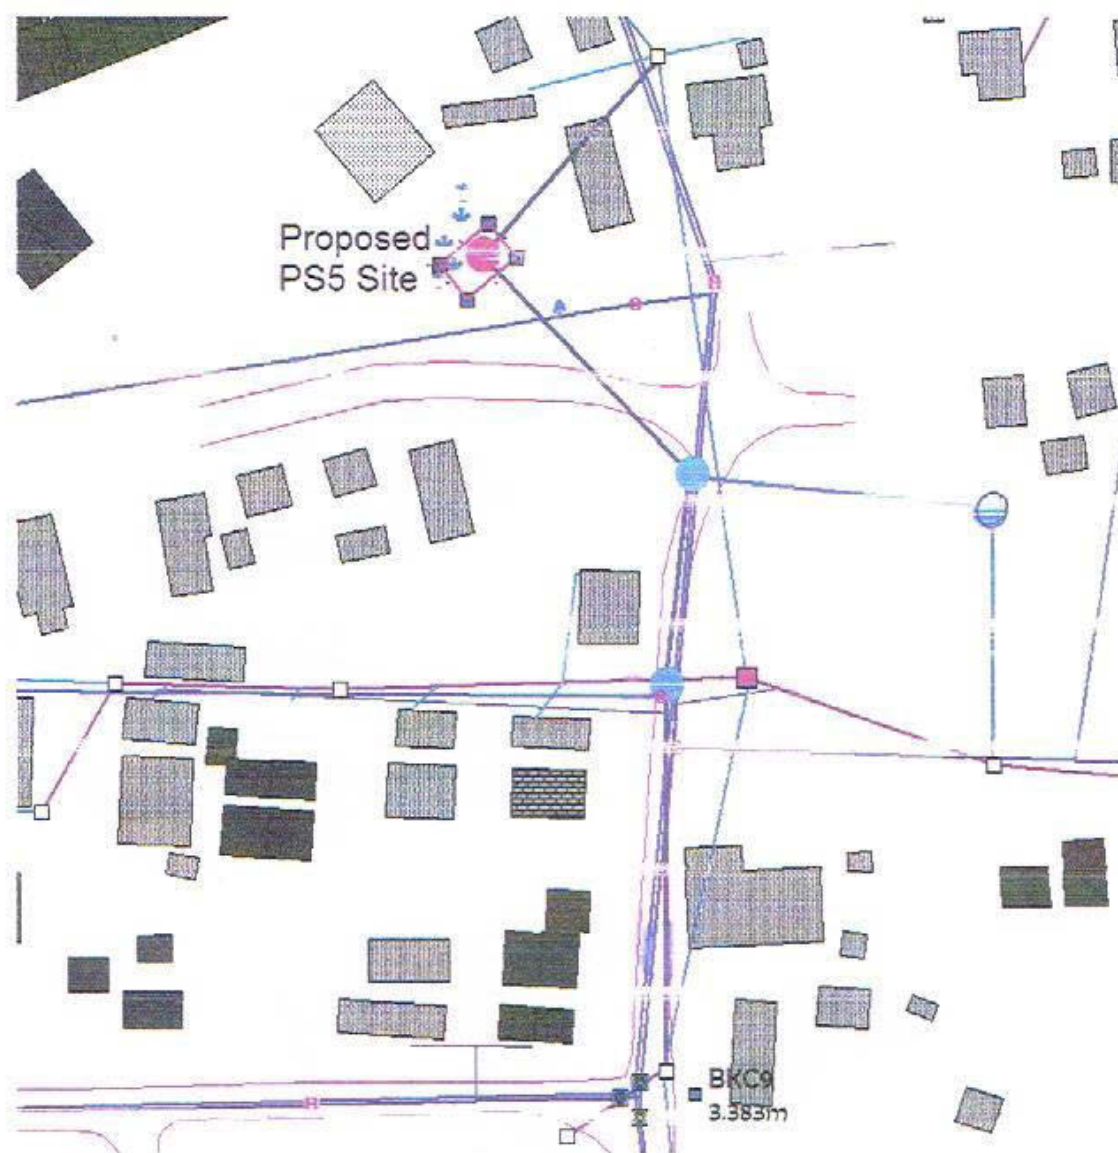
New Site for PS5 - Bikenibeu

The reconnaissance survey and positioning of the new site was conducted by Surveyors from MELAD on 8 – 9 November 2014 while the transferring of height to BKC9 (see map above) from a known reference point was conducted on 16 November 2014. The height of BKC9 is 3.383 m.

The Consultant has issued a recommendation to the GoK to halt further consideration of the original (and now occupied) site proposed for PS5 in favour of a site adjacent to that of the current pump station. The landowner of the current PS5 site wants the facility moved off his land but would consider compensation if it were to remain. The discussions with the landowner date back to 2011 – this issue must be resolved quickly to prevent delay. Use of a new site will have relocate all infrastructure except for one buried pipe out of the landowner’s property. The proposed site understood to be Government owned. The Consultant is awaiting advice from the GoK on whether the proposed parcel for is acceptable.
