Bride Replacement for Improved Rural Access Sector Project

Package 1: Hiritano and Magi Highway

ENVIRONMENTAL SAFEGUARDS MONITORING REPORT

(July to December 2017)

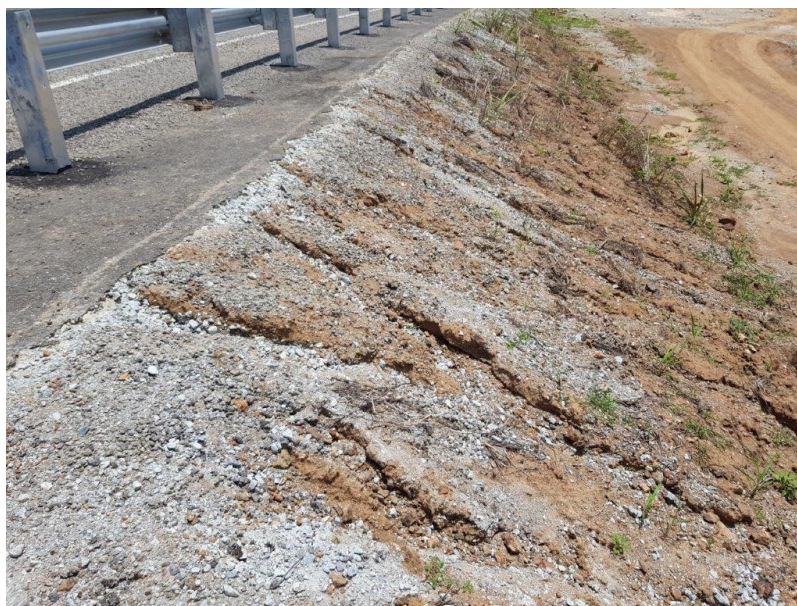
Photo 1: Rill Erosion On Fill Slope in Laloki

29. The soil erosion from sites and its sedimentation in rivers reported in the previous EMR has been naturally stabilised. There was some minor soil erosion in Laloki site. Apart from this, there are no more critical issues with regard to soil erosion and sedimentation. Re-vegetation of slopes and cut surfaces has been undertaken but the growth of grass cover is poor. Although Doguna and Kokebagu Rivers have no water flow during most parts of the year, sedimentation brought about by adjacent cut and fill sites is found to be high. Performance of re-vegetation, soil erosion and sedimentation will be monitored by ESSU.

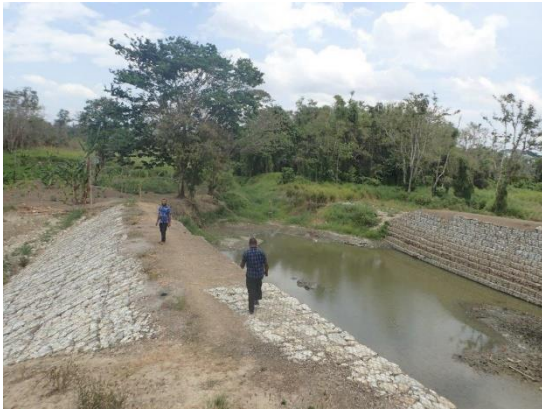
Photo 2: Kokebagu River Oct, 2017

30. The visual monitoring of water quality of Laloki river has been conducted and there has not been significant change. Laboratory analysis of river water has been found to be not important as the water quality deterioration is temporary and that there is no discharge of materials that will create permanent impact on river water. There were no complaints from the people living near rivers and other streams regarding the deterioration of water quality. The water quality in three rivers along Magi Highway is not an issue as water is available only during the rainy season. The Dogona river was completely dry whilst Kokebagu and Sivitatana only had stagnant water during the review period (Photos 2 and 3).

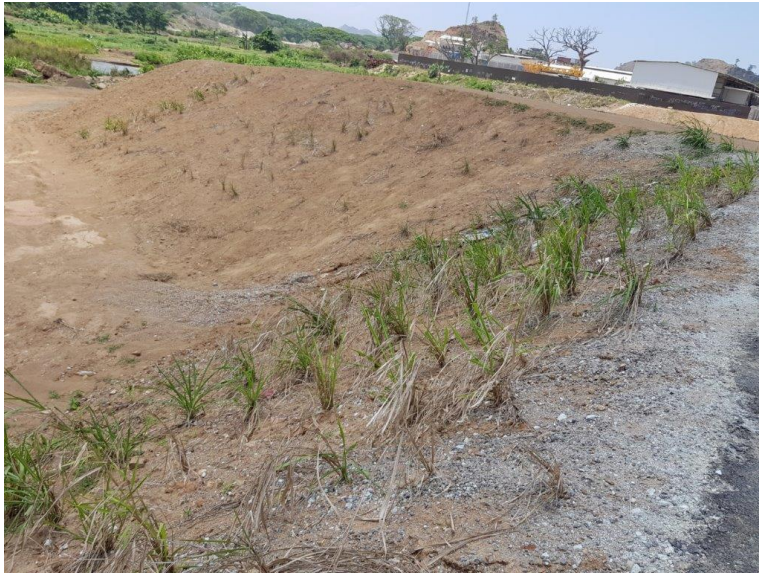
Photo 4: Turfing Work at Laloki Site

42. The trees removed in the past have not been followed up by a re-vegetation program. The contractor has completed turffing work on slopes where the progress is weak (Photo 4). This work will be monitored by ESSU.

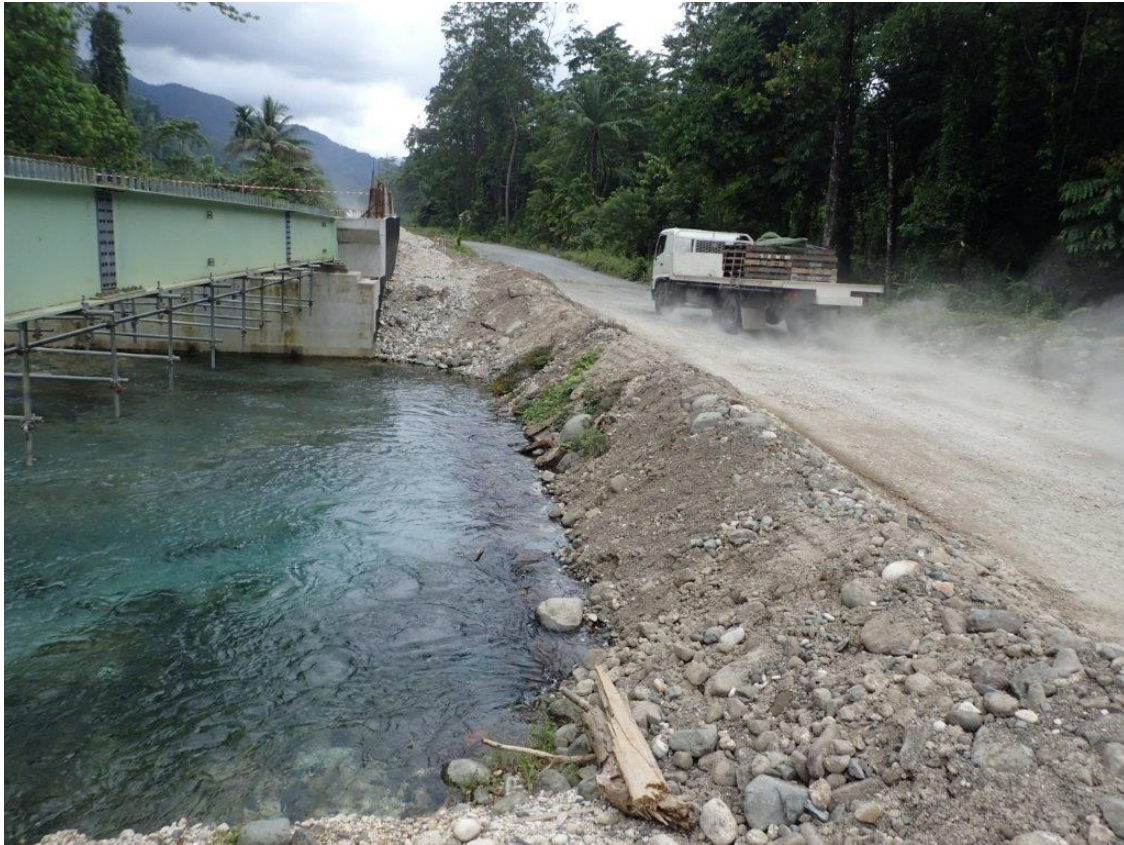
Photo 5: Dust Generation by Moving Vehicle Passing Bridge Site

71. There was no further impact on air quality as construction works did not proceed in the review period. However, evidence gathered on air-borne dust generated from moving vehicles of the general public (Photo 10).

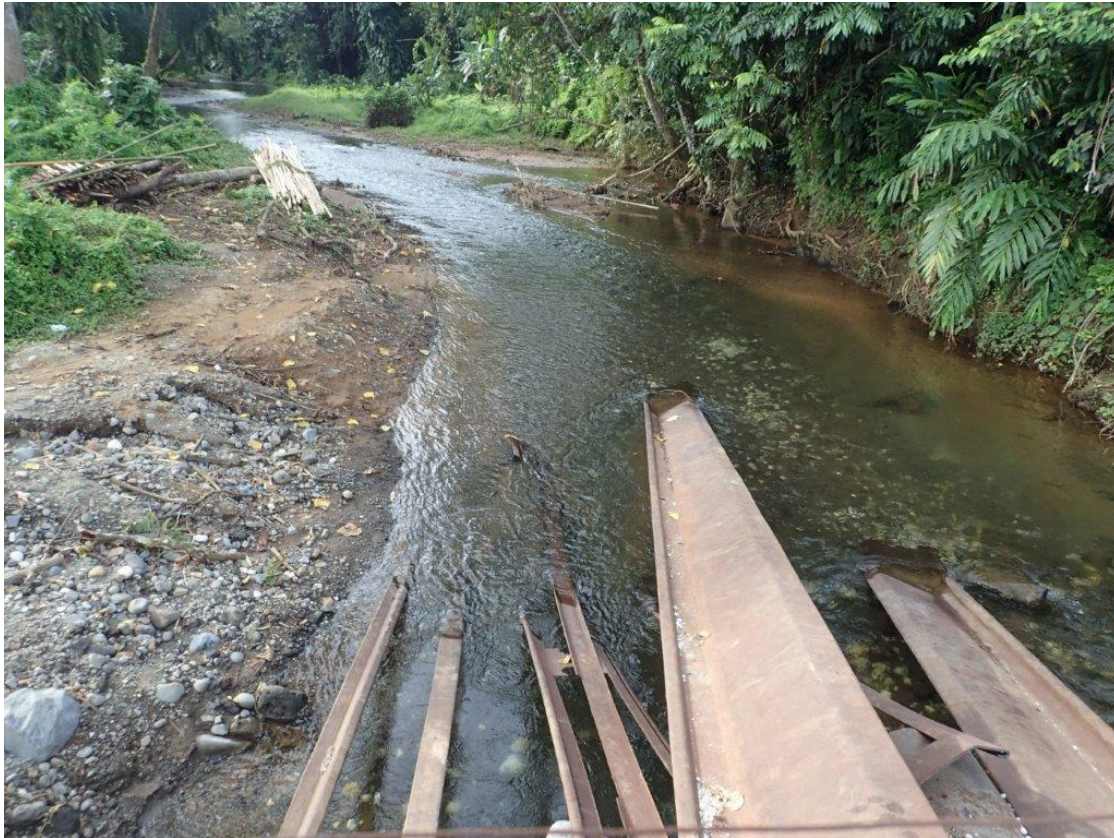
Photo 6: Work Site with Dismantled Iron Works on Site

74. The iron parts, old timber and other debris stayed on site during the previous period continued (photo 11). It is possible that stream water quality may be affected by the rusted escaped from iron bars.
