CAM: Provincial Roads Improvement Project

PROVINCIAL ROADS IMPROVEMENT PROJECT
ADB LOAN 2839-CAM (SF)/8254-CAM (SCF)

SEMI-ANNUAL ENVIRONMENTAL MONITORING REPORT

Covering Period from July to December 2015

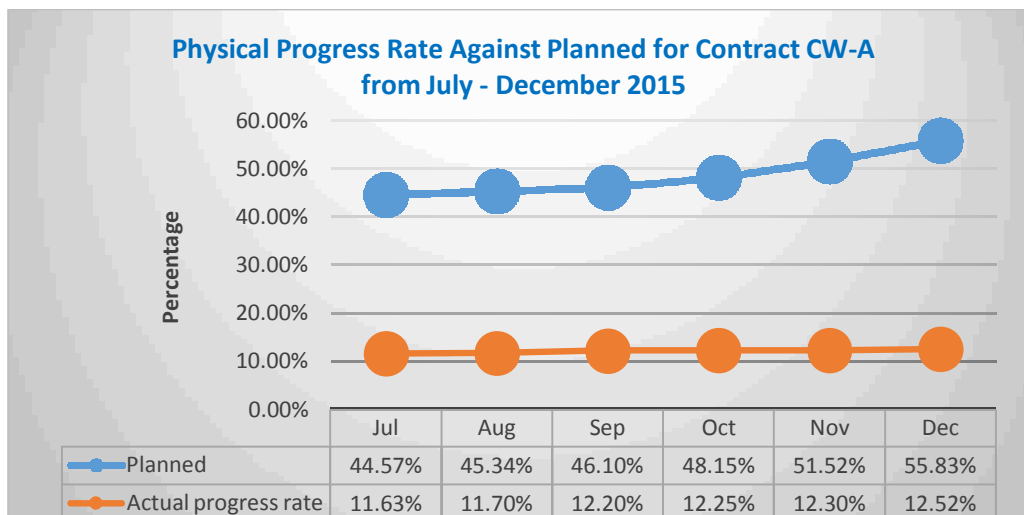
the time, most of road structures nearly completed. On the other hand, the Monthly Progress Report No.36, December 2015 shows that the work outputs for this subproject is on-going, however; the accumulated monthly progress by December 2015 was only 12.52% against the planned 55.83%. So -43.31% is behind of the scheduled. Detail of monthly progress rate of this contract (from July to December 2015) against planned are shown in the below figure.

Source: Monthly Progress Report No. 31 to 36 in July to December 2015 (KCI)

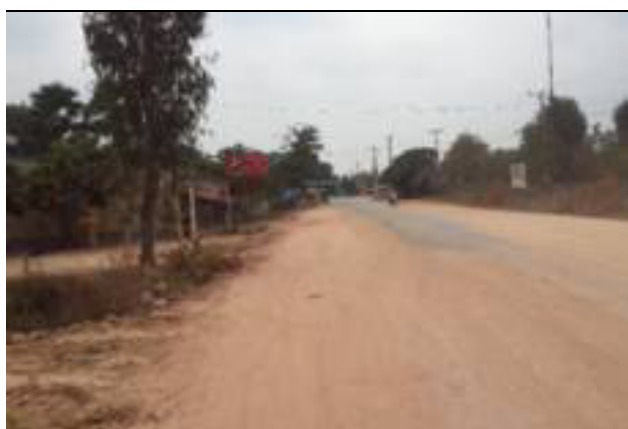
Figure 1: Embankment works at end point of NR13, date 20 January 2016

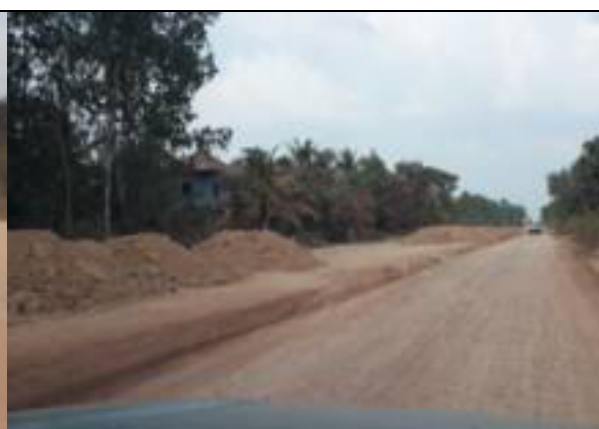
Figure 2: Embankment work activities at NR13, date 20 January 2016

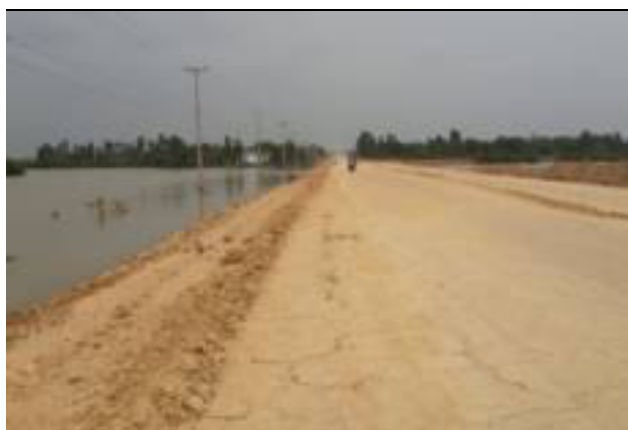
Figure 3: Embankment works at PK61+000, date 20 January 2016

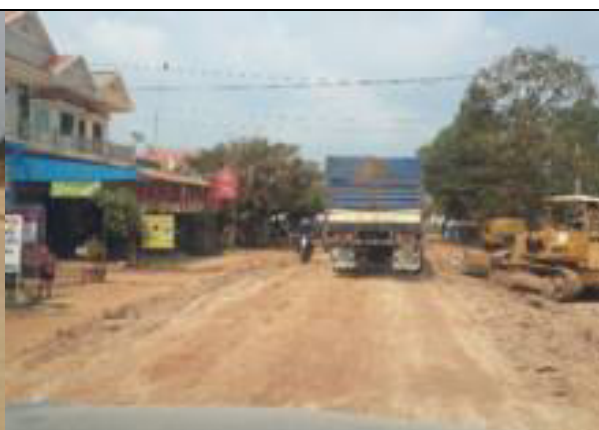
Figure 4: Activity of embankment works at NR13, date 20 January 2016

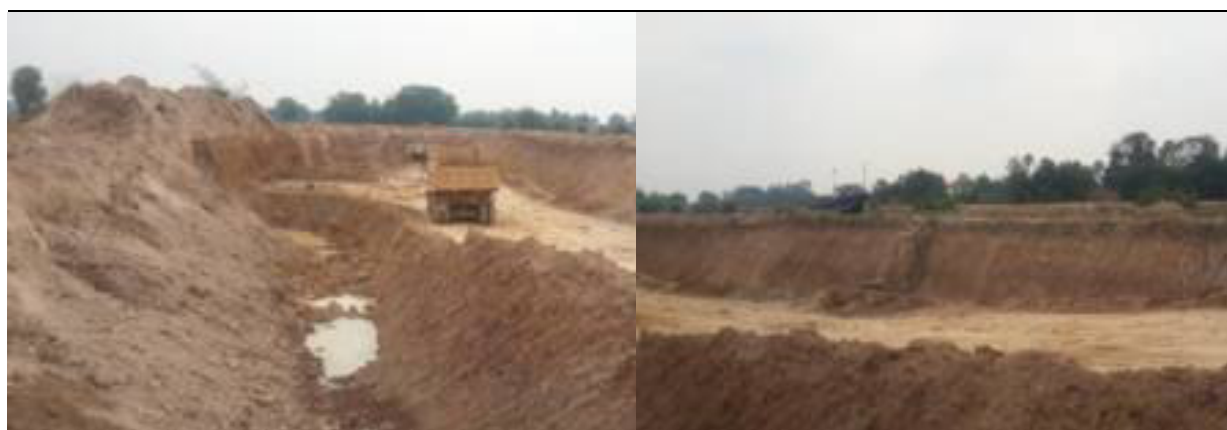
36. Borrow pits/quarries: By December 2015, there are 6 numbers of samples were tested for the cement stabilized sub-base mixing soil and 4 borrow pits have been approved. However, during site inspection, one borrow pit is selected to check environmental issues at PK 48+300 at RHS (attached field photos as below).

37. Based on the actual site indicates that the Contractor did not install a preventing fence/warning signs around the borrow pit as shown in photos below.

Figure 5: Borrow pit at PK48+300 (RHS), date 20 January 2016

Figure 6: Borrow pit at PK48+300 (RHS), date 20 January 2016

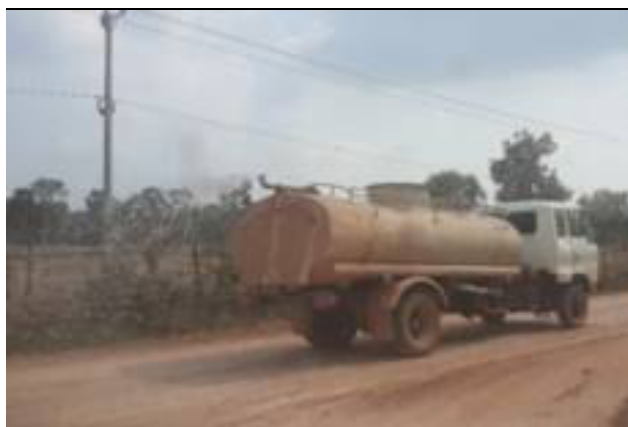
39. Dust generation: During embankment works, dust generation was observed. The Contractor's regular sprinkling of water is being done at least two times per day at that time (see in Figure 7 and Figure 8). However, the number of water spray truck is inadequate to effectively mitigate the heavy dust generation along the project road.

Figure 7: Regular sprinkling water was being done at NR13, date 20 January 2016

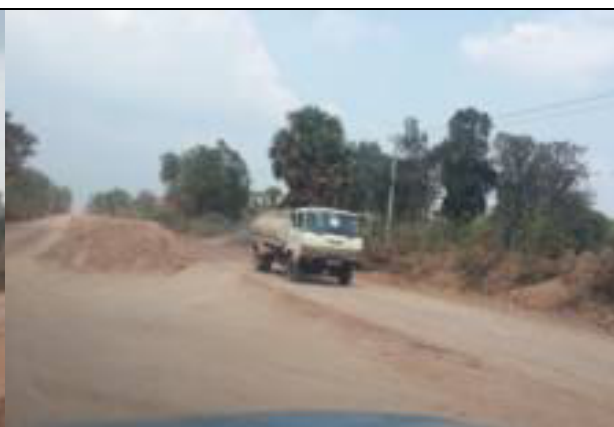
Figure 8: Regular sprinkling water was being done at NR13, date 20 January 2016

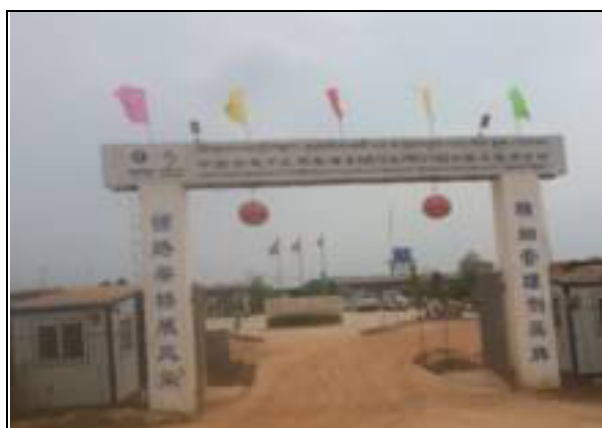
Figure 9: Good environment in/around the Contractor's site camp at PK58+400

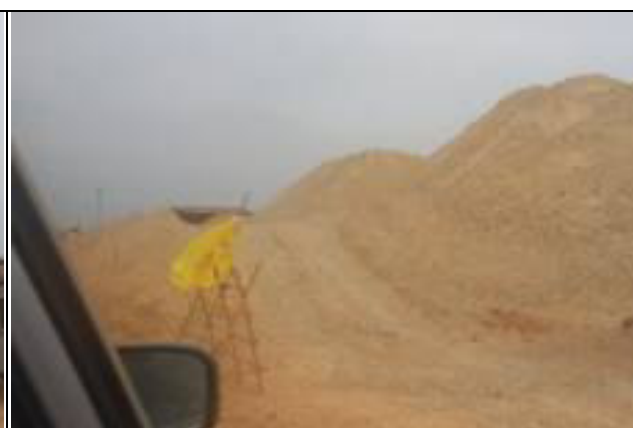
40. Waste management: The workshops and storage areas in Site Camp of the Contractor have been improved and equipped with garbage bin. The platform space of Contractor site camp is well cleaned. Most of the construction sites are well managed of solid waste as well as spoil soil. However, next to the site camp, there are stockpiled material of base course encroached the road shown in figure 10.

Figure 10: Material stockpile along the project road, 20 January 2016

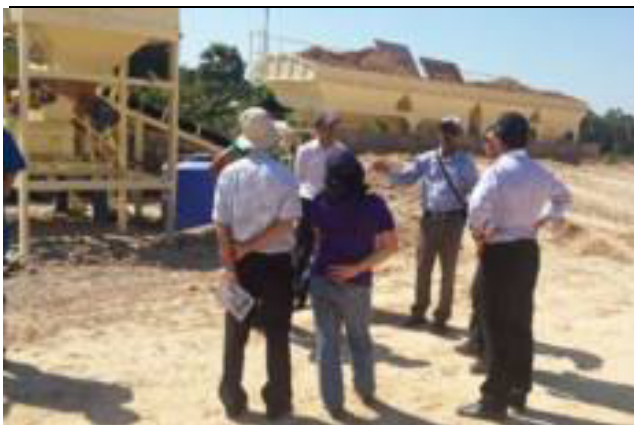
42. Safety: All the workshops and storage places have been equipped with extinguisher capacity of 4kg (at least 4 bottles). During the monitoring, an inappropriate location of batching plant along NR13 within a residential area without any approval and permission from DDIS consultant and Commune is observed as a non-compliance issue related to the EMP implementation.

Figure 11: Cement stabilization batching plant along NR13 at PK 55+400, 26 January 2016

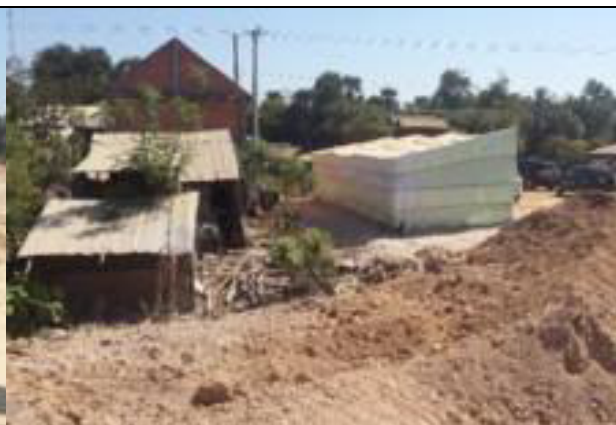
8. A major issue of concerning was observed during site inspection. Major issue is the inappropriate location of a cement stabilized batching plant along NR 13 at PK 55+400 within a residential area without any approval and permission from DDIS and commune. The DDIS consultant has addressed non-compliance issues related EMP implementation to the Contractor to take immediate action for reducing of the adverse environmental impacts in compliance with IEE and EMP. Responding to the environmental issue, the Contractor has actively organized equipment and personnel to correct non-compliance issue. However, proper remedy action is not shown during the monitoring.

Figure 12: Cement stabilization batching plant without fence along NR13 at PK 55+400, 26 January 2016

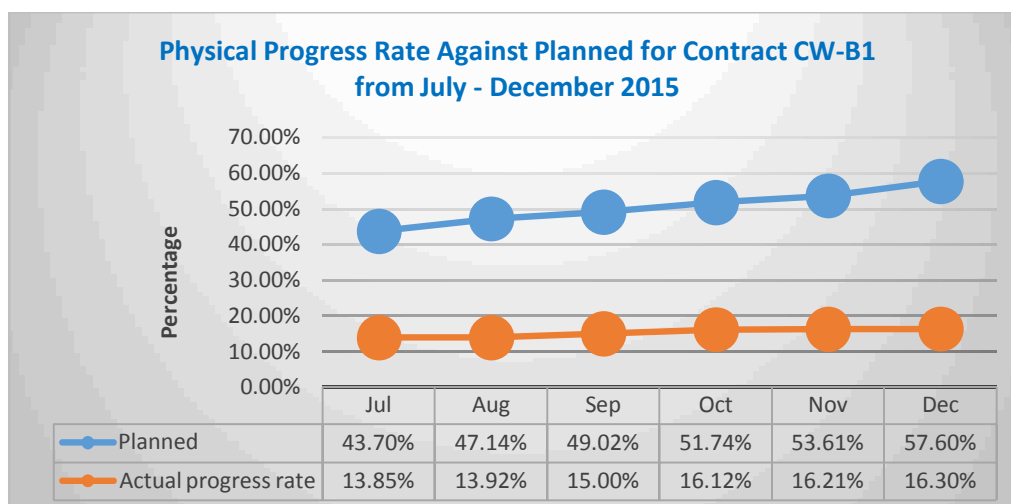
45. Basically, accumulated monthly progress of the contract CW-B1 in this month is 16.3% against planned 57.6%, therefore -41.3% delayed of the planned. The Contractor is requested to update construction plan. Detail of monthly progress rate of this contract (from July to December 2015) against planned are shown in the below figure.

Source: Monthly Progress Report No. 31 to 36 in July to December 2015 (KCI)

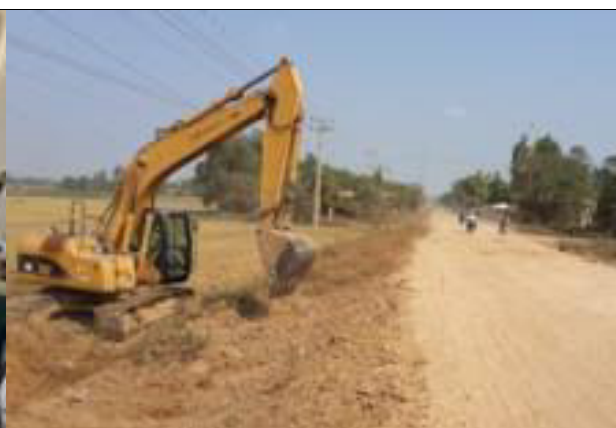
Figure 14: Earth work activities at NR314D for PK 15+500 to 20+000, date 20 Jan 16

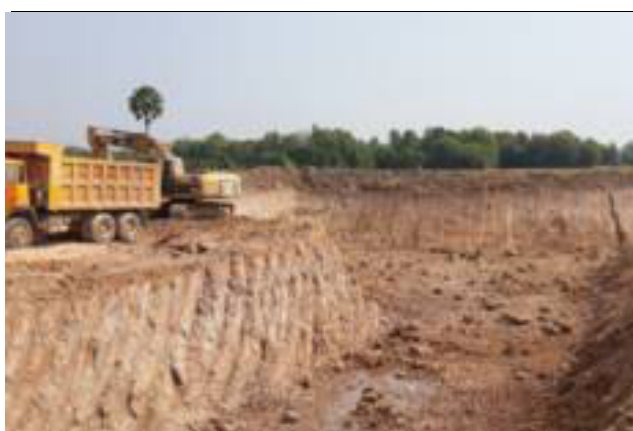
46. For this subproject, a total of 47 numbers borrow pits samples were tested for the embankment material and 27 borrow pits have been approved. 2 numbers of quarry samples were tested for the base course material and 1 quarry has been approved. During the site inspection of CW-B1, one borrow pit were selected by random for conducting checklist related to the EMP implementation. Contractor did not install a preventing fence/warning signs around the borrow pit as shown in photos below.

Figure 15: Borrow pit at PK17+000 (LHS), date 20 January 2016

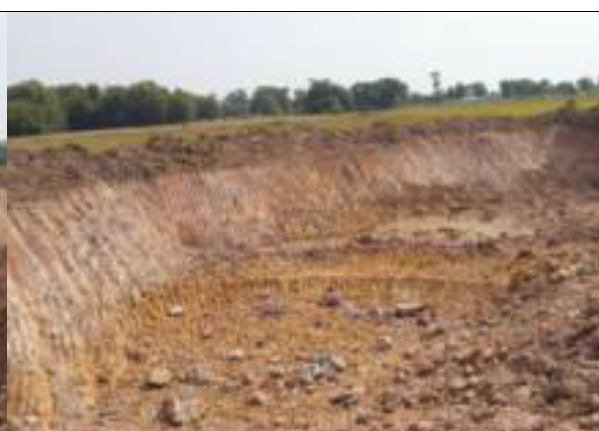
Figure 16: Borrow pit at PK17+000 (LHS), date 20 January 2016

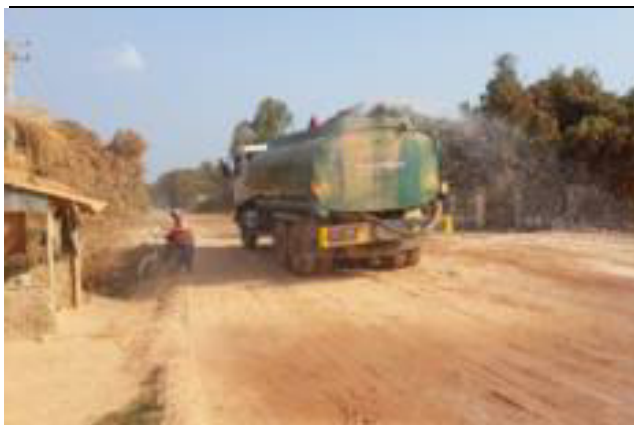
48. Dust management: The embankment work for CW-B1 is in progress, therefore the heavy dust generation was observed. During the site inspection, the Contractor try to do regular sprinkling of water at least two times per day, however; the number of water spray truck is inadequate to effectively mitigate the heavy dust generation along the project road (see in Figure 17 and Figure 18).

Figure 17: Regular sprinkling water was done at PR314D, date 20 Jan 2016

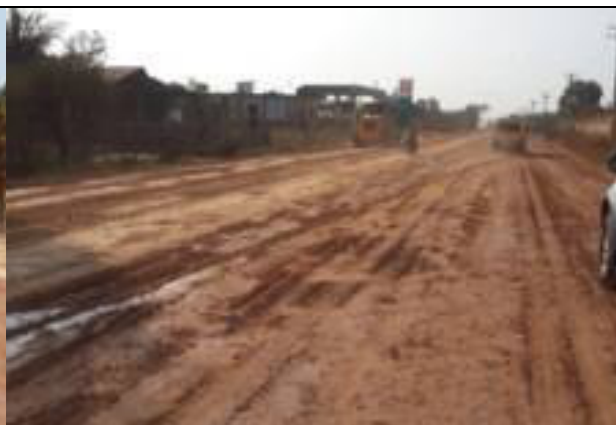
Figure 18: Road after sprinkling water was done at PR314D, date 20 Jan 2016

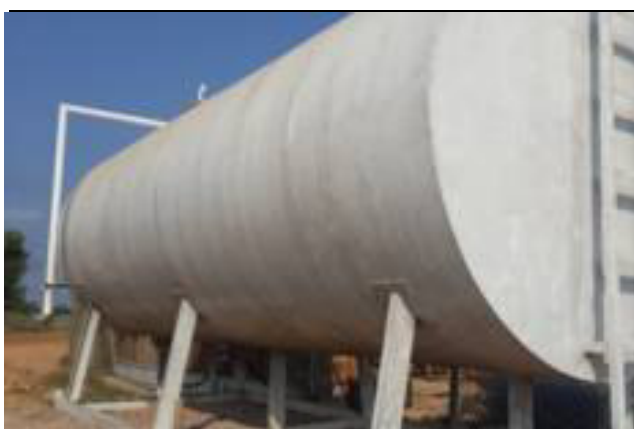
Figure 19: Fuel Storage facilities is under construction for CW-B1, date 20 January 2016

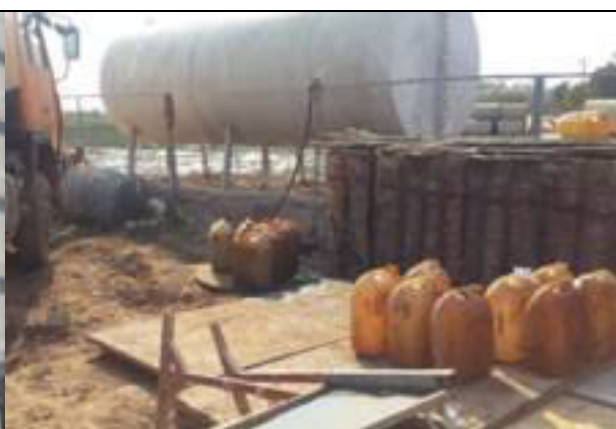
Figure 20: Temporary fuel storage facilities at PR314D, date 20 January 2016

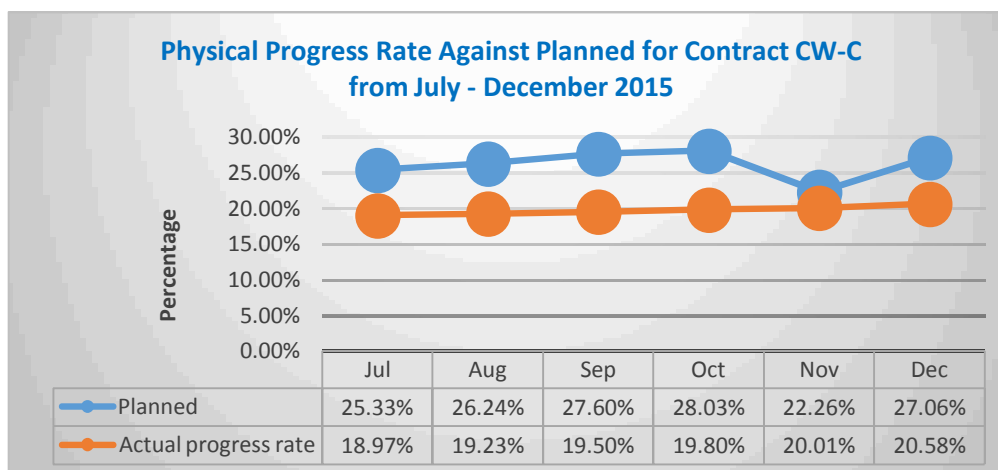
54. Based on the actual site inspection and reviewing of monthly progress report, it is indicated that the contract is slow progress at a progress rate of 20.58% against updated plan of 27.06% (the plan has been updated on November 2015). Detail of monthly progress rate of this contract (from July to December 2015) against planned are shown in the below figure.

Source: Monthly Progress Report No. 31 to 36 in July to December 2015 (KCI)

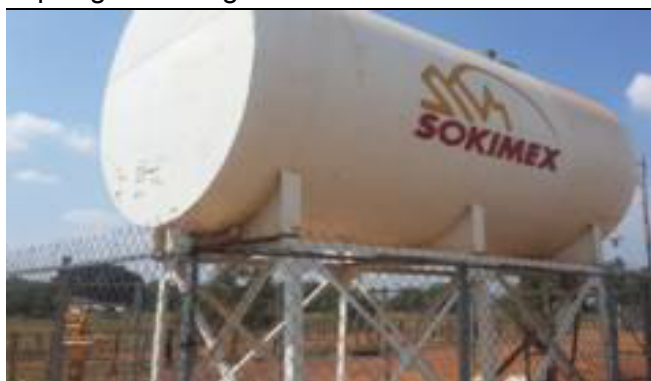
10. ABD has approved the Loan No.2839-CAM (SF)/8254-CAM (SCF) on 16 December 2011 and Grant 0278-CAM for Improvement of Provincial Roads at the southeastern and mid-west provinces in Cambodia as requested by the Government of Cambodia. This project is the most important project of the Royal Government of Cambodia to improve quality of people's life through improvement of roads and other infrastructures as it provides all-year access to provincial and rural agricultural communities of Prey Veng and Svay Rieng provinces of southeastern Cambodia, and Kampong Chhnang and Kampong Speu province in the mid-west of Cambodia.

Figure 21: Fuel storage facilities are good condition at the main contractor's site camp

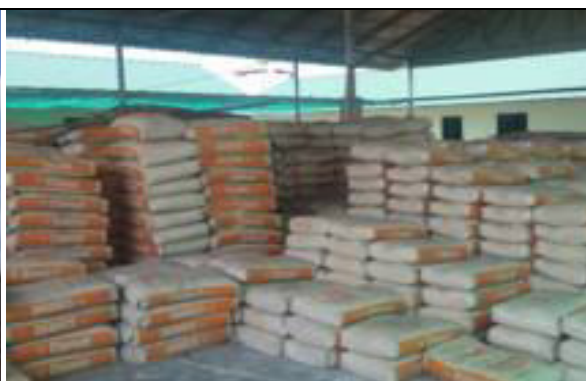
Figure 22: Properly Material storage in the workshop at the main contractor's site camp

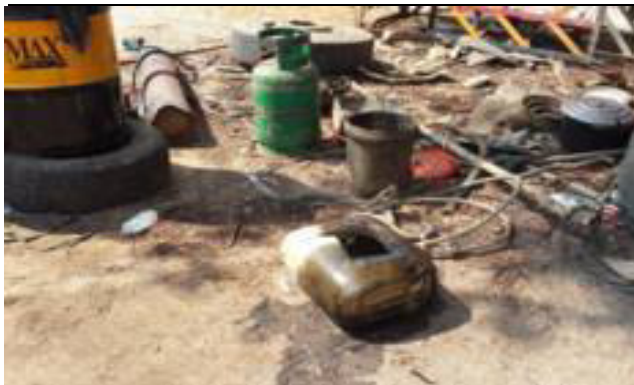
57. Leaks and spills of hazardous material (sub-contractor): Improper oil/fuel container storage or change engine oil was carried out inappropriately, and this place is also closed to the primary school (Andong Tramoung primary school) at PK 8+200 of PR150BW (figure 23 & 24). The contractor should have provided a suitable tank, including built concrete platform, wall, and security equipment and fence around the fuel storage. At the workshops and storage area, it was observed that (i) improper oil/fuel drum storage, (ii) insufficient housekeeping.

Figure 23: Improper oil/fuel drum storage for PR150BW, at PK8+200, on 19 January 2016

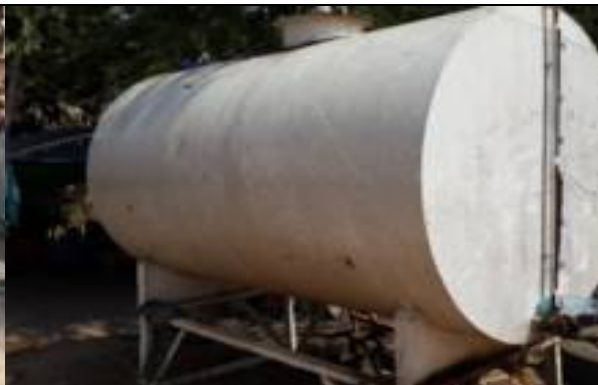
Figure 24: Improper oil/fuel drum storage for PR150BW, at PK8+200, on 19 January 2016

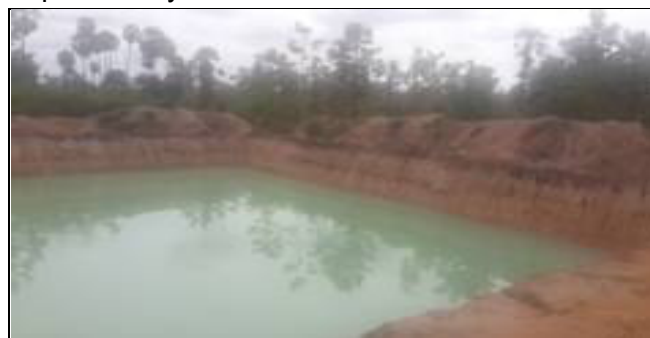
60. Interviewing with borrow pits' owner indicates that some borrow pits be utilized for aquaculture or developed as water reservoir for community use, however; most of the borrow pits did not install the prevention fence/warning sign to prevent any accidents may be accused. The Contractor will responsible for rehabilitating any borrow sites opened and operated by them.

Figure 25: Borrow pit was requested by owner to fish raising purposed at PK6+300

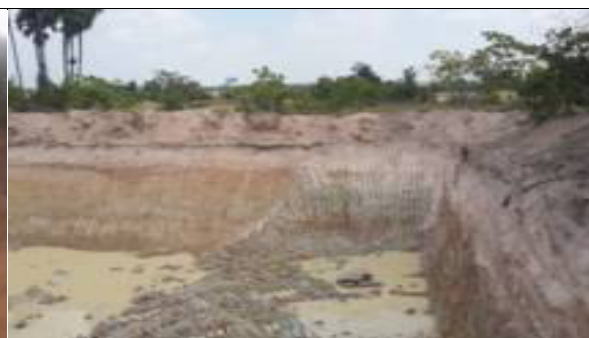
Figure 26: Borrow pits for PR150BW is not yet improved or re-fenced at PK14+500

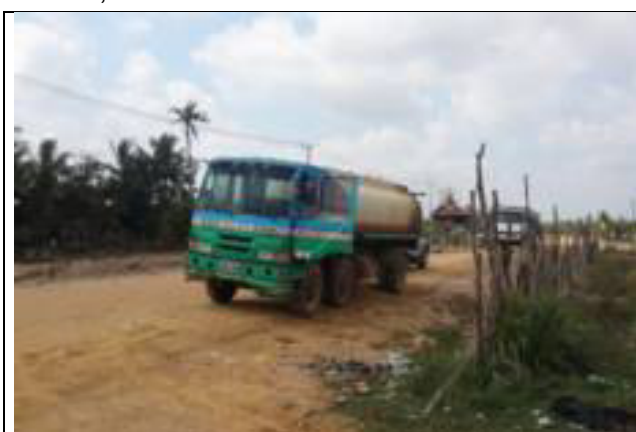
62. Air pollution: Project is a provincial road improvement where not much air pollution to be caused serious adverse impact to community except dust impact. Dust generation was observed along the project road during site inspection, while water spray trucks are standby on the road, due to some of water sources in this area are being insufficient. Those water sources are kept for local people uses during the dry season only. So, the Local Authorities did not allow pumping those water sources. Therefore, the Contractor should be taken action to solve this issue by finding other water sources for water sprinkling at least 2 times per day. Water spraying should be focused on populated areas and sensitive locations such as school zones, residential areas and health care centers.

Figure 27: Water spray truck is being stand by along the PR150B-W

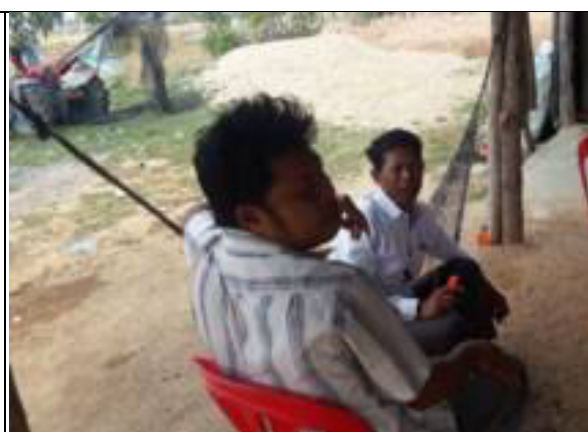
Figure 28: Interviewing with water spray truck 's driver at PR150B-W

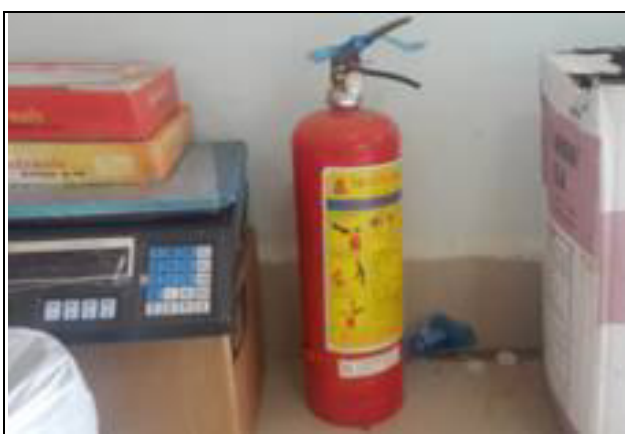
63. Safety: All the workshops and storage places have been equipped with extinguisher capacity of 8kg (at least 2 bottles). And first aid kits were equipped in the site camp as well.

Figure 29: Extinguisher were equipped at the contractor's site camp, date 19 January 2016

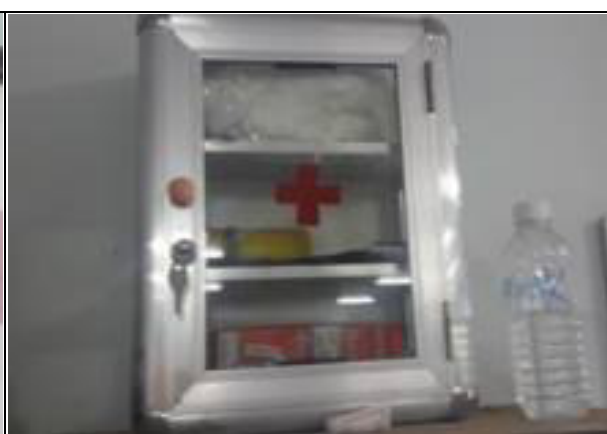
Figure 30: First aid kits were equipped at the contractor's site camp, date 19 January 2016

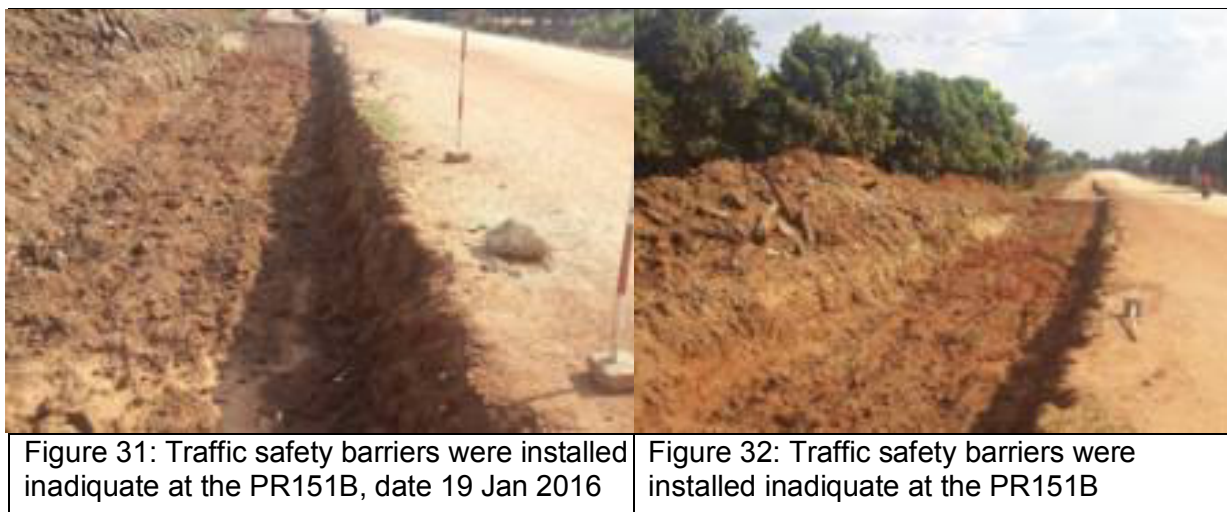
66. Clearing and grubbing is ongoing along the PR151B and PR150B-E, however, warning signs and traffic safety barriers are not installed sufficiently. (See in Figure 31 and Figure 32).
