Environmental Monitoring Report

Semi-Annual Report (July to December 2016)
January 2017

CAMBODIA: Provincial Roads Improvement Project

Detailed Design and Implementation Supervision (DDIS) Consulting Services

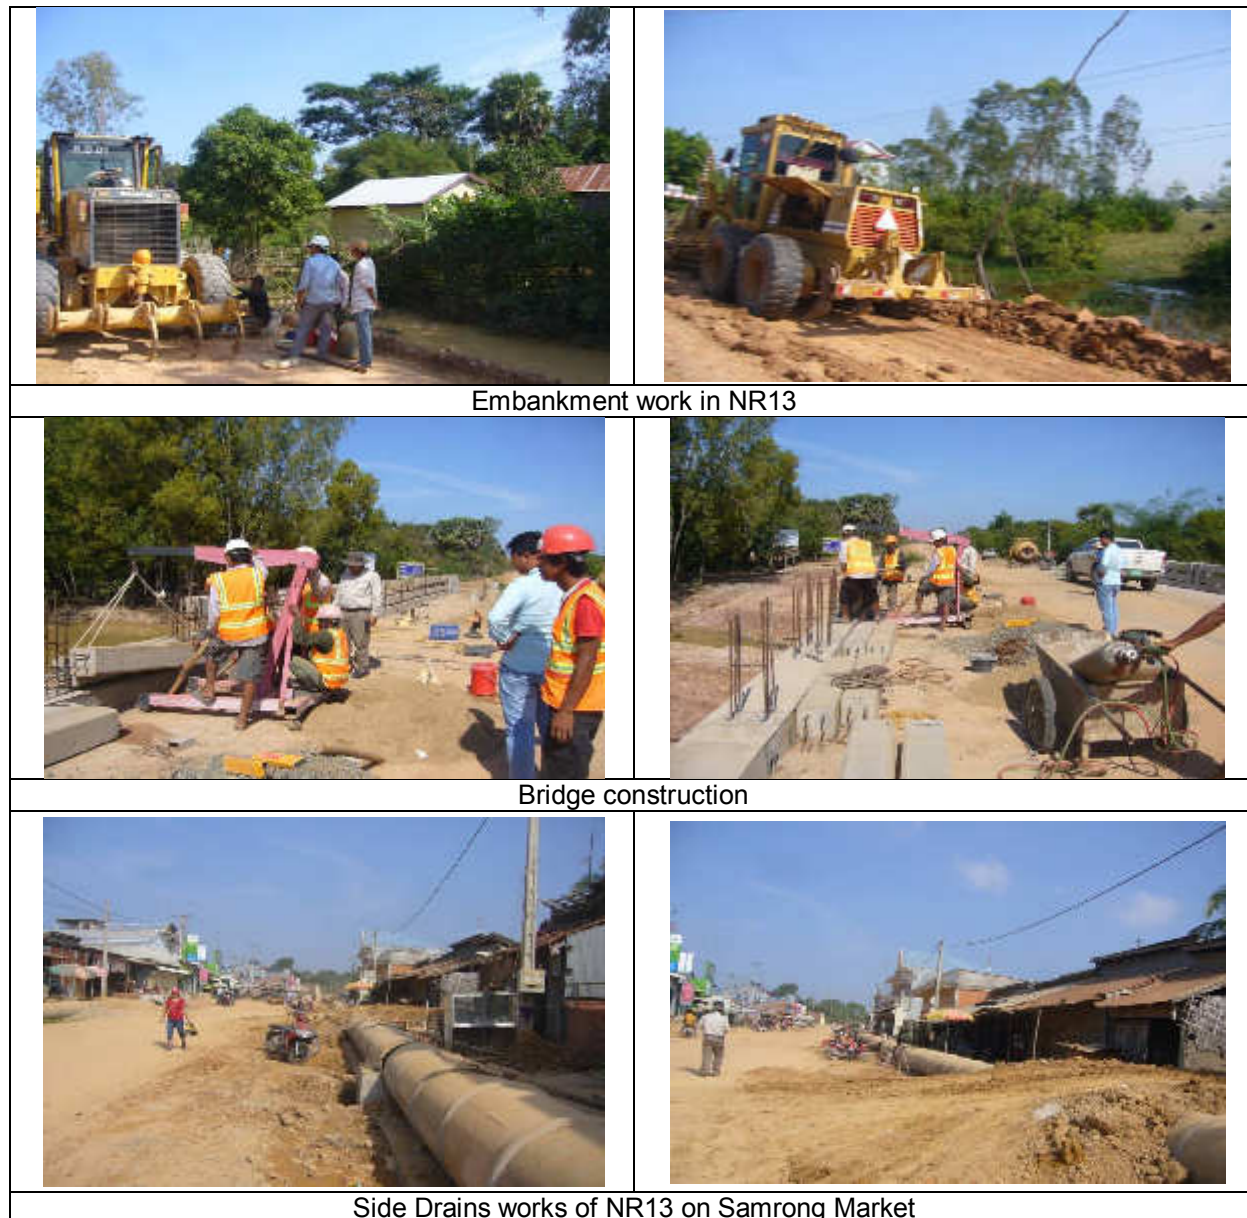
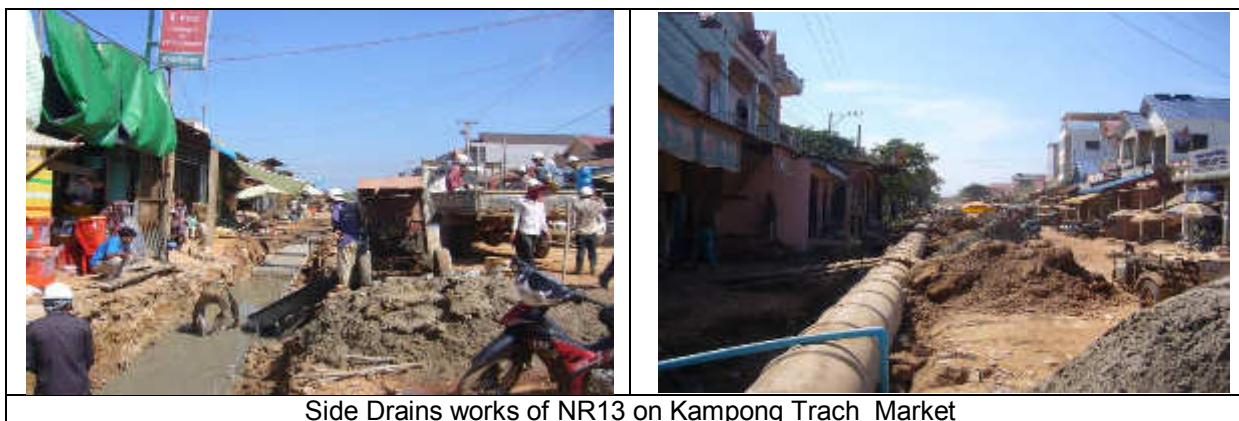
Pictures of Project Work Activities (CW-A)

42. In December 2016, the rain just finished and the construction of NR13 was started for some activities such as: (i) Earthworks (embankment), (ii) Drainage works, (iii) the bridges construction for BR-01. During rainy season the embankment and sub-base work had been suspended and other construction activities were restricted.

Side Drains works of NR13 on Kampong Trach Market

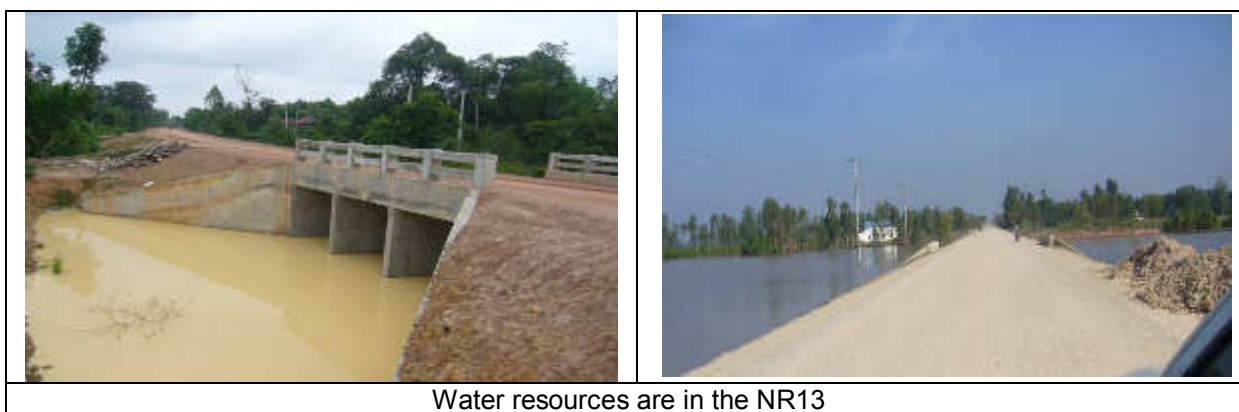
Water resources are in the NR13

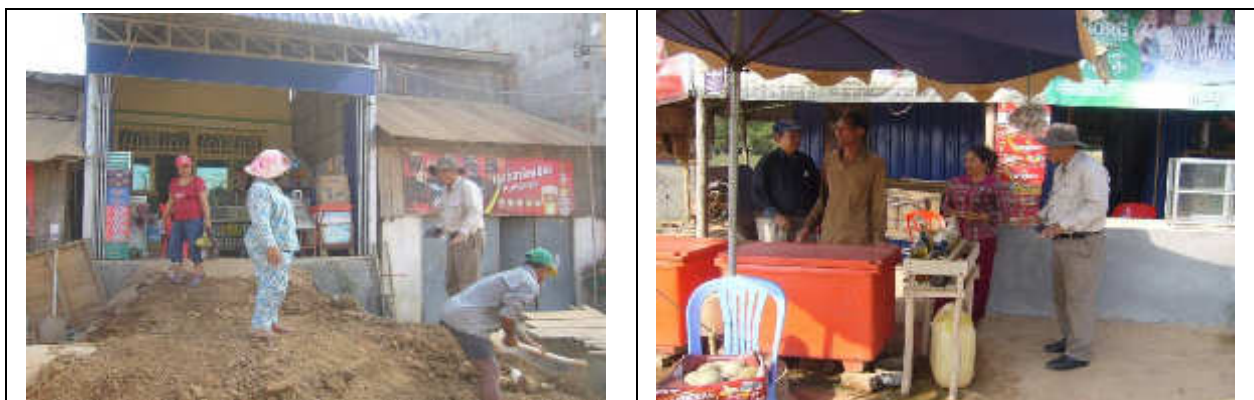
Solid waste in Sinohydro site camp	Consultation with camp cleaner

Consultation with Manager

Consultation with affected communities

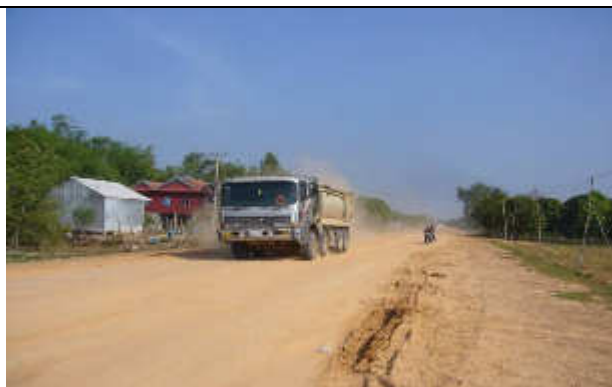
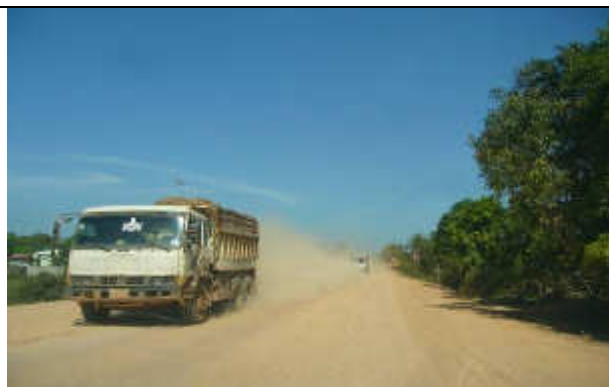
49. **Dust generation:** During the monitoring of embankment works, dust generation was observed. The Contractor's regular sprinkling of water is being done at least two times per day at minimum. However, the number of water spray truck is inadequate to effectively mitigate the heavy dust generation along the project road after reduced raining. During discussion with local communities they are concerned about dust pollution and delayed construction time because it will be significant impact on local businesses during construction works on market areas. During the monitoring, an inappropriate location of batching plant along NR13 within a residential area had been demobilized, and under installation at new isolated area from the resident.

Dust generation on NR13

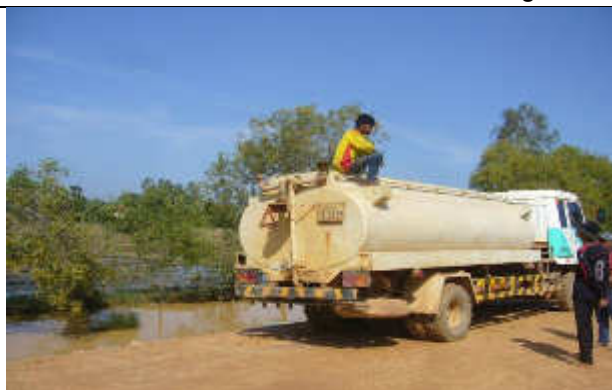
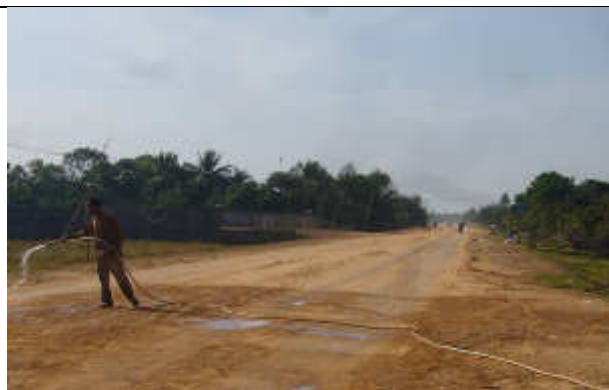
Watering truck

Local watering (supplement)

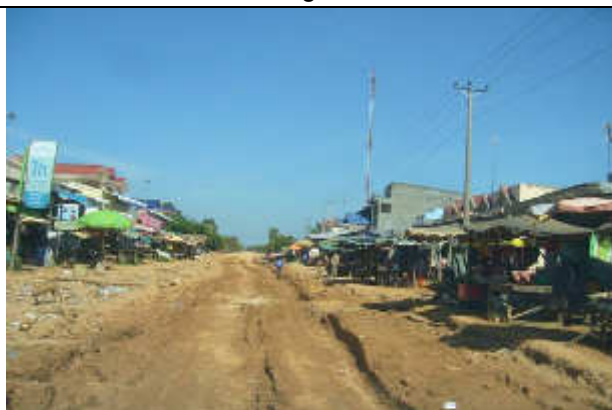
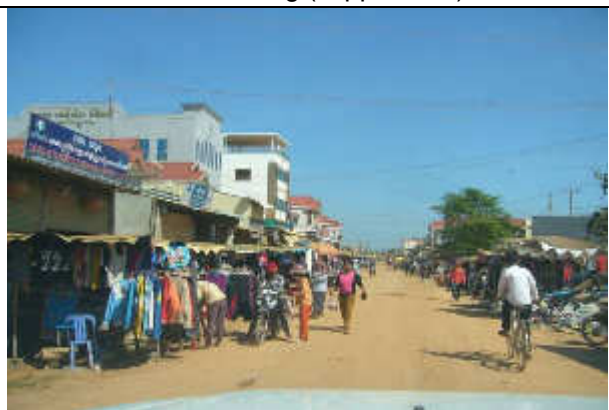
Local business activities on the NR13

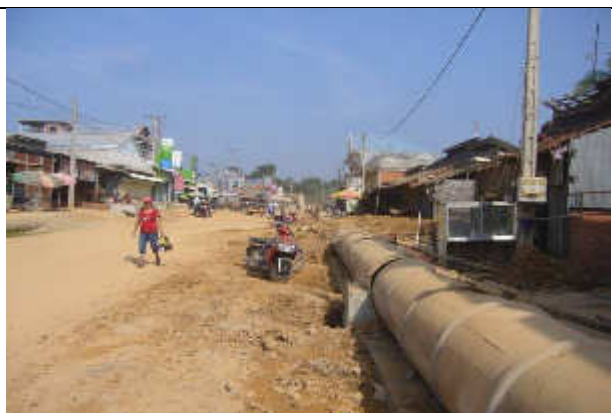
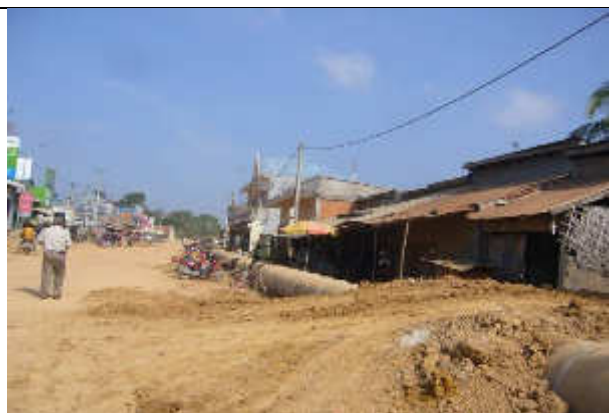
Local business activities on the NR13

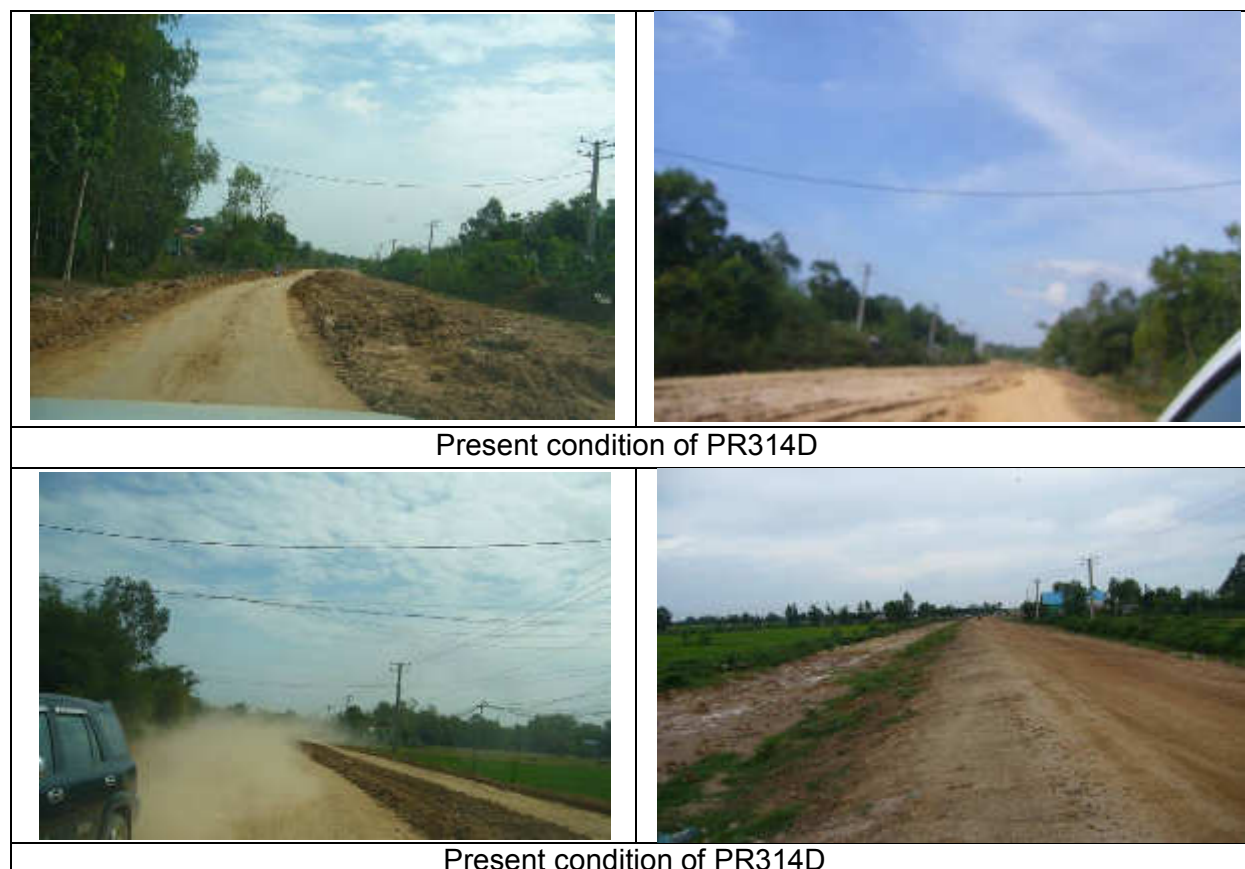
Pictures of Project Work Activities (CW-B1)

53. Related the EMP implementation, Environmental monitoring of this subproject (CW-B1) were inspected on 23-24 December, 2016. The progress of work is very slowly against the scheduled. Regarding to discussion with Resident Engineer and Project and Safety Manager of the contractor, during this rainy season, there was no earthwork activities. This year, the raining is continued in December, so site activities are still restricted.

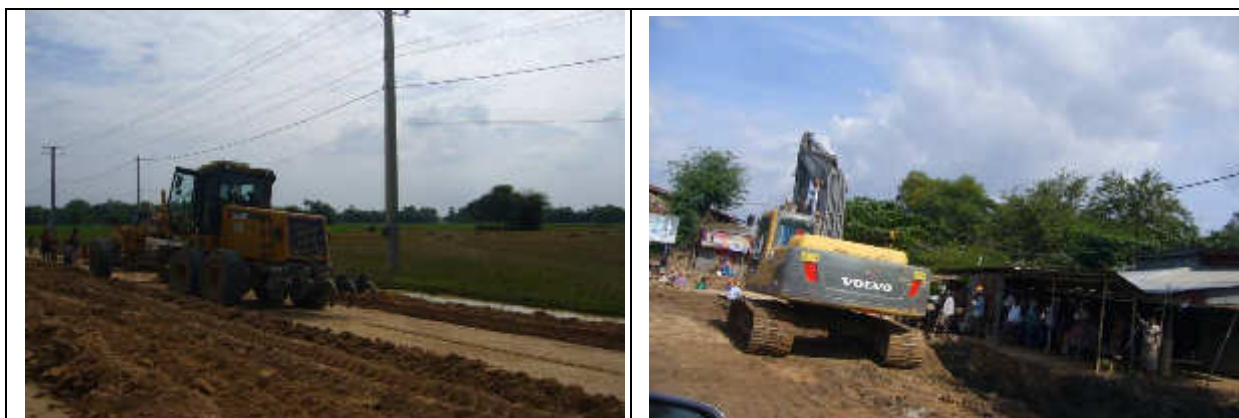
Starting construction activities of PR314D

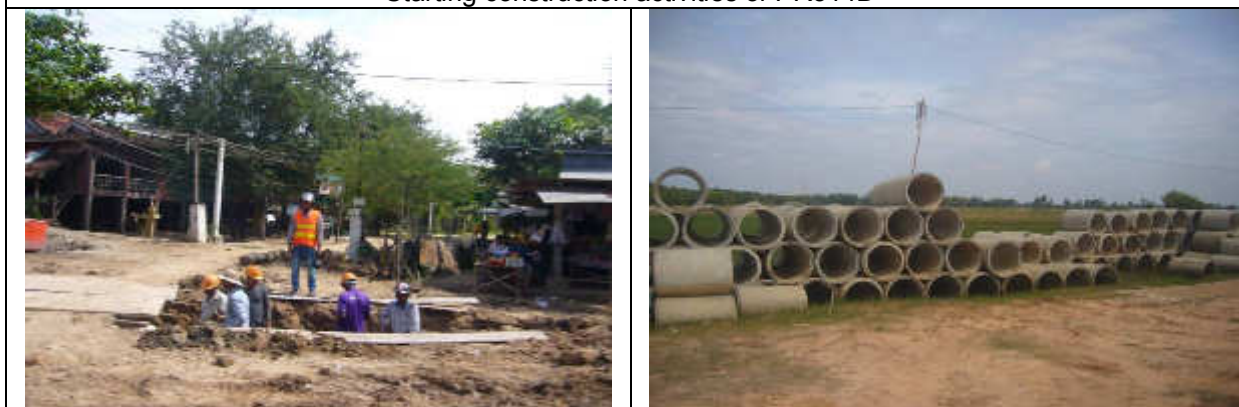
Side drains construction activities

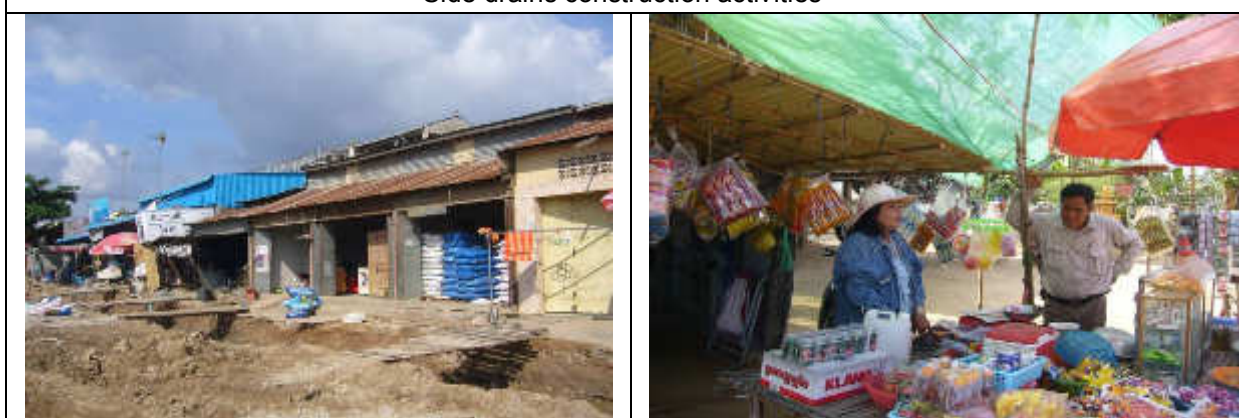
Local business activities on PR314D

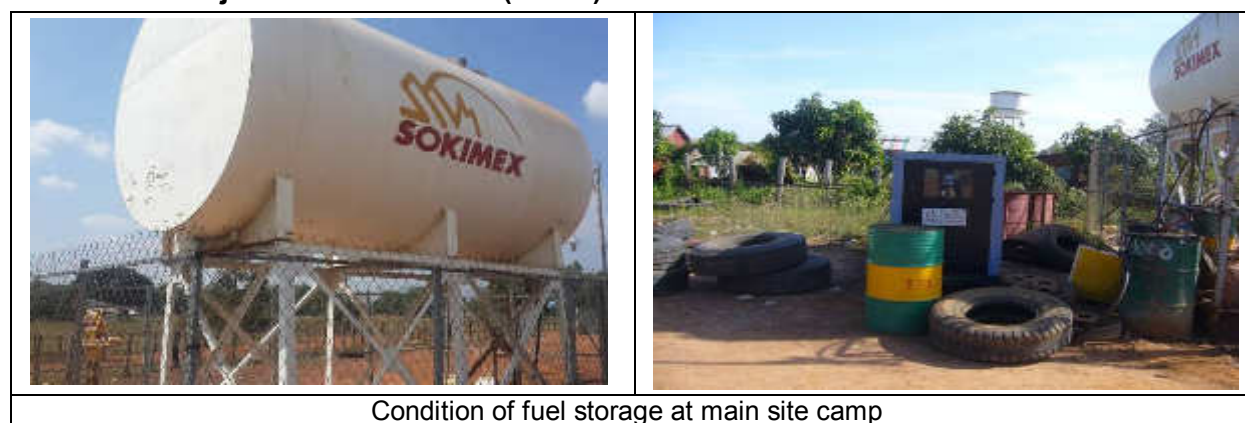
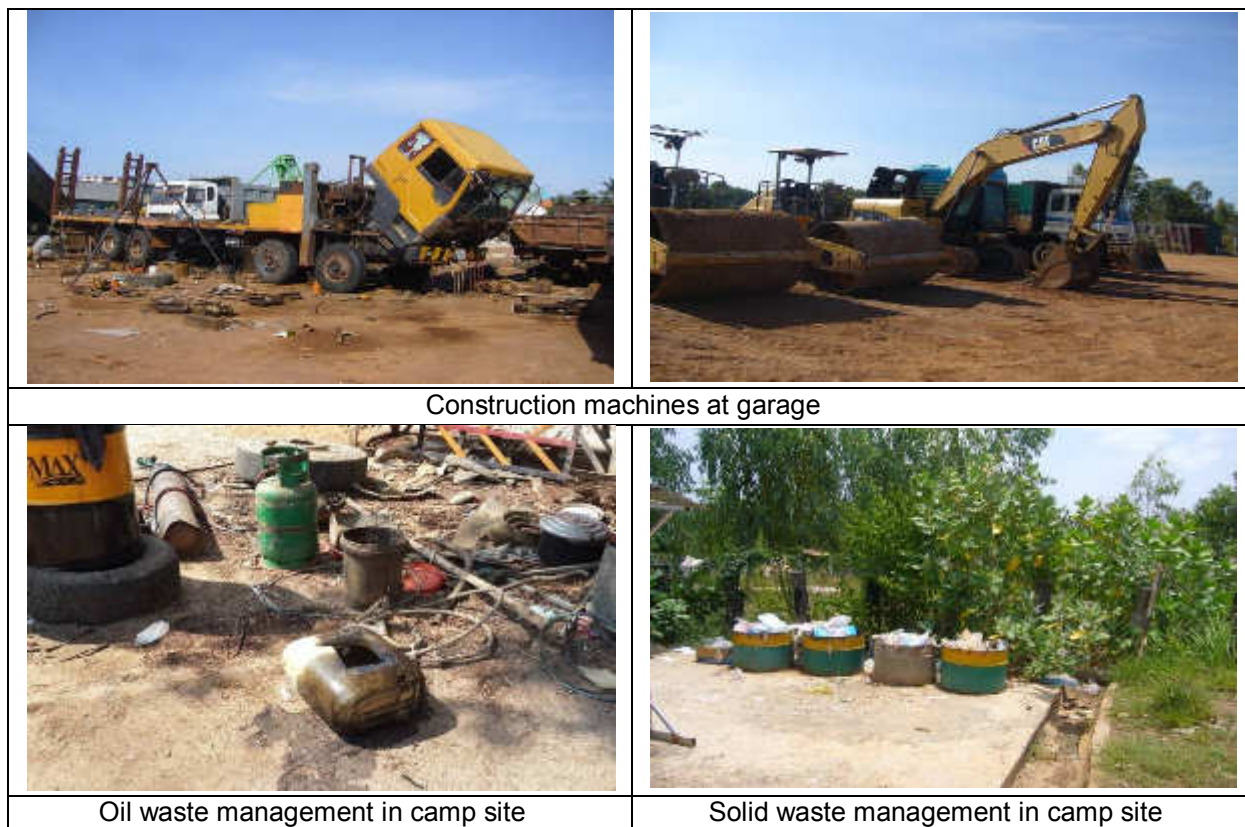
Pictures of Project Work Activities (CW-C)

60. During field monitoring on 27-28 December, 2016, it was observed a few construction activities have been just started on a few road sections such as an installation of pipe culvert work.

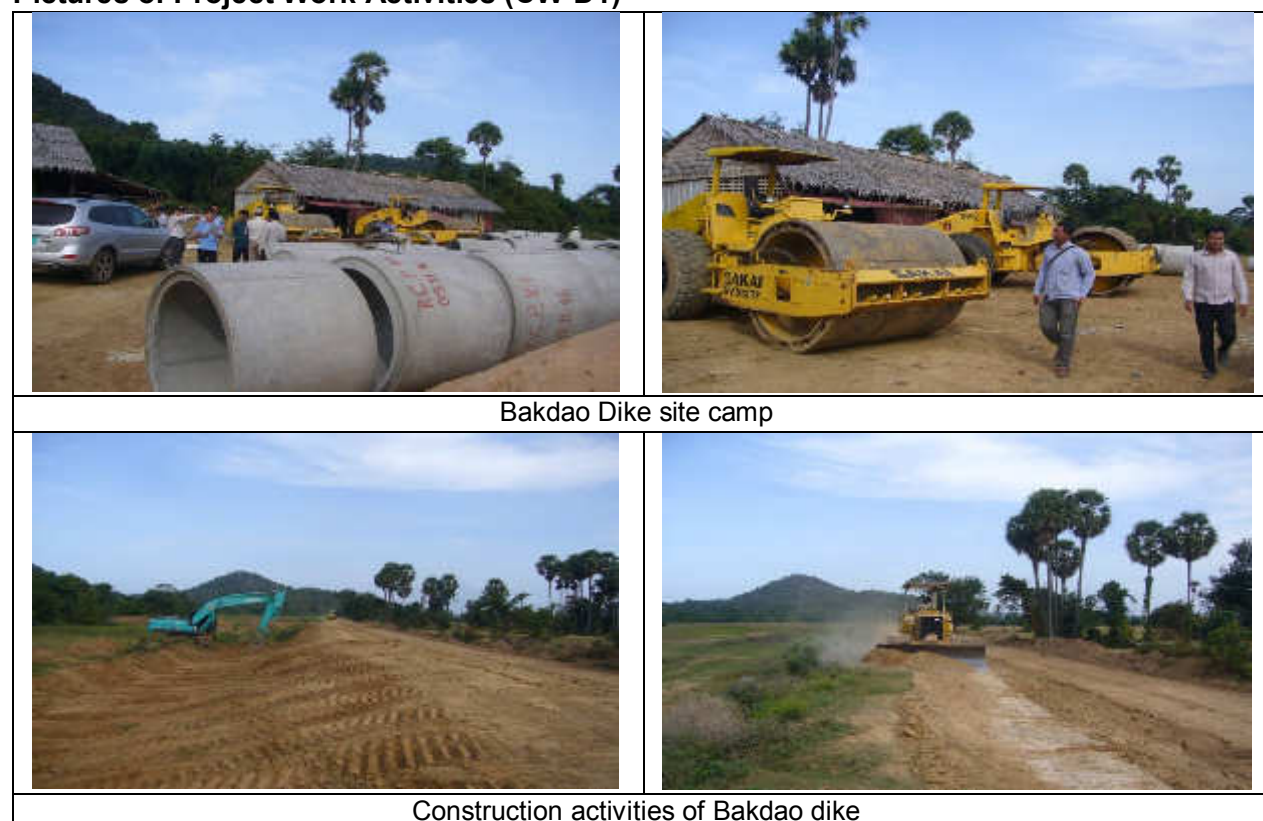
Pictures of Project Work Activities (CW-D1)

69. During field monitoring and discussion Project Manager and Site Engineer, in December 2016, construction activities just starting for Bakdao Dike only, the Portanorn and Srok dike is still wet/under water. There are some starting construction activities for Bakdao Dike: (i) Demining/UXO by CMAC, (ii) Resurvey of Bakdao and Portanorn dike, (iii) clearing and grubbing of Bakdao dike, and (iv) testing materials. No major adverse environmental issue was observed on the site.

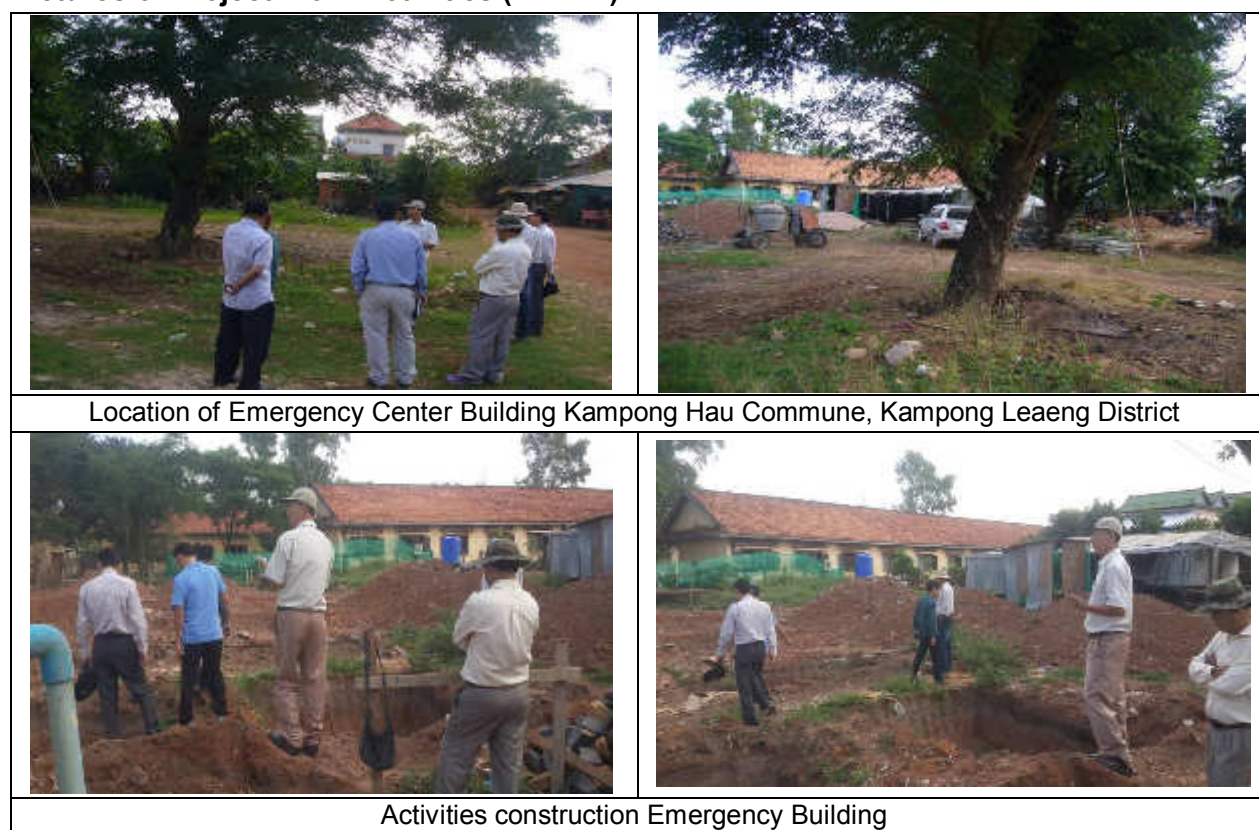
Pictures of Project Work Activities (CW-D4)

71. During the field monitoring and discussion with site manager of Tan Kim Eng Co., Ltd, this project is just started construction in December 2016 due to this continuous raining and high water level. The activities are implemented only for construction of Emergency Management Center such as mine/UXO clearance and demolishing of existing building. No major adverse environmental issue was observed on the site.
