CAM: Provincial Roads Improvement Project

PROVINCIAL ROADS IMPROVEMENT PROJECT ADB LOAN 2839-CAM (SF)/8254-CAM (SCF)

SEMI-ANNUAL ENVIRONMENTAL MONITORING REPORT

Covering Period from July to December 2017

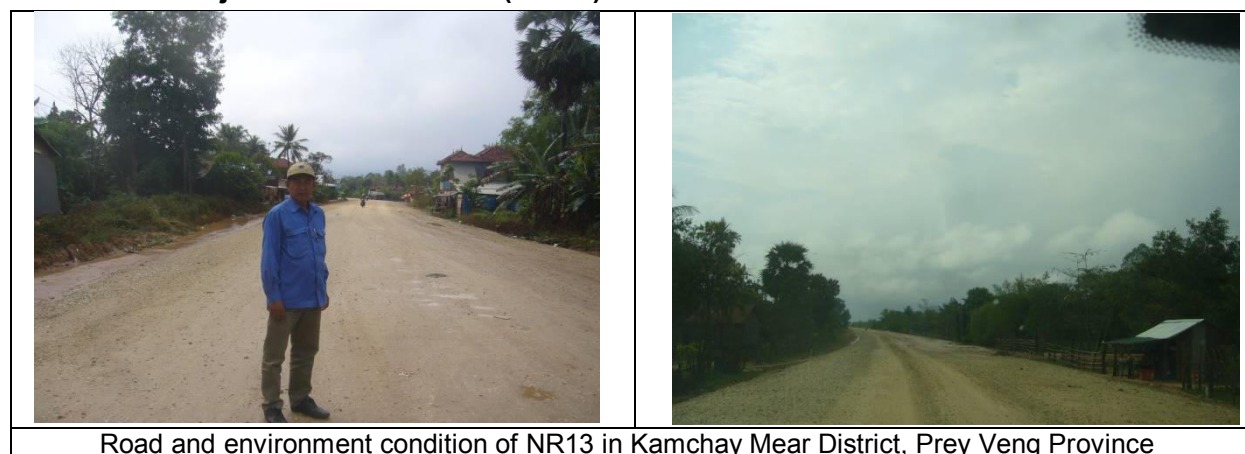
Pictures of Project Work Activities (CW-A)

Road and environment condition of NR13 in Kamchay Mear District, Prey Veng Province

| Road and environment condition of NR13 in Romeas Haek District, Svay Rieng | |
| Road and environment condition of NR13 in Svay Rieng | |
| Road condition and urban local markets of NR13 in Svay Rieng Province | |
| The condition of some road sections during construction stage of NR13 in Svay Rieng Province | |

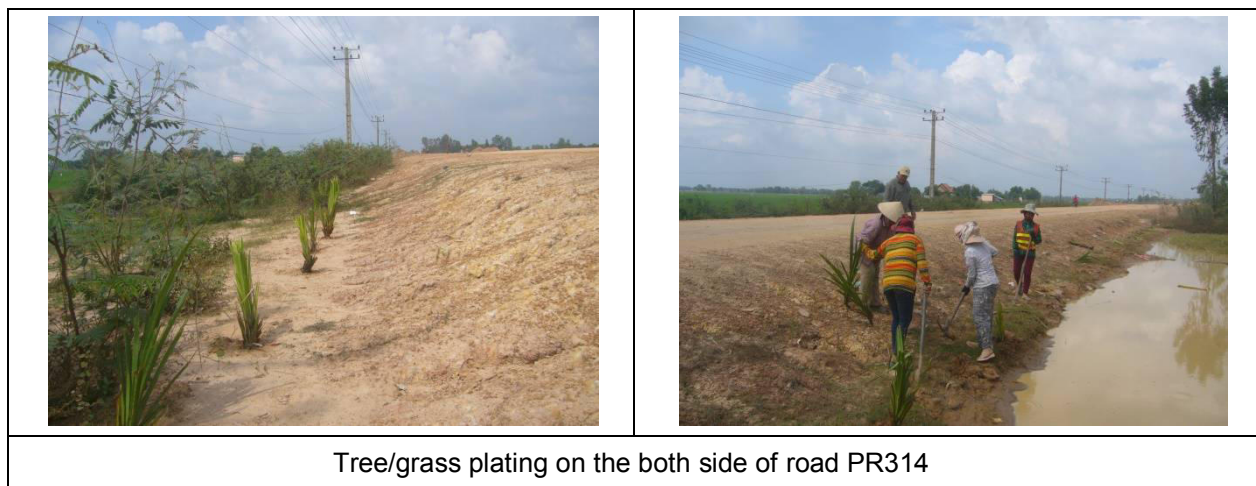
| The road condition during construction of PR314 in the urban and village areas | |
| Providing water in construction site of PR314 | |

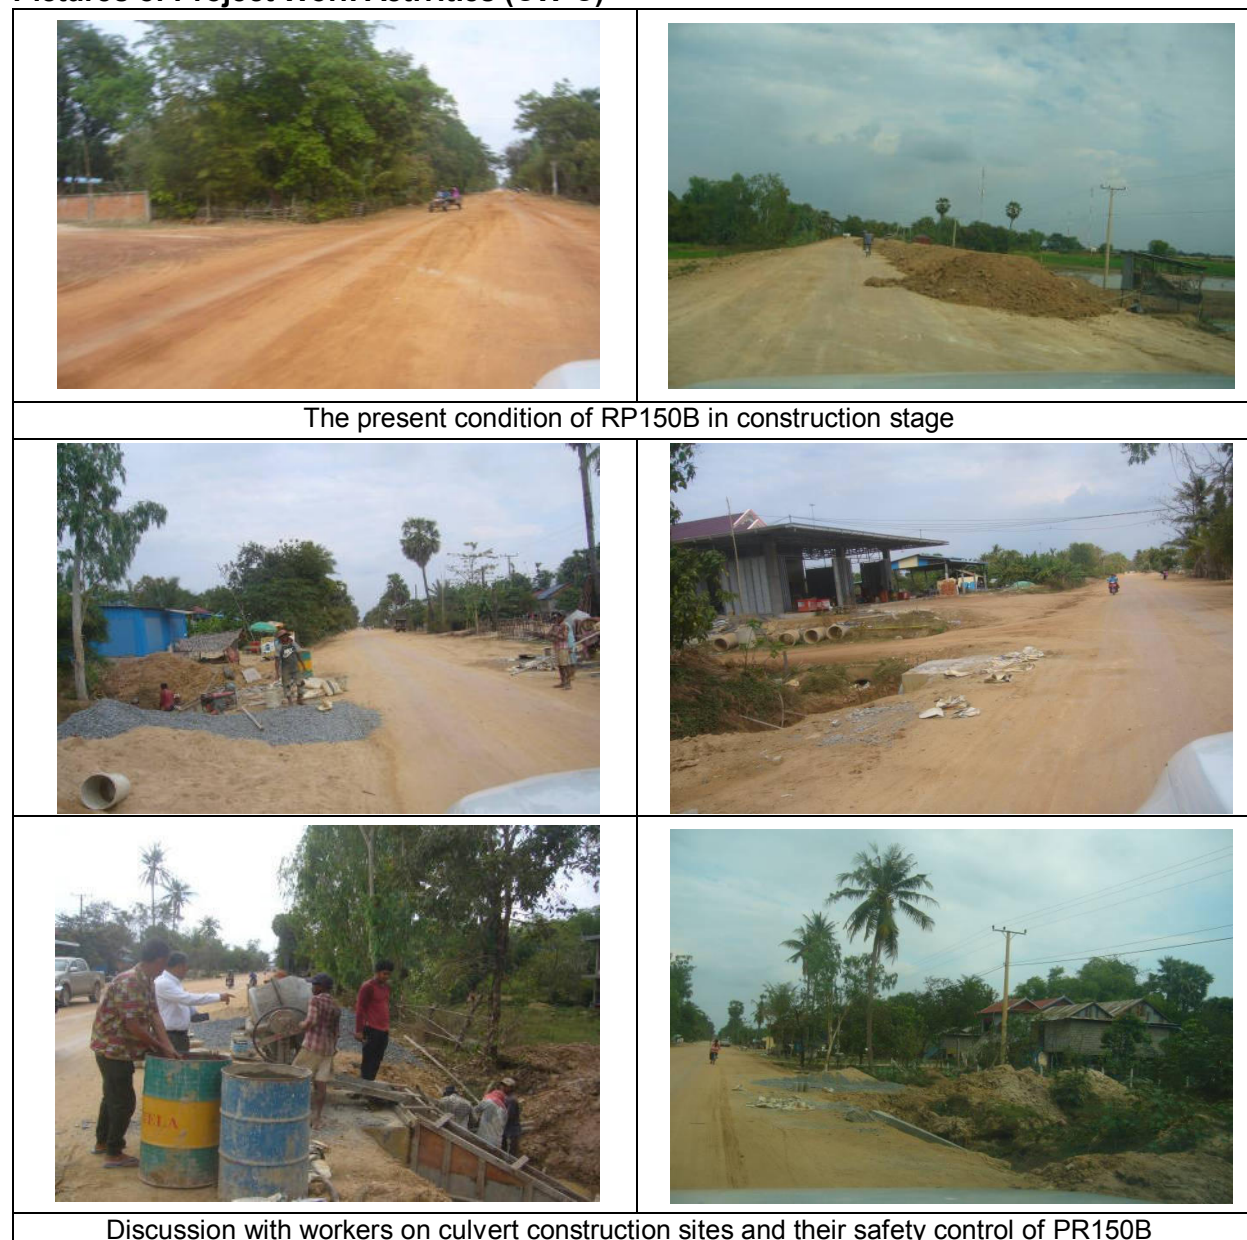
Pictures of Project Work Activities (CW-C)

70. **Traffic Safety:** During the monitoring, it was observed that the traffic signs and other safety signs for public safety are limited on the construction section. Most of the construction areas are not equipped warning signs and any safety devices and barriers for the road safety. Also road signs to reduce traffic speed should be in place at the dangerous areas such as deep excavations and narrow areas especially at bridge widening activity sections. The result of discussion with local communes, they worry about increasing of dust when road surface is dried and muddy surface road during raining because it will affect negatively to the local road traffic movements. Based on site monitoring, the public traffic safety signs at construction sections of PR150B and NR53 are very limited, especially in structure construction sites.

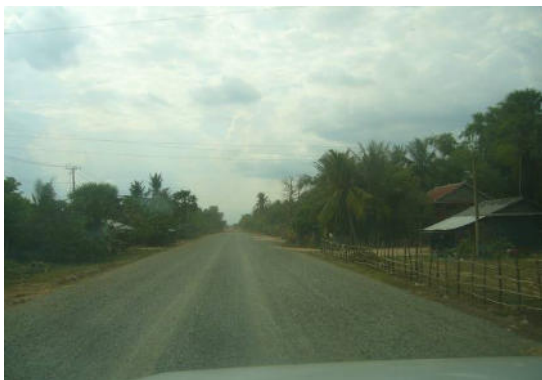
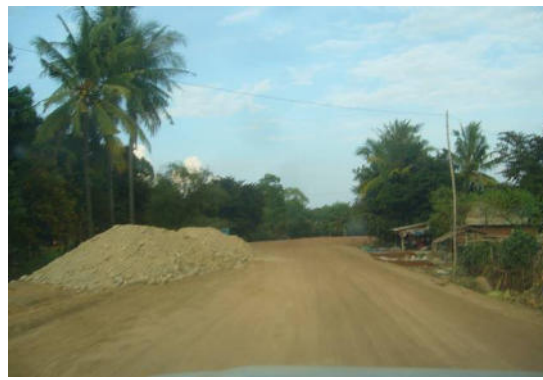
The present condition of PR53 during construction stage

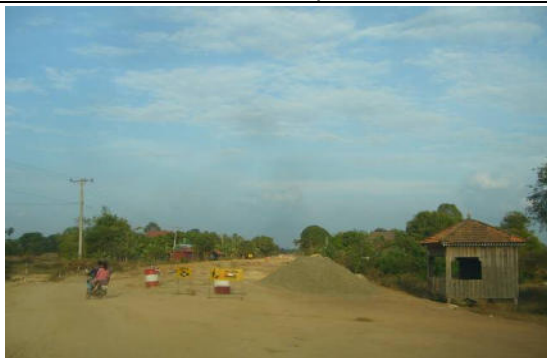
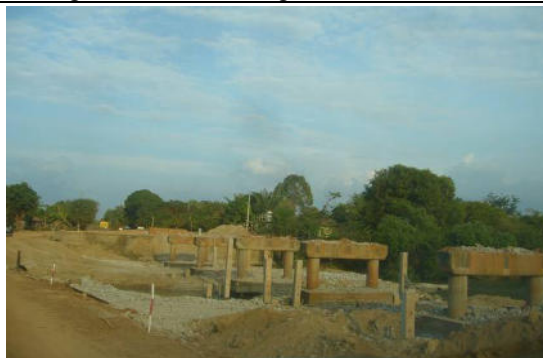
The construction activities of culvert and bridge section of NR53

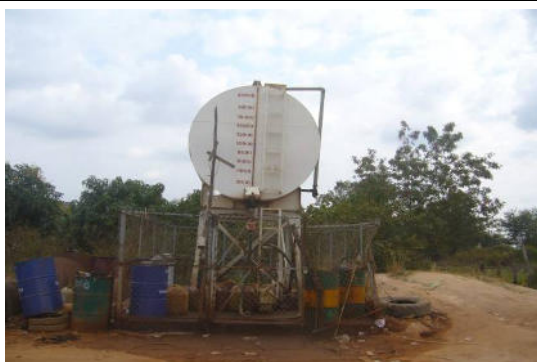
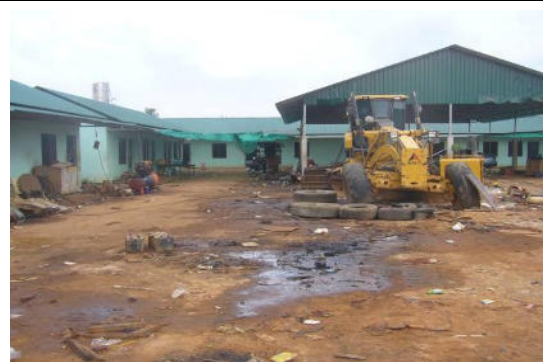
66. **Leaks and spills of hazardous material and oil waste:** Improper oil/fuel container storage and changed engine oil was observed. The contractor should have provided a suitable tank, including concrete platform, wall, and security equipment and fence around the fuel storage. At the workshops and storage area, it was observed that i) improper oil/fuel drum storage, and ii) insufficient housekeeping with lack of proper management of garbage/waste (sanitation). Based on visual monitoring, the oil waste in camp of **Gumkang-Visvakam JV** is not proper managed, and some oil discharges/leaks on the field/top of land. So the oil waste shall be stored in safety tank and provided to disposal agent to take out from the site.

Petroleum storage container and oil waste leaching at camp of Gumkang-Visvakam JV

80. **CW-C:** Lack of proper management of garbage/waste (sanitation) and fuels at the construction camp site, and placed fuels near river without proper protection from leakage. The contractor shall take corrective action. Sufficient road safety devices are necessary to install at all site activity area immediately, especially site activity area for bridge widening sections.

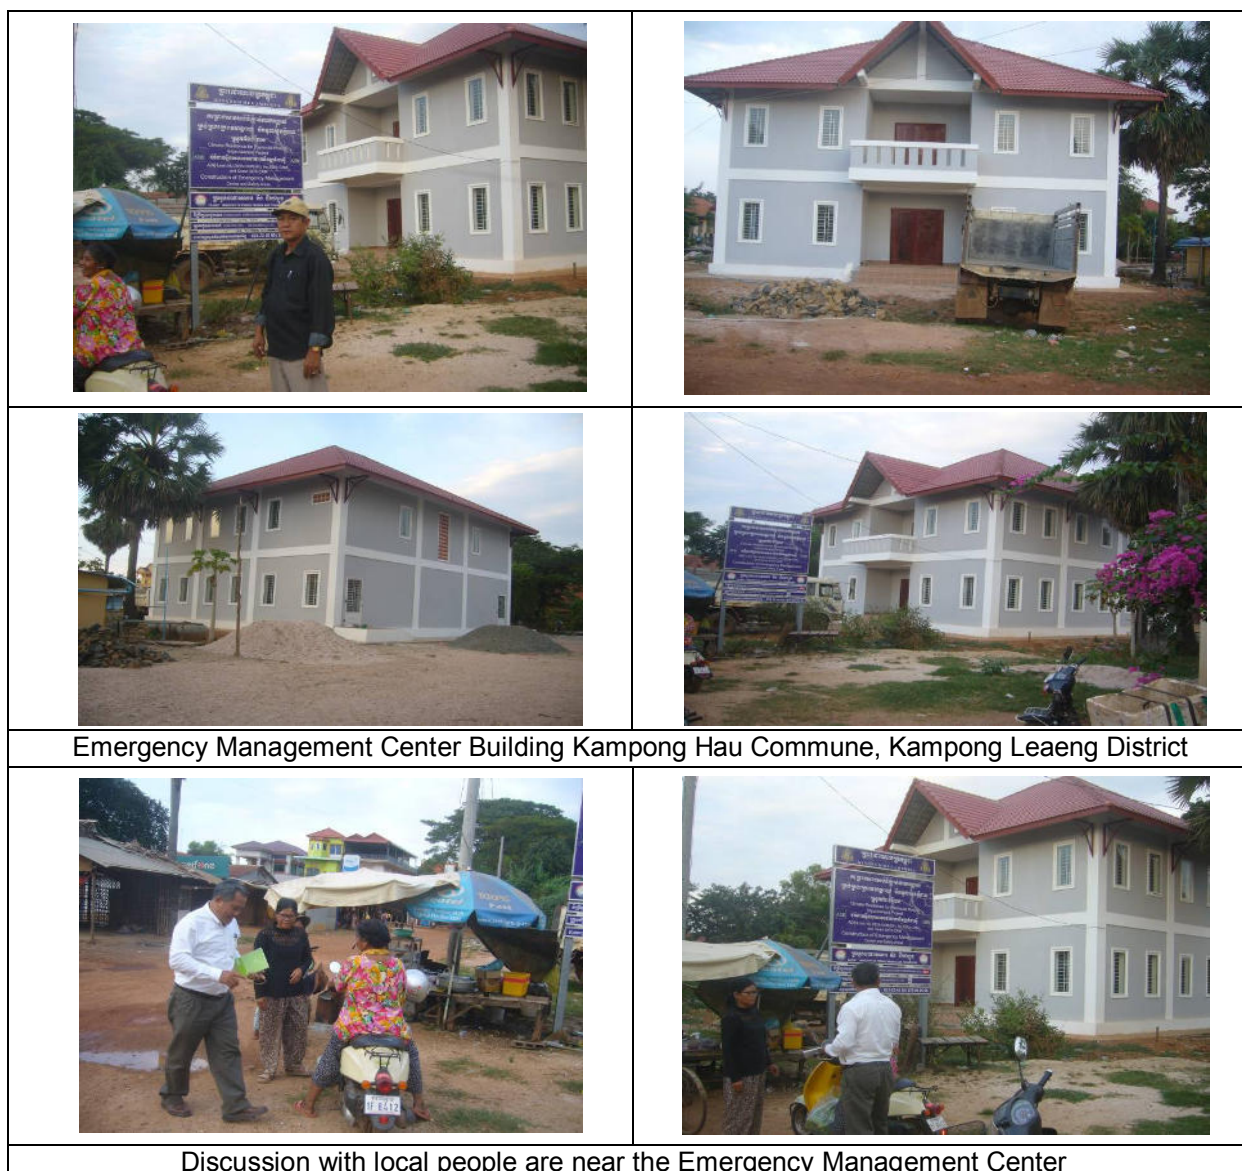
74. 3 safety areas have been completed and embankment works for remaining other 3 safety areas are little activity due to high water level. The construction of Emergency Management Center is almost completed and remained only fence around EMC. No major adverse environmental issue was observed during the site monitoring and there are no any negative complains from local communities.
