Safeguards Monitoring Report

Semi-Annual Report
June 2020

Lao PDR: Greater Mekong Subregion East- West Economic Corridor Towns Development Project (Part 1 of 3)

SEMIANNUAL ENVIRONMENTAL AND SOCIAL SAFEGUARDS MONITORING REPORT

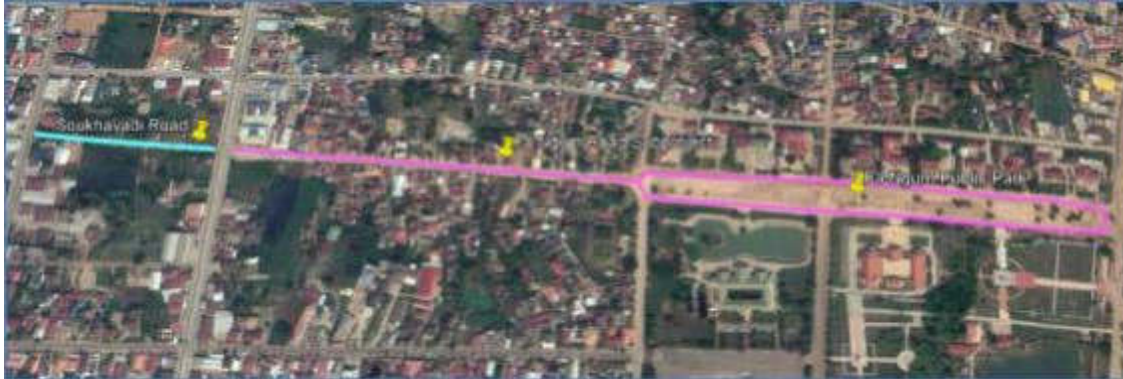
Figure 2. FA NGUM SUBPROJECT

23. Fa Ngum Road is composed of three (3) main roads with a total length 2,149 meters and public park recreation. The Contractor for this sub-project is Champakham Road and Bridge Construction Co. Ltd (CPK). The total cost is 2,289,611.17 USD; the contract duration is 24 months commencing on 14 November 2017. Cyan line presents Soukhavadi road, and it connects to F1 section of Fa Ngum road.

35. Thahae Road is connected with current concrete road being upgraded along with embankment, it is a concreted road to connect with Nouhak Phoumsavan park, it has 459.50 meters length, and Soukhavadi concrete road upgrading with 292 meters length. The soukhavadi road is presented in Figure 2, where it started from Santiphab road to Xayyavong road. These additional works are awarded to Lao Mixay construction company with a total cost 609,989.02 USD with 4 months periods commencing on December 9, 2019.

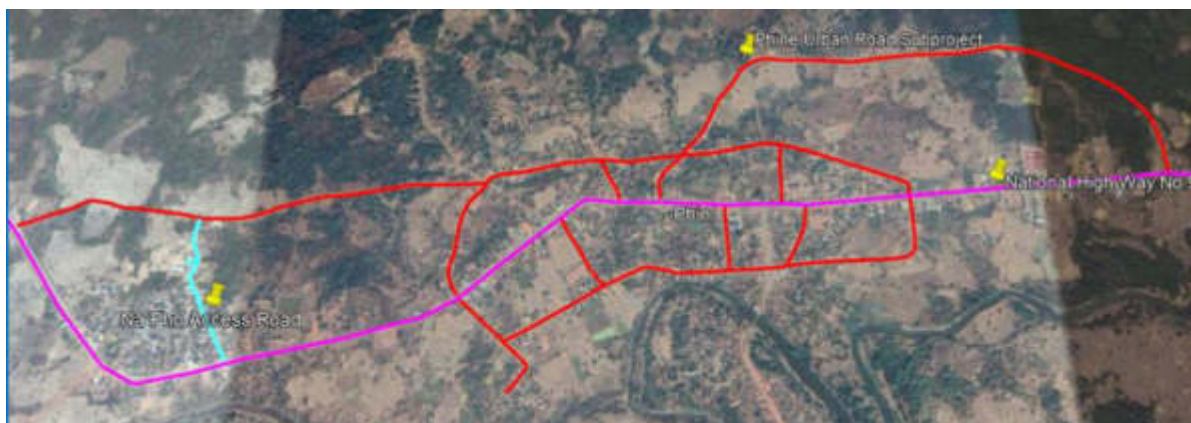
Figure 4. PHINE URBAN ROAD SUBPROJECT

26. Phine Urban Roads has a total length of 9,978 meters and a total cost of 4,010,613.00 USD. The construction of the sub-project was awarded to JV of Road No. 8 Construction Enterprise with PK and TSC. The Contract duration is 24 months commencing on 01 November 2017.
27. In Figure 4, below, red lines represent the scope of the original project and cyan shows the additional works comprising Ban Na Pho access roads with 619 meters in length. The cost is USD 189,225 with a three months period after receiving notification letter.

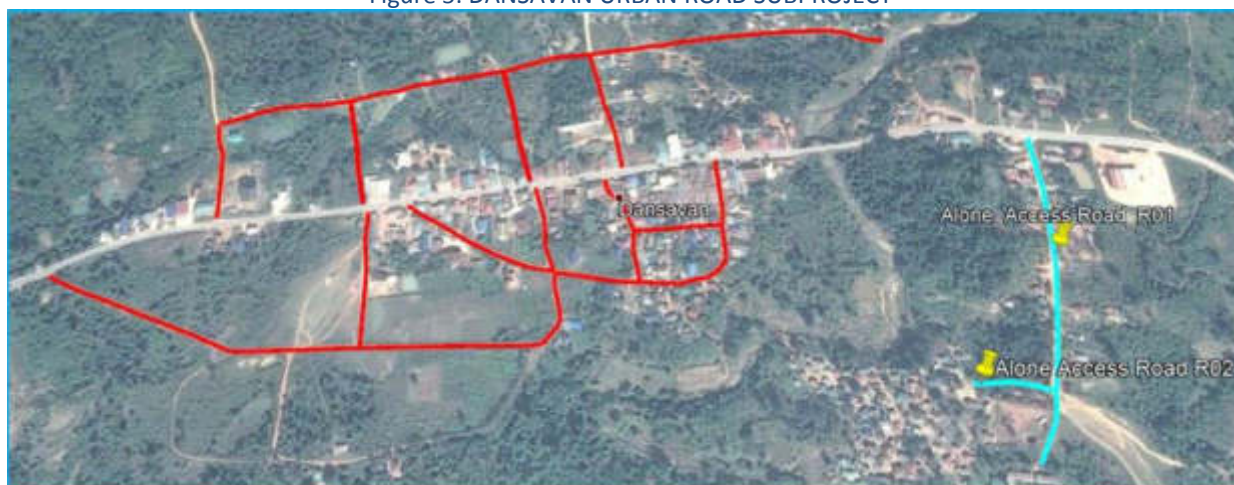
Figure 5. DANSAVAN URBAN ROAD SUBPROJECT

28. Dansavan Urban Roads has a total length of 3,884 meters with total cost of 2,312,621.58 USD. The Contractor for the sub-project is Noukham Construction Co., Ltd. The Contract duration is 24 months commencing on 11 November 2017.
29. In Figure 5, red lines indicate the completed urban road in Ban Dansavan, and cyan line shows the additional works comprising an access road to Alone community, 637 meters in length. The VO is awarded to Noukham Construction company with a total cost of USD 264,410.72. The construction duration is three months commencing on December 4, 2019.

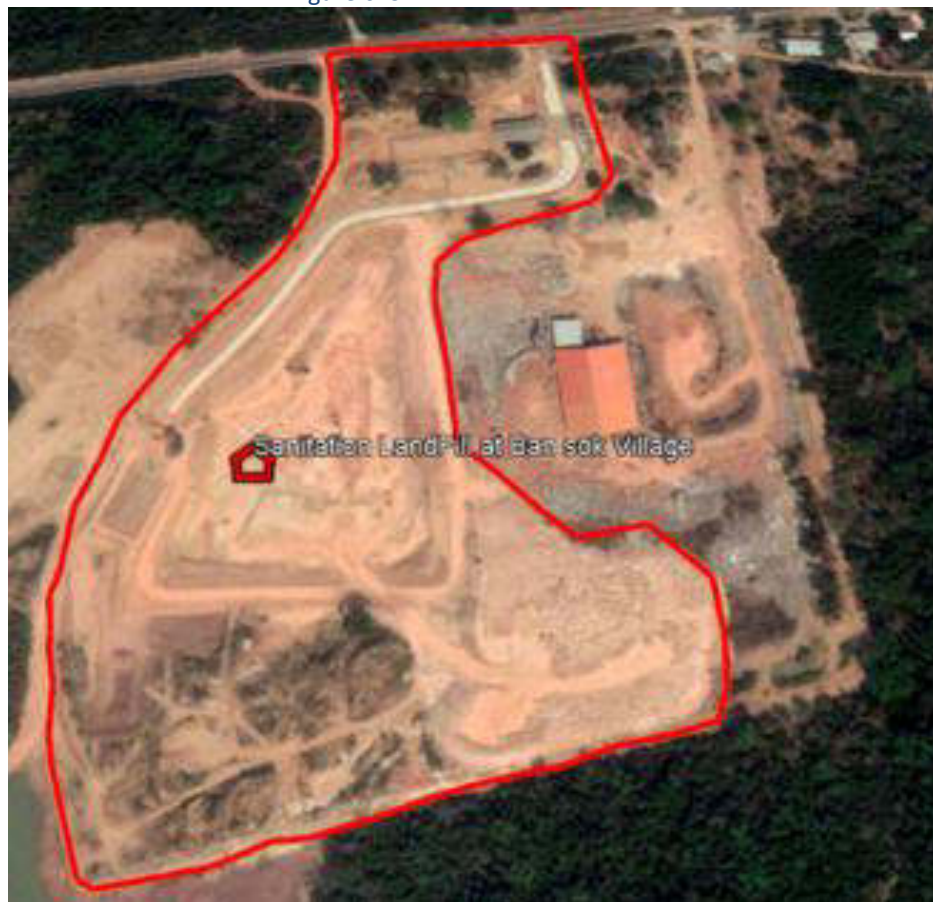
Figure 6. SAVANNAKHET LANDFILL

30. The total area covered by the sub-project is 10 hectares, primarily for the improvement of the existing landfill at a total cost 1,659,205.10 USD. VSP Construction Company Ltd was awarded the contract for the construction of the sub-project with a contract duration of 24 months commencing on 22 March 2018.
31. Currently, pipeline connection among old landfill and new landfill is designed and it is under construction. It is minor, but it is part of compliance with environment criteria, to collect leachate to the designed leachate treatment ponds.

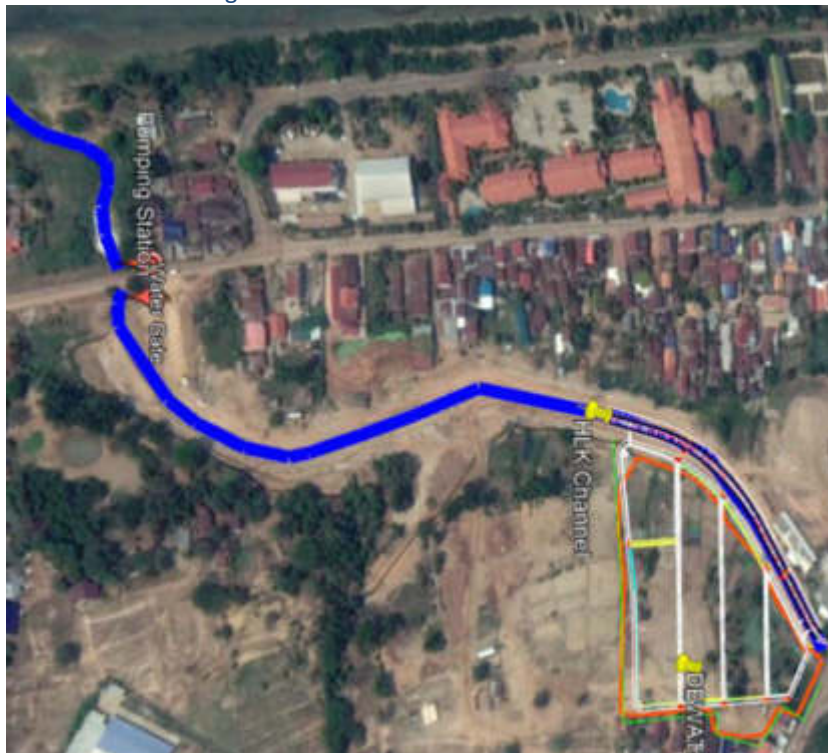
Figure 7. HLK CHANNEL WITH DEWATS

32. This sub-project involves the construction of a HLK channel with a length of 830 meters and a pumping station with an automatic gate. It has a total cost of 1,673,128.31 USD. The appointed Contractor is JV of Road No. 8 Construction Enterprise with PK and TSC. The Contract duration is 24 months commencing on 22 March 2018.
33. Decentralized Wastewater Treatment System (DEWATS) is designed in 2.7 hectares of land integrated into HLK channel, which is located on the right side of the starting point of HLK channel. VO for constructing DEWATS is approved with approximately cost USD 861,250.76 within 7 months period from December 9, 2019.

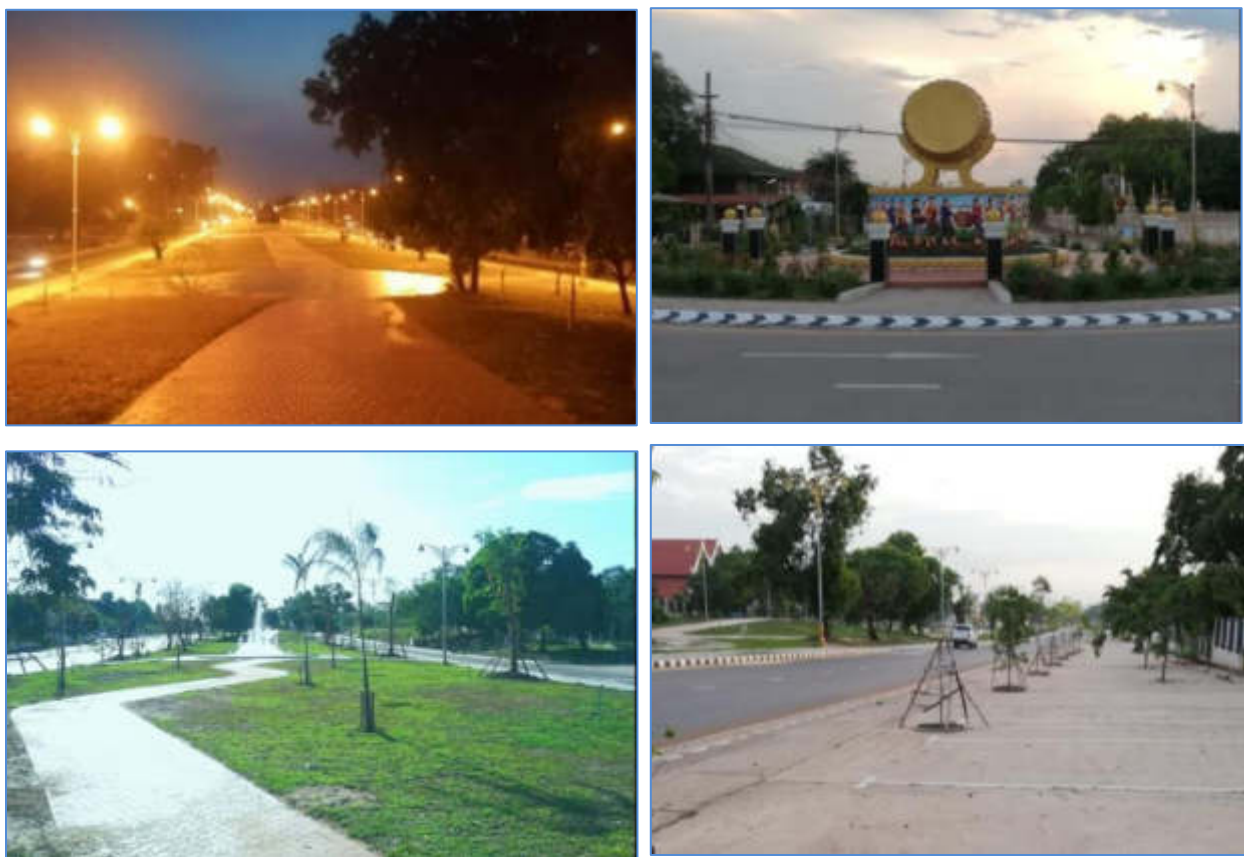
Figure 9. COMPLETION OF FA NGUM ROAD

37. Fa Ngum Road subproject: the construction work during this report period has included continuing landscape beautification in the Park, finalizing the asphalt concrete pavement in 2A section. Installing of curb, sidewalks, parking lots, roundabout, trees and grass planting at park, streetlight installation and other decoration works. Fa Ngum Road subproject is completely constructed.

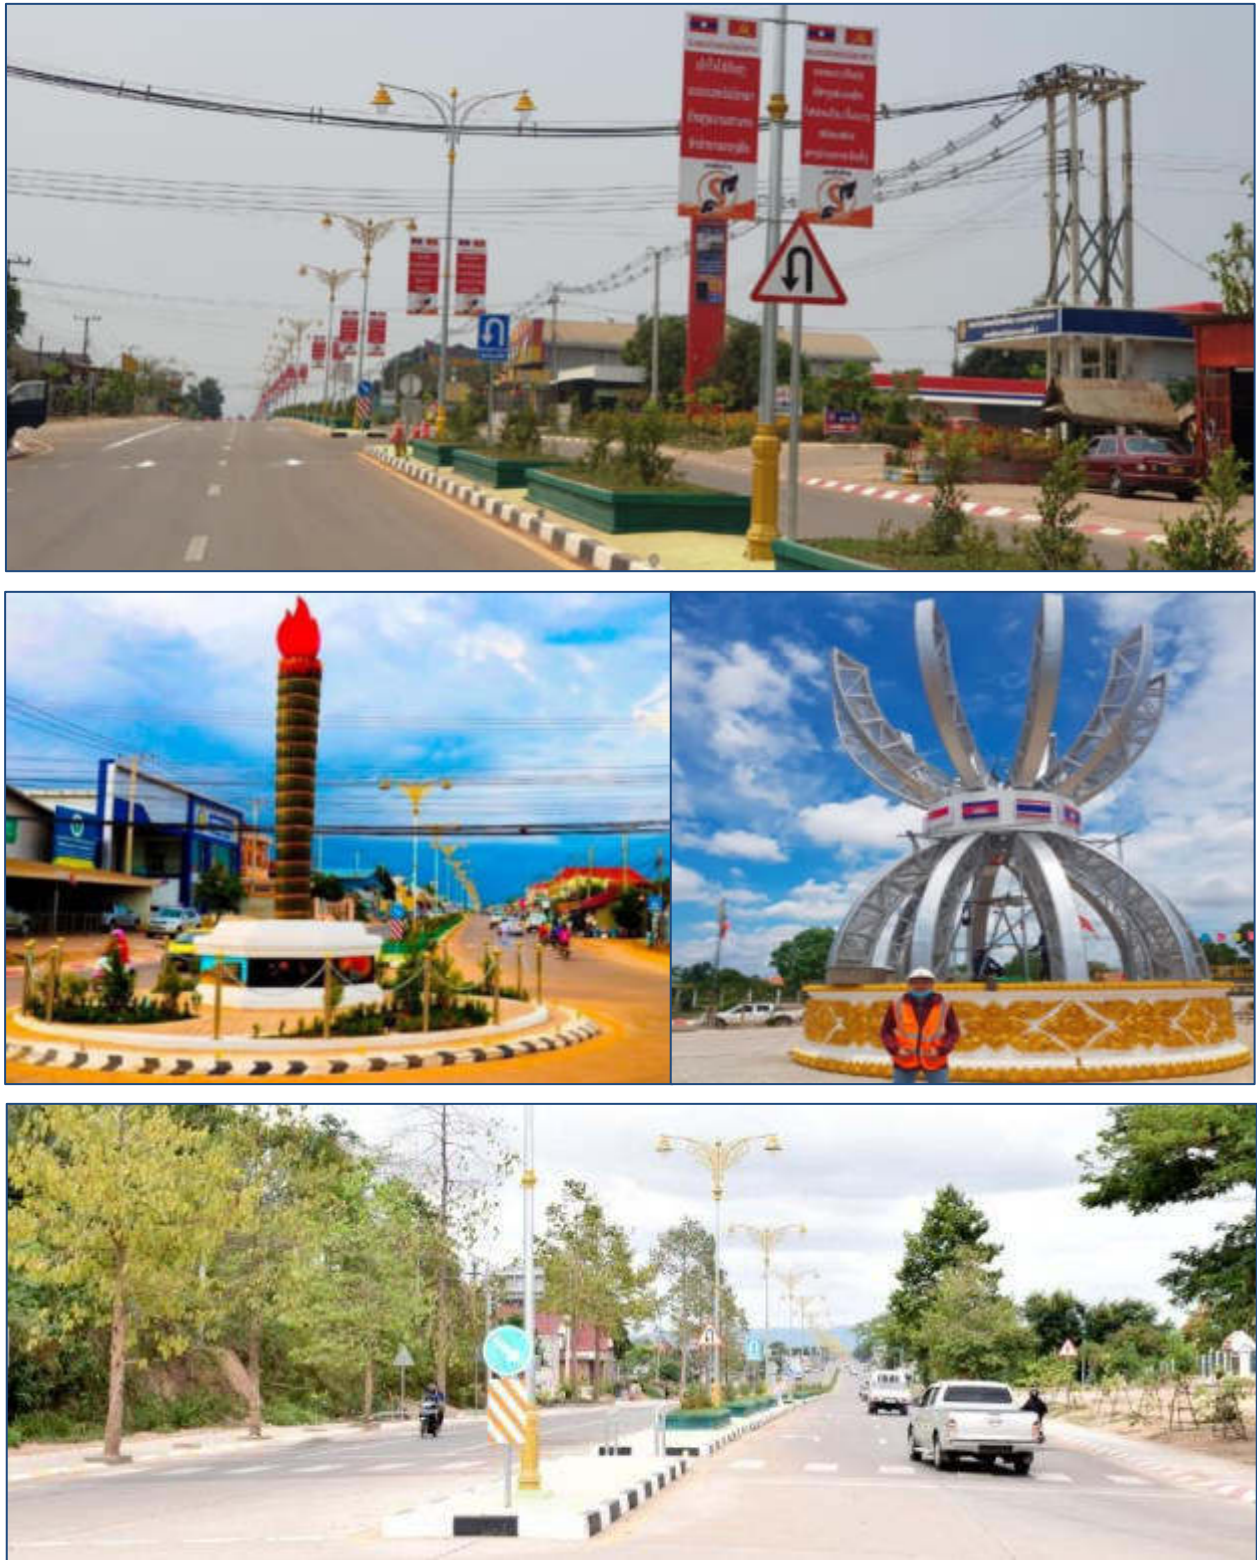
Figure 10. THE COMPLETION OF KAYSONEPHOMVIHAN ROAD

38. Kaysone Phomvihan road subproject: The main construction work during the report period has included two roundabouts, concrete pavement around the roundabout, and other road beautification such as median, curb and sidewalk installation and included street light installation, traffic sign installation and road markings and all access road to Kaysonephomvihan road. Construction is completed.
39. Savannakhet Airport access road during the report period has included all construction works as excavation, clearance, drainage installation on both sides, sub-base, base course layers, asphalt concrete pavement, curb installation, sidewalk, median, traffic sign installation and curb marking, road marking and street light installation, and tree planting on both sides. These works are completely constructed at this report period.

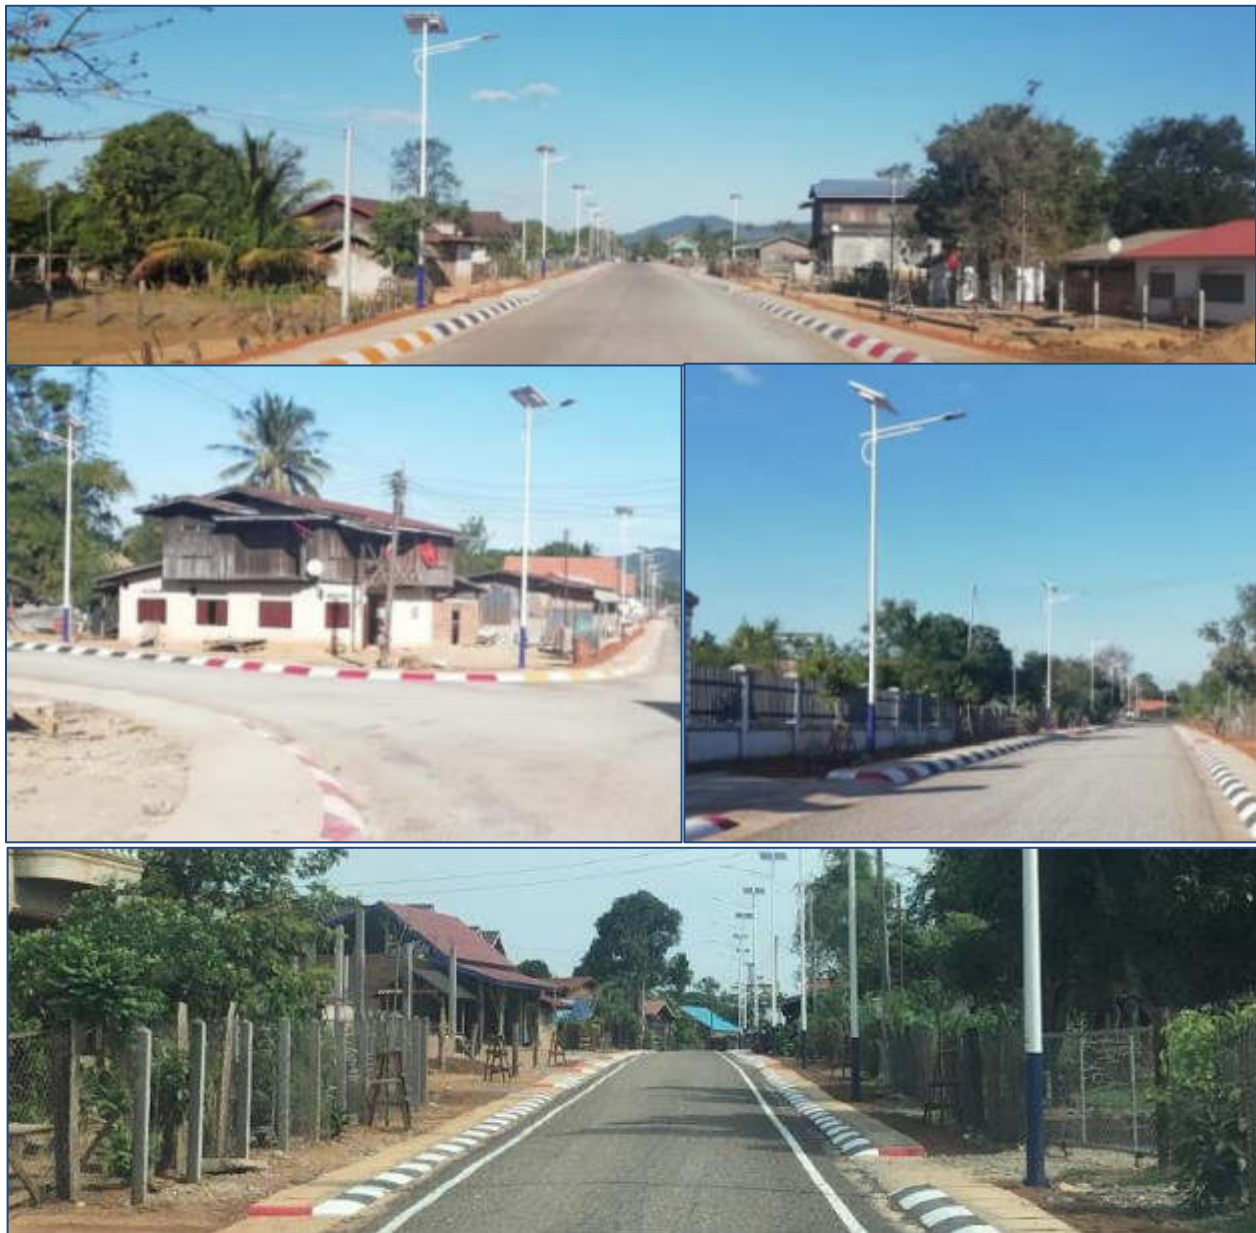
Figure 12. THE COMPLETION OF PHINE URBAN ROAD AND BAN NAPHO ACCESS ROAD

40. Phine Urban Road subproject: Contractor has continued to speed up beautification works such as curb installation, sidewalk, streetlight, included traffic signs and safety devices installation, and roundabout. Phine Urban road subproject has been handed over to client on 21 February 2020.
41. Ban Na Pho Access Road construction during the report period has included road construction works such as site clearing, U-ditch drainage on both sides, subgrade, sub-base and base course layers, DBST layers and other beautification works like streetlight, traffic sign, road marking and tree planting. All construction works has been completed.

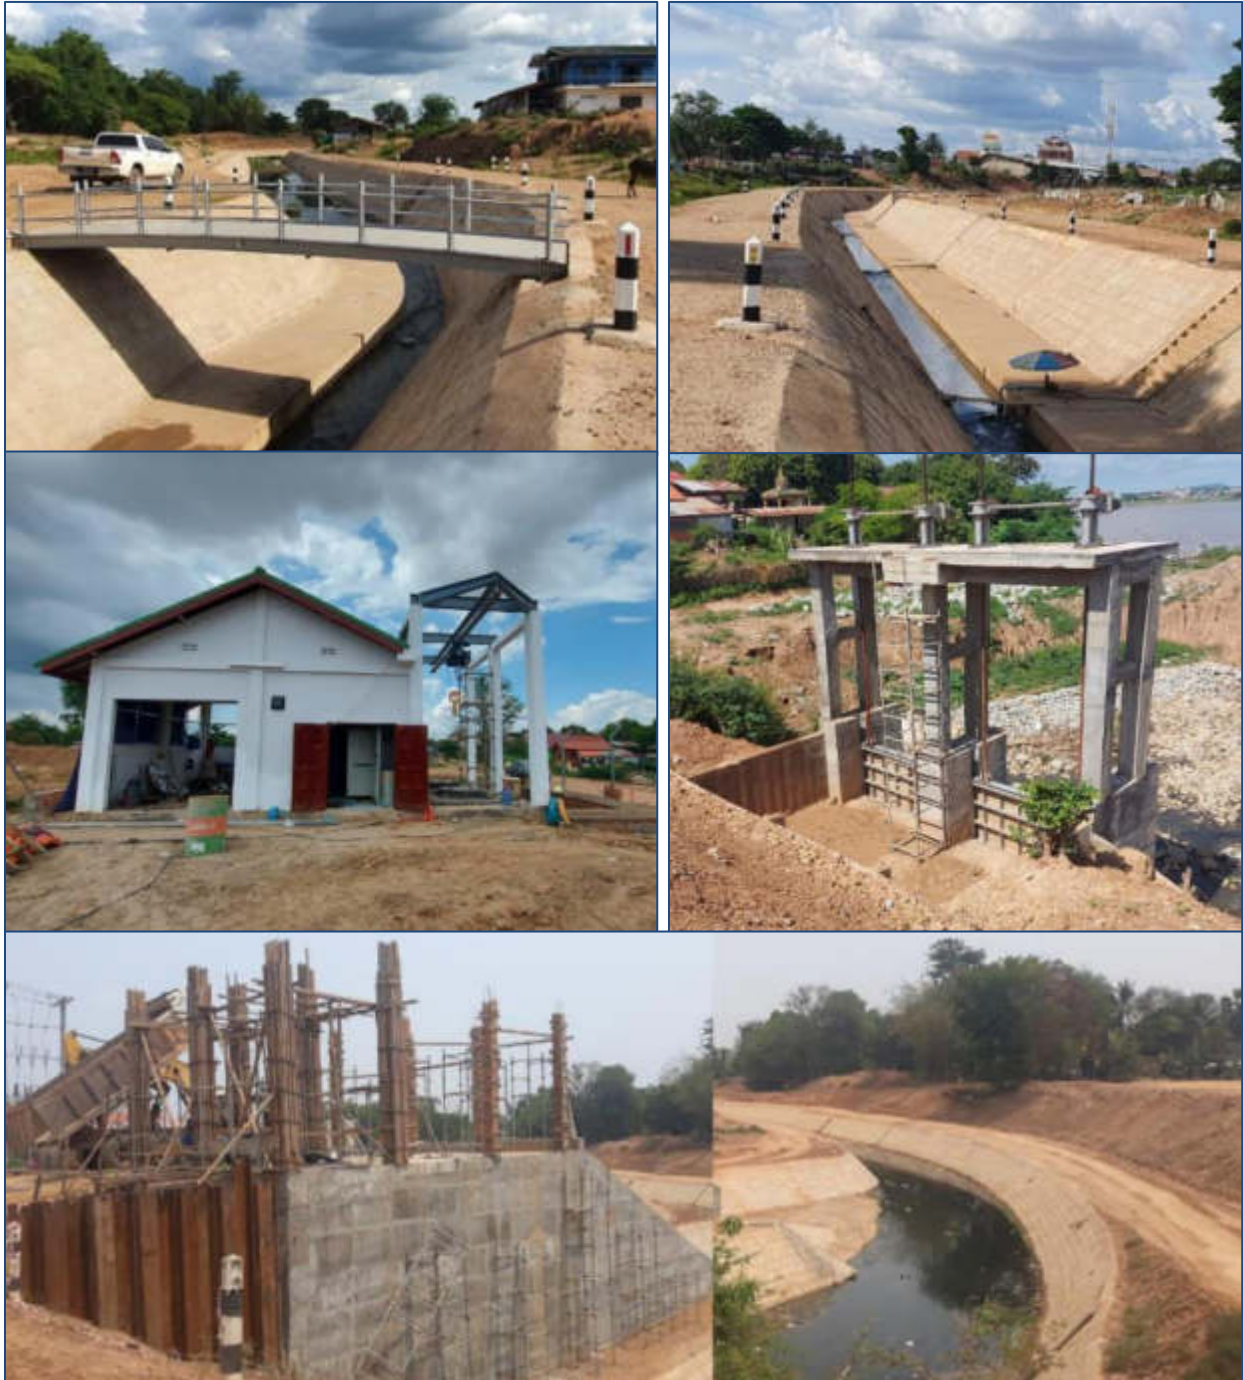
Figure 15. HLK CHANNEL, PUMPING AND GATE STATUS

44. Wastewater Management-HouayLongkong subproject: The construction activities during the report period has included pumping station installation (including pumping house) and water gate, and outlet channel, DEWATS construction activities has included excavation of

2.7 hectares with 3 meters depth, pond1, pond2, outlet and Horizontal Flow Planted Gravel Filter.

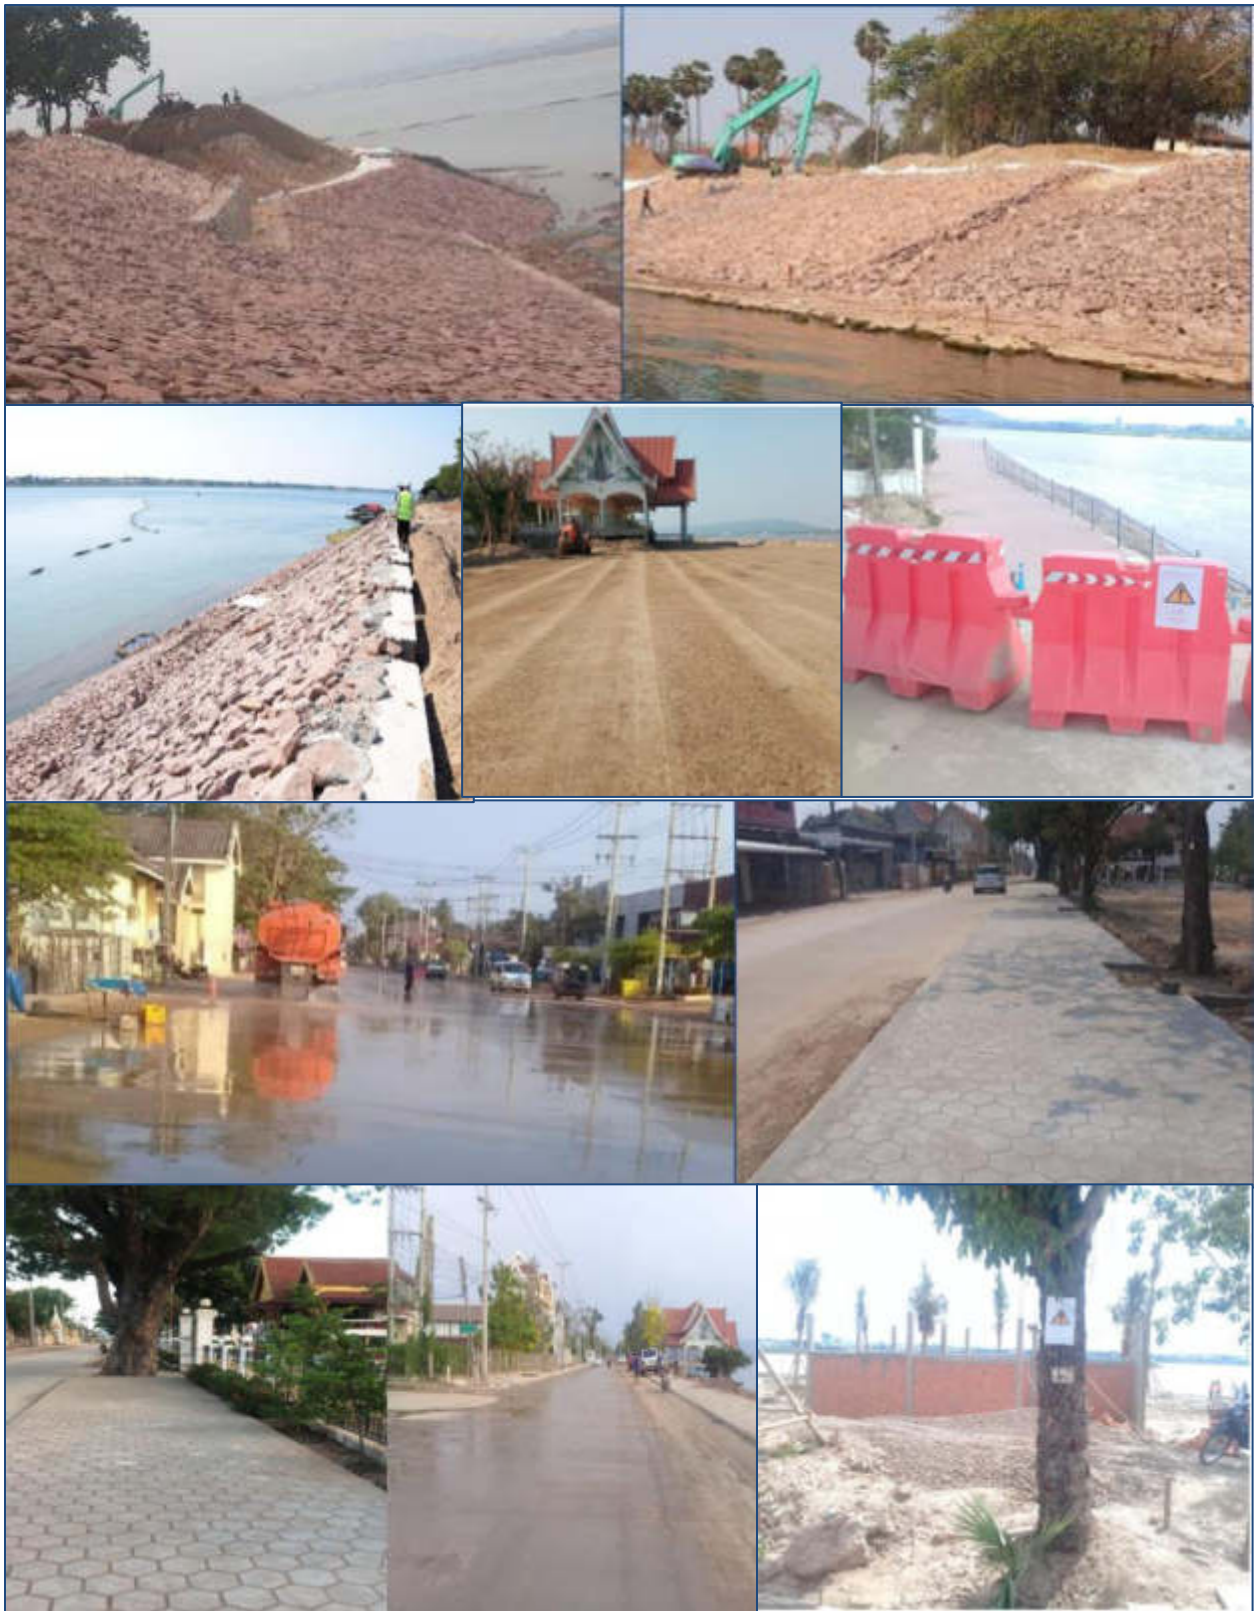
Figure 17. THE STATUS OF MEKONG RIVER EMBANKMENT

45. Mekong embankment subproject: (i) Road construction works include concrete pavement, curb and sidewalk installation, closing the manholes. (ii) embankment works including sand compacting layer by layer, retaining wall, stone riprap and prepare for stairs and outlet for drainages and park decoration and beautification works. Grass and tree planting are also done in this period.

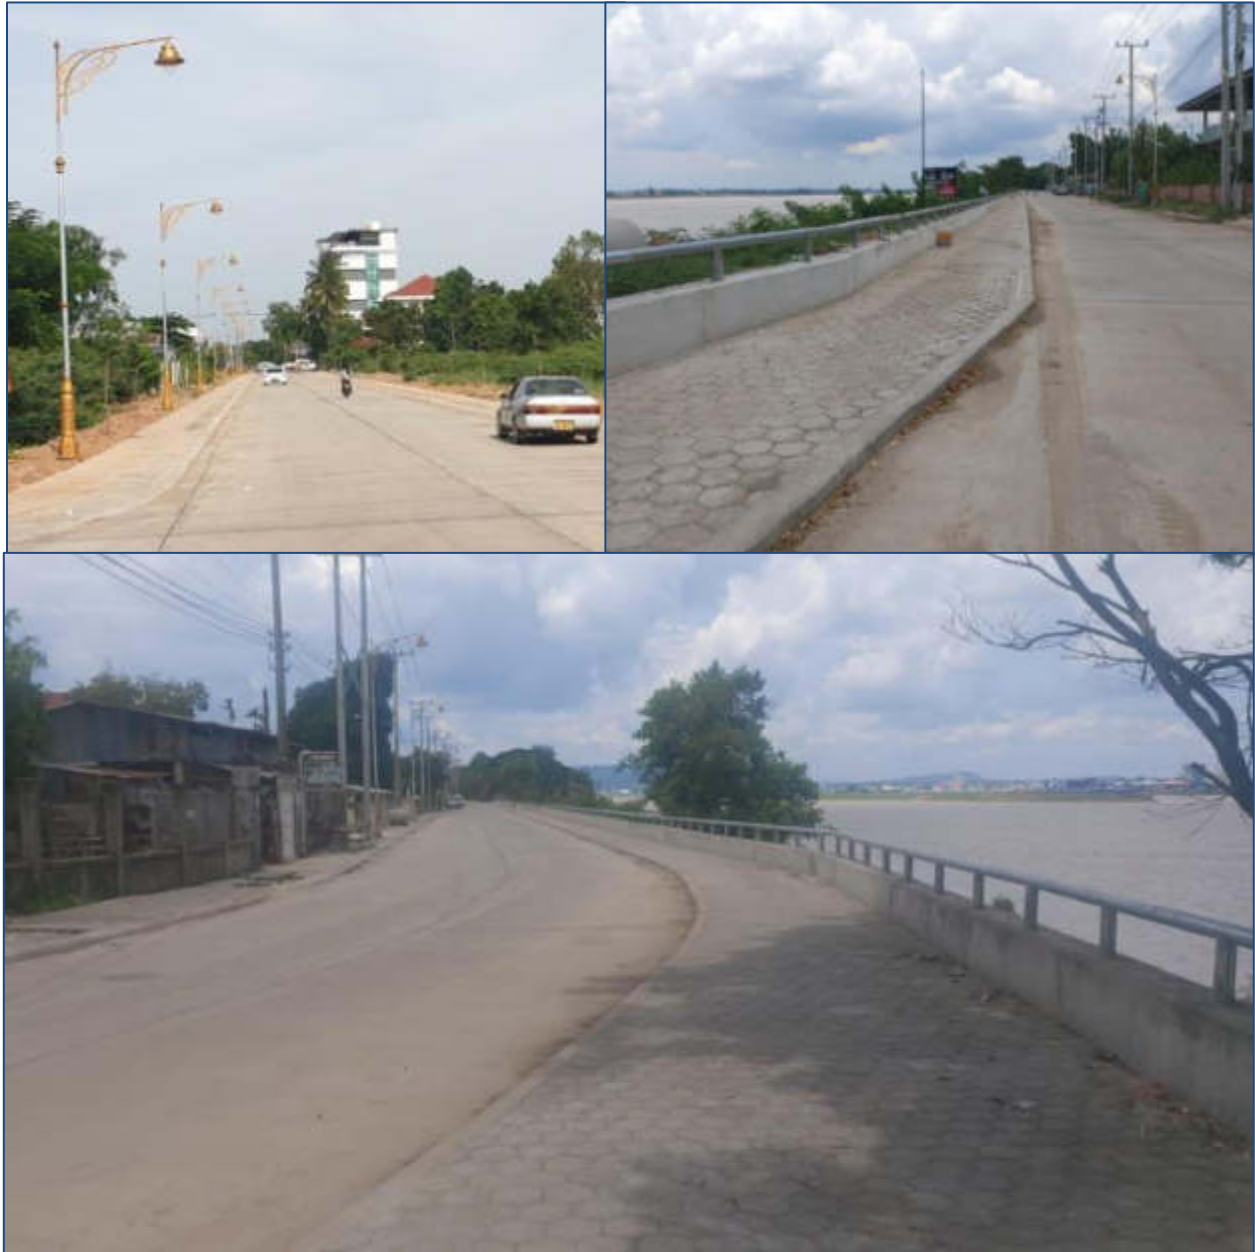
Figure 18. THE COMPLETION OF THAHAE AND SOUKHAVADI ROAD

46. Thahae and Soukhavadi road construction, these two roads were upgraded from DBST to concrete pavement with drainage, sidewalk and streetlight. The construction works has been completed during this report period. These included drainage, concrete pavement works and curbs and sidewalk installation, closing manholes, streetlight installation. The traffic signs and road marking will be implemented next quarter, together with main contract.

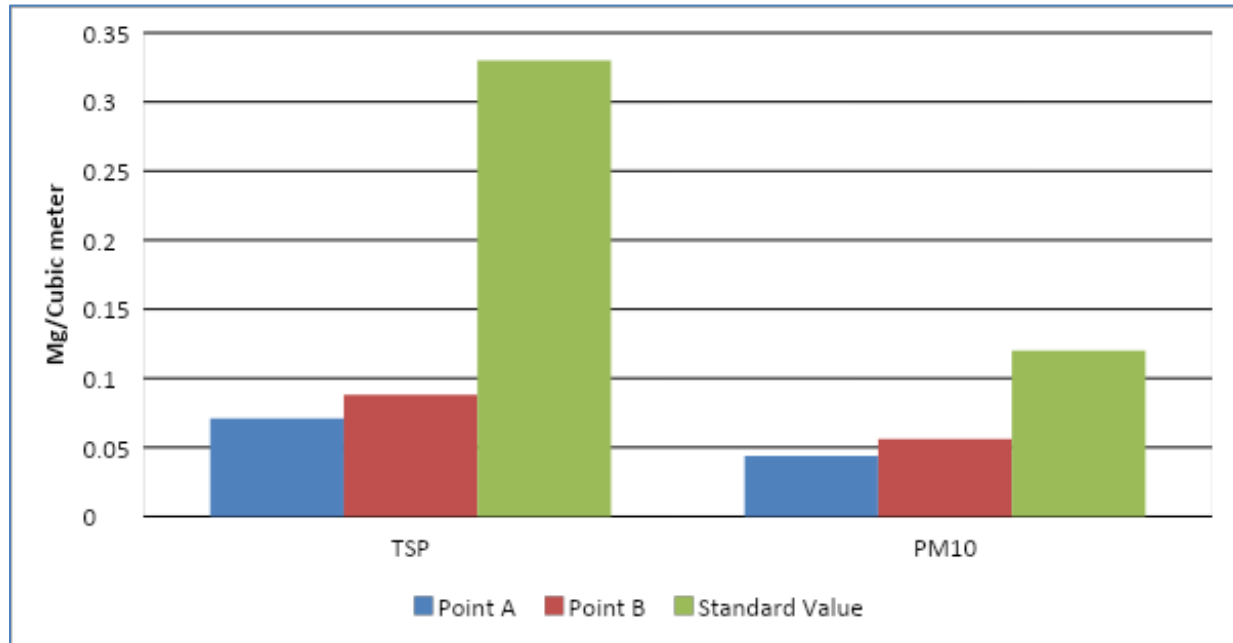
Figure 20. Dust Monitoring Result

Measured Items	Parameter	Point A	Point B	Standard ²	Unit
Dust Quality	TSP	0.071	0.088	0.33	Mg/m3
	PM10	0.044	0.056	0.12	Mg/m3
Ambient air quality in general	SO2-1h	0.0054	0.0073	0.13	ppm
	SO2-24h	0.0085	0.0062	0.05	ppm
	NO2-1h	0.016	0.0166	0.11	ppm
	NO2-24h	0.0117	0.0108	0.14	ppm
	CO-1h	1.1	1.2	30	ppm
	CO-24h	0.93	0.95	9	ppm
	OZ-8h	0.26	0.236	-	ppm
	OZ-24h	0.0289	0.234	-	ppm

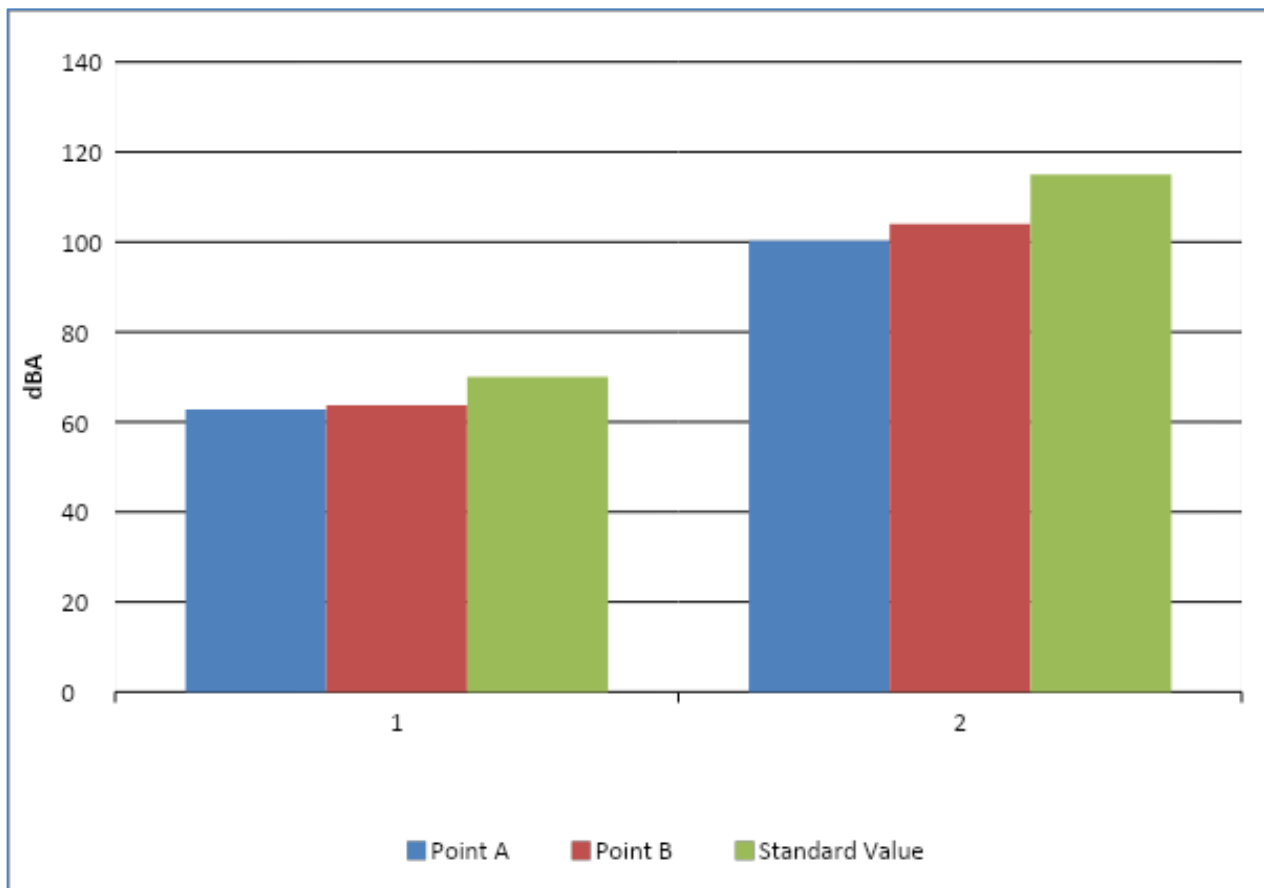
Figure 21. RESULT OF AMBIENT NOISE MONITORING

61. The ambient noise is also monitored in two locations same locations with ambient air selected for 24 hours and same time period. Table 9 presents result of ambient noise monitoring, there are two main parameters as Leq24, Lmax. Both parameters and two locations from result monitoring are under the national environment standard. Opposite of

Measured Items	Parameter	Point A	Point B	Standard2	Unit
Ambient Noise	$L_{eq\ 24}$	62.8	63.7	70	dBA
	L_{max}	100.3	104	115	dBA

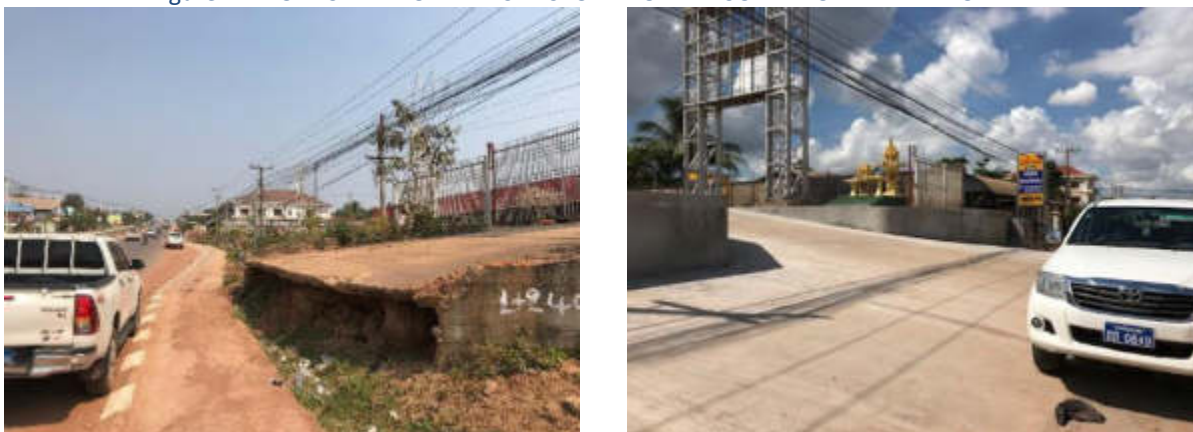
Figure 22. ROADSIDE PROPERTIES RESTORED ON KAYSONEPHOMVIHANE ROAD

Property access affected (left) has been restored (right)

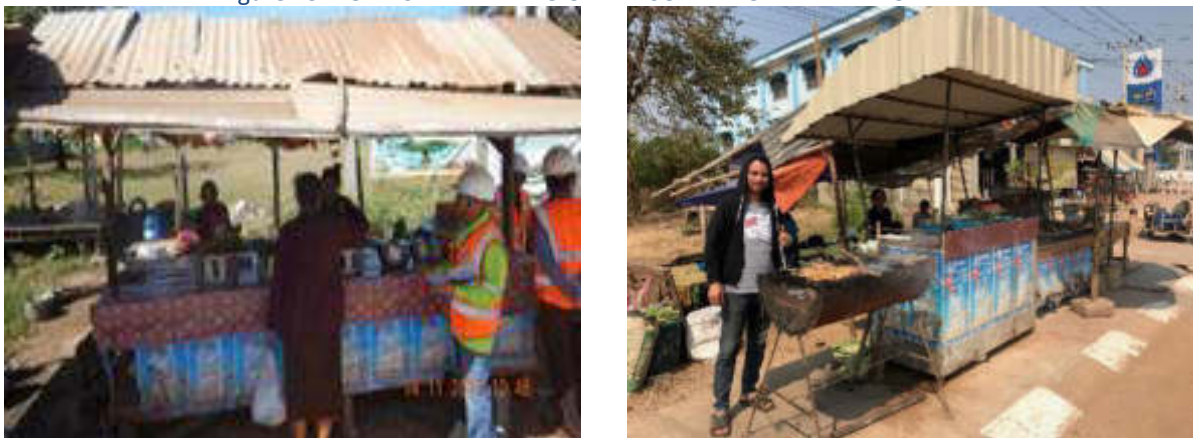
Figure 23. ROAD SIDE VENDING ON KAYSONE PHOMVIHANE ROAD

73. The Kayson Phomvihane Road Subproject includes bus bays at intervals along the road to enable passengers to safely embark and disembark. The Resettlement External Monitor (REM), observed that five vendors were previously located in the vicinity of the bus bay at STA 5+540-STA 5+734 but that no compensation or other allowances was provided by the Subproject. PMU/CSCS was requested to undertake a due diligence review to ensure these vendors had not been overlooked in the assessment of eligibility and entitlements. The review (see Appendix H) found these vendors had not been affected by the Subproject as they had been located on privately owned land outside the construction limits and had moved at the request of the land owner who wished to develop the land (an empty plot). Subsequently two of the vendors have returned to a nearby roadside location and continue to sell cooked foods, while the other three vendors have successfully re-located their businesses elsewhere.

Vendors observed in November 2018 prior to Subproject construction (left) and after construction works in February 2020 (right)

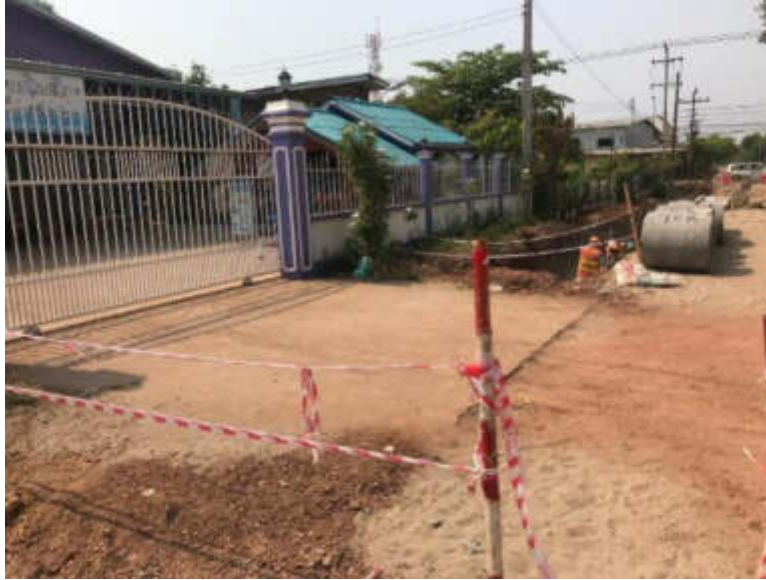
Figure 24. MAINTAINING ACCESS TO PROPERTY ON FANGUM ROAD

74. Regular site inspections have been undertaken to ensure continuous access to roadside properties during the construction period. No issues or grievances are outstanding. The completed road was handed-over to Municipal authorities on 1 July 2020.

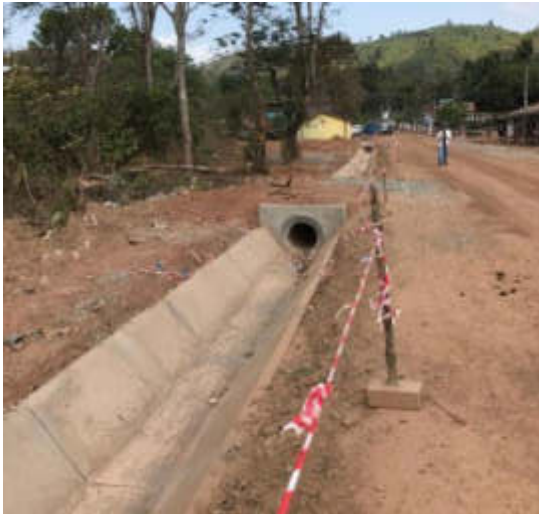
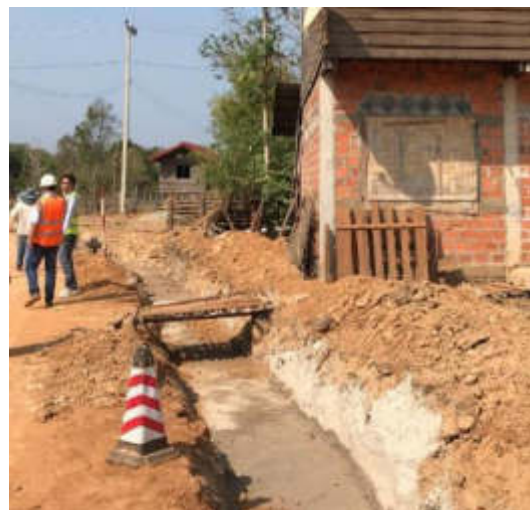
Figure 25. ACCESS FOR ROADSIDE PROPERTIES MAINTAINED IN DANSAVANH AND PHINE

75. Regular site inspections have been undertaken to ensure continuous access to road side properties during the construction period. No issues or grievances are outstanding. The completed road was handed-over to District authorities on 1 July 2020.

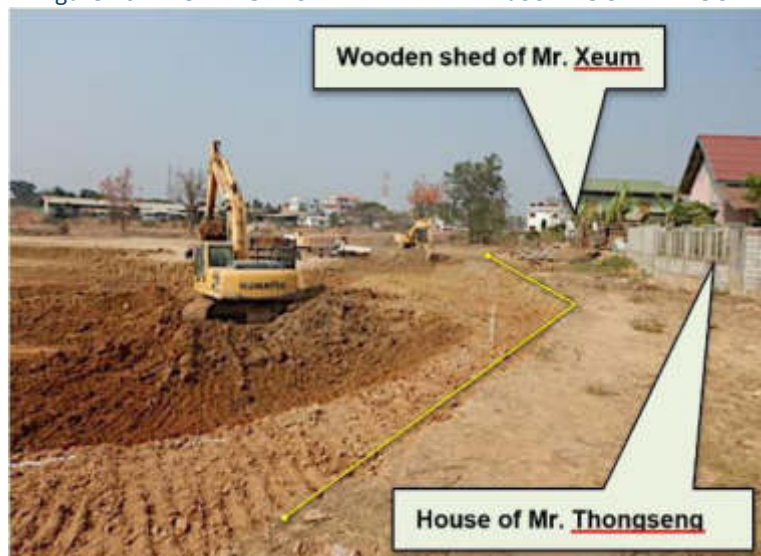
Figure 26. AVOIDING RESETTLEMENT BY ADJUSTING SITE LAYOUT

Construction limit is marked by yellow line

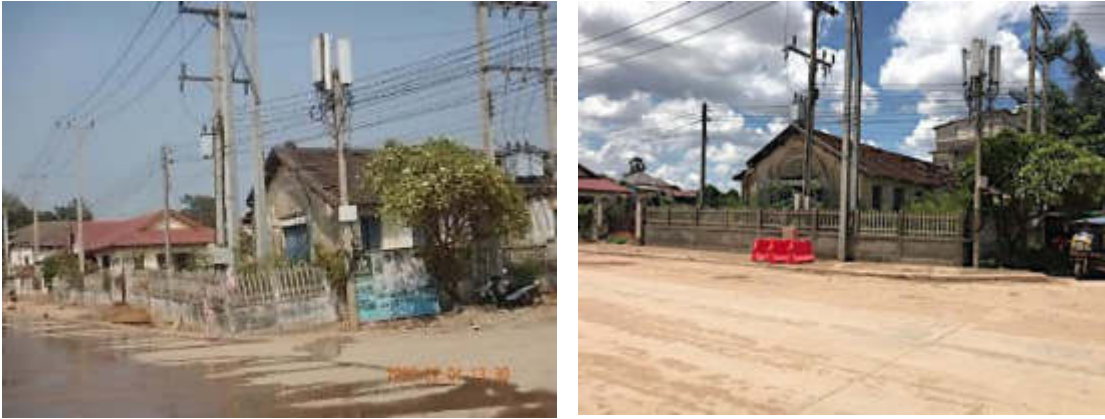
Figure 29. BOUNDARY WALLS ON MEKONG EMBANKMENT ROAD

89. Two boundary walls abutting the Mekong Embankment road were damaged by road construction: 1) a brick boundary wall has slumped as a consequence of earthworks nearby, and 2) a low wall between a property and the side-walk was removed by road contractors to enable the pavement to be re-laid. The civil works contractor has been instructed to ensure these are restored to their pre-project state. The first wall has been rebuilt. The second case remains outstanding; the Project team will monitor compliance.

A boundary wall slumped due to drainage works carried out by the sub-project and has been repaired

and Soukhavadi Road).			
Damaged assets of residents should be restored or repaired (e.g., fences at Mekong River Embankment Subproject)	Not applicable (new item)	Not applicable (new item)	□ In progress 1 wall prepared; agreement in place to repair 2 nd wall before completion of road

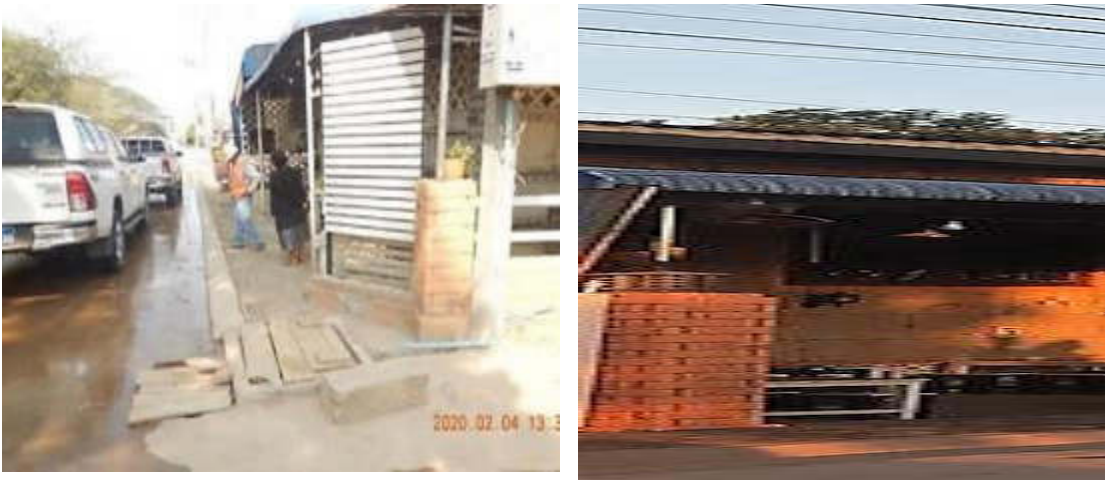
A low (40cm high) brick wall was removed for drainage and pavement works. The owner is undecided if she wants the brick wall restored, as it may interrupt access to her restaurant.

Date Subproject	Description of Grievance	Result of Investigation	Resolution Status
Issues outstanding from previous reporting period			
26.08.2019 Mekong Embankment	One (1) road-side property owner complained that road works had encroached on land, damaged a brick wall and negatively affected business revenue.	Investigation found: - road works are within right of way and no encroachment has occurred; - Boundary wall was damaged by road construction; - Business can continue operating without adverse effects	Pending - One damaged fence has been rebuilt. - Owner of second wall is undecided about the need for restoring the wall as they are operating a kerb-side restaurant.
