Environmental Monitoring Report

Semestral Report
July 2015

GEO: Urban Services Improvement Investment Program – Project 1

**Georgia: Urban Services Improvement Investment Program (Tranche 1)
(Financed by the Asian Development Bank)**

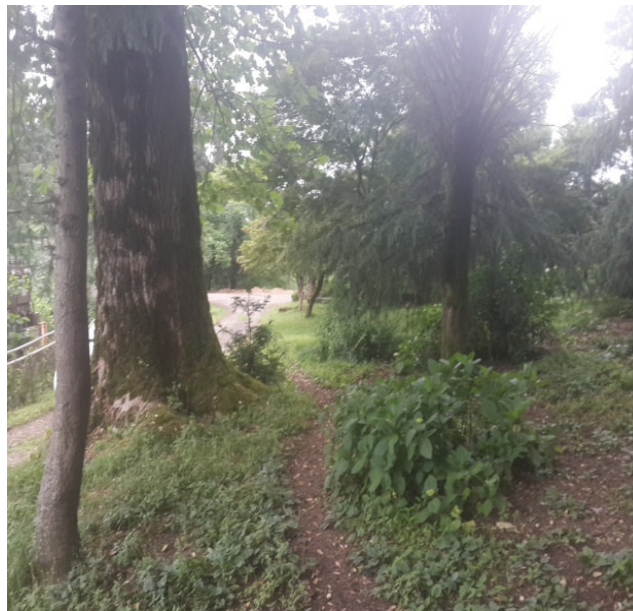
Fig. 3: 100 years old pine tree in Ureki #1 Reservoir

74. Mission requested UWSCG to discuss several alternatives in order to minimize cutting of trees and make optimal design of reservoir #1 under the Ure-01 project. ADB's approach was to keep 100 years old tree, which is located at the border of the reservoir design, close to the residential house and the households' graveled road and applied to the Contractor's representative during the mission to discuss all possible options to avoid cutting of this particular tree.

75. As a follow up to this requirement UWSCG/DREP organized special meeting and developed Minutes of the Meeting, shortly after the return of the mission to discuss how to proceed with this issue. UWSCG/DREP invited UWSCG's design staff, SC, Contractor and Environmental Specialist of RETA/ADB Ms. Ketevan Dgebuadze. Based on the hard discussions it was agreed that in order to save this particular tree, there would not be any problem if the location of the red line of the reservoir will be shifted with 5-6 meters at the expense of the reservoir's

76. Finally, as a result of intensive communication with the biodiversity specialist, parties agreed (in order to avoid any unforeseen cases, like damage of the roots of the tree) the reservoir border to be shifted with 6 meters underling that this will reduce capacity of one of the reservoirs down to 2,000m³ and instead of two 3,000m³ reservoirs finally two reservoirs with the capacity of 3,000m³+2,000m³ will be constructed.
77. Other activities envisaged by the Mission's Note (5-8 May, 2015) are currently on-going and new deadlines are presented in Article 5 – Action Plan for the Next Period. Implementation status of these activities will be presented in the next EMRs.

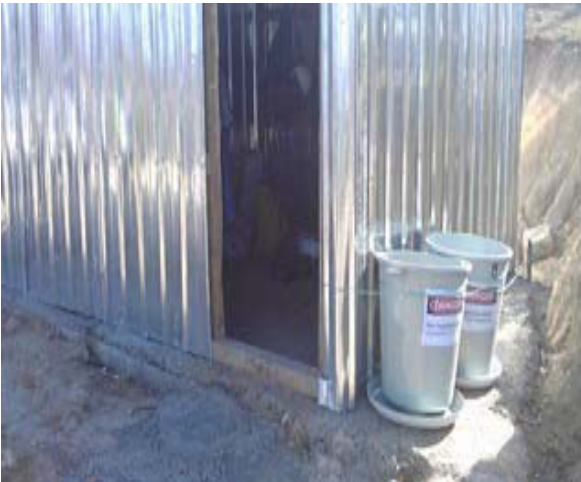
EMR reports and Non-compliant Notes are available on all construction sites

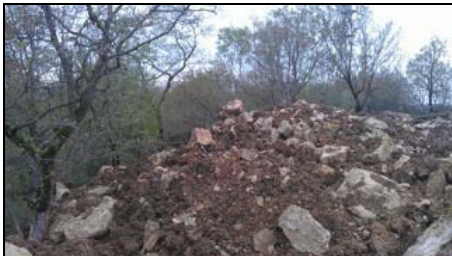
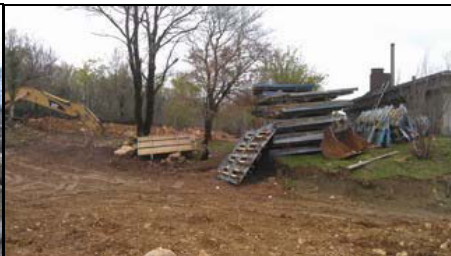
</div>	
Vaja-Pshavela site	
<ul style="list-style-type: none">- Proper fuel/oil spill response items should be available at the site as per SEMP. It should be noted that non-relevant spill response item (adsorbent) was only once available on site according to monitoring recordings- Special shelter or storage should be arranged for hazardous materials storage.- On site there is only non-hazardous waste container available, however there are number of spots detected with improper placement of hazardous waste. Haz.waste container should be available permanently on site.- Site internally should be arranged properly and cleaned regularly- There is only tree available on site that needs thorough protection, however contractor does not take any measures for its protection- Warning sign at the entrance gate should be bilingual- Trucks wheel washing platform and its drainage system needs fixing and regular cleaning

- There is no enough personnel safety measures implemented i.e. there is high risk of personnel damage with electric devices

All these conditions have to be remedied immediately by the Contractor (Cobra).

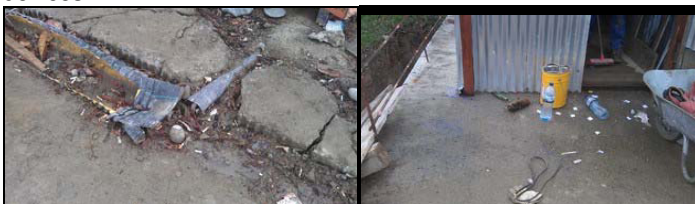
TV Tower site

- Site boundaries are not well defined/fenced and there is risk of damage of vegetation.
- Relevant and enough warning signs should be installed
- Site should be organized and cleaned regularly. Moreover, hazardous waste should not be available on site.
- Construction materials should be kept segregated and in appropriate places to avoid blockage of road.
- Special place for hazardous materials (chemicals) storage should be allocated/arranged
- Bio Toilet should be installed

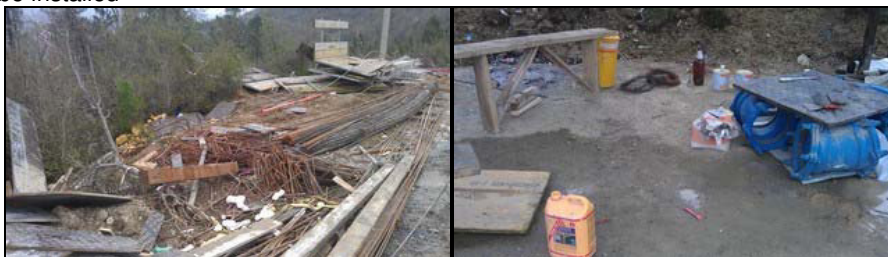
Network

- Tranches should be fenced with safety lines to avoid accident of population
- Accumulated waste soil should be placed in a place to avoid disturbance of population
- Construction materials should be brought when needed to avoid its long time disposal in the streets. Even if so, construction materials have to be fenced and marked relevantly
- Enough and relevant walkways/planks should be installed across open tranches when passing settlement area! (example: Solomon I street)
- Water should be pumped immediately from the tranches
- Special blinking signs and flag men should be provided when passing intensive streets to avoid disturbance of car movements
- Entrance of resident houses should be clean from construction materials to avoid disturbance of residents and businesses
- Enough and regular safety personnel should be provided by contractor when passing heavily populated sections

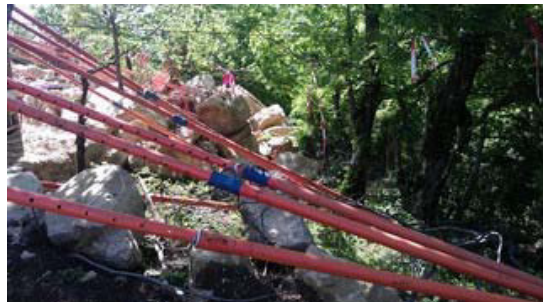
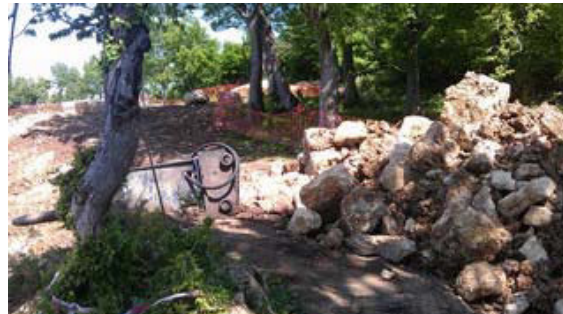
Vaja-Pshavela Site

- Proper fuel/oil spill response items should be available at the site as per SEMP
- Hazardous materials are stored improperly. Moreover, the sign of its leaking was detected. Urgently such materials should be reallocated and stored in safe place with special protection measures
- Hazardous waste container should be available permanently on site
- Site internally should be arranged properly and cleaned regularly
- There is only tree available on site that needs thorough protection, however contractor does not take any measures for its protection
- Trucks wheel washing platform and its drainage needs fixing. Drainage pipe is not available at all
- Safety signs should be placed at the fencing (especially from school side)

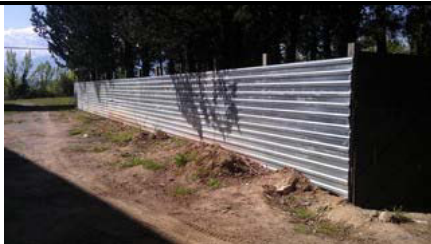
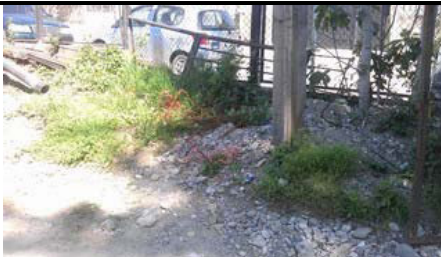
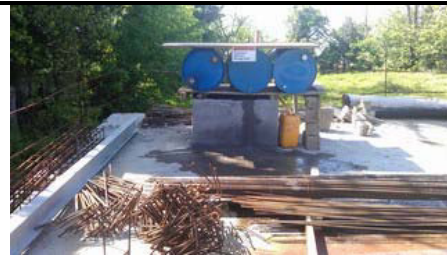
TV Tower site

- Relevant and enough warning signs should be installed
- Site should be organized and cleaned regularly
- Hazardous waste container should be available permanently on site
- Household container should be marked with sign
- Bio Toilet should be installed

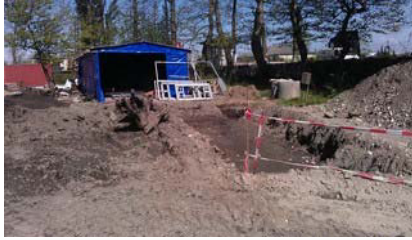
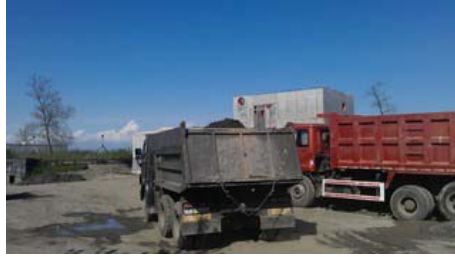
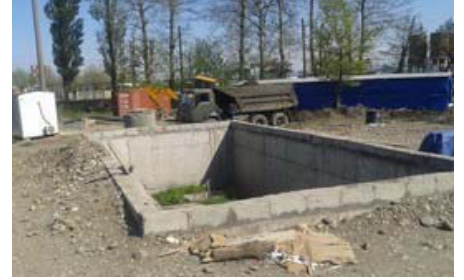
Poti - Nabada

- Open trenches should be fenced with safety lines to avoid accident
- Hazardous and household waste container should be available permanently on site. In the past it was available all the time!

- Proper fuel/oil spill response items should be available at the site as per SEMP. Due to improper operation of contractor such items are damaged and are not available anymore!

- Tarpaulins should be used to cover trucks when transporting construction materials
- Chlorine balloon should be removed from construction site. No measures are implemented with this regard!

- Bulky waste materials should be removed from the site!
- Site should be fenced completely
- Surplus soil should be removed from construction site. If it is intended to be used for beneficial purposes it should be stored and fenced in proper remote place!

All these conditions have to be remedied immediately by the Contractor (Cobra).
