Environmental Monitoring Report

Semestral Report
July 2017

GEO: Urban Services Improvement Investment Program – Project 1

Project Number: 43405-023
January-June 2017
Loan Number 2749-GEO (SF)

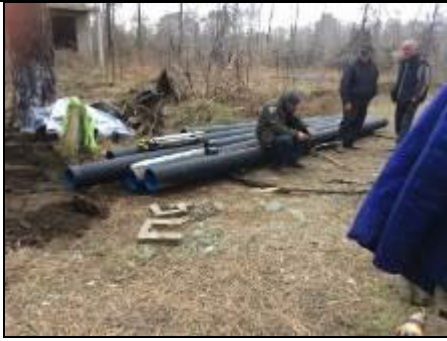
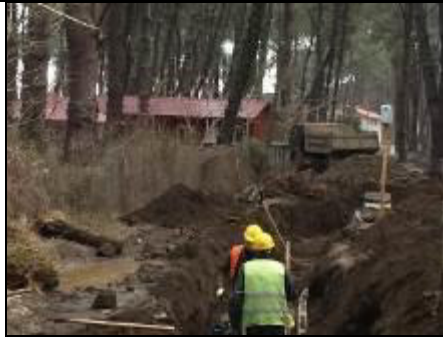
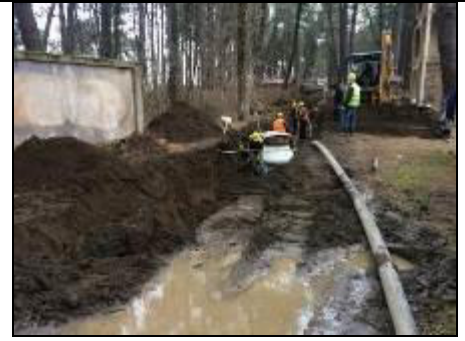
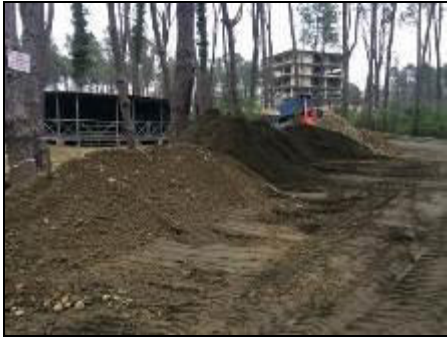
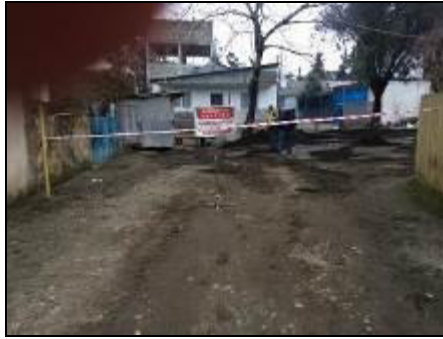
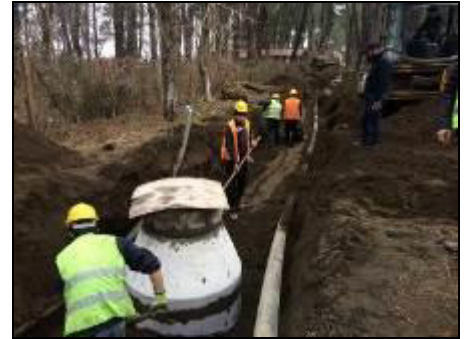
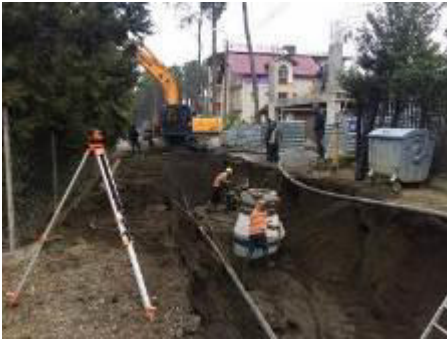
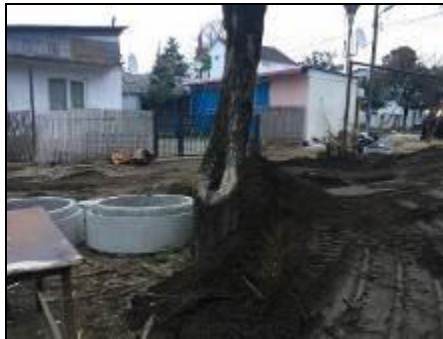
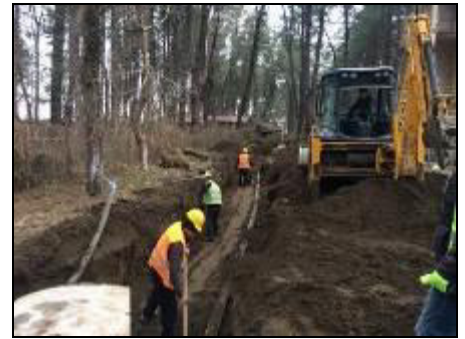
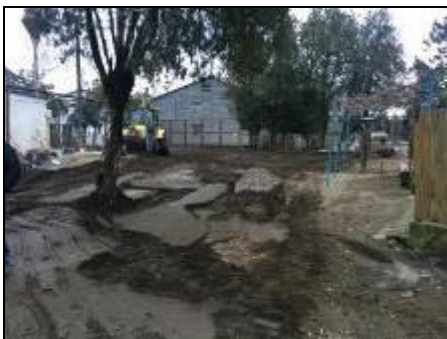
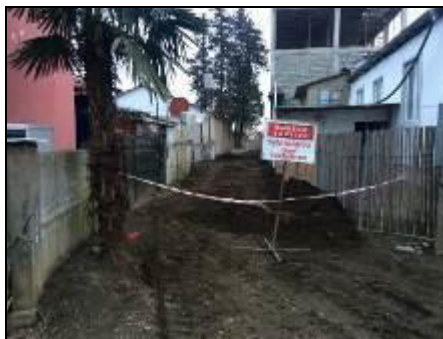
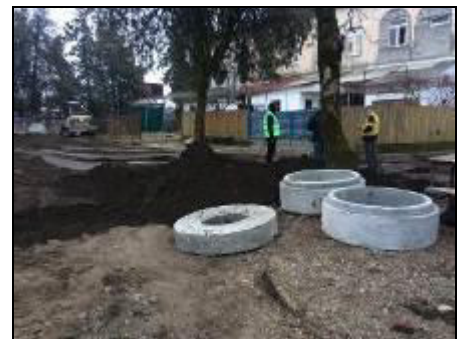
Project: USIIP	Non-compliance Notice UREKI
Contract No: URE-01	
Contractor: PERI	
Reference: UREKI – NETWORK, RESERVOIR	
This notice is to advice you, the prime Contractor, on the referenced Contract, of the following notice on environmental measures to be implemented urgently .	
 <u>NON-COMPLIANCE IN UREKI</u> NETWORK High visible safety signs/tapes and trench side barriers around of deep open trenches should be installed to avoid accident of population Construction activities information signs should be installed at each construction segment Walls of the deep trenches (>1.5m) should be strengthened by boards to avoid landfall of the soil and accidents Where are necessary proper wooden/metal walkways/planks across open trenches should be installed Accumulated waste soil should be removed from construction area and disposed in a proper place Construction materials should be brought when needed to avoid its long time disposal in the streets and disturbance of residents and businesses Resident houses nearby areas should be clean from construction materials to avoid disturbance of residents and businesses Trees of nearby construction zone should be protected to avoid its damage Use tarpaulins to cover during materials transportation Workers always should use complete PPE All network line construction segments should be cleaned/well organized on regular bases

All these conditions have to be remedied within four days (by the 18 February 2017) by the prime Contractor (Peri).

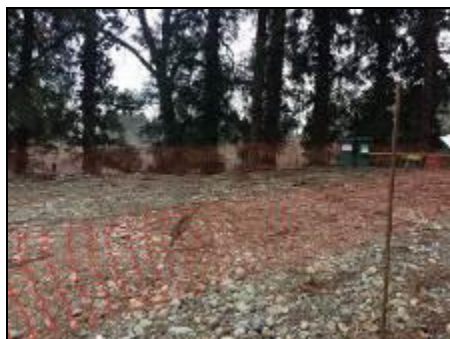
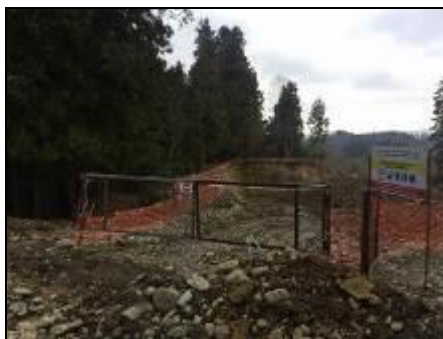
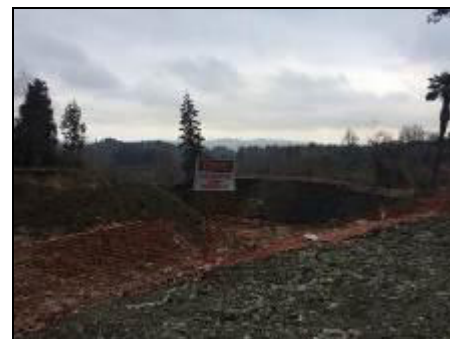
RESERVOIR

Trees at the construction site should be protect to avoid its damage

Proper fuel/oil spill response items (sand, sawdust, special containers) should be available at the site

Site internally should be arranged properly and cleaned regularly

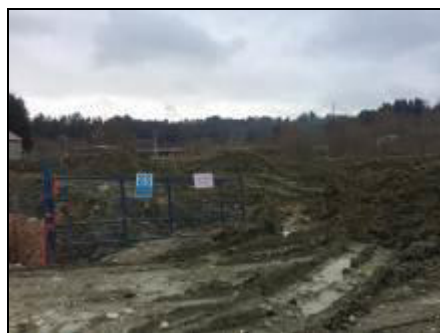
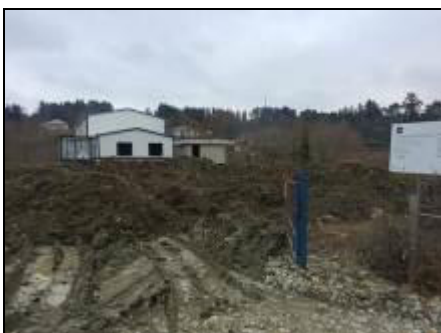
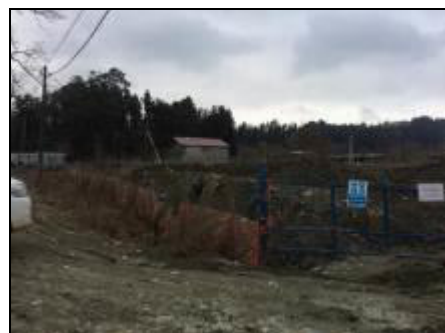
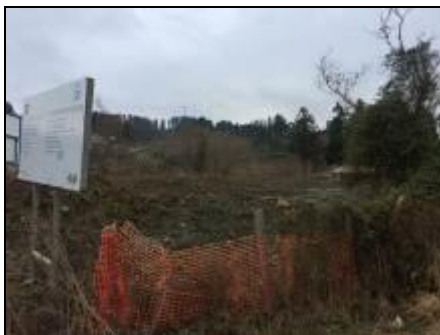
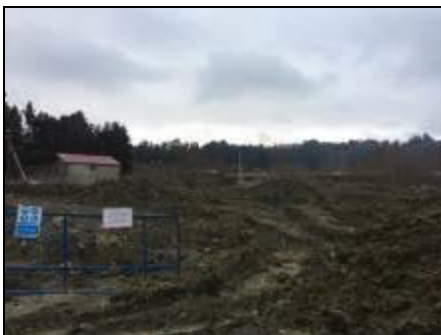
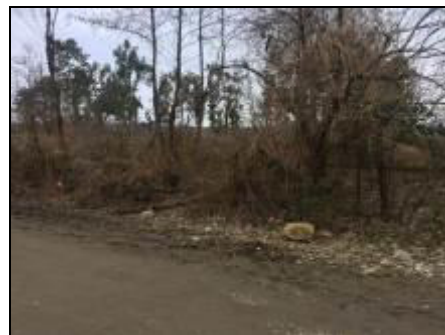
PUMPING STATION

- Entrance door of construction site should be in better operational condition and closed as needed
- Piles of soil at the construction territory should be managed properly (grading/leveling)
- The site access road and internal roads should be arranged
- Proper place for Parking with relevant sign should be arranged
- Site internally should be arranged properly with signage and cleaned regularly

All these conditions have to be remedied within four days (by the 18 February 2017) by the prime Contractor (Peri).

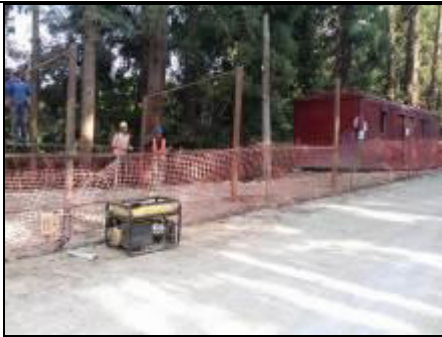
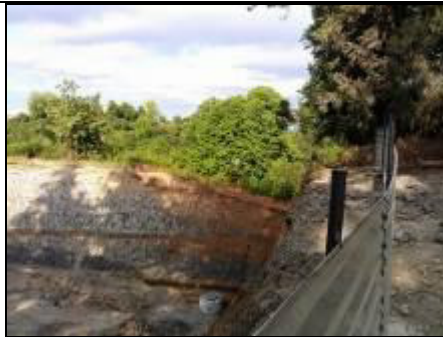
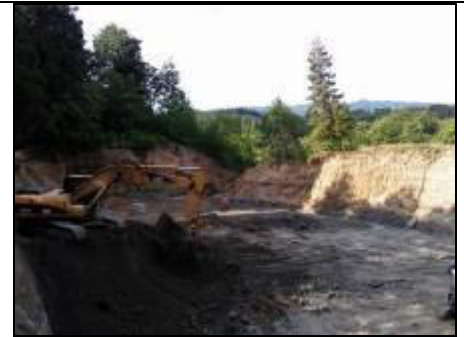
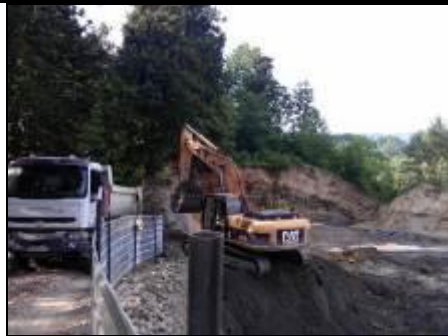
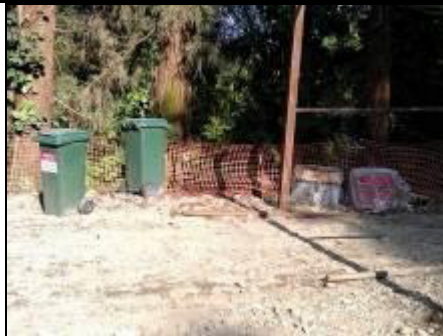
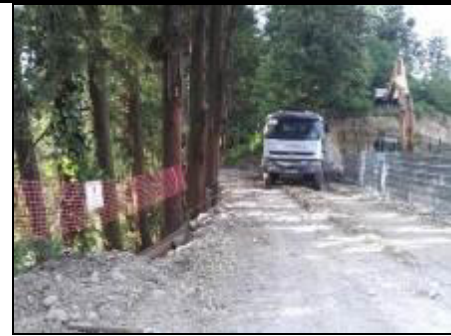
Trees at the construction site and nearby deep excavation zone should be fenced protect to avoid its falling and damage

Walls of the deep trenches (>1.5m) should be strengthened to avoid landfall of the soil and accidents

Workers always should use complete PPE

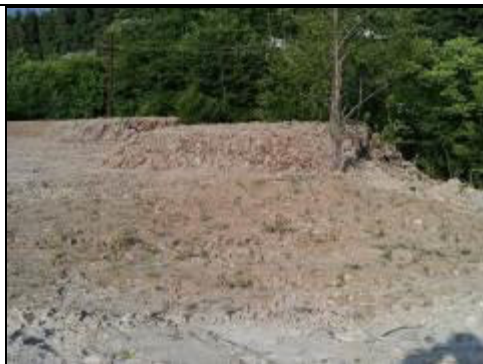
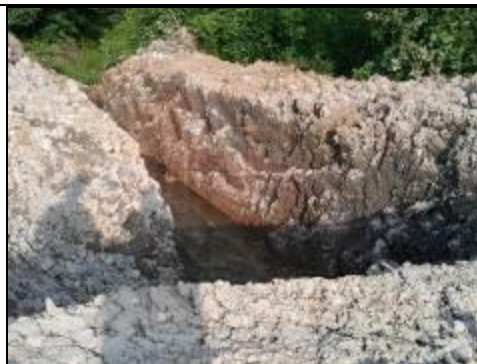
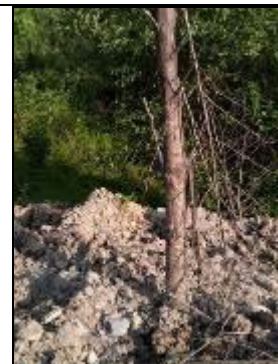
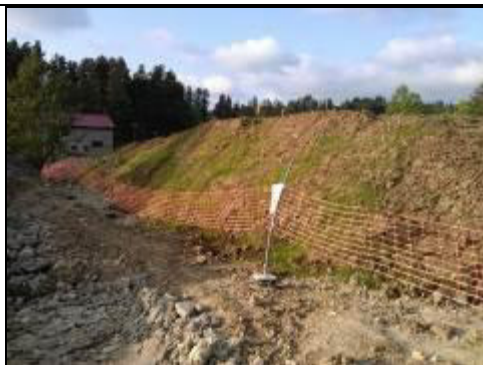
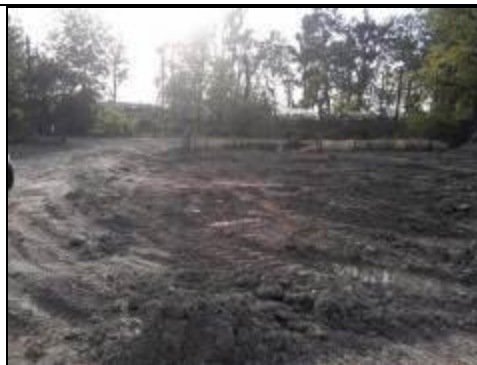
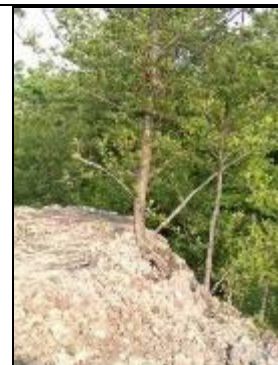
PAMPING STATION

Trees at the construction site and nearby should be well protect to avoid its damage

Gate should be closed and locked to avoid non-authorized entrance at the site

Site internally should be arranged properly and cleaned regularly

All these conditions have to be remedied within four days (by the 10 June 2017) by the prime Contractor (Peri).

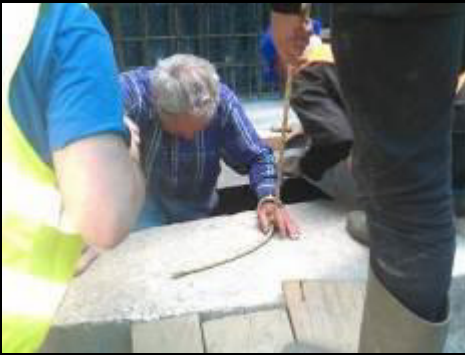
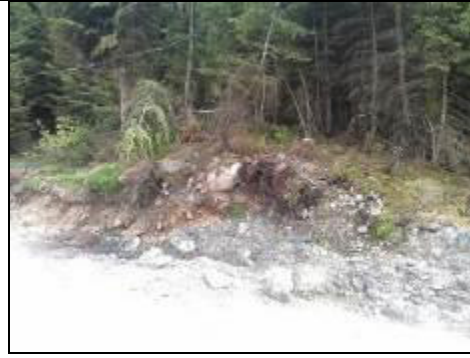
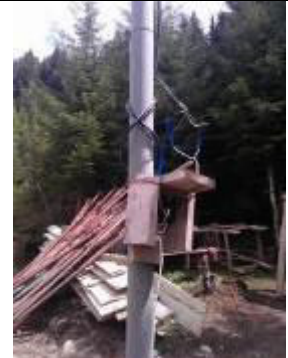
ZARGASHI RESERVOIR

- **Construction territory should be fenced from all sides properly**
- **Electricity equipment (transformer, cable) safe maintenance should be ensured**

- Soil for backfilling purposes should be stored properly
- Construction waste materials should be managed properly and disposed at the proper organized place

- PPE equipment should be used always and completely by all workers (even personnel of subcontractor)
- Site internally should be arranged properly and cleaned regularly

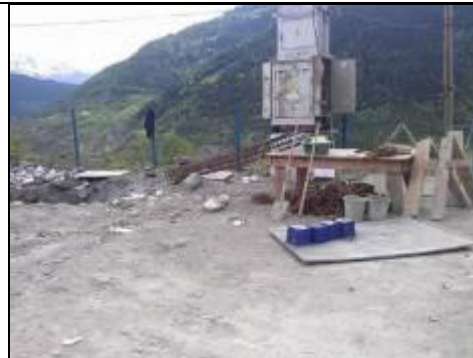
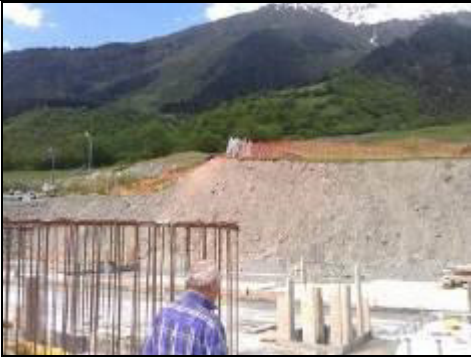
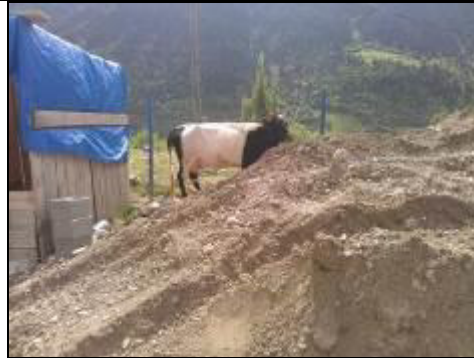
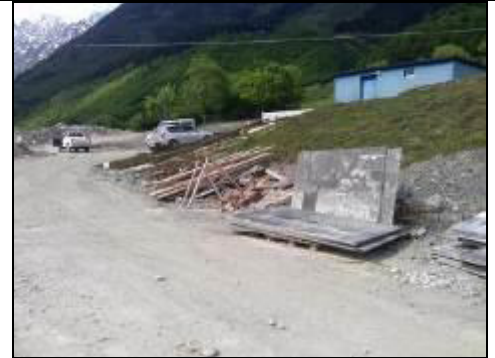
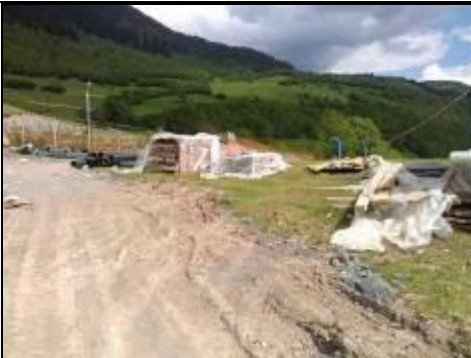
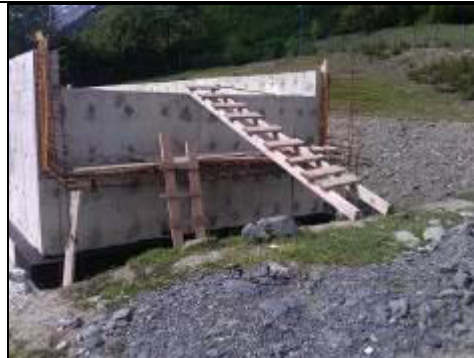
LANCHVALI RESERVOIR

- Construction sites should be fenced from all sides and equipped with lockable gate with proper warning signs
- Ladder safety should be ensured
- Special equipment during working at heights should be used
- Dust prevention activities should be provided in windy and dry weather
- All construction materials should be properly segregated and stored adequately
- Construction waste materials should be managed properly and disposed at the proper organized place
- PPE equipment should be used always and completely by all workers (even personnel of subcontractor)
- Site internally should be arranged properly and cleaned regularly

All these conditions have to be remedied within eight days (by the 20 June 2017) by the prime Contractor (Pfeiffer).

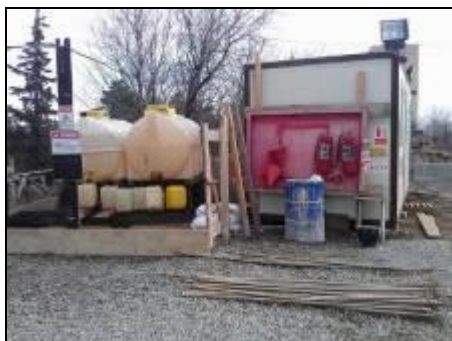
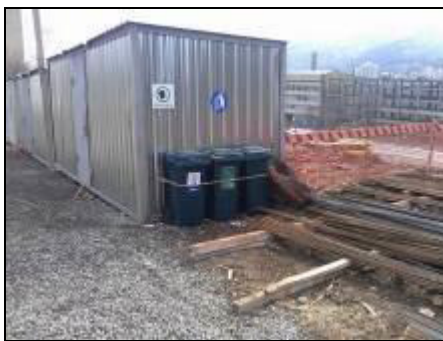
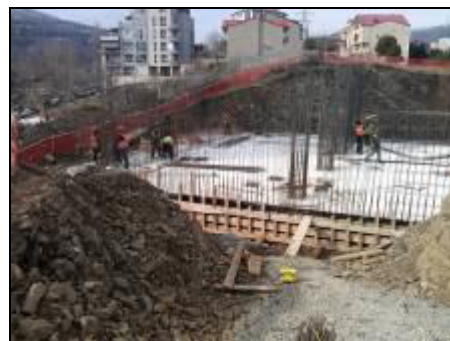
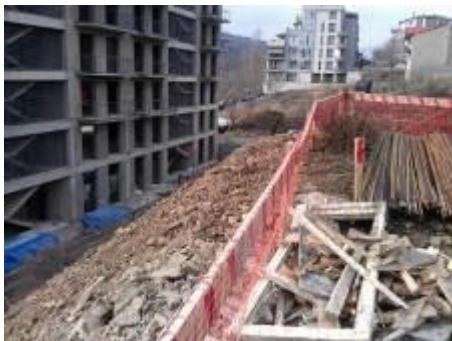
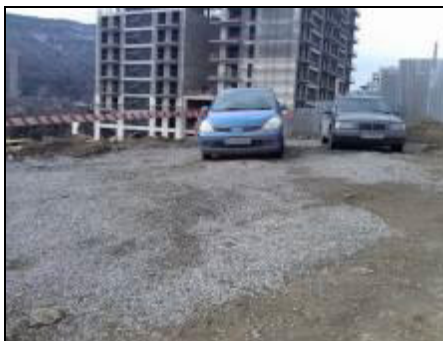
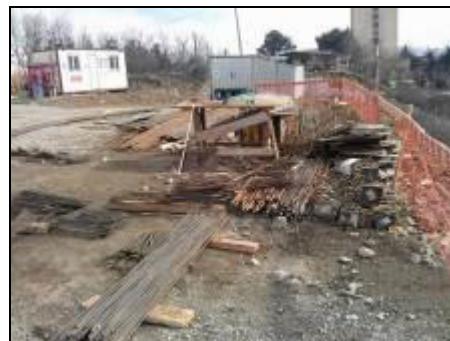
Construction of New Office Building for UWSCG

- Place of fuel containers storage should be with roofing
- Waste containers should be properly labeled (Household waste, Hazardous waste and etc.)
- Waste should be placed in proper waste container and discharged timely
- Parking should be arranged with relevant sign
- Transport should be parked only at the parking area
- Waste construction materials should be removed from the site timely and permanently

All these conditions have to be remedied within four days (by the 18 February 2017) by the prime Contractor (Dagi).

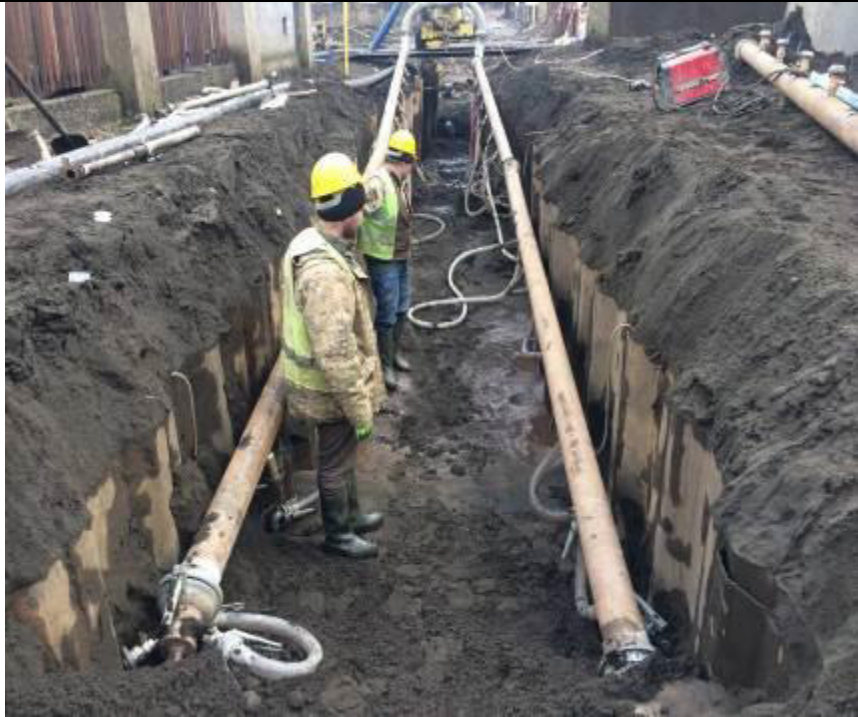
Photo 1

Shoring used for protection of trench collapse.

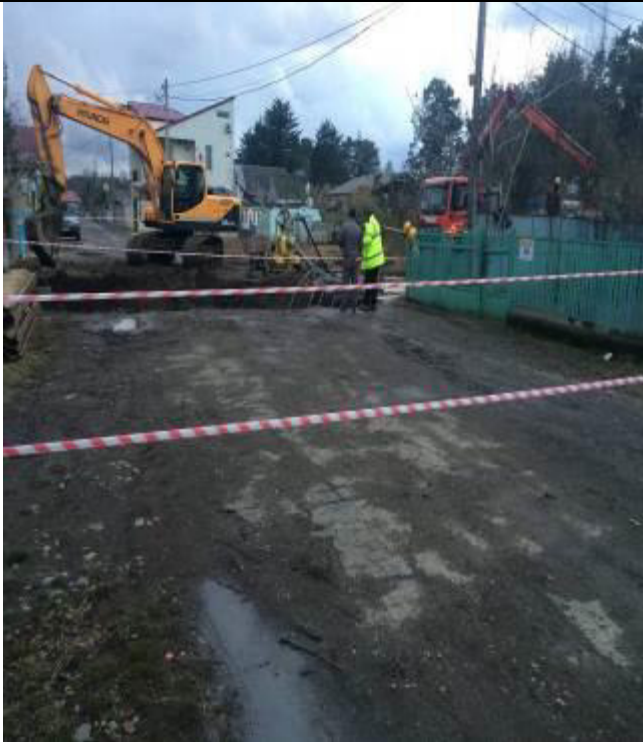
Photo 2

Excavation area protected with high visibility safety tape;

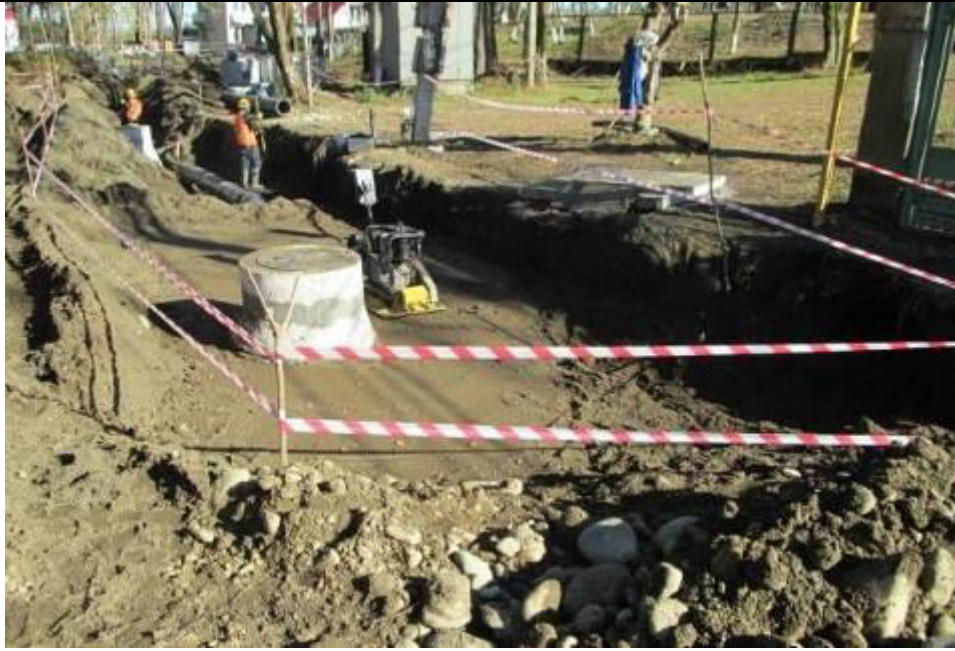
Pipeline installation process;

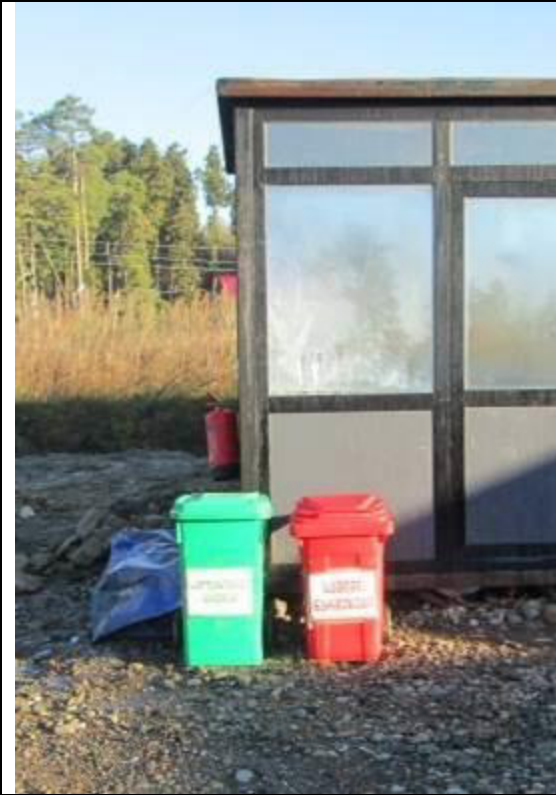
Waste bins at site;

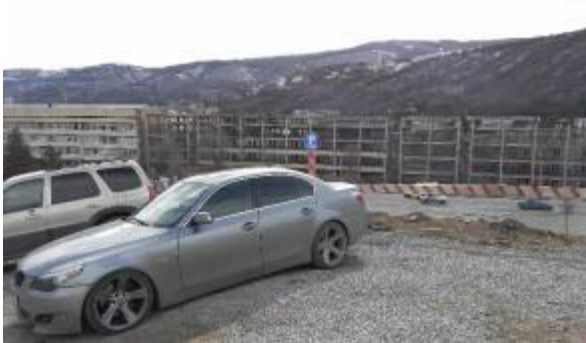
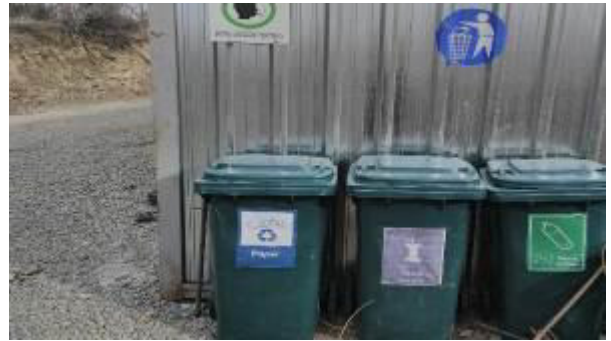
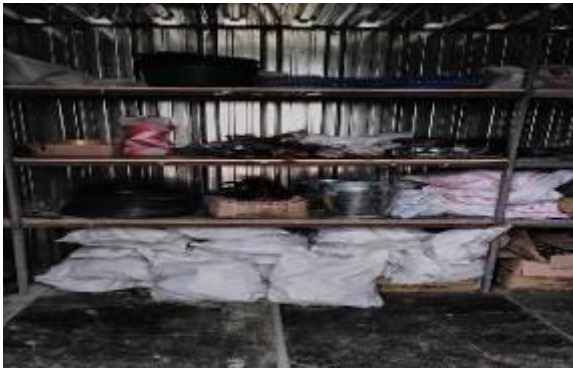
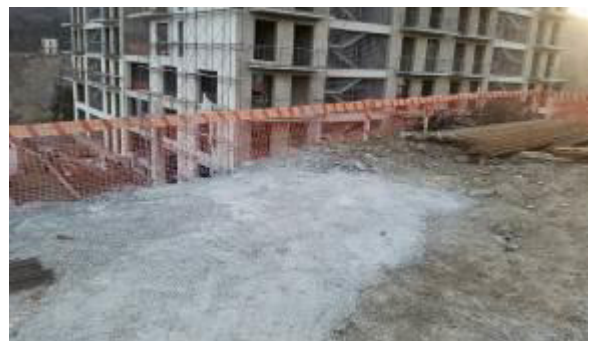
Corrective Action Evidence Photos

6	Waste should be placed in proper waste container and discharged timely	Waste placed in proper waste container and discharged timely	✓	18.02.17	HSE MANAGAR A.CHUMBURIZE
