BI-ANNUAL ENVIRONMENTAL MONITORING REPORT

Project Number: 43405-023
January-June 2018
Loan Number 2749-GEO (SF)

GEORGIA: URBAN SERVICES IMPROVEMENT INVESTMENT PROGRAM (TRANCHE 1) (FINANCED BY THE ASIAN DEVELOPMENT BANK)

Prepared by: Ketevan Chomakhidze, Environmental Consultant
“United Water Supply Company of Georgia”, LLC
Tbilisi, Georgia

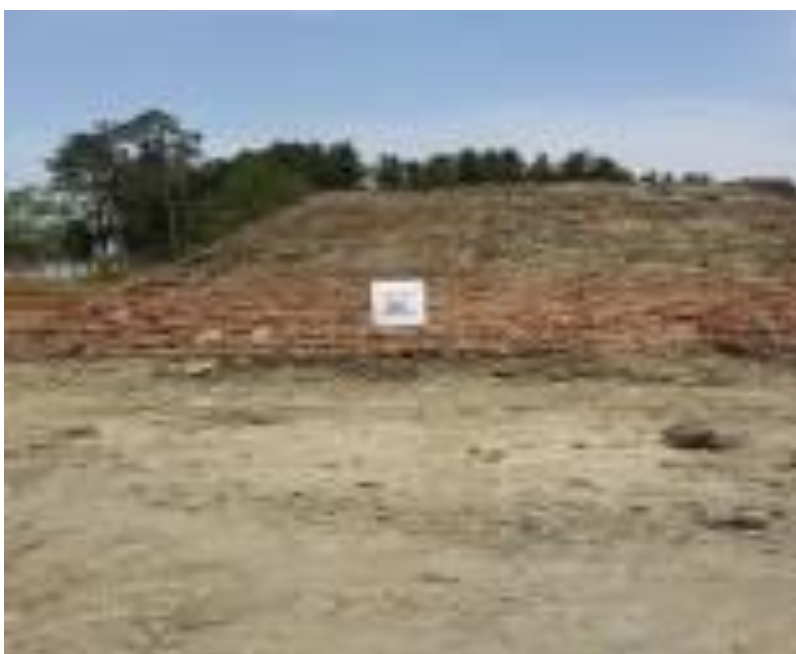
Photo 1: Improved top-soil management under Ure-01/PS

- 73.** Small part of topsoil stockpiled according to the GEO regulations has been mixed with subsoil during backfilling and leveling activities of the territory of Pumping Station under Ure-01 project. The ADB's Mission (April 2017) requested contractor to prepare corrective action plan in cooperation with Supervision Consultant and improve non-compliance within the identified deadline.
- 74.** Status: Completed. Corrective action plan regarding incorrect disposal of topsoil was prepared by contractor. The Topsoil was separated from subsoil and stockpiled separately in accordance with Georgian regulations.

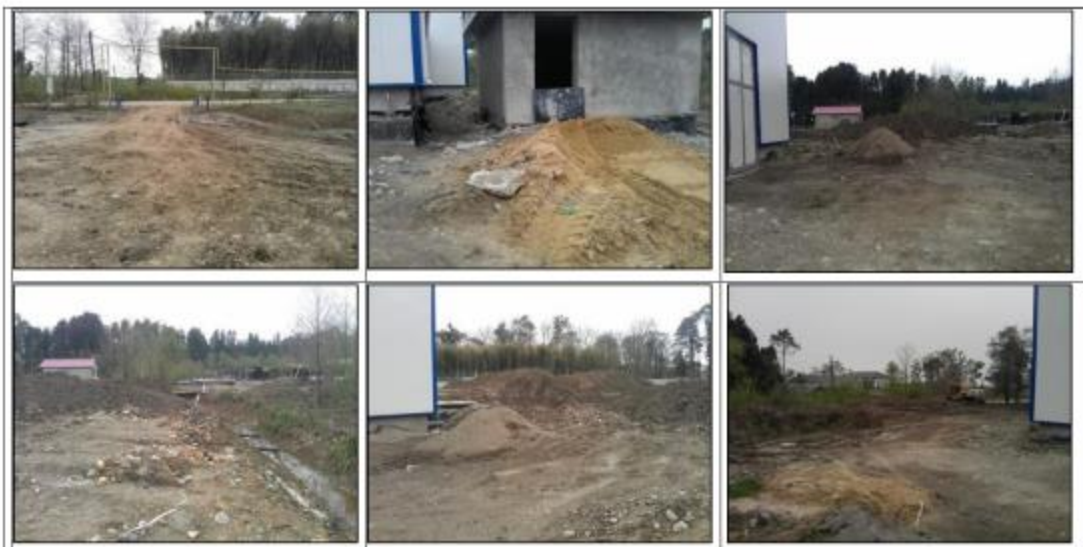
Project: USIIP	Non-compliance Notice UREKI	
Contract No: URE-01		
Contractor: PERI		
Reference: UREKI - UREKI PUMPING STATION		
This notice is to advise you, the prime Contractor, on the referenced Contract, of the following notice on environmental measures to be implemented urgently .		
<u>NON-COMPLIANCE IN UREKI</u>		
<u>PAMPING STATION</u>		
<ul style="list-style-type: none">- Entrance door and fencing of the construction site should be in better condition and complete- Piles of soil at the construction territory should be managed properly- Top soil should be separated from surplus waste soil and managed properly (fencing, signage, piling standard)- Safety tapes around open trenches should be installed- The site access road and internal roads should be better arranged (graveling)- All workers should be equipped with complete PPE- Site internally should be arranged properly and cleaned regularly

All these conditions have to be remedied within four days (by the 31 March 2018) by the prime Contractor (Peri).

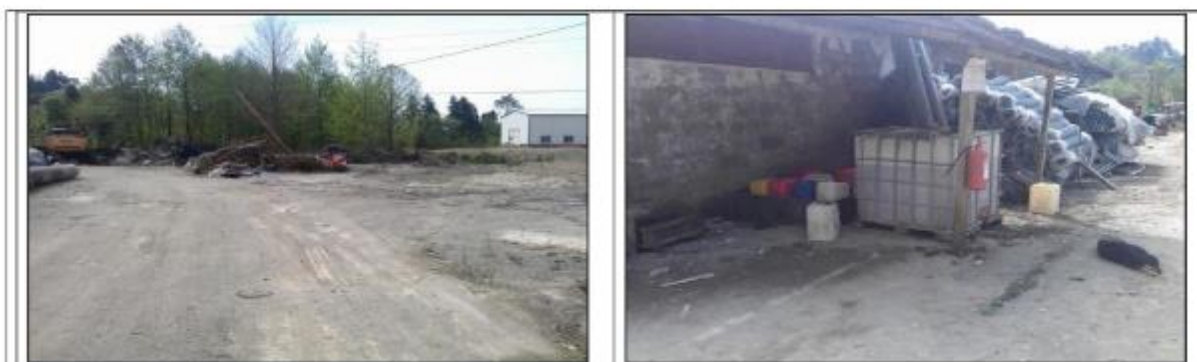
Project: USIIP	Non-compliance Notice UREKI
Contract No: URE-01	
Contractor: PERI	
Reference: UREKI – Camp	
This notice is to advice you, the prime Contractor, on the referenced Contract, of the following notice on environmental measures to be implemented urgently .	
<u>NON-COMPLIANCE IN UREKI</u>	
<ul style="list-style-type: none">- Construction equipment should be in good condition (non leakage)- Proper fuel/oil spill response items (sand, sawdust, special containers) should be available at the site- Construction waste (wooden, metal, plastic, etc.) should be removed from construction area completely and timely- Site gate should be operation at every entrance or exit with relevant signage- Site fencing should be complete and with visible materials on it- Oil spillage traces should not be available at the site- Waste should be placed at the proper standard waste containers with labeling- Containers of lubricants should be managed properly (concrete flooring and relevant roofing)- Construction materials should be segregated precisely and stored properly- Site internally should be arranged properly (including signage) and cleaned regularly (animals should not be available at the site)

All these conditions have to be remedied within ten days (by the 4 May 2018) by the prime Contractor (Peri).	
Date of site visits: 17.04-18.04.2018	
Irakli Legashvili EPTISA – Environment Kate Chomakhidze Environmental Specialist – USIIP UWSCG Maka Goderdzishvili Head of Environmental Department - UWSCG

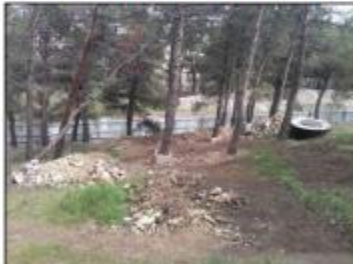
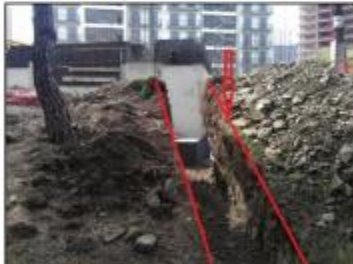
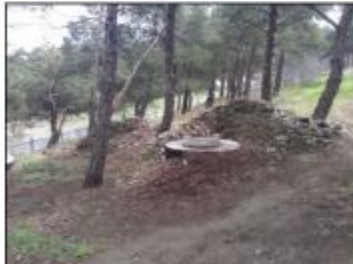
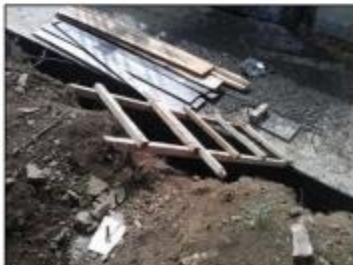
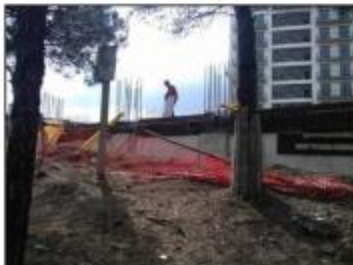
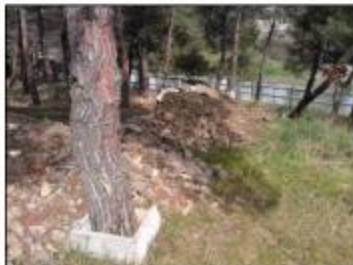
Project: USIIP	Non-compliance Notice TBILISI
Contract No: TBI-01	
Contractor: DAGI	
Reference: Tbilisi – NEW OFFICE BUILDING FOR UWSCG	
This notice is to advise you, the prime Contractor, on the referenced Contract, of the following notice on environmental measures to be implemented urgently .	
NON-COMPLIANCE IN TBILISI	
Construction of New Office Building for UWSCG	
<ul style="list-style-type: none"> - Construction territory visible fencing should be restored in some locations - All trees at the construction area and nearby should be protected on proper way (freed from surplus waste soil and stones) to avoid its damage - Surplus waste soil should be removed from the construction territory and disposed according agreement - Special equipment during working at heights should be used - Safety norms during works at the height should be respected to avoid workers damage - Ladder safety should be ensured - Safety rules with electric cable use should be respected - Walls of the deep trenches (>1.5m) should be strengthened by boards to avoid landfall of the soil and accidents - The slope near of the construction area should be strengthened by special grid to avoid land/stone falling and damage - Construction territory and wooden materials should be freed from used nails to avoid personnel damage - The way to the waste containers should be freed from construction materials - All construction materials should be properly segregated and stored adequately - All workers should be equipped with complete PPE - Site internally should be arranged properly and cleaned regularly

All these conditions have to be remedied within four days (by the 31 March 2018) by the prime Contractor (Dagi).

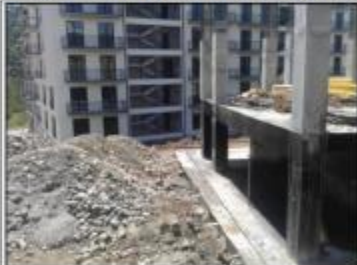
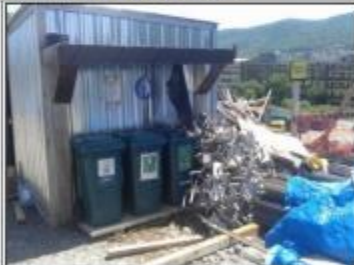
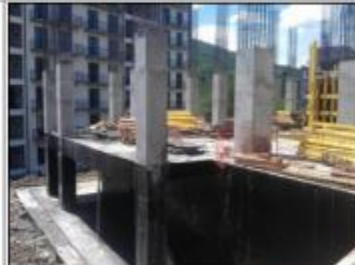
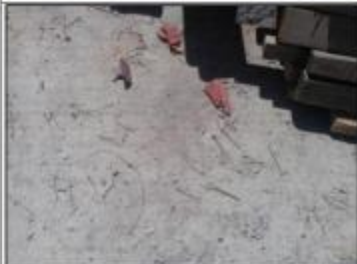
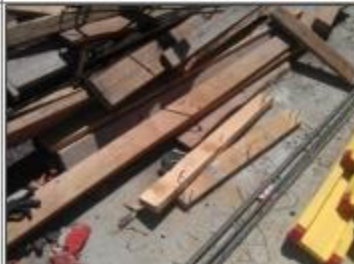
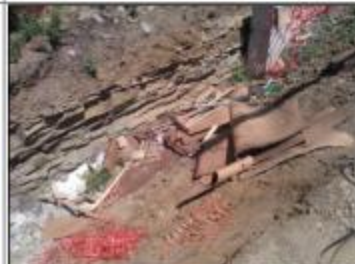
Project: USIIP	Non-compliance Notice TBILISI
Contract No: TBI-01	
Contractor: DAGI	
Reference: Tbilisi – NEW OFFICE BUILDING FOR UWSCG	
This notice is to advice you, the prime Contractor, on the referenced Contract, of the following notice on environmental measures to be implemented urgently .	
<p>NON-COMPLIANCE IN TBILISI</p> <p>Construction of New Office Building for UWSCG</p> <ul style="list-style-type: none"> - Surplus waste soil should be removed from the construction territory (especially from green zone) - Everyday safety related instructions should be carried out with relevant signature from personnel - Safety norms during works at the height should be respected to avoid workers damage - High visible safety signs/tapes and strong barriers should be installed at complete perimeter and at the each floor of the construction building to avoid workers falling/damage - Trees at the construction area and nearby should be protected on proper way to avoid its damage - Special equipment during working at heights should be used - Construction territory and wooden materials should be freed from nails to avoid personnel damage - The access to the waste containers should be freed from construction materials - Waste should be discharged timely - All construction materials should be properly segregated and stored adequately - Fuel/oil spill spots should be remedied promptly using special response items (sand, sawdust, special powder) - The slope near of the construction area should be strengthened by special grid to avoid land/stone falling and workers damage - All workers should be equipped with complete PPE - Site internally should be arranged properly and cleaned regularly

All these conditions have to be remedied within four days (by the 18 May 2018) by the prime Contractor (Dagi).	
Date of site visits: 14.05.2108	
Irakli Legashvili EPTISA – Environment Ketevan Chomakhidze UWSCG USIIP Environment

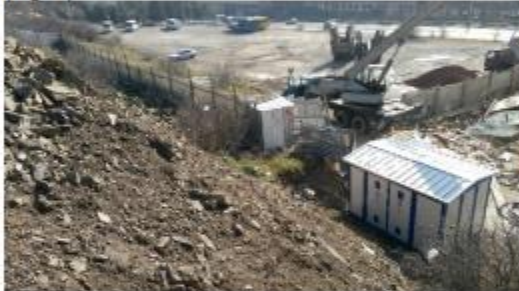
(Fig. 1)

ADB recommended cc to construct concrete protective wall at the east part of the territory to avoid damaging of inhabitants living at nearby apartment buildings (fig. 1)

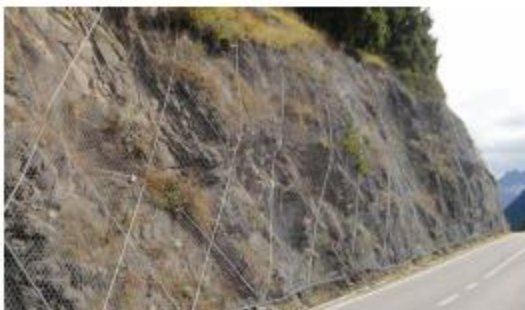
Sample: rock fall protection (fig. 2)

For safety the east part of the territory to avoid damaging of inhabitants living at nearby apartment buildings (fig. 2)

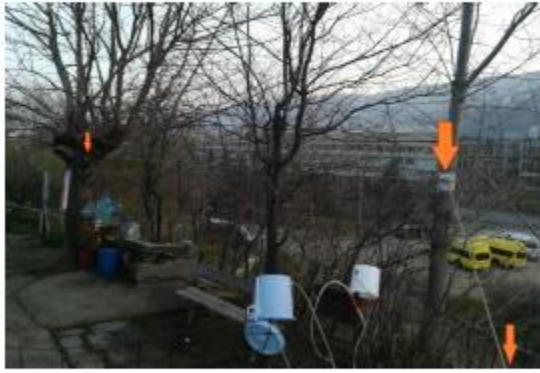
After cutting for the construction NOUWSCG access road, on the rights side there is a danger of the fallen tree, that the tree did not fall, the tree was connected with ropes to the ground by anker (fig.3)
Trees protection (fig.3)
