# Environmental Monitoring Report

Bi-annual Report (Jul -Dec 2018)

## Georgia: Urban Services Improvement Investment Program – Tranche 1

## **GEORGIA: URBAN SERVICES IMPROVEMENT INVESTMENT PROGRAM (TRANCHE 1) (FINANCED BY THE ASIAN DEVELOPMENT BANK)**

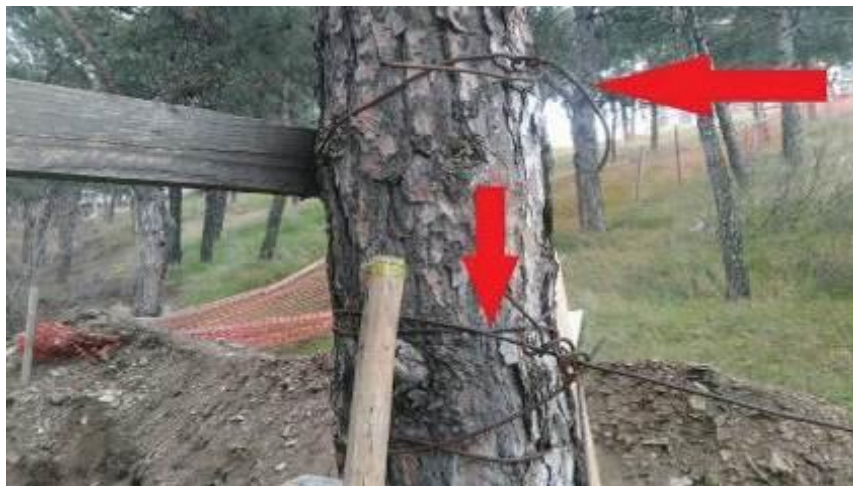
#### **Photo 1: Incorrectly attached wire on the tree**

79. Example No2: Wire is not properly affixed and damaged the tree (Please see photo below).

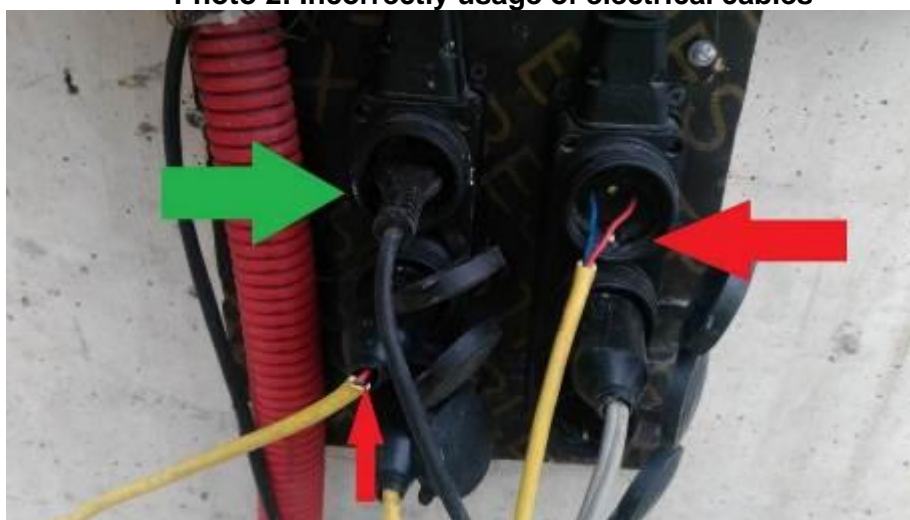
**Photo 2: Incorrectly usage of electrical cables**

**80.** Example No3: Electrical cables are not properly used. Electrical plug missing, no insulation.

Description of first aid / medical treatment			
Corrective / Preventive action taken or recommendation	In the warehouse, all electrical cables must be checked before work. Red arrow is wrong, Green is correct.		
Do we have a safety manager on site	YES	ALEXANDER CHUMBURIDZE	
Where any of the above boxes are ticked as "Other" please describe below:			
Other:			
<b>Reported By: ALEXANDER CHUMBURIDZE</b>			
Name: ALEXANDER CHUMBURIDZE	Position: HSE MANAGER	Date: 19.03.18.	
<b>Circulation (on the day of the event)</b>			
Original Project File:			
<div style="display: flex; align-items: flex-start;"> <div style="flex: 1;"> <input checked="" type="checkbox"/> X Project Manager  <input checked="" type="checkbox"/> X Country Manager  <input checked="" type="checkbox"/> X HS&amp;E Manager         </div> <div style="flex: 1; text-align: center;">   </div> </div>

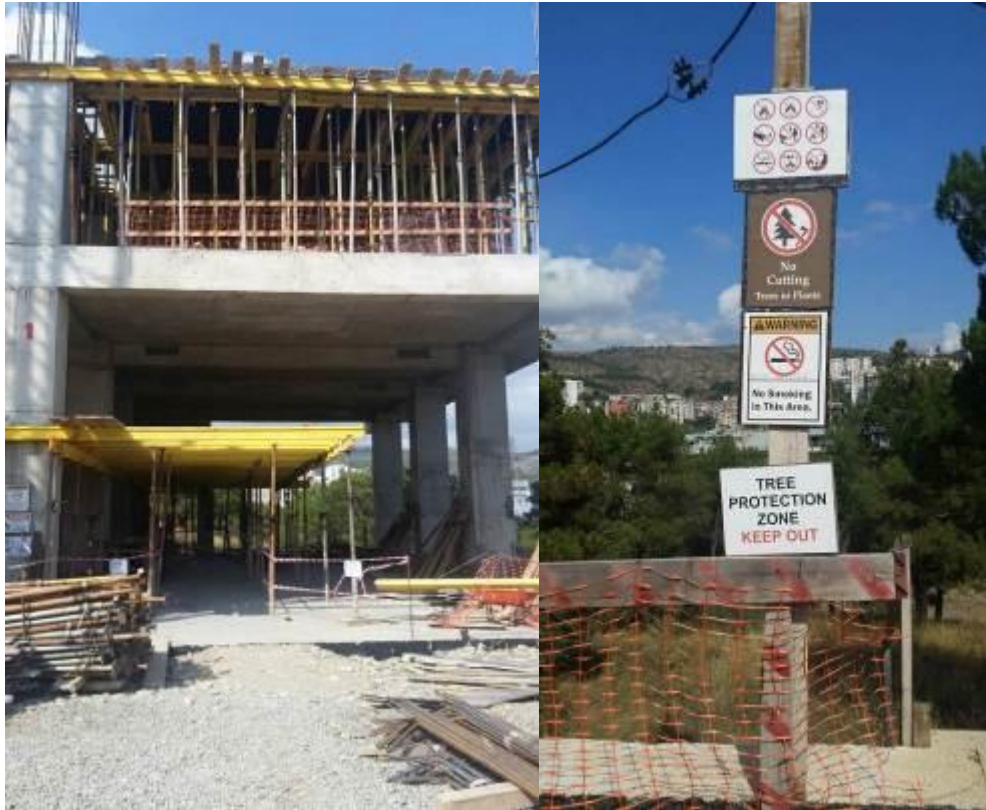
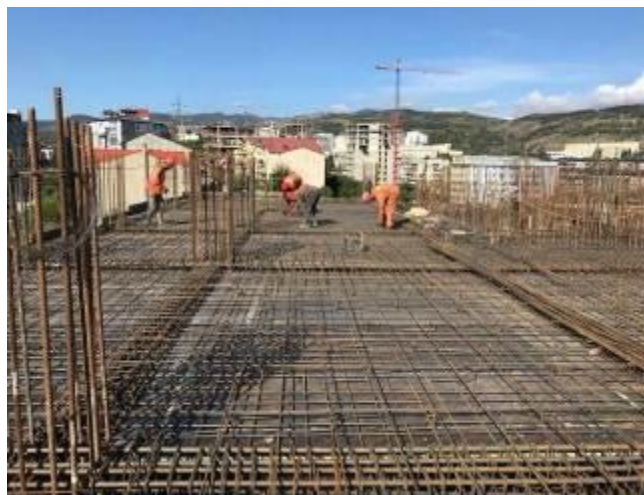
Photo: UWSCG Office Building, TBI-01

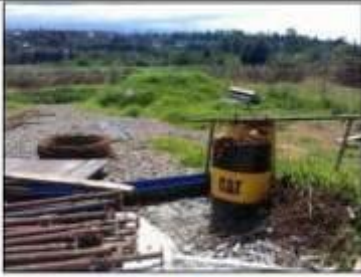
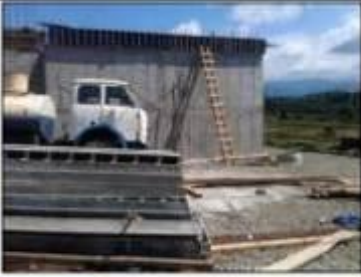
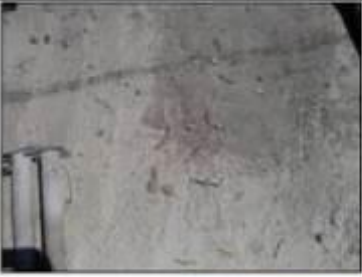
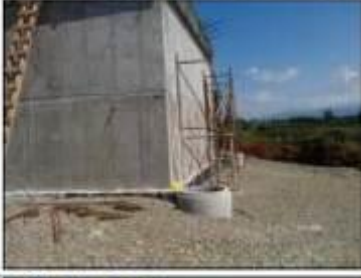
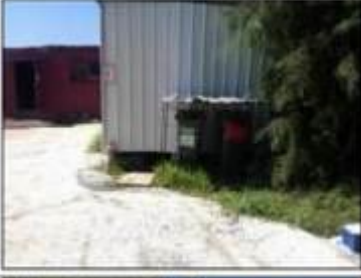
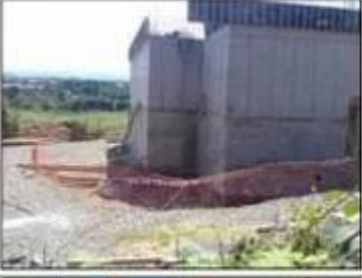
Project: USIIP	Non-compliance Notice UREKI
Contract No: URE-01	
Contractor: PERI	
Reference: UREKI – RESERVOIR IN LAITURI	
This notice is to advice you, the prime Contractor, on the referenced Contract, of the following notice on environmental measures to be implemented <b>urgently</b> .	
<b><u>NON-COMPLIANCE IN UREKI</u></b>	
<b>RESERVOIR IN LAITURI</b>	
<ul style="list-style-type: none"><li>- Construction site should be properly fenced from all sides and equipped with lockable gate</li><li>- Construction waste should be timely removed from the construction site and disposed properly</li><li>- Construction territory should be lighted adequately</li><li>- Proper warning and information signs should be arranged at the entrance and perimeter of the site</li><li>- Proper toilet with relevant sign should be arranged</li><li>- Construction territory and wooden materials should be freed from big nails to avoid personnel damage</li><li>- Safety norms during working at height should be provided</li><li>- Special equipment during working at heights should be used</li><li>- Ladder safety should be insured</li><li>- Soil (surplus/accumulated soil) for backfilling purposes should be managed/stored properly</li><li>- Proper fuel/oil spill response items (sand, sawdust, special containers) should be available at the site</li><li>- Containers with fuel/lubricant should be managed properly (stored at the proper organized place with concrete floor and roofing) to avoid leakage and ground contamination</li><li>- All construction materials should be properly segregated and stored adequately</li><li>- Workers always should use complete PPE</li><li>- Site internally should be arranged properly and cleaned regularly</li></ul>

All these conditions have to be remedied within six days (by the 22 August 2018) by the prime Contractor (Peri).		
Date of site visits: 14.08-15.08.2018		
Irakli Legashvili EPTISA - Environment

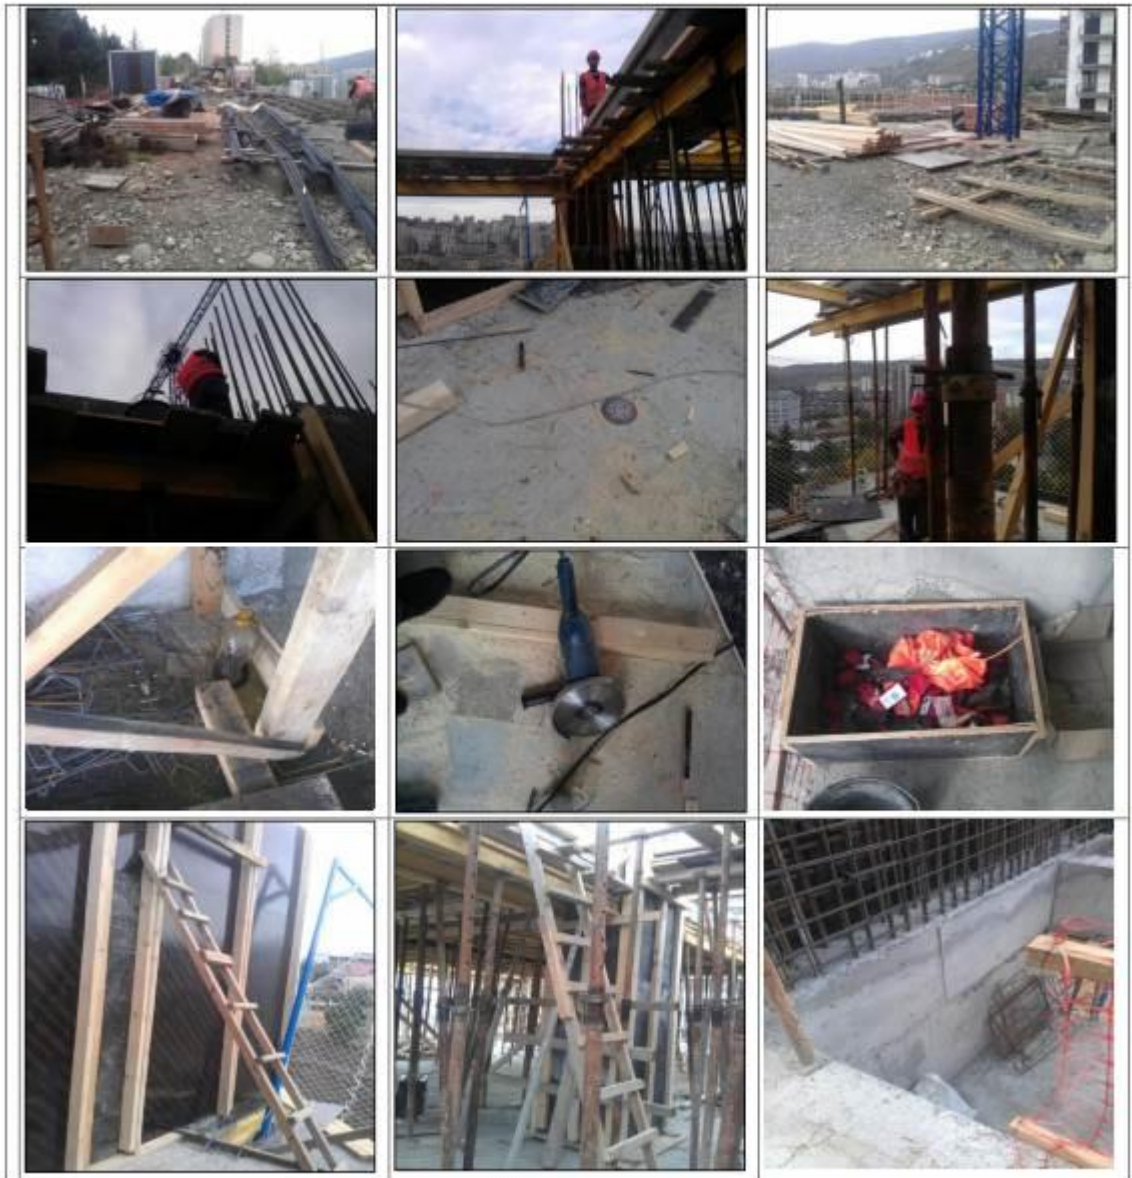
Project: USIIP	Major Non-compliance Notice TBILISI
Contract No: TBI-01	
Contractor: DAGI	
Reference: Tbilisi – NEW OFFICE BUILDING FOR UWSCG	
This notice is to advise you, the prime Contractor, on the referenced Contract, of the following notice on environmental measures to be implemented <b>urgently</b> .	
Extraction from IEE, Office-01 project: There could be some short-term socio-economic benefits from the construction work if local people gain employment in the workforce. To ensure that these benefits are directed to local people, the Contractor should be required to employ as much of his labour force as possible from the local communities in the vicinity of construction sites.	
<u>Based on the above mentioned, the Contractor should as soon as possible justify why the Workers are hired from Azerbaijan.</u>	
<u>NON-COMPLIANCE IN TBILISI</u>	
<b>Construction of New Office Building for UWSCG</b>

<ul style="list-style-type: none"><li>- Safety norms during works at the height should be respected to avoid workers damage. Special equipment during working at heights should be used</li><li>- Jacks fixator should be properly installed to avoid damage of workers. High risk of workers health damage!</li><li>- HSE officer should be present at the site permanently to ensure execution of all HSE requirements</li><li>- Ladder safety norms should be ensured. Proper ladders should be installed in every case</li><li>- Safety rules during electric equipment use should be respected</li><li>- High visible safety signs/tapes and barriers should be installed at the each floor of the building (not leaving even small open gaps) to avoid workers falling</li><li>- Construction territory and wooden materials should be freed from nails to avoid personnel damage. Regular cleaning of site from used nails is required</li><li>- Containers with fuel/lubricant should be managed properly (stored at the proper organised place with concrete floor and roofing) to avoid leakage and ground contamination</li><li>- Waste should be placed in proper waste container and discharged timely</li><li>- Site internally should be arranged properly and cleaned regularly</li></ul>

All these conditions have to be remedied within **five days (by the 30 October 2018)** by the prime Contractor (Dagi).
