Environmental Monitoring Report

Semi-annual Report (July - December 2019)
February 2020

GEO(COL): Urban Services Improvement Investment Program – Tranche 1

SEMI-ANNUAL ENVIRONMENTAL MONITORING REPORT

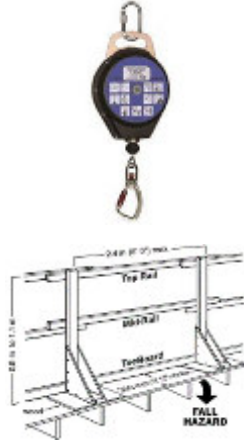
<p>Worker not used fall arrest system (safety belt). Not installed safety hard barricade, High risk of workers health damage</p>

09.10.19.	<p>Stop work. All person must use fall arrest or (safety belt) arrest who works at the Height (need to be fined, so as not to be repeated again) timely installed safety hard barricade.</p>

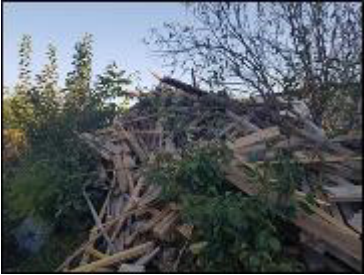
<p>On the wooden material there are nails, which can damage the all personals on the site. Construction rubbish, all site need housekeeping and removal waste.</p>

15.11.19.	<p>Must be cleaned all wood materials or sealed separately storage. Need housekeeping. All rubbish must be removed, housekeeping all site and timely discharge waste.</p>

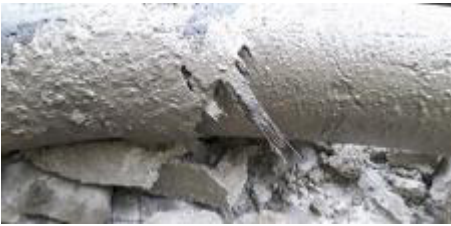
Near Miss Description of Near Miss (Include Details of Operations & activities)	D.M.Y.	Corrective/Preventive, Action Taken or Recommendation
<p>Concrete stationary pump, the hose not quality is a dangerous, when concrete casting, to be Damage to workers</p>

<p>15.11.19.</p>	<p>Concrete stationary pump hose must be replaced before work begins Techniques should be checked.</p>

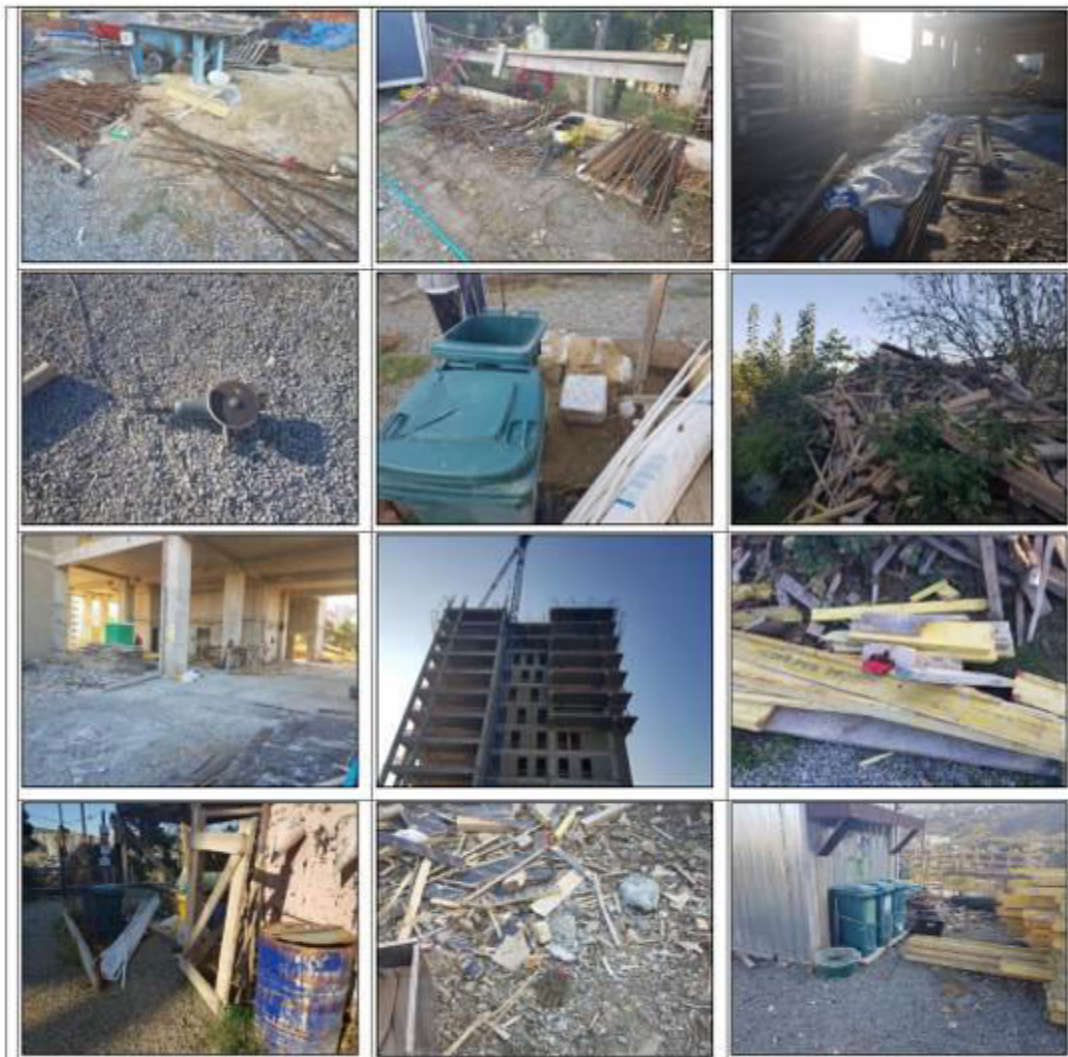
Project: USIIP	Non-compliance Notice TBILISI
Contract No: TBI-01	
Contractor: DAGI	
Reference: Tbilisi – NEW OFFICE BUILDING FOR UWSCG	
This notice is to advise you, the prime Contractor, on the referenced Contract, of the following notice on environmental measures to be implemented urgently .	
<u>NON-COMPLIANCE IN TBILISI</u>	
Construction of New Office Building for UWSCG	
<ul style="list-style-type: none">- Daily presence of HSE officer at the construction territory is necessary- High visible safety signs/tapes, grids and barriers should be installed at the each floor of the building to avoid incidents of workers falling- Trees at the construction area drying at visual observation. Needs proper investigation. In case trees are dried it should be replaced with new once- Safety norms during works at the height should be respected to avoid workers damage- Special equipment during working at heights should be used- Safety rules during electrical equipment use should be respected- Construction waste should be removed timely and proper disposed- All workers should be equipped with complete PPE- Site internally should be arranged properly and cleaned regularly

All these conditions have to be remedied within three days (by the 7 October 2019) by the prime Contractor (Dagi).

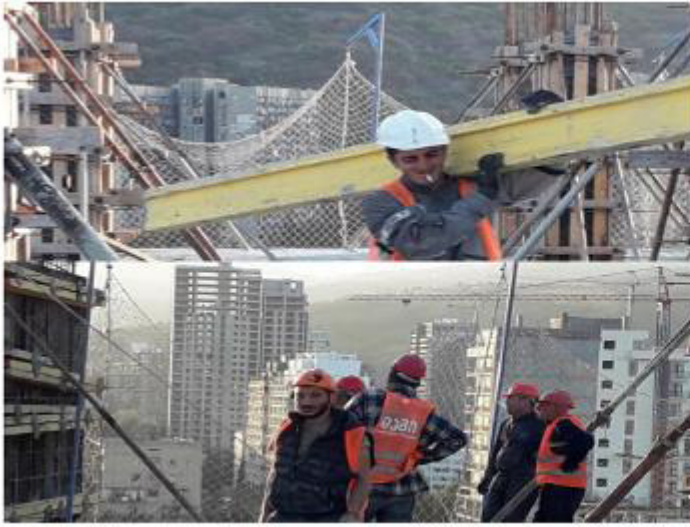
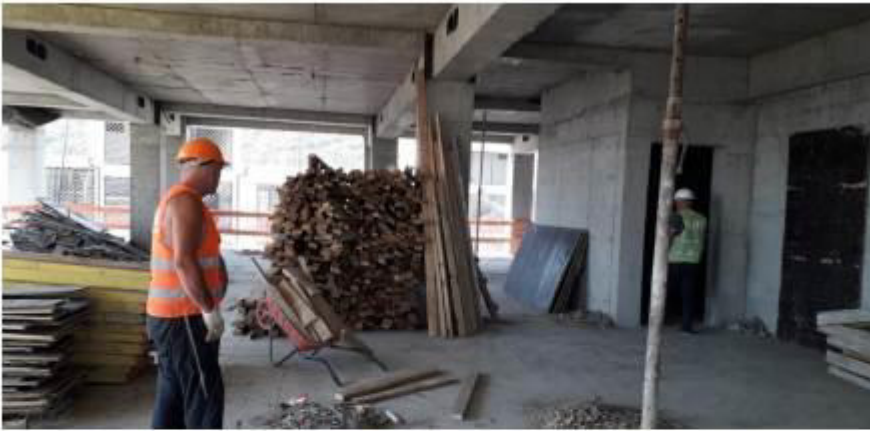
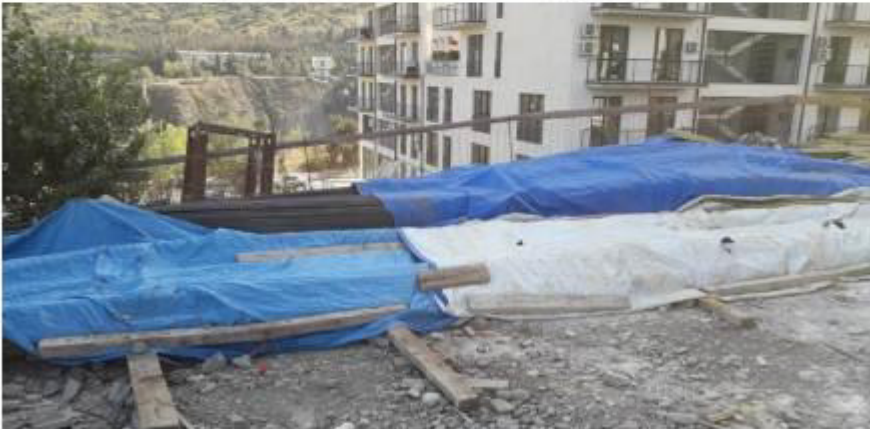
შესაბამისი ფოტომასალა/Photo materials:

2.3	The Contractor has executed the contract with the licensed organization on the hand-over and disposal of hazardous waste. კონტრაქტორს გაფორმებული აქვს სახიფათო ნარჩენების გადაცემისა და გატანის ხელშეკრულება ლიცენზირებულ ორგანიზაციასთან.	✓				საიტზე მოწყობილია სახიფათო ნარჩენების განთავსების დროებითი საწყობი.

3.7	სამშენებლო ტერიტორიაზე, სამუშაოების ზონაში არსებული ხეების შეპირაგვა (დაზიანების თავიდან აცილების მიზნით) Protect all trees nearby construction zone to avoid its damage	✓				თხილქვების ტერიტორიაზე ხეები დაცულია შემორჩენილია დაზიანებისგან და აღნიშნულია შესაბამისი გამაფრთხილებელი ნიშნებით.

3.15	სამშენებლო ტერიტორიაზე საშიშვლო ნარჩენებისთვის თავსახურიანი კონტეინერის განთავსება და შესაბამისი წარწერებით აღჭურვა (მაგ. "HAZARDOUS WASTE") Placement of proper Hazardous Waste container at the special dedicated places with relevant indication signs (for example "Hazardous Waste")	✓			ობიექტის ტერიტორიაზე არის სამივე ნარჩენების კონტეინერი, და შესაბამისი წარწერით.
