Environmental Monitoring Report

Georgia: Urban Services Improvement Investment Program -Tranche 1

Project: Construction of Mestia Water Treatment Plant and Reservoirs

Project: Construction of Water Supply and Wastewater Network in Ureki (URE-01)

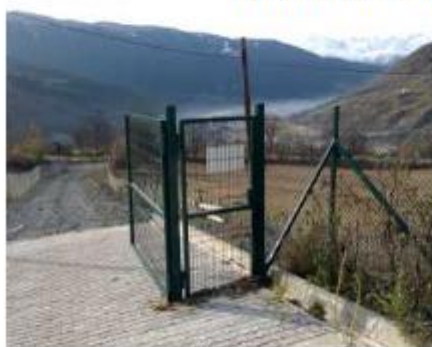
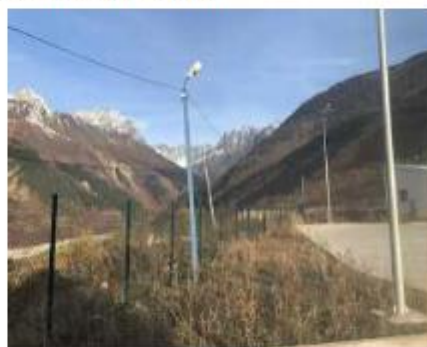
Figures 1 and 2: All project areas are fenced

22. All the above-mentioned sites were fenced and it was impossible for strangers as well as domestic animals to enter the site (see **Figure 1 and 2**).

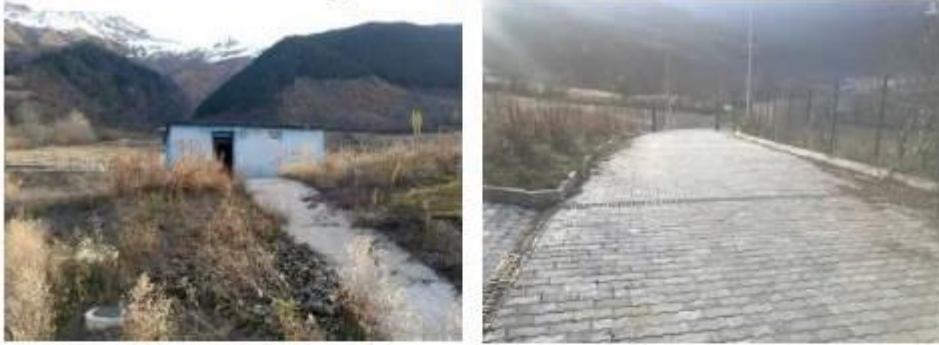
Figures 3 and 4: Local roads

23. The territories were restored in a timely manner; the removed topsoil was used for the rehabilitation works. The local roads of all objects are improved (see **Figures 3 and 4**)

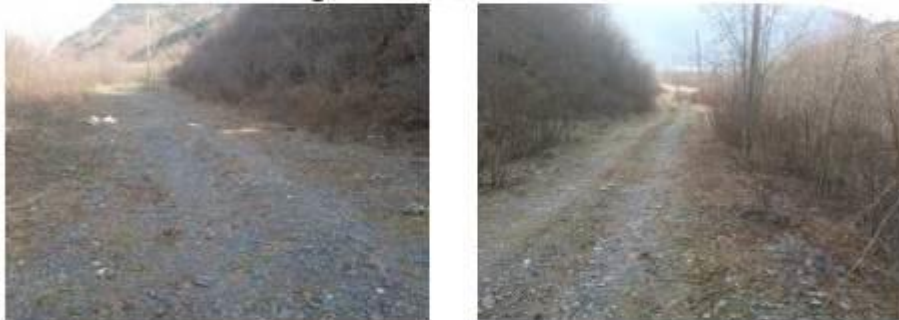
Figures 5 and 6: Access roads

24. No grass was planted on the territory. The vegetation cover was self-restored (**Figures 3 and 4**). The ground access roads to the facility are also restored (**Figures 5 and 6**).

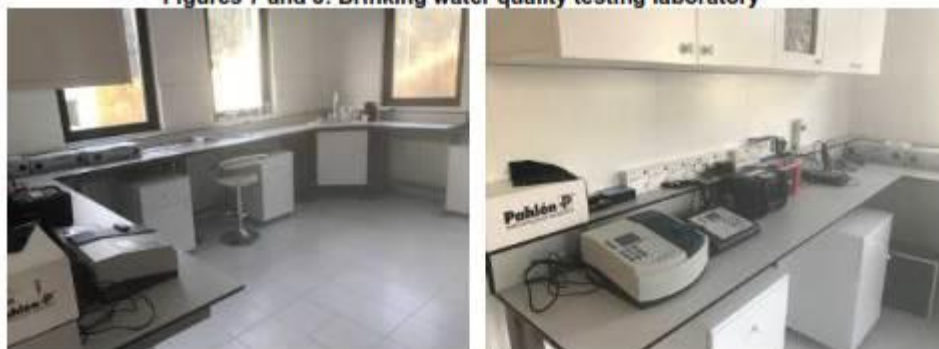
Figures 7 and 8: Drinking water quality testing laboratory

25. Both, the hazardous and household waste was totally disposed from the project zone. Besides, the construction techniques and construction materials were removed as well, and lighting poles were installed all over the area.
26. The water quality testing laboratory was fully equipped (see **Figures 7 and 8**).

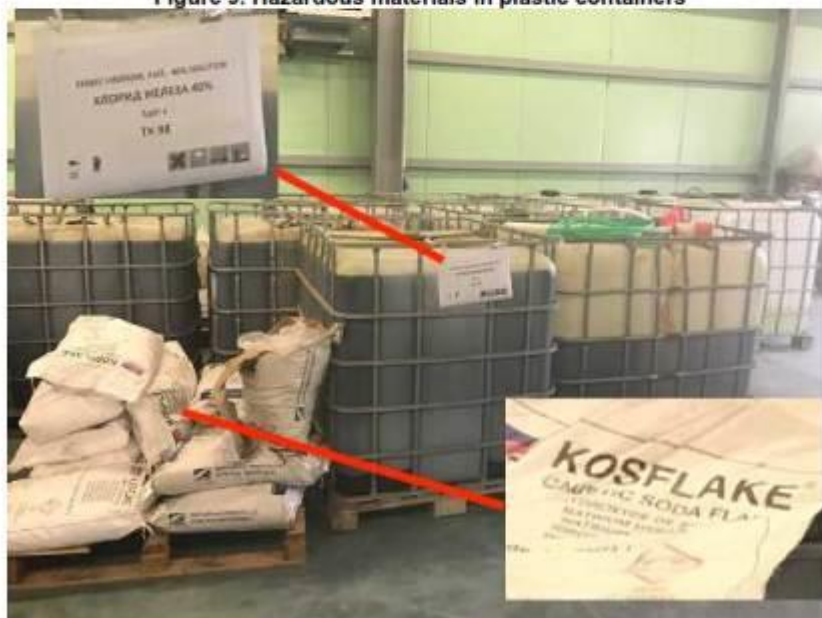
Figure 9. Hazardous materials in plastic containers

27. **Non-compliance #1:** Large quantities of hazardous materials (see **Figure 9**), namely Ferric chloride FeCl_2 40% solution, were in the plastic containers in the closed space of the given territory. There are also approximately 10 pieces of 50-kg paper bags of caustic soda near the plastic containers.

28. **Requirement:** (i) The hazardous liquid material containers must be placed on secondary containment with its volume of 110% of the main container. If the hazardous materials are placed in several containers, the volume of the secondary container must be 25% of the total volume of all containers with hazardous liquid materials in them. (ii) It is forbidden to place the materials near one another that can react with each other.

29. **Corrective action:** The plastic containers with hazardous materials must be placed on secondary containment with its volume of 25% of the containers with hazardous materials in them. Besides, the 50-kg bags with caustic soda must be removed to a separate building.

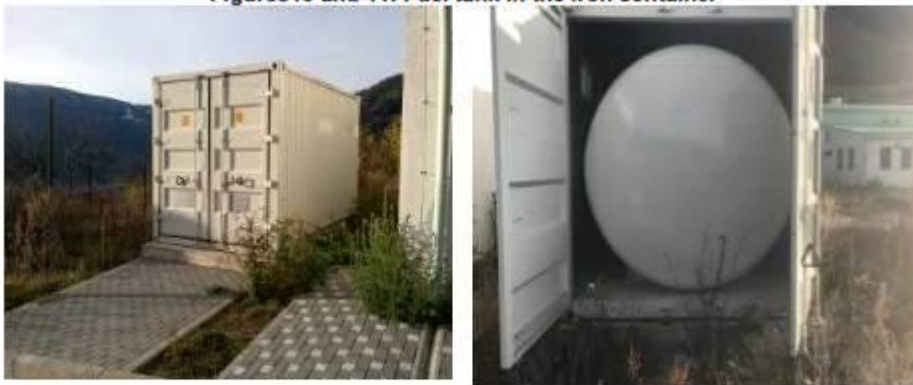
Figures 10 and 11: Fuel tank in the iron container

30. **Non-compliance #2:** The tank with hazardous materials in the area is not placed on a secondary containment (**Figures 10 and 11**). Despite the fact that the given tank is placed in an iron container, there is a risk of soil pollution in case of spills.

31. **Requirement:** The hazardous liquid material containers must be placed on secondary containment with its volume of 110% of the main container.
32. **Corrective action:** The fuel tank must be placed on a secondary containment with its volume of 110% of the main container.

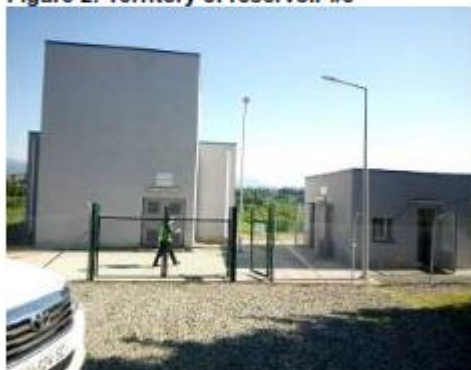
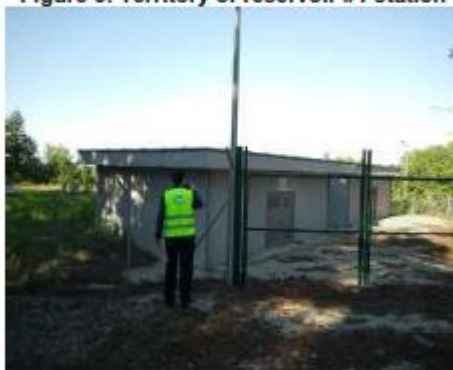
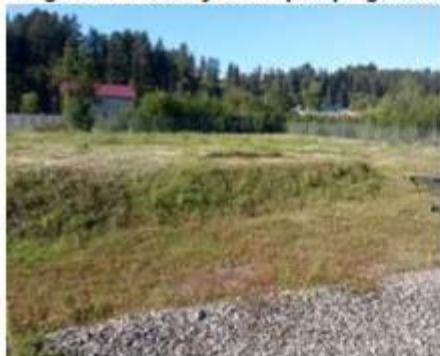
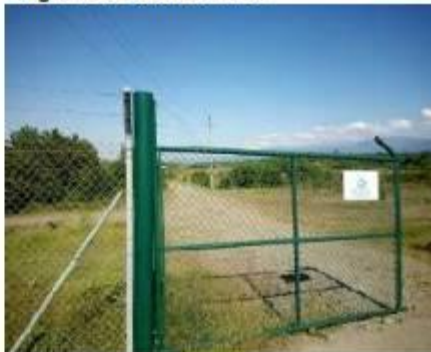
18. All the above-mentioned sites were fenced and it was impossible for strangers as well as domestic animals to enter the site (see **Figure 2 - 5**).

Figure 2: Territory of reservoir #3

Figure 3: Territory of reservoir #1 station

Figure 4: Territory of the pumping station

Figure 5: Borehole area

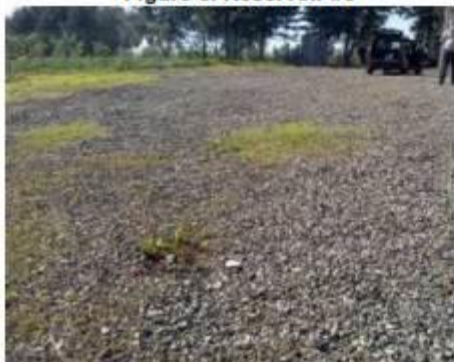
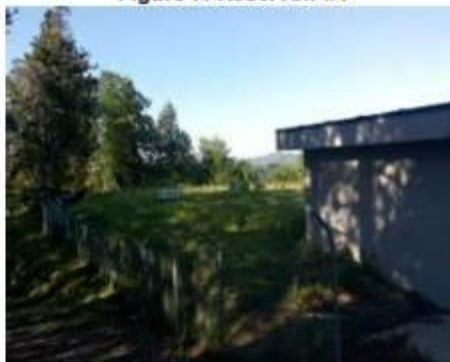
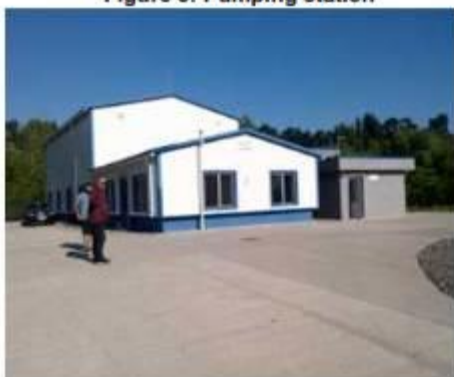
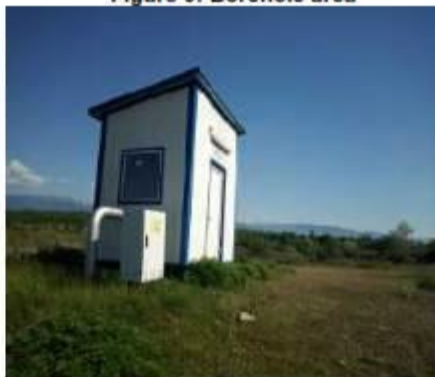
19. The construction waste was disposed from all facilities except some minor exceptions (see non-compliance 1) and the area was cleaned (**Figures 6 - 9**).

Figure 6: Reservoir #3

Figure 7: Reservoir #1

Figure 8: Pumping station

Figure 9: Borehole area

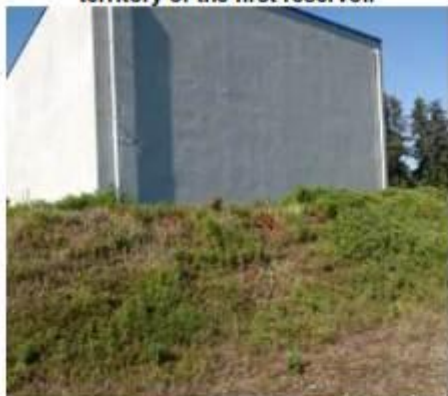
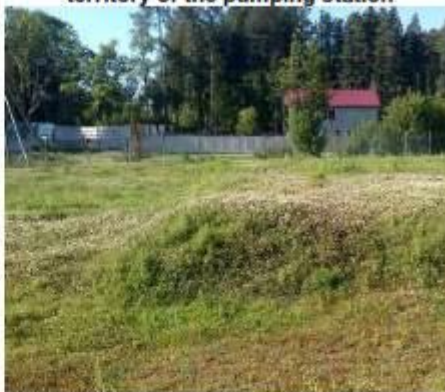
20. The restoration works are completed all over the area and the topsoil was taken back to the project area. It should be noted that no artificial plantings were done in the area. So, it is clear that the self-restoration process took place in the project area (see **Figures 10 and 11**).

Figure 10: Self-restored grass – the territory of the first reservoir

Figure 11: Self-restored grass – the territory of the pumping station

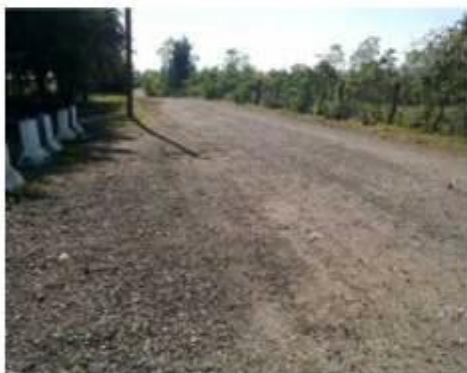
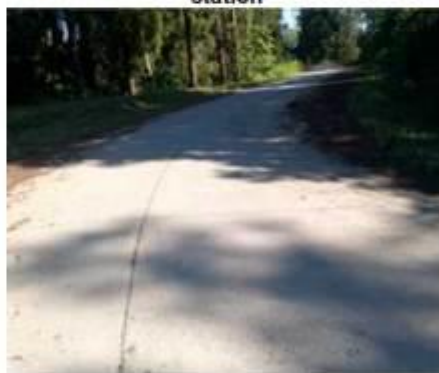
21. The access roads to the project area were restored and paved. Their physical state corresponds to the IEE requirements (**Figures 12 and 13**).

Figure 12: Access road to the first reservoir

Figure 13: Access road to the pumping station

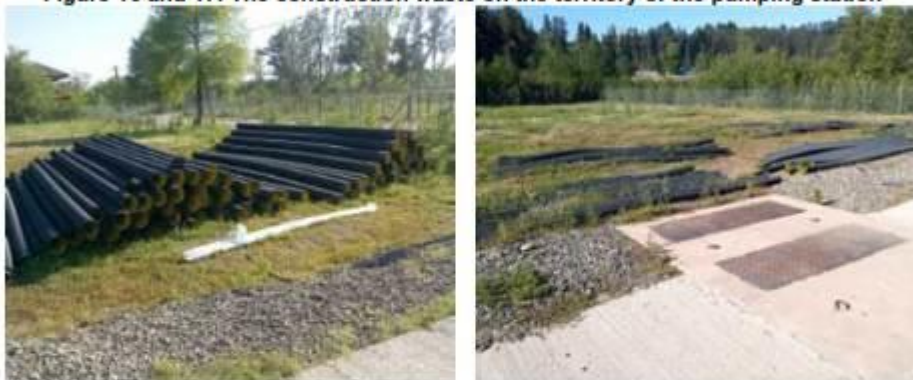
24. **Requirement:** Following the completion of the project, the waste must be handed over to a duly licensed company.
25. **Corrective action:** The waste must be collected and disposed from the project area. The waste must be handed over only to duly licensed contractors for further management.
26. **Non-compliance #2:** The area of the construction materials on the territory of the pumping station was not fenced and was not protected from the impact of the atmospheric precipitation (**Figures 16 and 17**).

Figure 16 and 17: The construction waste on the territory of the pumping station

27. **Requirement:** The area with the construction waste must be fenced and have relevant information signs.
28. **Corrective action:** The territory of the construction materials area must be duly fenced. The construction materials must be disposed in the project area more compactly and must be protected from the atmospheric precipitation by using an appropriate protective cover.
29. A number of violations of the rules of safety were observed in the water intake area.
30. **Non-compliance #3:** The underground infrastructure and the well in the project area were not duly covered (**Figures 18 and 19**).

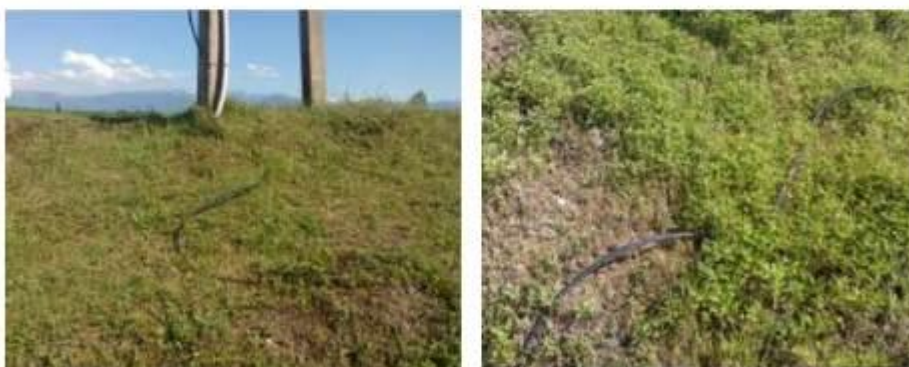
Figures 20 and 21: The wire cable on the earth surface

31. **Requirement:** All underground infrastructural facilities must be closed after the project is complete to prevent service personnel or animals from falling into them.
32. **Corrective action:** In the first stage, the area must be fenced or warning signs must be installed. And finally, it will be necessary to provide a capital cover or a hatch over such underground facilities.
33. **Non-compliance #4:** A power cable was fixed near the power transmission pole located in the water intake area, which was cut off for unknown reasons and lying on the ground in an uncontrolled manner (see **Figures 20 and 21**).

34. **Requirement:** A power transmission line is not admitted to be on the ground in an uncontrolled manner.
35. **Corrective action:** First of all, the given area must be marked. Then, owner of the given cable must be identified and addressed immediately to carry out relevant repair works. If the given wire is used to supply power to the wells, it is necessary to install them in compliance with the requirements of the relevant instructions.
