Environmental Monitoring Report

Semestral Report
July 2017

GEO: Urban Services Improvement Investment Program – Project 3

GEORGIA: URBAN SERVICES IMPROVEMENT INVESTMENT PROGRAM (TRANCHE 3) (FINANCED BY THE ASIAN DEVELOPMENT BANK)

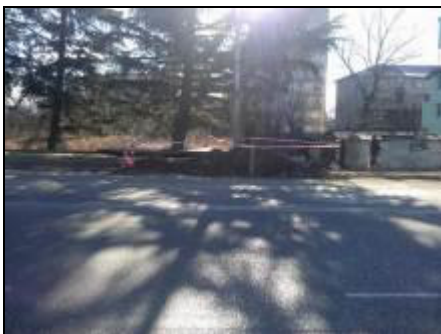
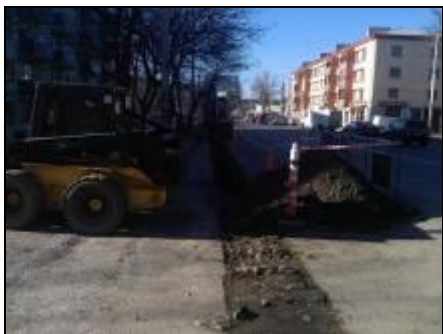
havchavadze street	havchavadze street

Project: USIIP	Non-compliance Notice KUTAI SI
Contract No: KUT-01	
Contractor: SMK	
Reference: Kutaisi – NETWORK	
This notice is to advice you, the prime Contractor, on the referenced Contract, of the following notice on environmental measures to be implemented urgently .	
<u>NON-COMPLIANCE IN KUTAI SI</u>	
NETWORK	
<ul style="list-style-type: none">- Piles of surplus waste soil should be removed from construction area and disposed in a proper place- Construction materials should be brought when needed to avoid its long time disposal in the streets and disturbance of residents and businesses- Construction activities information signs should be installed at each construction segment- Enough and high visible safety signs/tapes should be installed to avoid accident of population- Special blinking signs or flag men where necessary should be provided when passing streets to avoid disturbance of car movements- Enough and proper wooden/metal walkways/planks across open trenches should be installed- Sidewalks and resident houses nearby areas should be clean from construction materials to avoid disturbance of pedestrians, residents and businesses- Use tarpaulins to cover during materials transportation- Workers always should use complete PPE- All transmission line construction segments should be cleaned/well organized on regular bases

All these conditions have to be remedied within six days (by the 15 January 2017) by the prime Contractor (SMK).

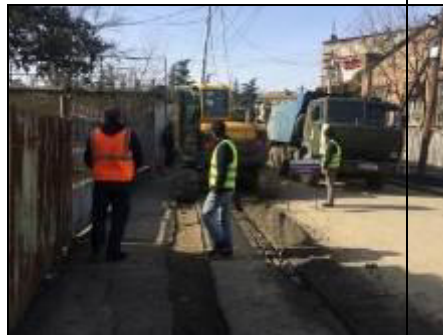
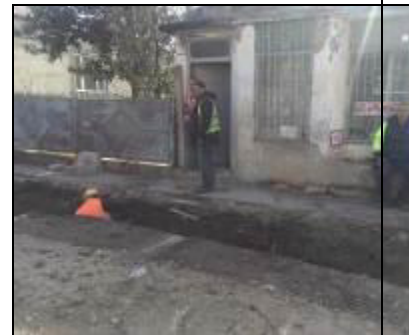
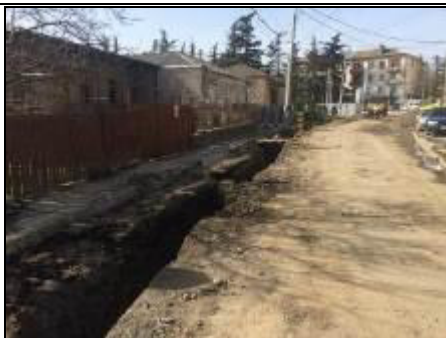
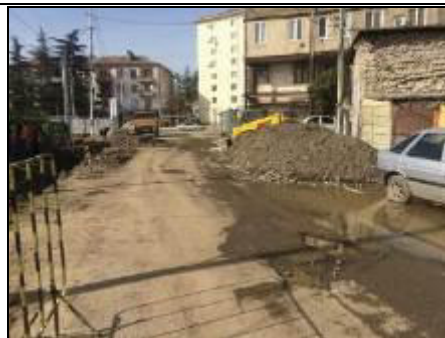
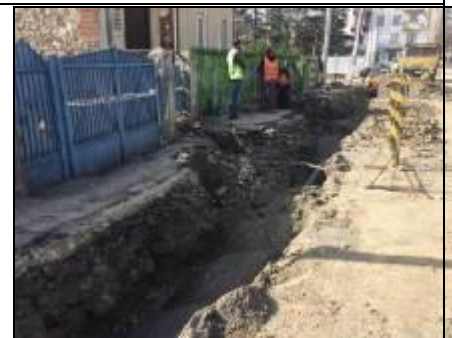
Baratashvili str.

- Trees of nearby construction zone should be protected to avoid its damage
- Construction activities information signs should be installed at each construction segment

- Workers always should use complete PPE, especially helmets and boots (even some foremen do not wear PPE)
- Local environment/safety stuff should have available vehicles to manage permanent monitoring of the sites

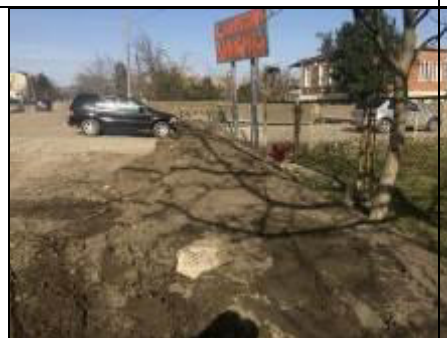
Gamsakhurdia str.

- Trees at the construction site should be fenced on proper way and protect to avoid its damage
- Safety signs/tapes and trench side barriers should be installed completely around of excavation of reservoir
- Proper fuel/oil spill response items (sand, sawdust, special containers) should be available at the site
- Transport should be parked only at the parking area
- All construction materials should be properly segregated and stored in relevant place with signage
- Construction waste materials should be removed timely and permanently
- All workers (even personnel of subcontractor) should be equipped with complete PPE
- Site internally should be arranged properly and cleaned regularly

All these conditions have to be remedied within eight days (by the 10 March 2017) by the prime Contractor (SMK).

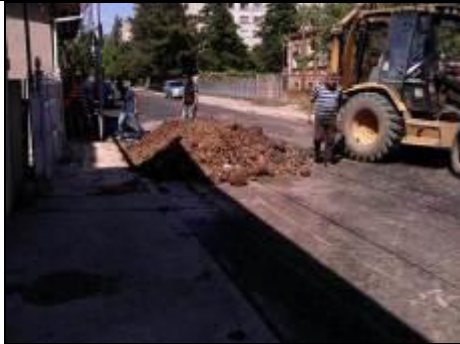
Maisuradze str.

Project: USIIP	Non-compliance Notice KUTAISI
Contract No: KUT-01	
Contractor: SMK	
Reference: Kutaisi – NETWORK	
This notice is to advice you, the prime Contractor, on the referenced Contract, of the following notice on environmental measures to be implemented urgently .	
<div><u>NON-COMPLIANCE IN KUTAISI</u></div> <div>NETWORK</div> <div><ul style="list-style-type: none">• Construction activities information signs should be installed at each construction segment• Trees of nearby construction zone should be protected to avoid its damage• Safety signs/tapes and trench side barriers around of all open trenches should be installed to avoid accident of population• Piles of surplus waste soil should be removed timely from construction area and disposed in a proper place</div>

- Enough and proper wooden/metal walkways/planks across open trenches should be installed
- Construction materials should be brought when needed to avoid its long time disposal in the streets and disturbance of residents and businesses
- Resident houses nearby areas should be clean from construction materials to avoid disturbance of residents and businesses
- Special blinking signs or flag men where necessary should be provided when passing streets to avoid disturbance of car movements
- Dust prevention activities (watering of territory) should be carried out in dry/windy weather permanently
- Use tarpaulins to cover during materials transportation (all trucks were observed without tarpaulins)
- Workers always should use complete PPE

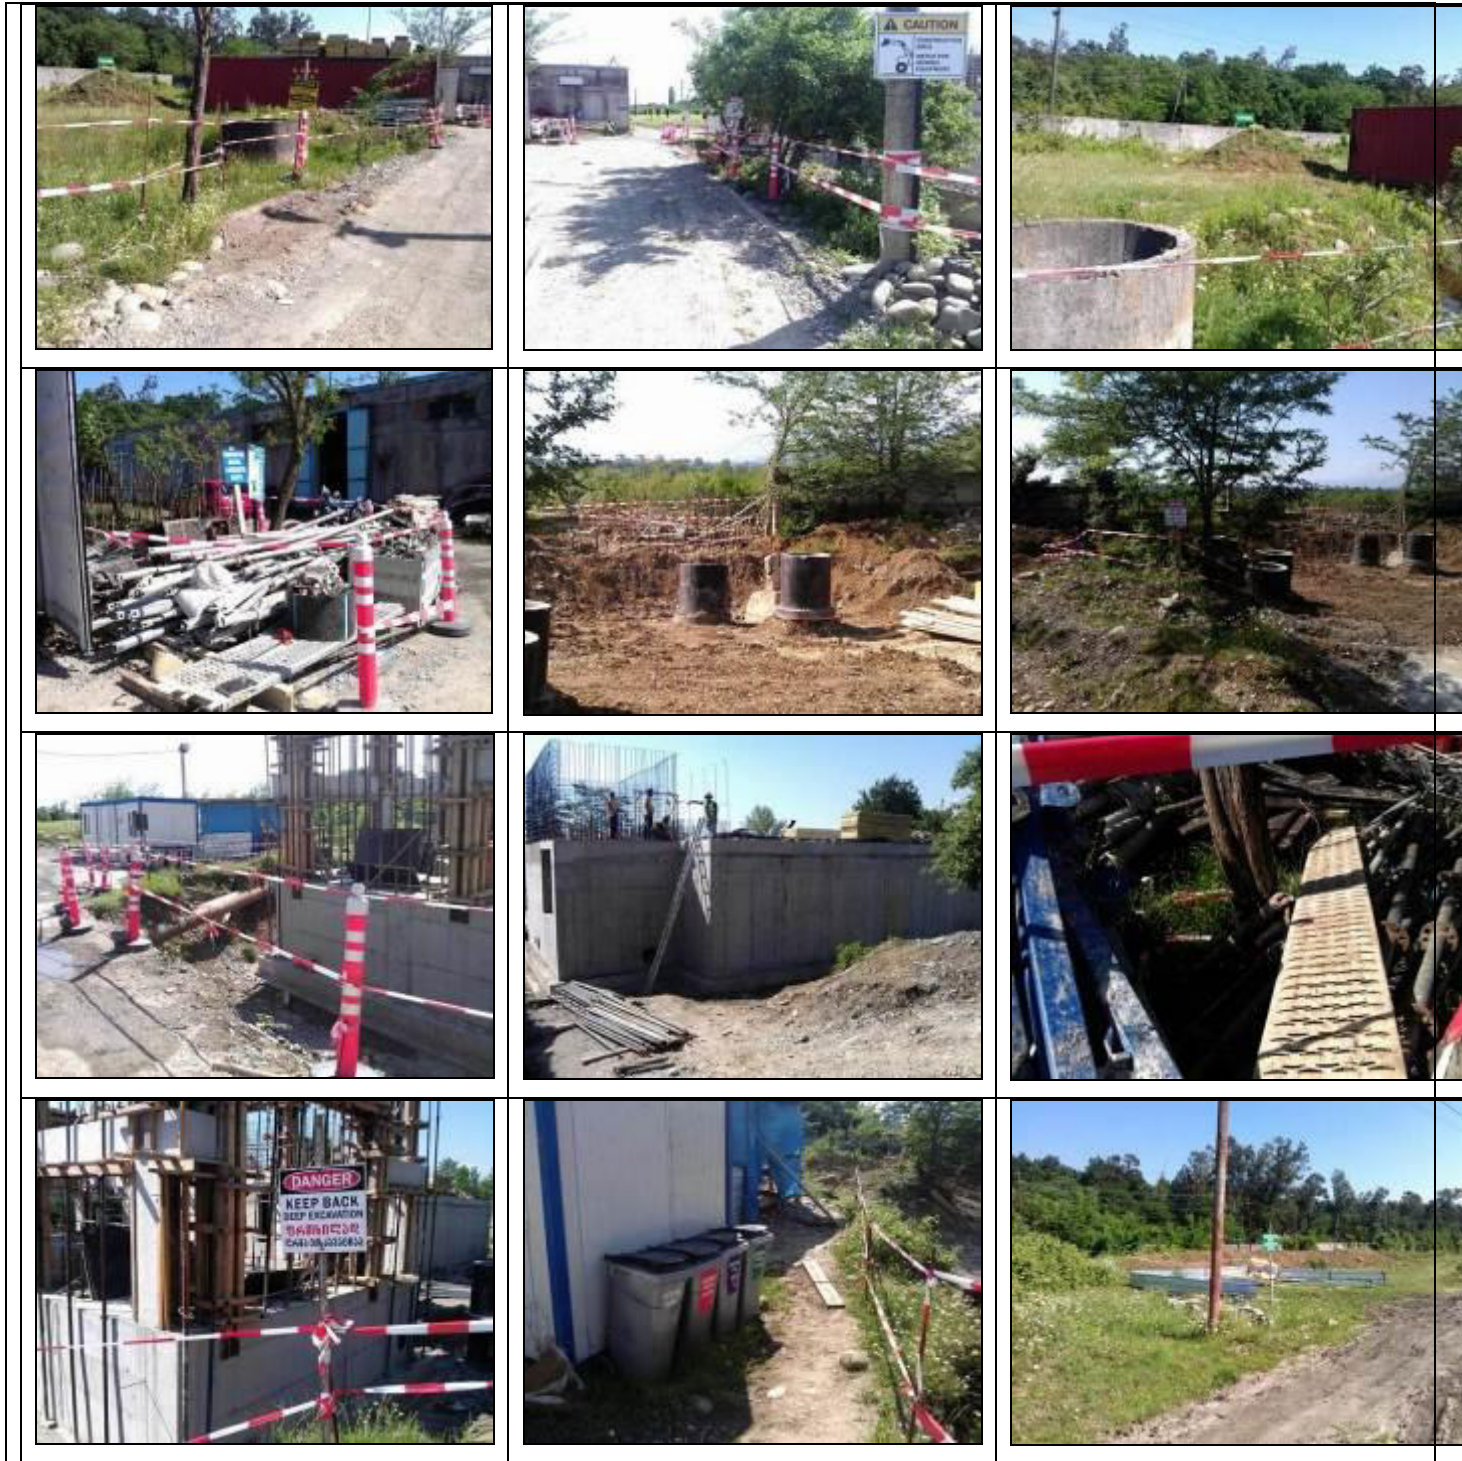
Mukhnari Reservoir

- Trees at the construction site should be fenced on proper way and protect to avoid its damage
- Trench side barriers should be installed all-around of deep excavation
- Proper fuel/oil spill response items (sand, sawdust, special containers) should be available at the site
- All construction materials should be properly segregated and stored adequately
- Safety rules during high-altitude works should be respected to avoid workers damage
- All workers (even personnel of subcontractor) should be equipped with complete PPE
- Site internally should be arranged properly and cleaned regularly

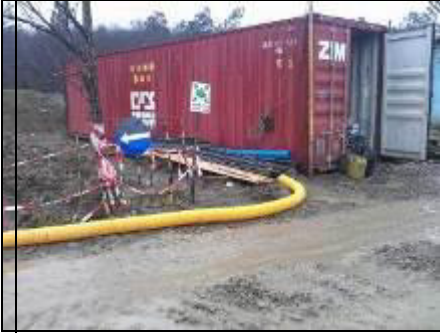
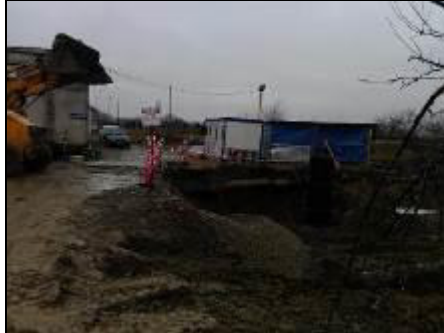
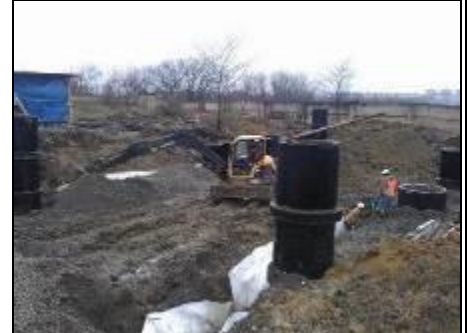
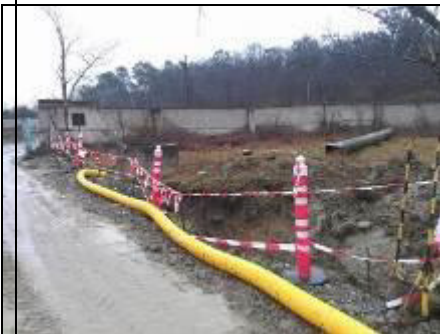
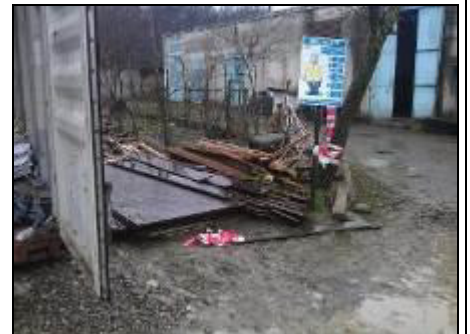
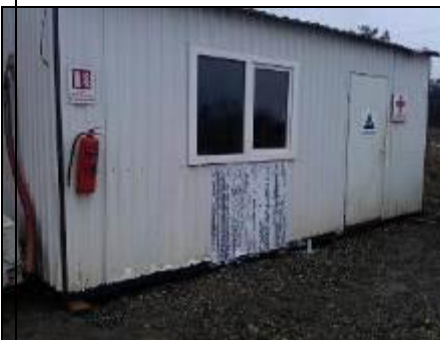
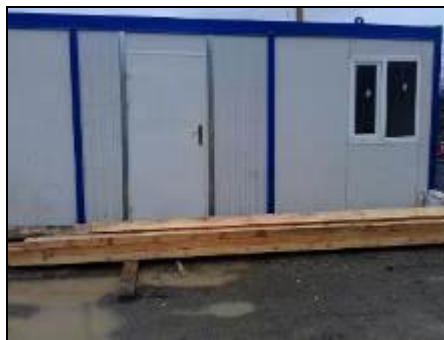
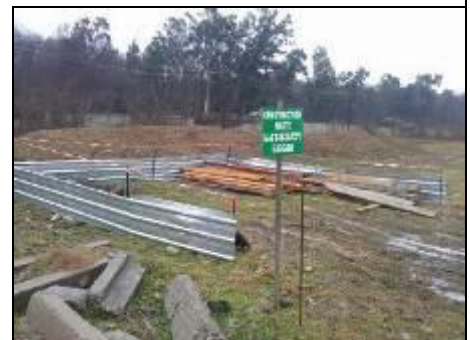
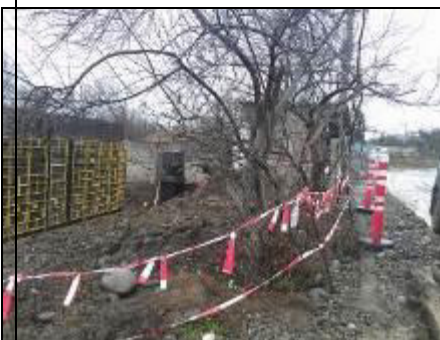
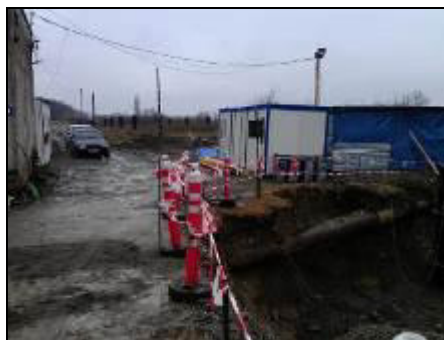
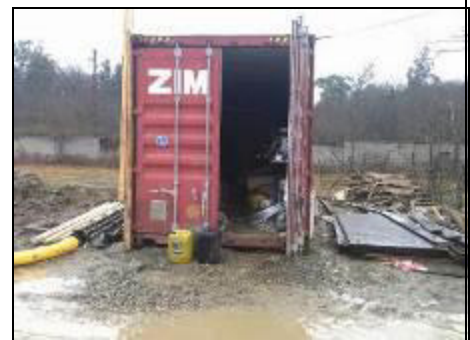
- All containers of fuel and lubricants should be installed in a special place
- Proper fuel/oil spill response items (sand, sawdust, special containers) should be available at the site
- Transport should be parked only at the parking area. Vehicles should not be parked at the construction site
- All construction materials should be properly segregated and stored adequately
- Storage and office containers' should be named with signs
- Construction waste materials should be removed timely and permanently
- All workers (even personnel of subcontractor) should be equipped with complete PPE
- Site internally should be arranged properly and cleaned regularly

All these conditions have to be remedied within four days (by the 18 February 2017) by the prime Contractor (SMK).

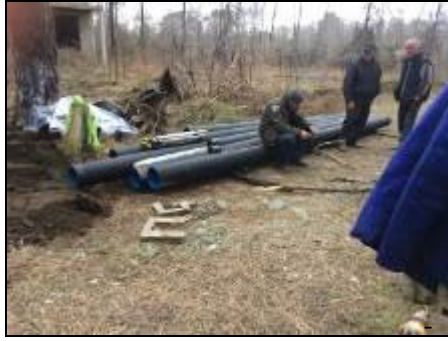
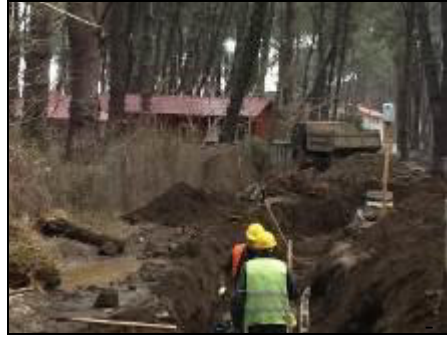
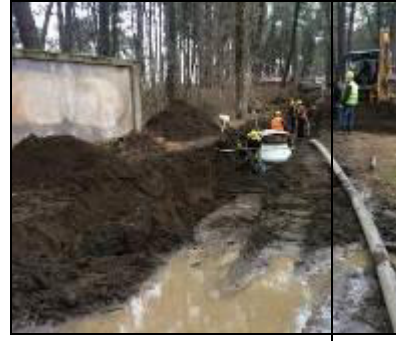
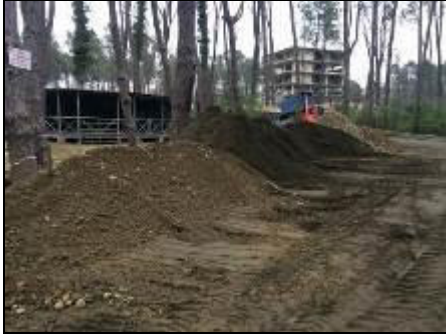
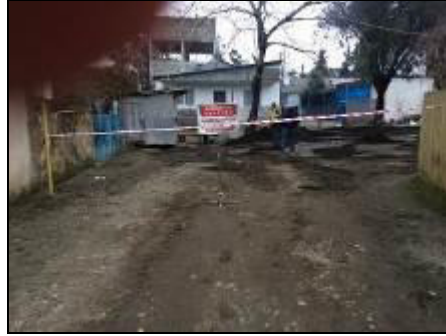
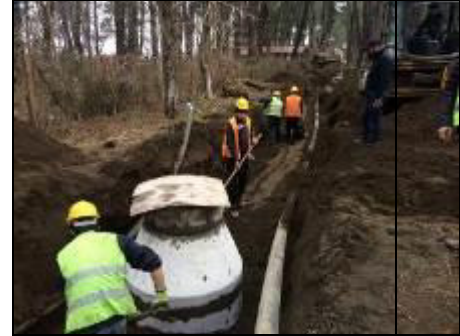
RESERVOIR

- Trees at the construction site should be protect to avoid its damage
- Proper warning and information signs should be arranged at the perimeter of the site
- Internal roads should be arranged properly
- Safety signs/tapes and trench side barriers should be installed around of deep excavation
- Walls of the deep trenches (>1.5m) should be strengthened by boards to avoid landfall of the soil and accidents
- Proper fuel/oil spill response items (sand, sawdust, special containers) should be available at the site
- Site internally should be arranged properly and cleaned regularly

All these conditions have to be remedied within four days (by the 18 February 2017) by the prime Contractor (Peri).	
Date of site visits: 09.02-10.02.2017	
Irakli Legashvili EPTISA - Environment

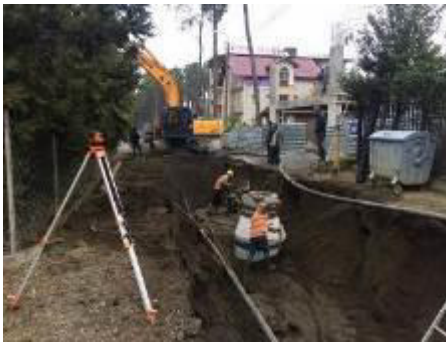
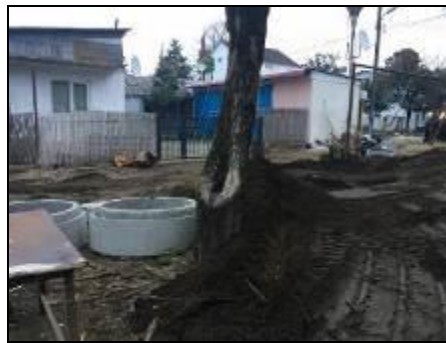
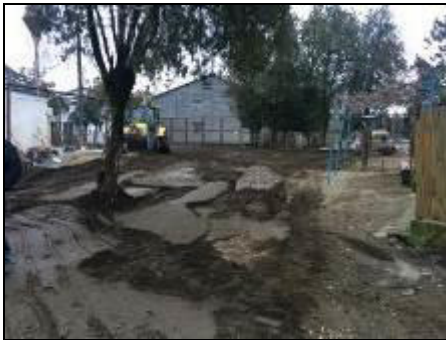
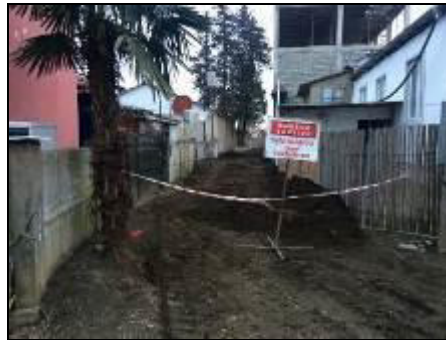
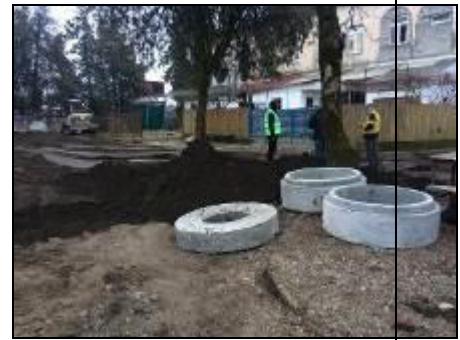
Project: USIIP	Non-compliance Notice UREKI
Contract No: URE-01	
Contractor: PERI	
Reference: UREKI – NETWORK, RESERVOIR	
This notice is to advice you, the prime Contractor, on the referenced Contract, of the following notice on environmental measures to be implemented urgently .	
<div><div><u>NON-COMPLIANCE IN UREKI</u></div><div>NETWORK</div><div><ul style="list-style-type: none">- High visible safety signs/tapes and trench side barriers around of deep open trenches should be installed to avoid accident of population- Construction activities information signs should be installed at each construction segment- Walls of the deep trenches (>1.5m) should be strengthened by boards to avoid landfall of the soil and accidents- Where are necessary proper wooden/metal walkways/planks across open trenches should be installed- Accumulated waste soil should be removed from construction area and disposed in a proper place- Construction materials should be brought when needed to avoid its long time disposal in the streets and disturbance of residents and businesses- Resident houses nearby areas should be clean from construction materials to avoid disturbance of residents and businesses- Trees of nearby construction zone should be protected to avoid its damage- Use tarpaulins to cover during materials transportation- Workers always should use complete PPE- All network line construction segments should be cleaned/well organized on regular bases</div></div>

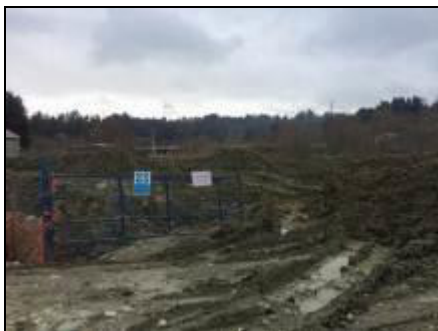
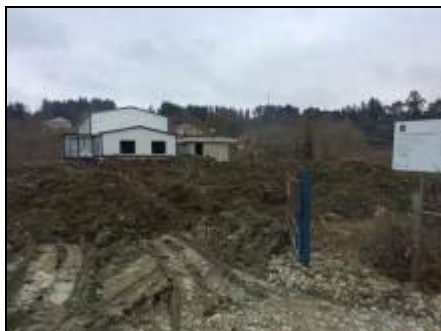
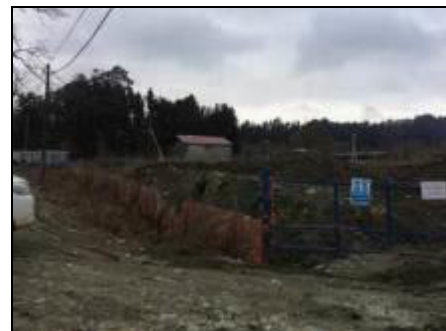
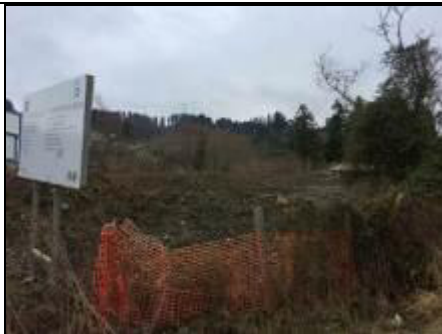
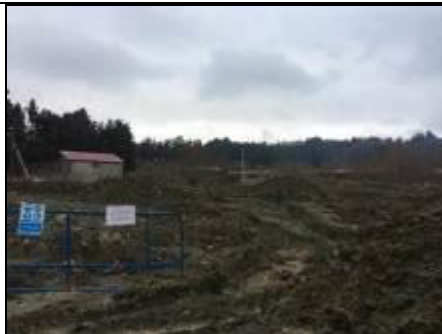
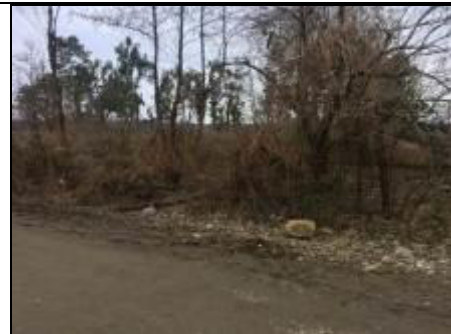
PUMPING STATION

- Entrance door of construction site should be in better operational condition and closed as needed
- Piles of soil at the construction territory should be managed properly (grading/leveling)
- The site access road and internal roads should be arranged
- Proper place for Parking with relevant sign should be arranged
- Site internally should be arranged properly with signage and cleaned regularly

All these conditions have to be remedied within four days (by the 18 February 2017) by the prime Contractor (Peri).

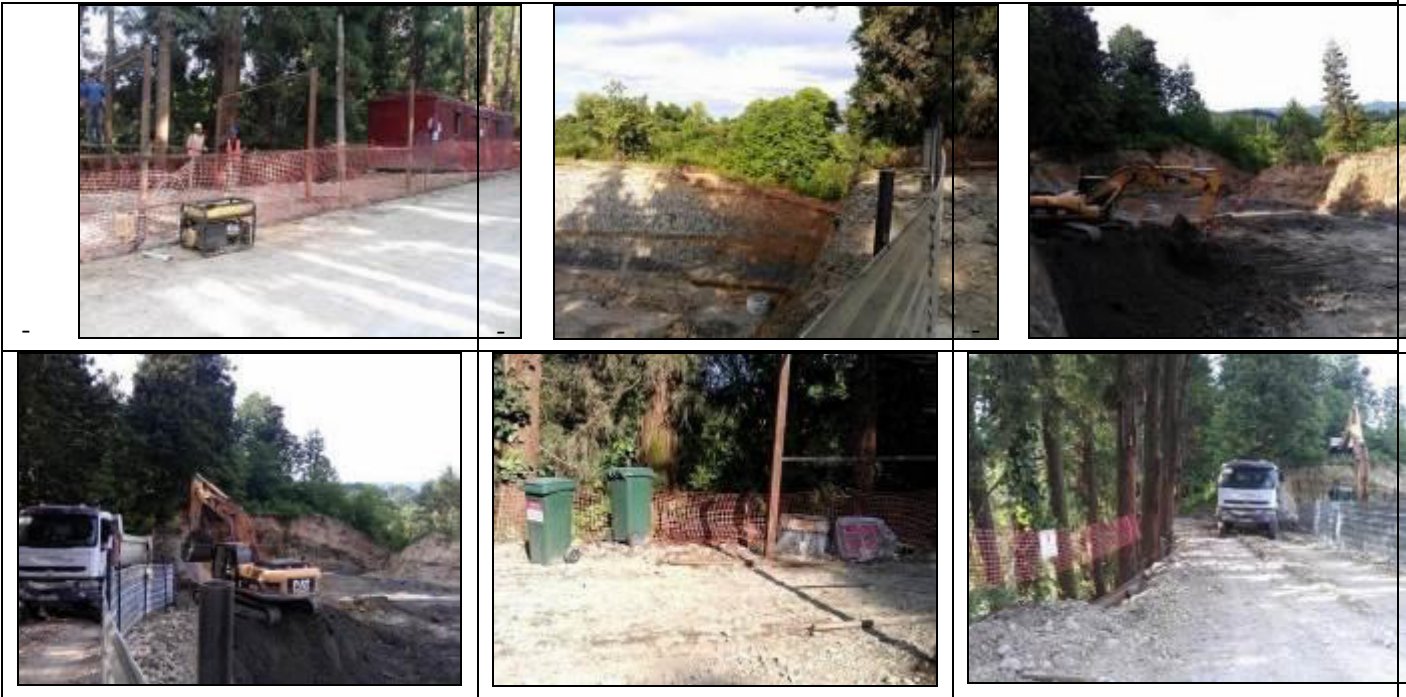
RESERVOIR

- Trees at the construction site and nearby deep excavation zone should be fenced protect to avoid its falling and damage
- Proper warning and information signs should be arranged at the entrance and perimeter of the site
- Safety signs/tapes and trench side barriers around of deep open excavation should be installed from all sides to avoid accidents
- Walls of the deep trenches (>1.5m) should be strengthened to avoid landfall of the soil and accidents
- Workers always should use complete PPE

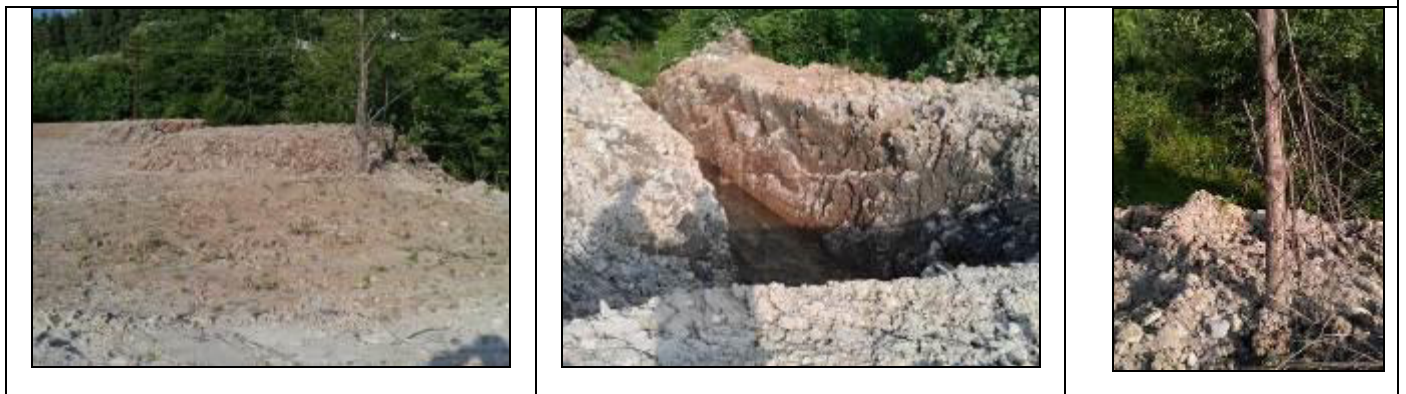
PAMPING STATION

- Trees at the construction site and nearby should be well protect to avoid its damage
- Trenches should be fenced adequately
- Gate should be closed and locked to avoid non-authorized entrance at the site
- Site internally should be arranged properly and cleaned regularly

All these conditions have to be remedied within four days (by the 10 June 2017) by the prime Contractor (Peri).		
Date of site visits: 29.05-30.05.2017		
Irakli Legashvili EPTISA - Environment

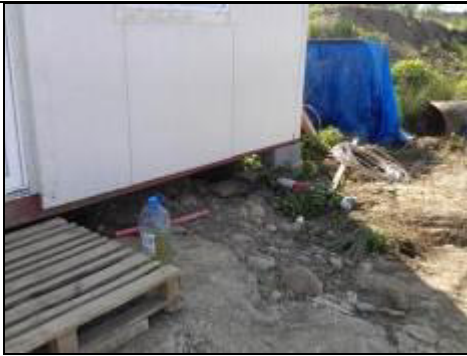
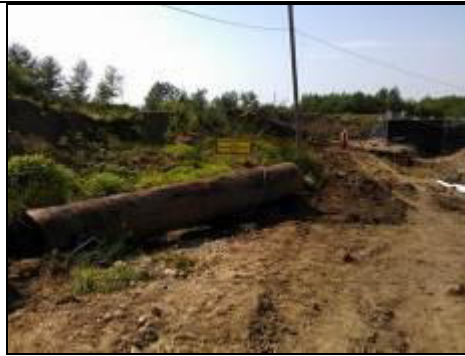
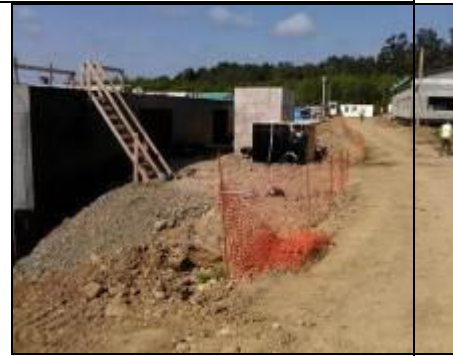
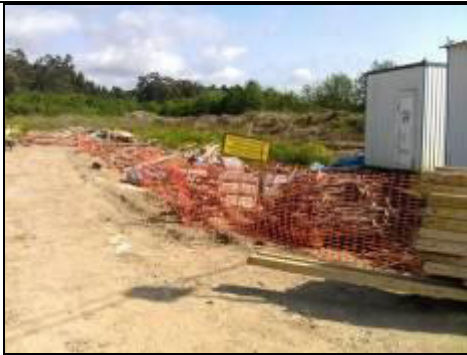
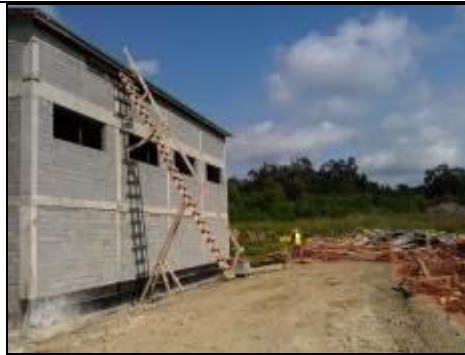
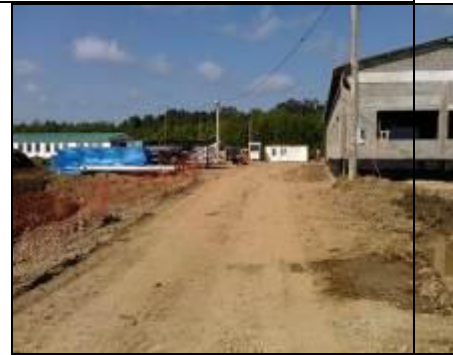
- Safety rules during high-altitude works should be respected to avoid workers damage (special attention to non-standard ladders)
- All construction materials should be properly segregated and stored adequately

- PPE equipment should be used always and completely by all workers
- Solid waste should be removed on timely manner to avoid its long time storage

All these conditions have to be remedied within four days (by the 10 June 2017) by the prime Contractor (Pfeiffer).

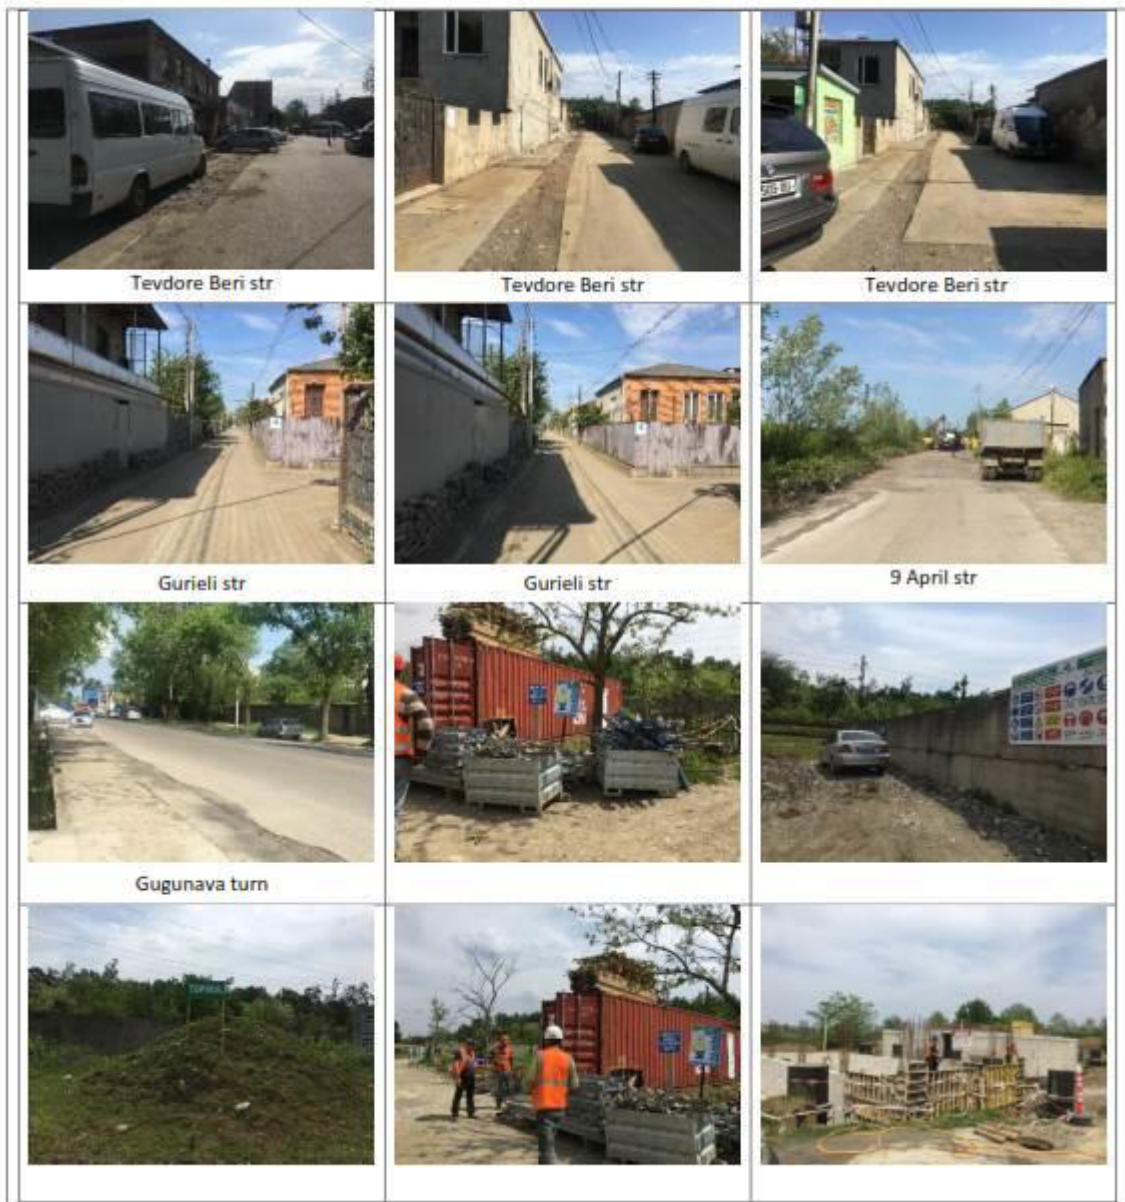
Photos of Network and Mukhnari Reservoir

- Proper fuel/oil spill response items (sand, sawdust, special containers) are available at the site
- Transport is parked only at the parking area
- All construction materials are properly segregated and stored adequately
- Topsoil disposal location is well labelled
- All workers even personnel of subcontractor are equipped with PPE
- One side of Mukhnari Reservoir site is opened for permanent usage, as the machinery (crane, pump etc) stand there. As soon as it is finished, mentioned part will be fenced.
