Georgia: Urban Services Improvement Investment Program —  
Tranche 3

# BI-ANNUAL ENVIRONMENTAL MONITORING REPORT

*Project Number: 43405-025*

*Reporting Period: January-June 2018*

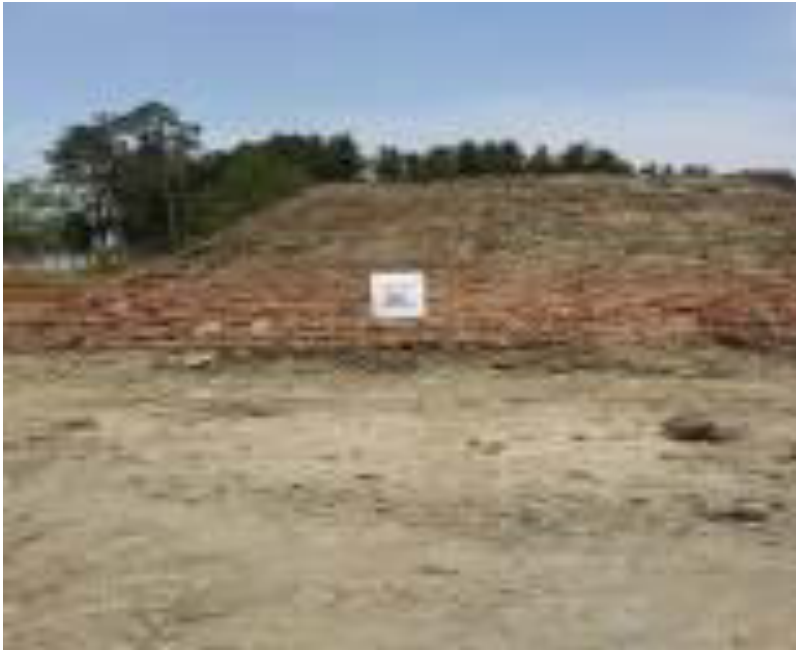
Photo 1: Improved top-soil management under Ure-01/PS

Status: Completed. Corrective action plan regarding incorrect disposal of topsoil was prepared by contractor. The Topsoil was separated from subsoil and stockpiled separately in accordance with Georgian regulations.

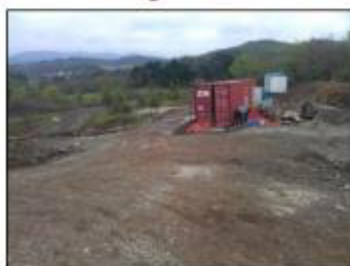
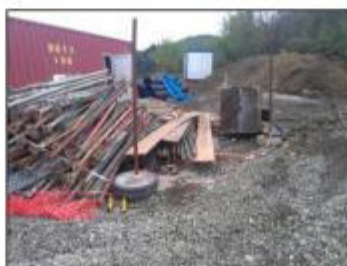
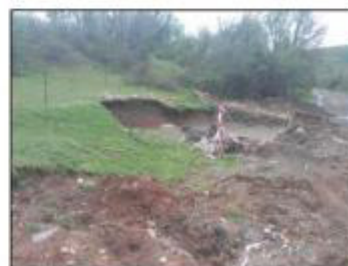
#### Photos of Godogani Reservoir

- Trees at the construction site and nearby deep excavation zone should be protect to avoid its damage
- Safety tapes and fencing around concrete washing pit and proper sign should be installed

- Workers always should use complete PPE
- Site internally should be arranged properly and cleaned regularly

All these conditions have to be remedied within four days (by the 31 March 2018) by the prime Contractor (SMK).

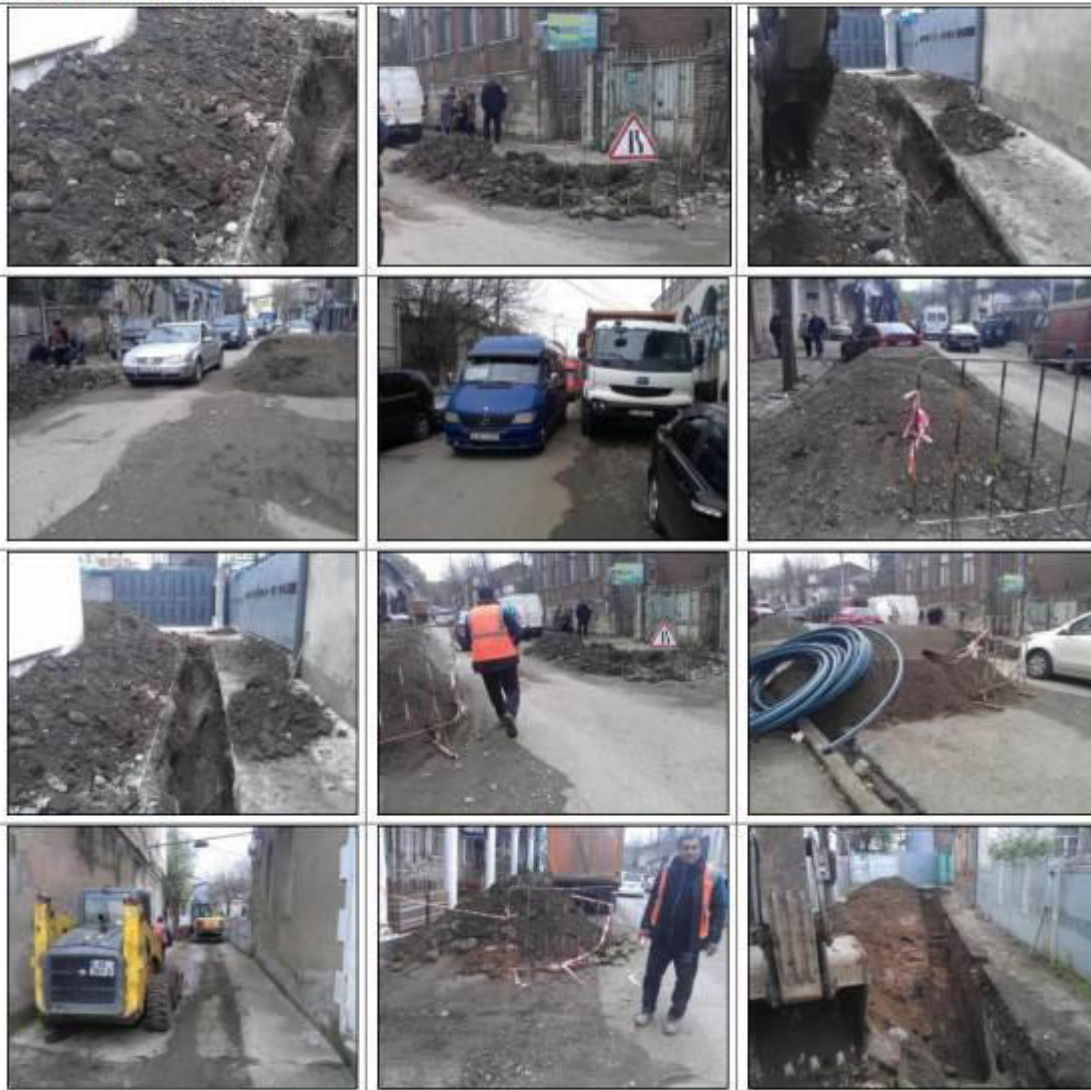
**Photos of Kutaisi Network**

- Construction activities information signs should be installed at each construction segment
- Safety signs/tapes around of all open trenches should be installed to avoid accident of population
- Surplus waste soil should be removed and disposed in a proper place on time
- Top soil before starting of excavation works should be removed and stored separately with signage
- Construction materials should be brought when needed to avoid its long time disposal in the streets and disturbance of residents and businesses
- Resident houses nearby areas should be clean from construction materials to avoid disturbance of residents and

- Resident houses nearby areas should be clean from construction materials to avoid disturbance of residents and businesses
- All transmission line construction segments should be cleaned/well organized on regular bases
- Workers always should use complete PPE
- Refilling/compaction and reinstatement process should bring site at the same or better condition as it was before construction

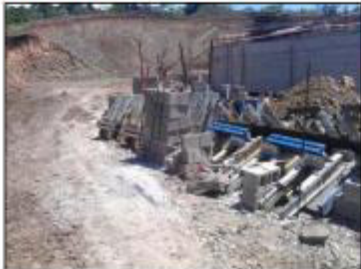
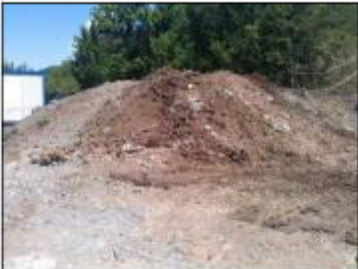
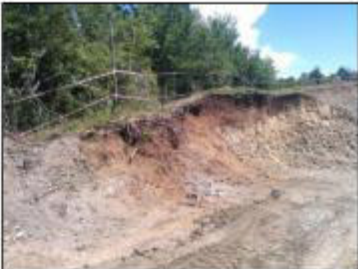
<b>Photos of Godogani Reservoir</b>

Project: USIIP	Non-compliance Notice KUTAI SI	
Contract No: KUT-01		
Contractor: SMK		
Reference: Kutaisi – Godogani Reservoir, Network		
This notice is to advice you, the prime Contractor, on the referenced Contract, of the following notice on environmental measures to be implemented <b>urgently</b> .		
<b><u>NON-COMPLIANCE IN KUTAI SI</u></b>		
<b>Godogani Reservoir</b>		
<ul style="list-style-type: none"><li>- Construction site should be properly fenced from all sides and equipped with lockable gate</li><li>- Construction territory should be lighted adequately</li><li>- Proper warning and information signs should be arranged at the entrance and perimeter of the site</li><li>- High visible safety signs/tapes and trench side barriers around of deep open excavation should be installed from all sides to avoid accidents</li><li>- Special equipment during working at heights should be used</li><li>- Safety rules during electric cable use should be respected, including the way of its installation.</li><li>- Trees at the construction site and nearby deep excavation zone should be protect to avoid its damage</li><li>- Proper fencing around concrete washing pit with relevant information/warning sign should be installed</li><li>- Safety officer should be permanently visiting/monitoring construction site</li><li>- Proper fuel/oil spill response items (sand, sawdust, special containers) should be available at the site</li><li>- Spots of oil spills should be remediated immediately</li><li>- Containers with fuel/lubricant should be managed properly (stored at the proper organised place with concrete floor and roofing) to avoid leakage and ground contamination</li><li>- Equipment &amp; vehicles used for construction activities should be in good condition (no leakage)</li><li>- All construction materials should be properly segregated and stored adequately</li><li>- The access road and internal roads should be arranged properly</li><li>- Parking area should be better organized, transport should be parked only at the Parking area</li><li>- Workers always should use complete PPE</li><li>- Site internally should be arranged properly and cleaned regularly</li></ul>

All these conditions have to be remedied within five days (by the 27 May 2018) by the prime Contractor (SMK).

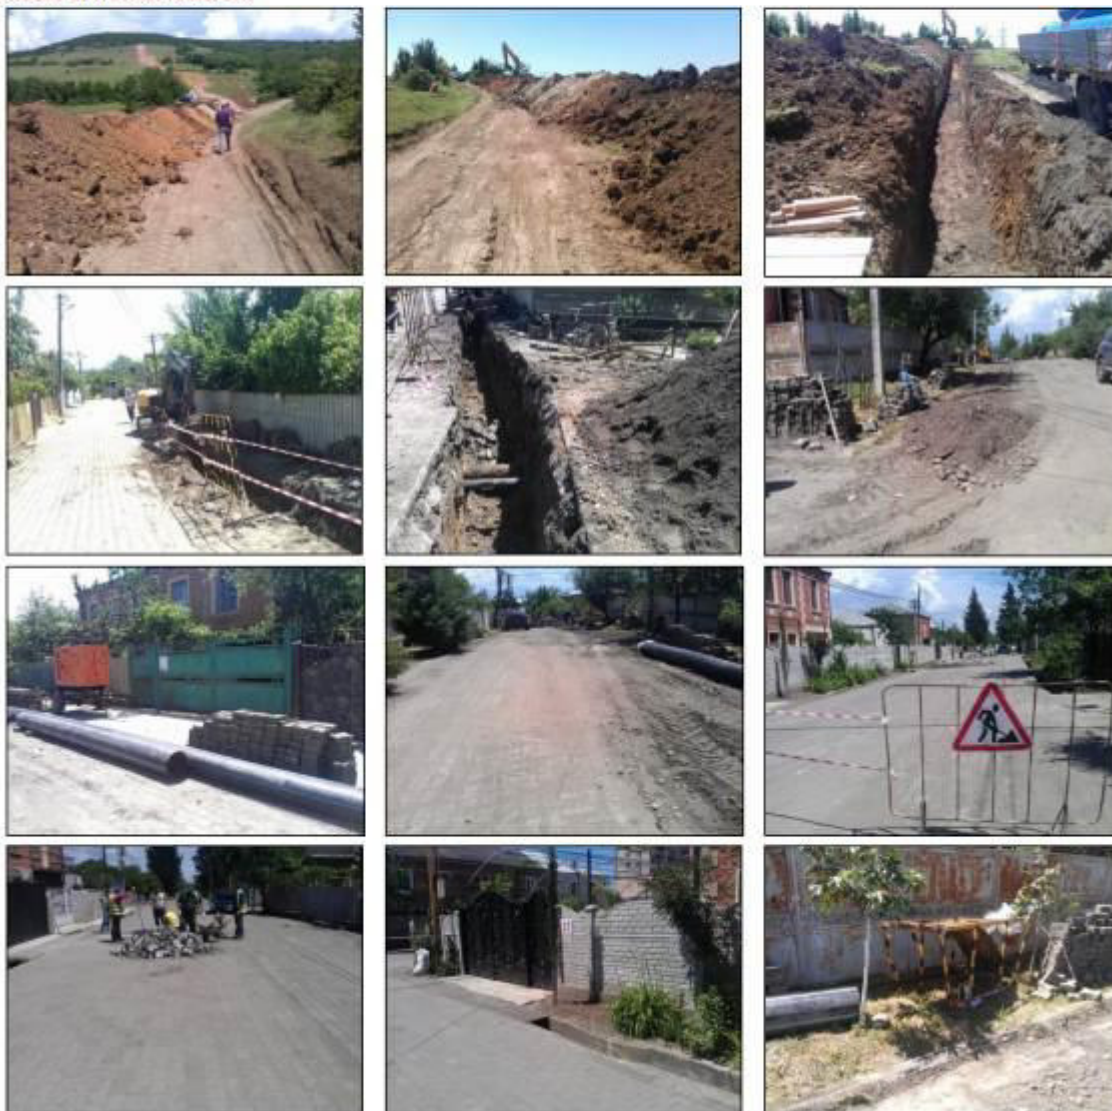
**Photos of Kutaisi Network**

- Construction segments should be watered regularly to avoid dust generation
- Special blinking signs or flag men should be provided when passing streets to avoid disturbance of car movements
- All transmission line construction segments should be cleaned/well organized on regular bases
- Workers always should use complete PPE
- Refilling/compaction and reinstatement process should bring site at the same or better condition as it was before construction

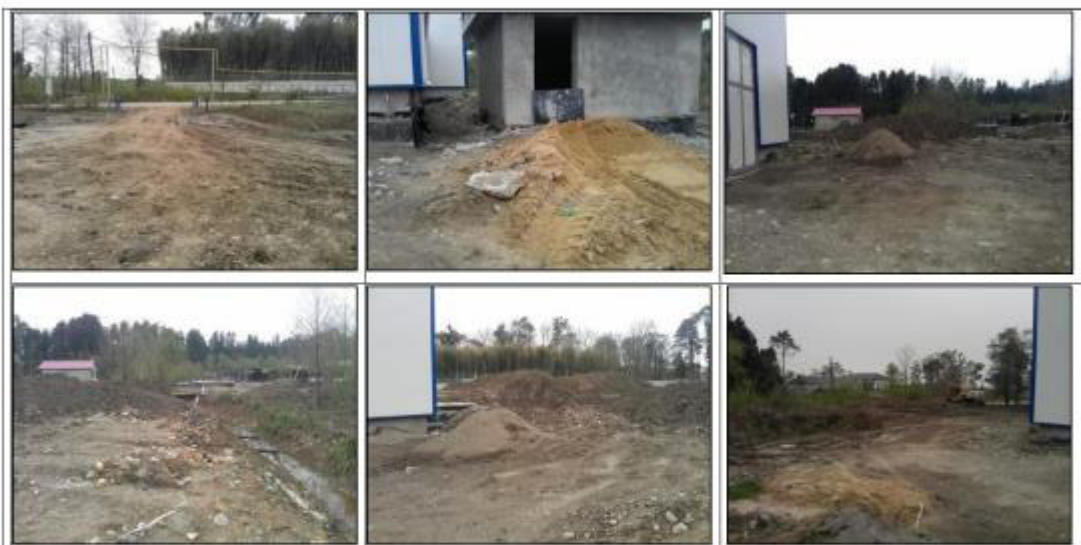
Project: USIIP	Non-compliance Notice UREKI	
Contract No: URE-01		
Contractor: PERI		
Reference: UREKI - UREKI PUMPING STATION		
This notice is to advice you, the prime Contractor, on the referenced Contract, of the following notice on environmental measures to be implemented <b>urgently</b> .		
<b><u>NON-COMPLIANCE IN UREKI</u></b>		
<b>PAMPING STATION</b>		
<ul style="list-style-type: none"><li>- Entrance door and fencing of the construction site should be in better condition and complete</li><li>- Piles of soil at the construction territory should be managed properly<ul style="list-style-type: none"><li>- Top soil should be separated from surplus waste soil and managed properly (fencing, signage, piling standard)</li></ul></li><li>- Safety tapes around open trenches should be installed</li><li>- The site access road and internal roads should be better arranged (graveling)</li><li>- All workers should be equipped with complete PPE</li><li>- Site internally should be arranged properly and cleaned regularly</li></ul>

All these conditions have to be remedied within four days (by the 31 March 2018) by the prime Contractor (Peri).

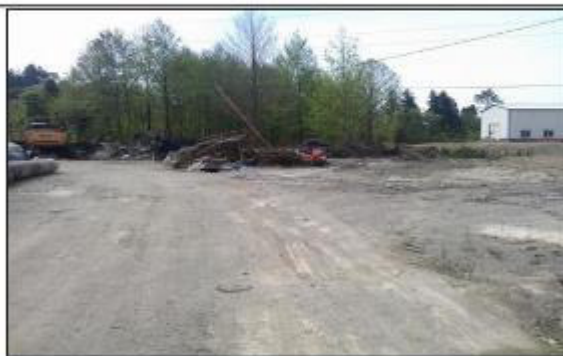
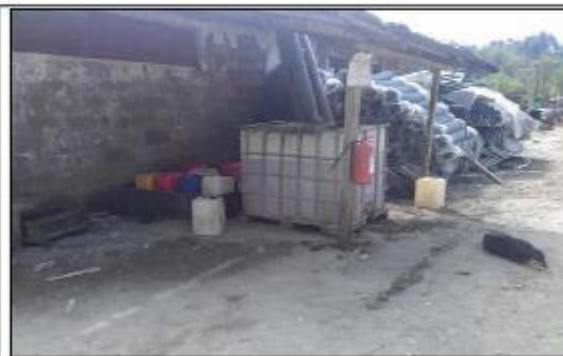
Project: USIIP	Non-compliance Notice UREKI
Contract No: URE-01	
Contractor: PERI	
Reference: UREKI – Camp	
This notice is to advice you, the prime Contractor, on the referenced Contract, of the following notice on environmental measures to be implemented <b>urgently</b> .	
<b><u>NON-COMPLIANCE IN UREKI</u></b>	
<ul style="list-style-type: none"><li>- Construction equipment should be in good condition (non leakage)</li><li>- Proper fuel/oil spill response items (sand, sawdust, special containers) should be available at the site</li><li>- Construction waste (wooden, metal, plastic, etc.) should be removed from construction area completely and timely</li><li>- Site gate should be operation at every entrance or exit with relevant signage</li><li>- Site fencing should be complete and with visible materials on it</li><li>- Oil spillage traces should not be available at the site</li><li>- Waste should be placed at the proper standard waste containers with labeling</li><li>- Containers of lubricants should be managed properly (concrete flooring and relevant roofing)</li><li>- Construction materials should be segregated precisely and stored properly</li><li>- Site internally should be arranged properly (including signage) and cleaned regularly (animals should not be available at the site)</li></ul>

All these conditions have to be remedied within ten days (by the 4 May 2018) by the prime Contractor (Peri).

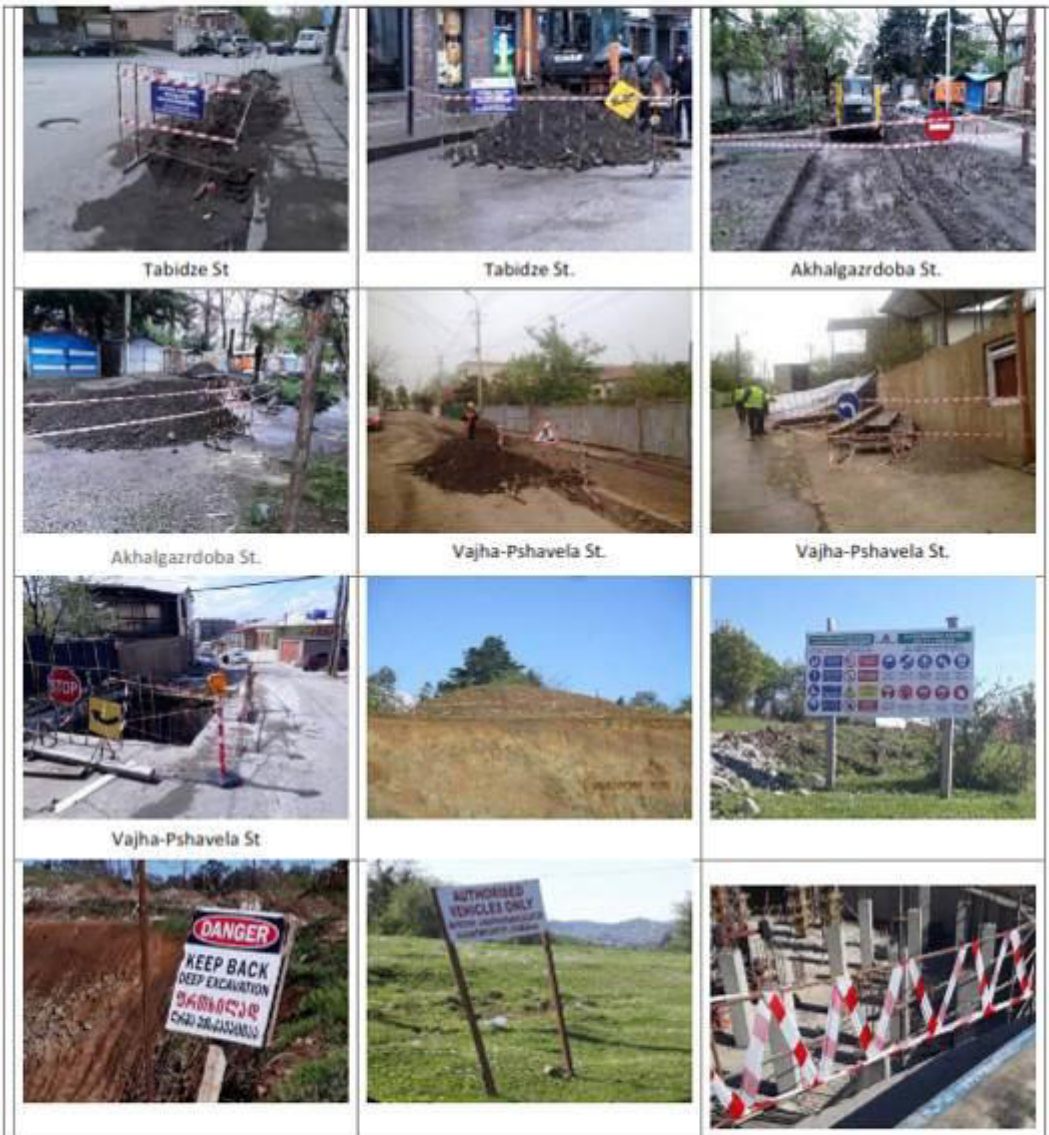
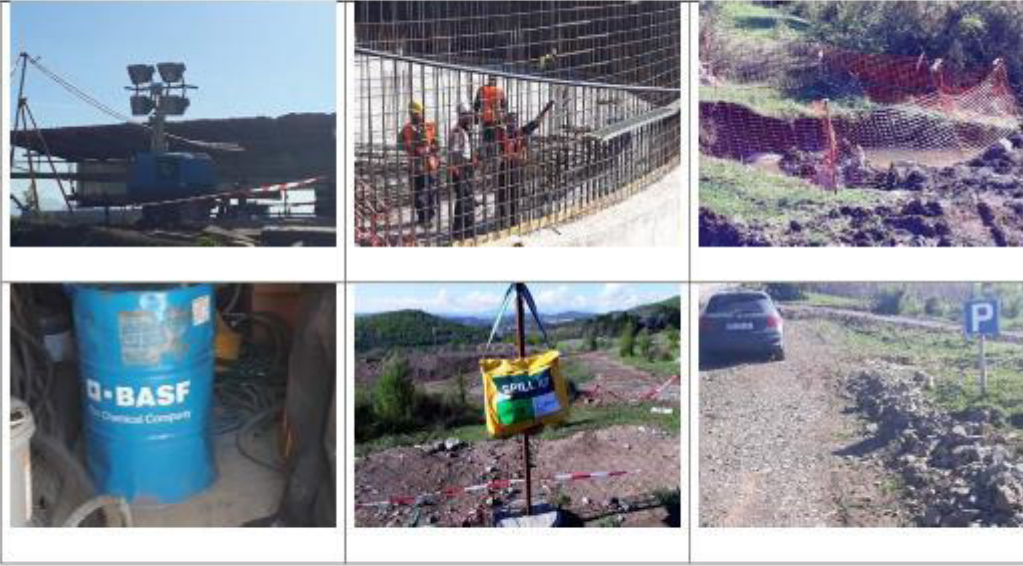
<b>Photos of Network and Godogani Reservoir</b>

<b>Godogani</b>	
<ul style="list-style-type: none"> <li>- Site is fenced from all sides and lockable gate will be provided as soon as possible</li> <li>- SMK took action and proper warning and information signs are installed at the entrance and perimeter of the site</li> <li>- Excavation area is fenced with temporary orange safety tape</li> <li>- Construction territory is lighted adequately</li> <li>- Safety tapes and fencing around concrete washing pit and proper sign is installed</li> <li>- SMK took action and trees nearby construction site are fenced to avoid damage</li> <li>- Safety officer will be available within two days at construction site</li> <li>- Oils or similar liquid containers are stored properly</li> <li>- Proper fuel/Oil spill response items(sand,sawdust,special containers)are available at the site</li> <li>- Eccess road will be arranged after finishing heavy construction works</li> <li>- Parking area with relevant sign is arranged</li> <li>- All wokers are equipped with PPE</li> </ul>
