Environmental Monitoring Report

Bi-annual Report (Jul -Dec 2018)

Georgia: Urban Services Improvement Investment Program – Tranche 2

SEMI-ANNUAL ENVIRONMENTAL MONITORING REPORT

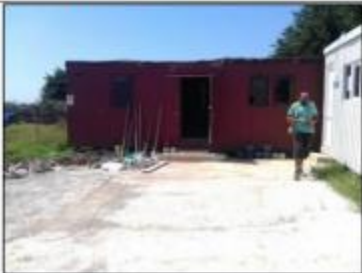
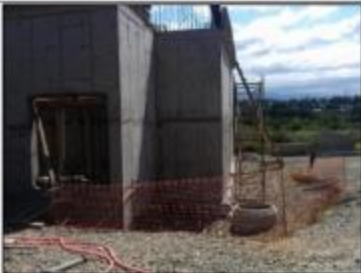
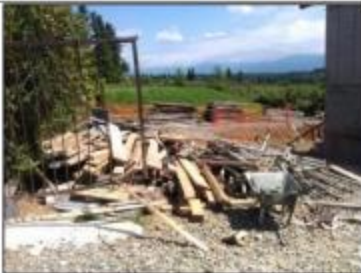
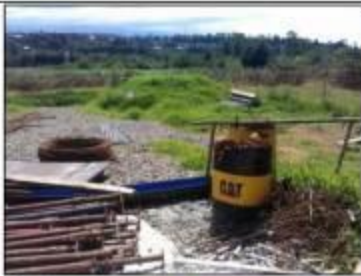
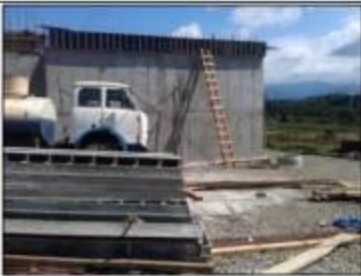
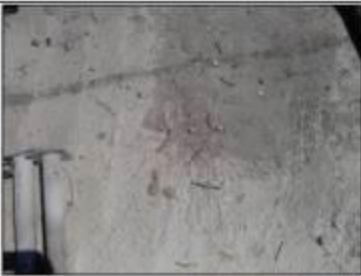
Project: USIIP	Non-compliance Notice UREKI
Contract No: URE-01	
Contractor: PERI	
Reference: UREKI – RESERVOIR IN LAITURI	
This notice is to advice you, the prime Contractor, on the referenced Contract, of the following notice on environmental measures to be implemented urgently .	
<u>NON-COMPLIANCE IN UREKI</u>	
RESERVOIR IN LAITURI	
<ul style="list-style-type: none">- Construction site should be properly fenced from all sides and equipped with lockable gate- Construction waste should be timely removed from the construction site and disposed properly- Construction territory should be lighted adequately- Proper warning and information signs should be arranged at the entrance and perimeter of the site- Proper toilet with relevant sign should be arranged- Construction territory and wooden materials should be freed from big nails to avoid personnel damage- Safety norms during working at height should be provided- Special equipment during working at heights should be used- Ladder safety should be insured- Soil (surplus/accumulated soil) for backfilling purposes should be managed/stored properly- Proper fuel/oil spill response items (sand, sawdust, special containers) should be available at the site- Containers with fuel/lubricant should be managed properly (stored at the proper organized place with concrete floor and roofing) to avoid leakage and ground contamination- All construction materials should be properly segregated and stored adequately- Workers always should use complete PPE- Site internally should be arranged properly and cleaned regularly

All these conditions have to be remedied within six days (by the 22 August 2018) by the prime Contractor (Peri).		
Date of site visits: 14.08-15.08.2018		
Irakli Legashvili EPTISA - Environment

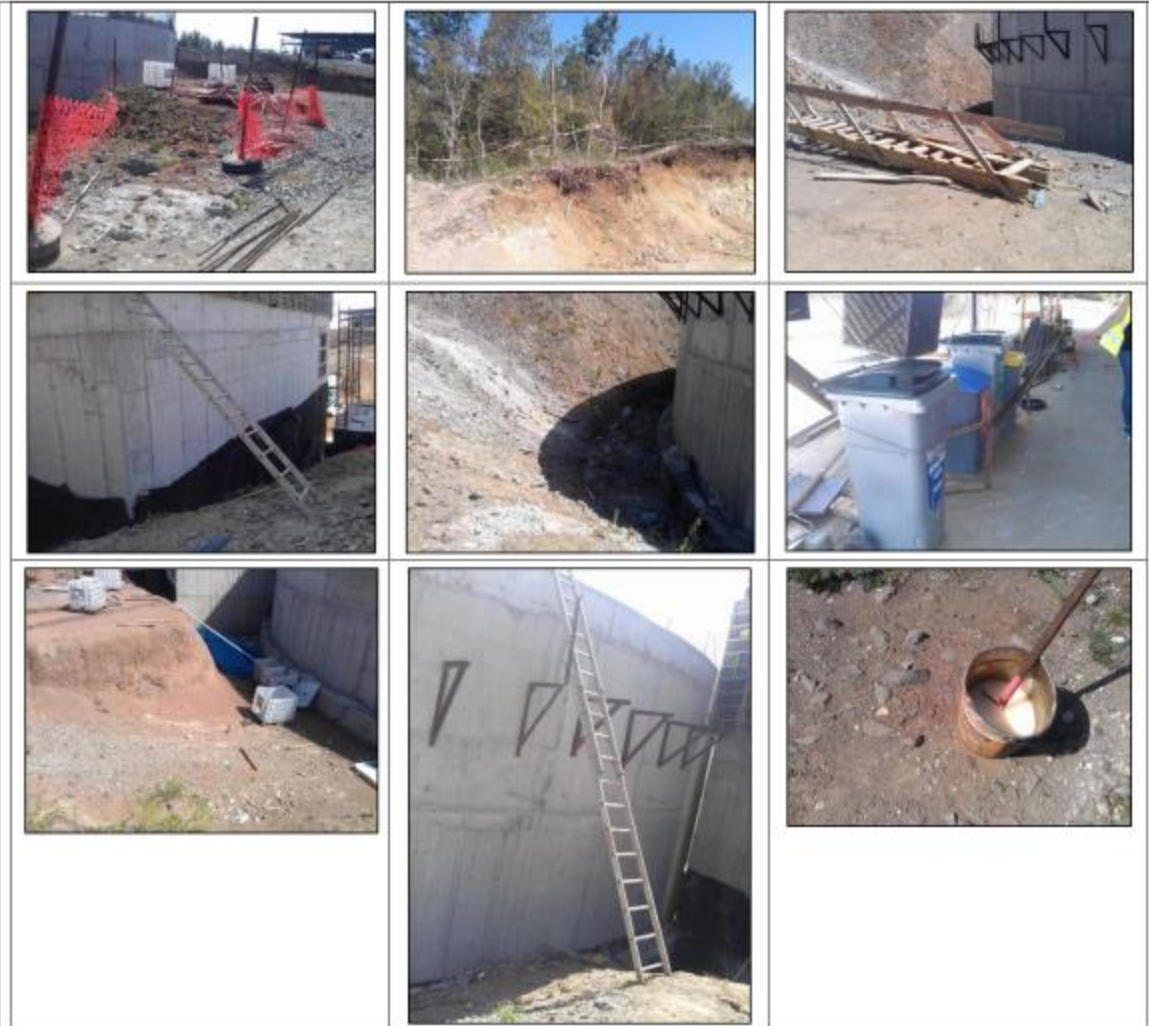
Photos of Godogani Reservoir

- Trees at the construction site and nearby deep excavation zone should be protect to avoid its damage
- Construction waste should be timely removed from the construction site and disposed properly

- Containers with fuel/lubricant should be managed properly (stored at the proper organized place with concrete floor and roofing) to avoid leakage and ground contamination

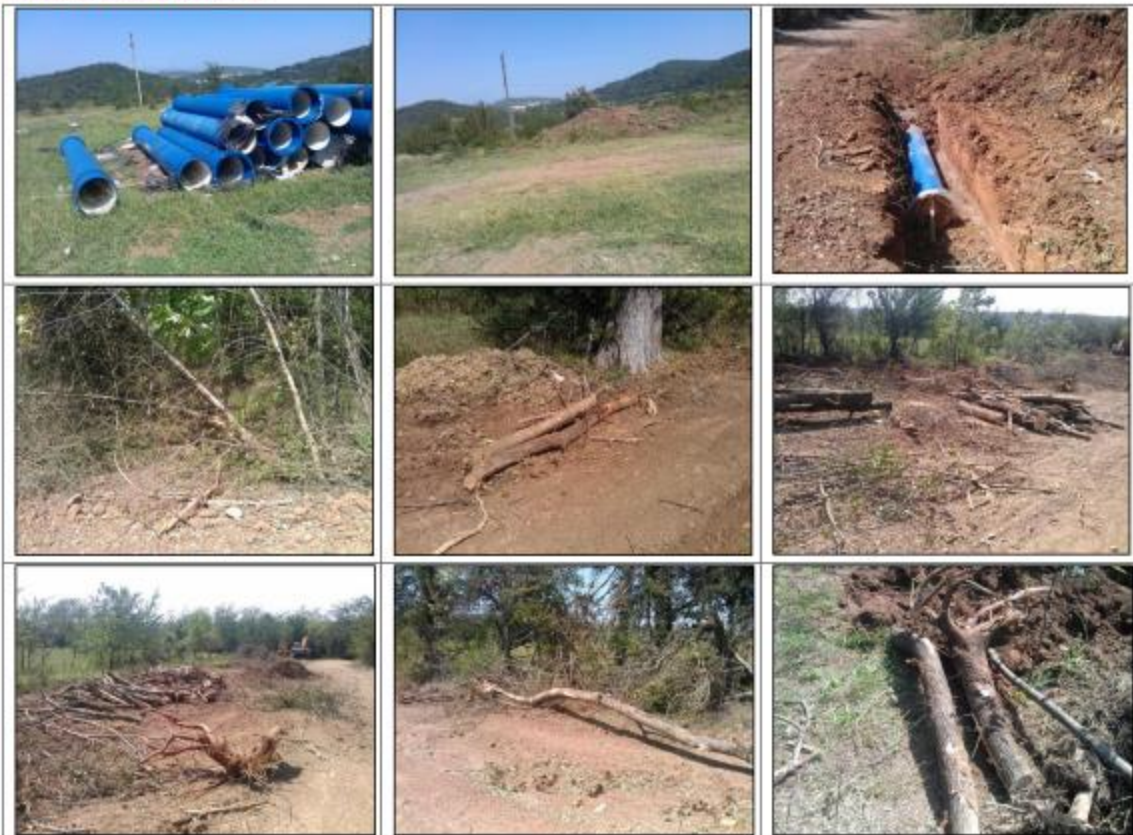
Photos of Kutaisi Network

- Construction activities information signs should be installed at each construction segment
- Safety signs/tapes around of all open trenches should be installed to avoid accident of population

- Trees nearby construction works and excavation zone should be protect to avoid its damage
- Trees cutting without proper agreement/permit is prohibited

- Workers always should use complete PPE
- Refilling/compaction and reinstatement process should bring site at the same or better condition as it was before construction

All these conditions have to be remedied within five days (by the 27 September2018) by the prime Contractor (SMK).	
Date of site visits 05.09-06.09.2018	
Irakli Legashvili	
EPTISA - Environment

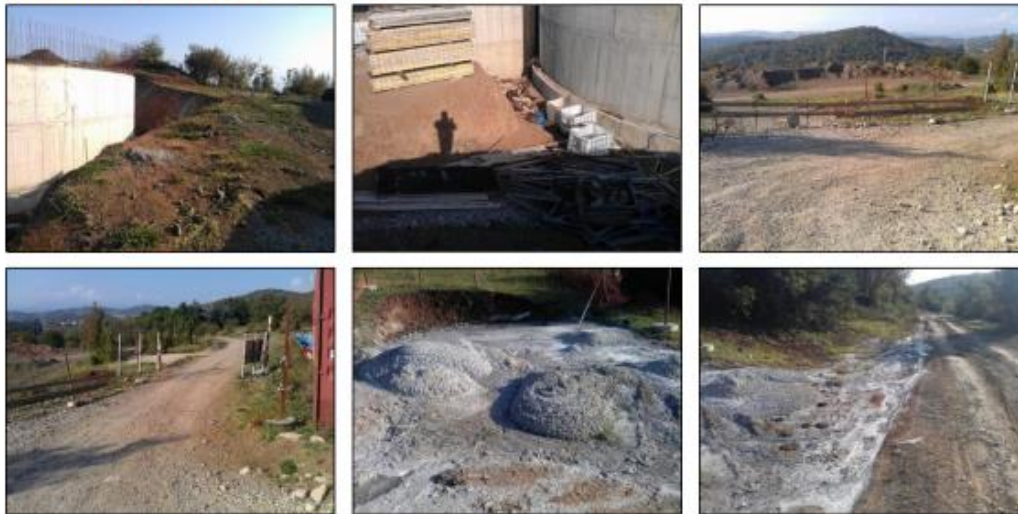
Photos of Godogani Reservoir

- Complain box should be properly signed and place at the entrance of the site
- Concrete washout pit should be managed properly, discharged, fenced and signed. With current condition ground needs urgent remediation

- Workers always should use complete PPE
- Safety norms during working at height should be respected
- Site internally should be arranged properly and cleaned regularly

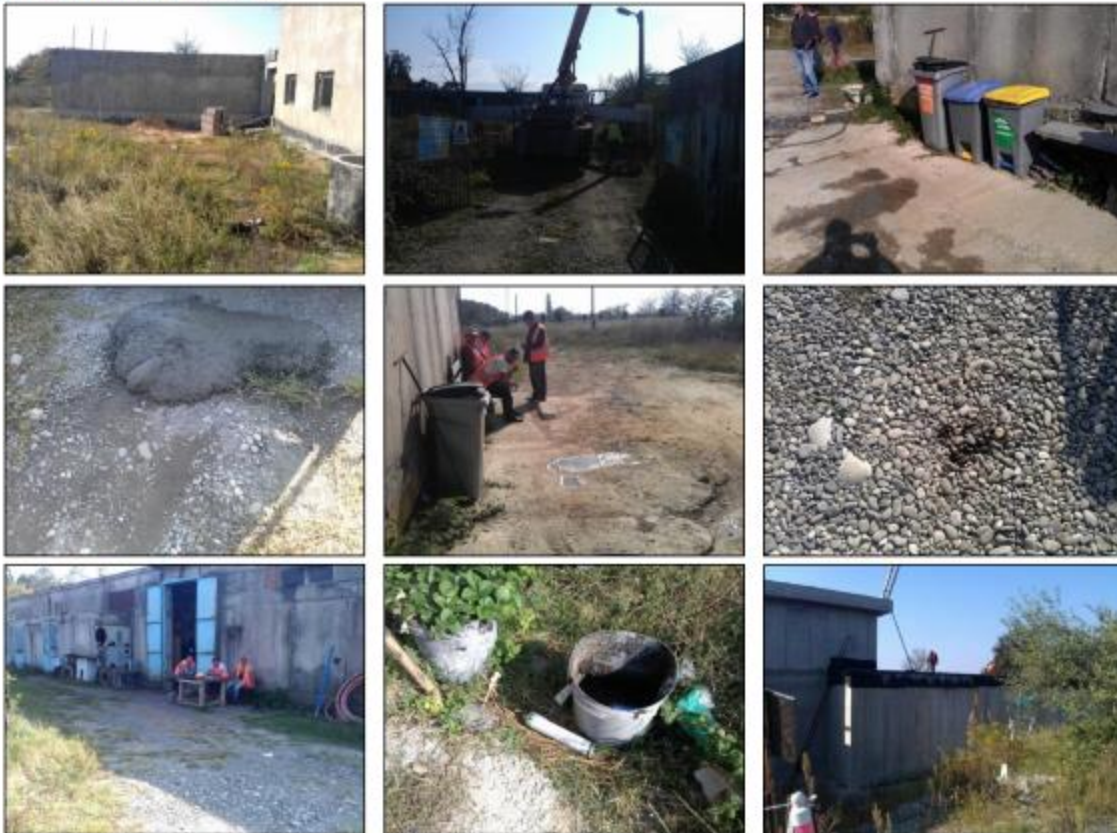
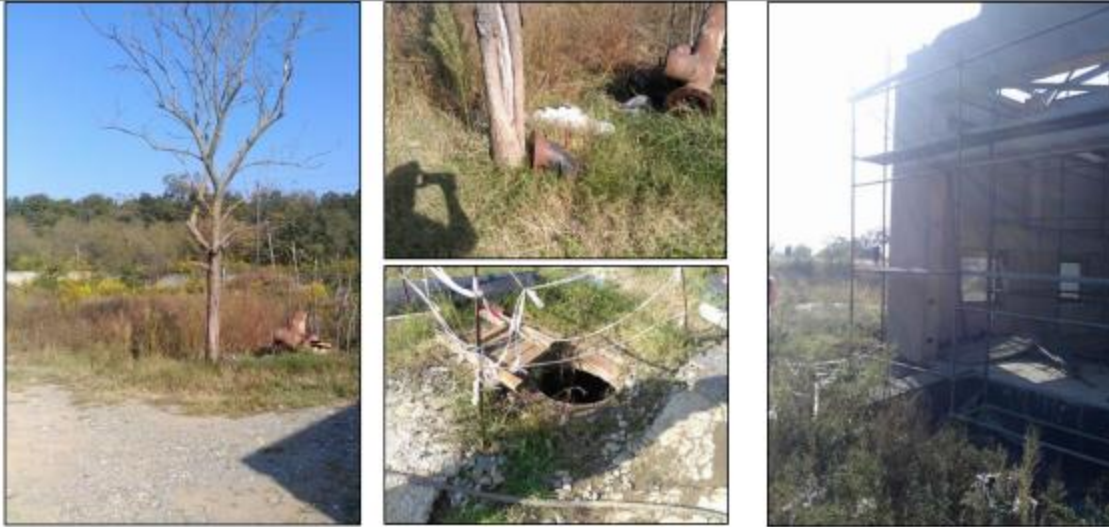
Photos of Mukhnari Reservoir

- Construction waste should be timely removed from the construction site and disposed properly
- Equipment & vehicles used for construction activities should be in good condition (no leakage) to avoid leakage and ground/water contamination
- Proper fuel/oil spill response items (sand, sawdust, special containers) should be available at the construction site
- Trees nearby/at the construction zone should be protected/fenced to avoid its damage
- All construction materials should be properly segregated and stored adequately
- All workers should be equipped with complete PPE
- Safety norms during works at the height should be respected
- Ladder safety should be ensured
- Site internally should be arranged properly and cleaned regularly

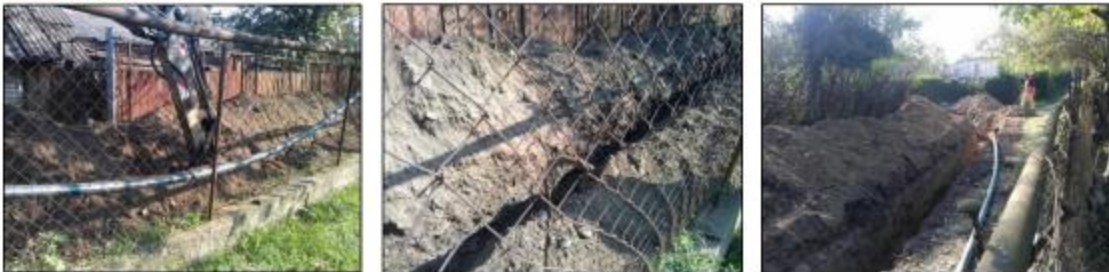
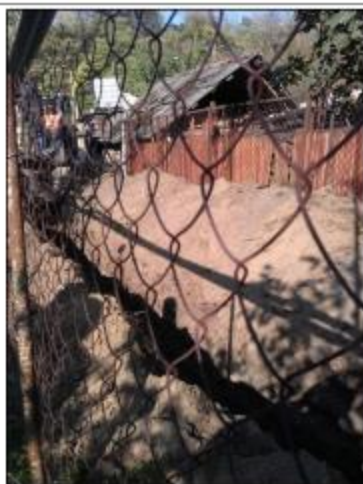
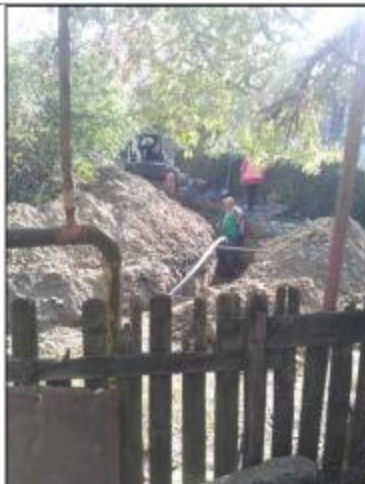
Photos of Network

- Safety signs/tapes around of all open trenches should be installed to avoid accident of population
- Construction activities information signs should be installed at each construction segment

- Surplus waste soil should be removed and disposed in a proper place
- Trees nearby/at the construction activities zone should be protected/fenced to avoid its damage

- Workers always should use complete PPE
- All transmission line construction segments should be cleaned/well organized on regular bases
- Refilling/compaction and reinstatement process should bring site at the same or better condition as it was before construction

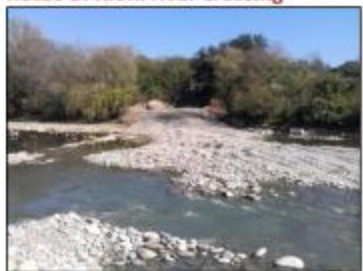
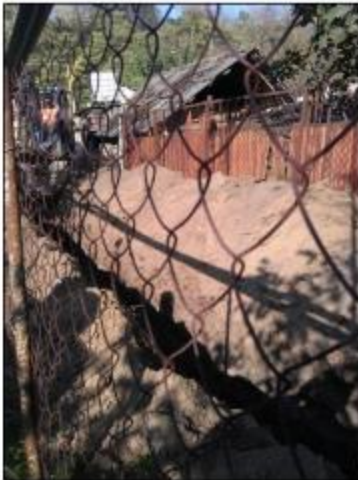
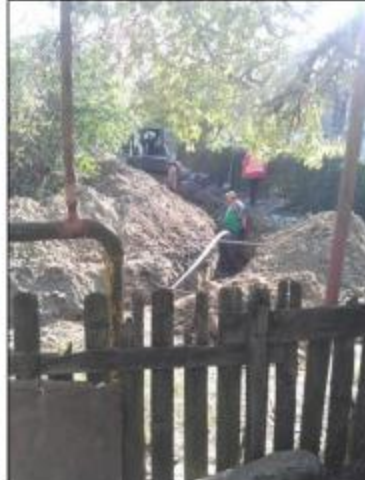
Photos of Rioni river crossing

- Construction activities information and warning signs should be installed along the construction site
- High visible safety signs/tapes should be installed around excavation/construction works area and open trenches to avoid accidents

- Trees nearby construction activities zone should be protect to avoid its damage
- Proper fuel/oil spill response items (sand, sawdust, special containers) should be available

- Workers always should use complete PPE
- Construction area should be arranged properly and cleaned regularly

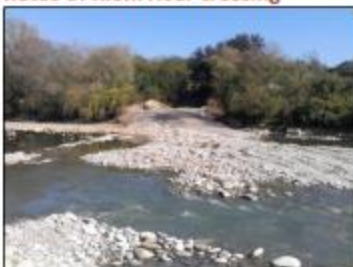
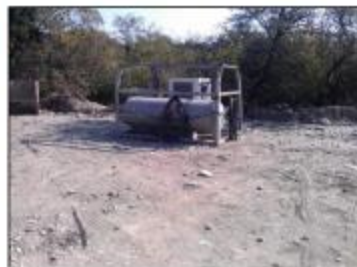
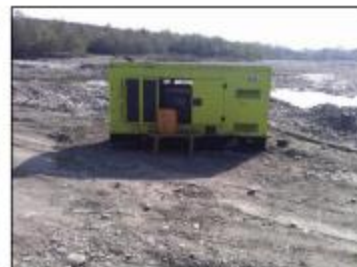
Photos of Rioni river crossing

- Construction activities information and warning signs should be installed along the construction site
- High visible safety signs/tapes should be installed around excavation/construction works area and open trenches to avoid accidents

- Workers always should use complete PPE
- Construction area should be arranged properly and cleaned regularly

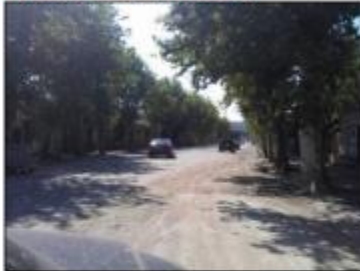
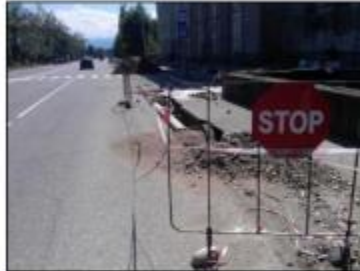
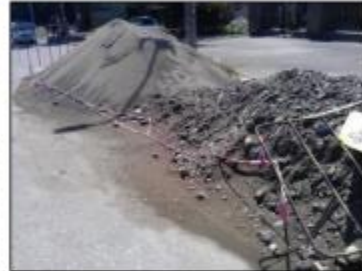
Photos of Kutaisi Network

- Construction activities information signs should be installed at each construction segment
- Surplus waste soil should be removed and disposed in a proper place
- Construction materials should be brought when needed to avoid its long time disposal in the streets and disturbance of residents and businesses
- All transmission line construction segments should be cleaned/well organized on regular bases
- Refilling/compaction and reinstatement process should bring site at the same or better condition as it was before construction

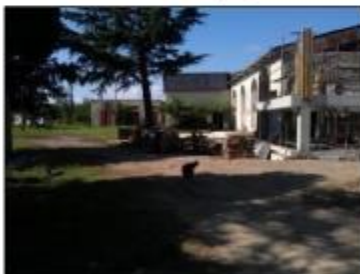
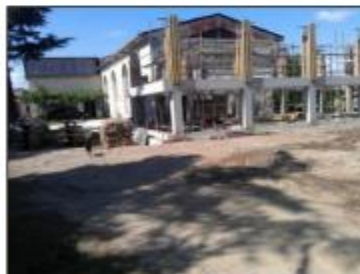
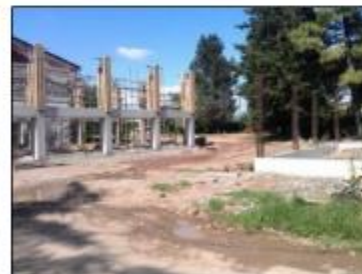
Photos of Kutaisi Pumping station

- Proper warning and information signs should be arranged at the construction territory and perimeter of the site
- Safety norms during working at height should be provided
- Special equipment during working at heights should be used
- Trees at the construction site should be protect (trees should be exempt from materials) to avoid its damage
- All construction materials should be properly segregated and stored adequately
- Workers always should use complete PPE
- Site internally should be arranged properly and cleaned regularly

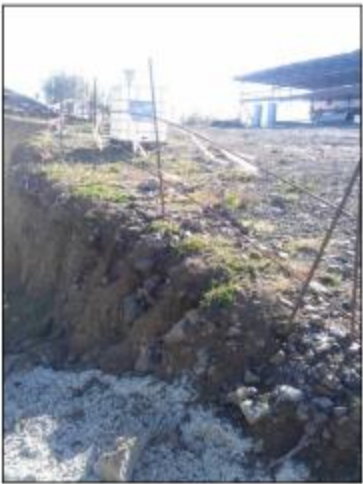
Photos of Godogani Reservoir

Project: USIIP	Non-compliance Notice KUTAISI	
Contract No: KUT-01		
Contractor: SMK		
Reference: Kutaisi – Godogani Reservoir, Mukhnari Reservoir, Network, Rioni river crossing		
This notice is to advise you, the prime Contractor, on the referenced Contract, of the following notice on environmental measures to be implemented urgently .		
<u>NON-COMPLIANCE IN KUTAISI</u>		
Godogani Reservoir		
<ul style="list-style-type: none">- Tree nearby to deep excavation zone should be protect to avoid its falling and damage- Trench side barriers (mesh material) around of deep excavation should be installed from all sides to avoid accidents- Entrance gate of the construction site should be repaired- Construction waste should be timely removed from the construction site and disposed properly (construction site should be cleaned regularly)- Concrete washout pit should be lined with the geomembrane- Workers always should use complete PPE

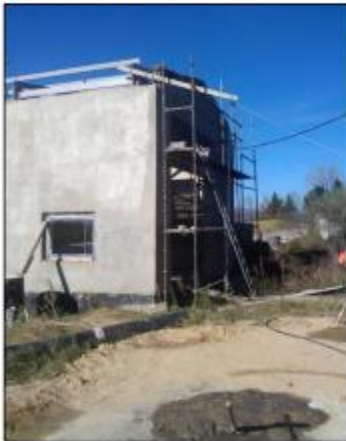
Photo of Mukhnari Reservoir

- All workers should be equipped with complete PPE
- Safety norms during works at the height should be respected (special equipment during high altitude works should be used)
- Ladder safety should be ensured

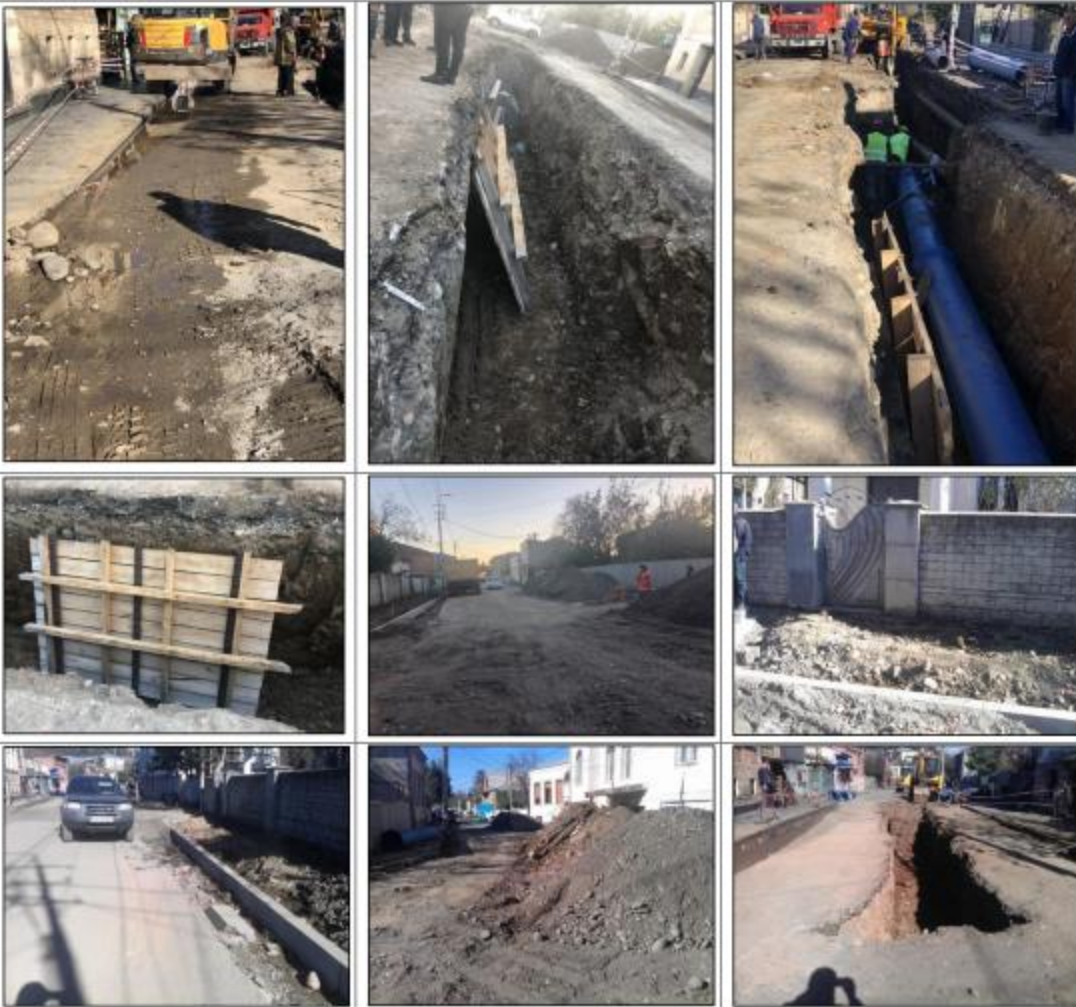
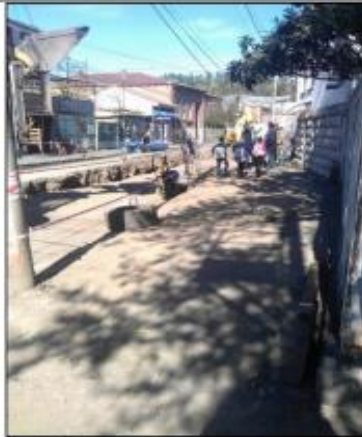
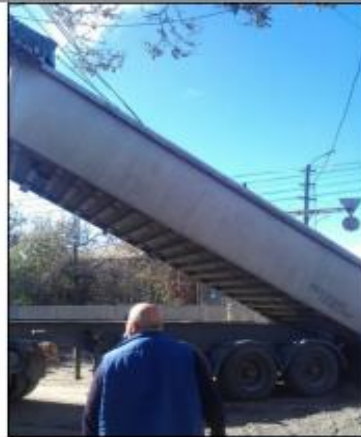
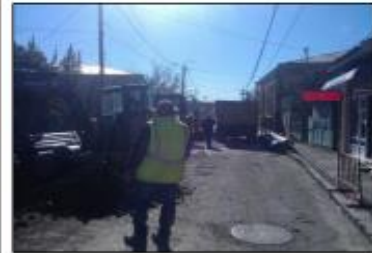
Photos of Network

- Construction activities information signs should be installed at each construction segment
- Safety signs/tapes and trench side barriers around of open trenches should be installed to avoid accident of population
- Walls of the deep trenches (>1.5m) should be strengthened by boards to avoid landfall of the soil and accidents
- During materials transportation tarpaulins cover should be used every time
- Sidewalks should be cleaned from the surplus waste soil and construction materials
- Surplus waste soil should be removed and disposed in a proper place
- Dust prevention activities should be carried out
- During construction works careful operation is needed with high voltage cables to avoid its break and damage of personnel
- Construction materials should be brought when needed to avoid its long time disposal in the streets and disturbance of residents and businesses

- Nearby area of residential houses (entrance) should be cleaned from the construction materials/surplus waste soil
- Regulation of transport/pedestrian movement should be provided. Permanent dedicated personnel should be on site to regulate population movement nearby to construction site
- Workers always should use complete PPE
- Refilling/compaction and reinstatement process should bring site at the same or better condition as it was before construction

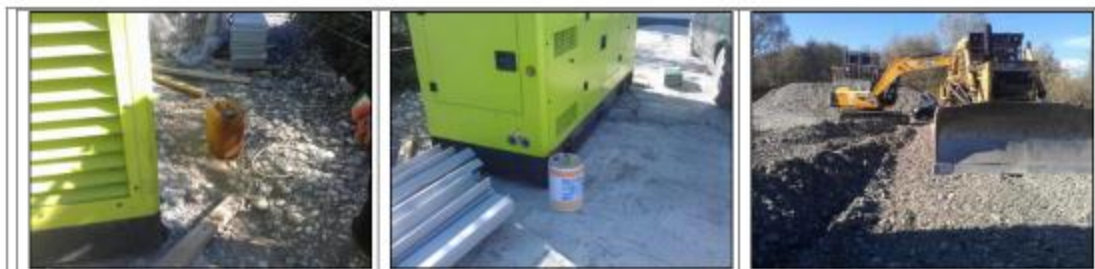
Photos of Rioni river crossing

- High visible safety signs/tapes should be installed around excavation/construction works area
- Trees nearby construction activities zone should be protect to avoid their damage
- Containers with fuel/lubricant should be managed properly (stored at the proper organized place with concrete floor and roofing) to avoid leakage and ground/water contamination
- Equipment used (power generator) should be in good condition (no leakage) to avoid leakage and ground/water contamination. Urgent mitigation should take place and contaminate ground removed/treated
- Workers always should use complete PPE
- Construction area should be arranged properly and cleaned regularly

All these conditions have to be remedied within three days (by the 12 November 2018) by the prime Contractor (SMK).

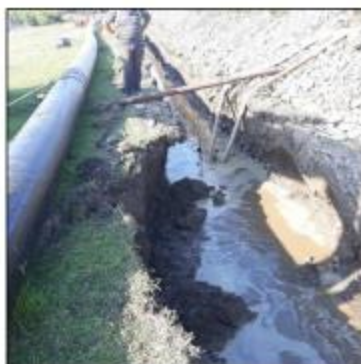
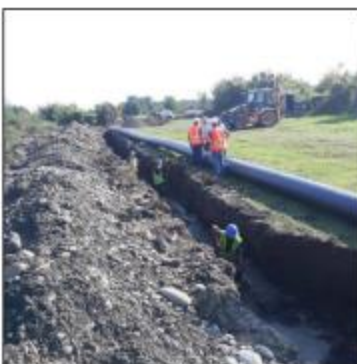
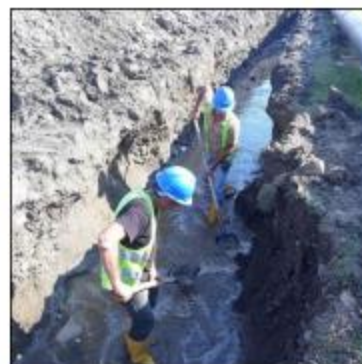
Photos of Abasha Network

- Trees of nearby construction zone should be protected to avoid its damage
- Refilling/compaction and reinstatement process should bring site at the same or better condition as it was before construction

All these conditions have to be remedied within five days (by the 25 August 2018) by the prime Contractor (As Inshaan-N).		
Date of site visits: 15.08.2018		
Irakli Legashvili EPTISA - Environment

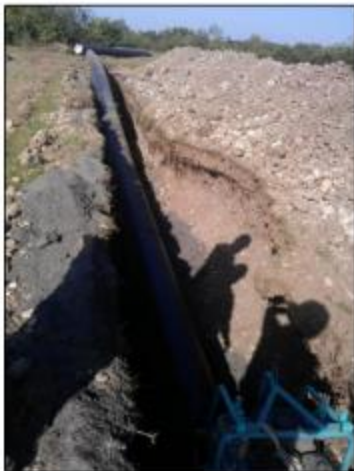
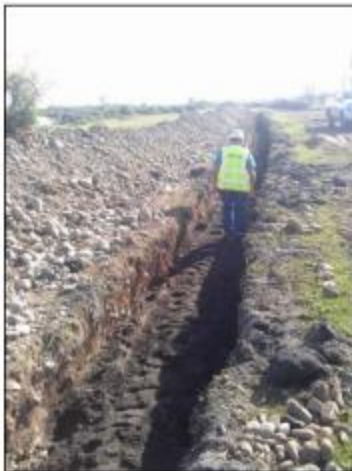
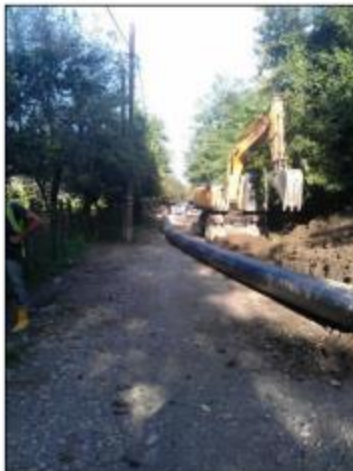
Photos of Abasha Network

Project: USIIP	Non-compliance Notice ABASHA	
Contract No: ABA-01		
Contractor: As Inshaan-N		
Reference: ABASHA – Network		
This notice is to advise you, the prime Contractor, on the referenced Contract, of the following notice on environmental measures to be implemented urgently .		
NON-COMPLIANCE IN ABASHA		
NETWORK		
<ul style="list-style-type: none">- Safety signs/tapes around of all open trenches should be installed (at the non-operational segments)- Surplus/accumulated soil for backfilling purposes should be managed/stored properly- Top soil should be removed and stored at the proper place before excavation works start and marked properly- Trees of nearby construction zone should be protected to avoid its damage- Waste should be placed only at the proper container and discharged timely- Construction activities information signs should be installed at each construction segment- Trench side barriers around of deep open trenches should be installed to avoid accident of population- Walls of the deep trenches (>1.5m) should be strengthened by boards to avoid landfall of the soil and accidents (workers damage)- Workers always should use complete PPE- Refilling/compaction and reinstatement process should bring site at the same or better condition as it was before construction

All these conditions have to be remedied within five days (by the 27 September 2018) by the prime Contractor (As Inshaan-N).		
Date of site visits: 05.09-06.09.2018		
Irakli Legashvili EPTISA - Environment

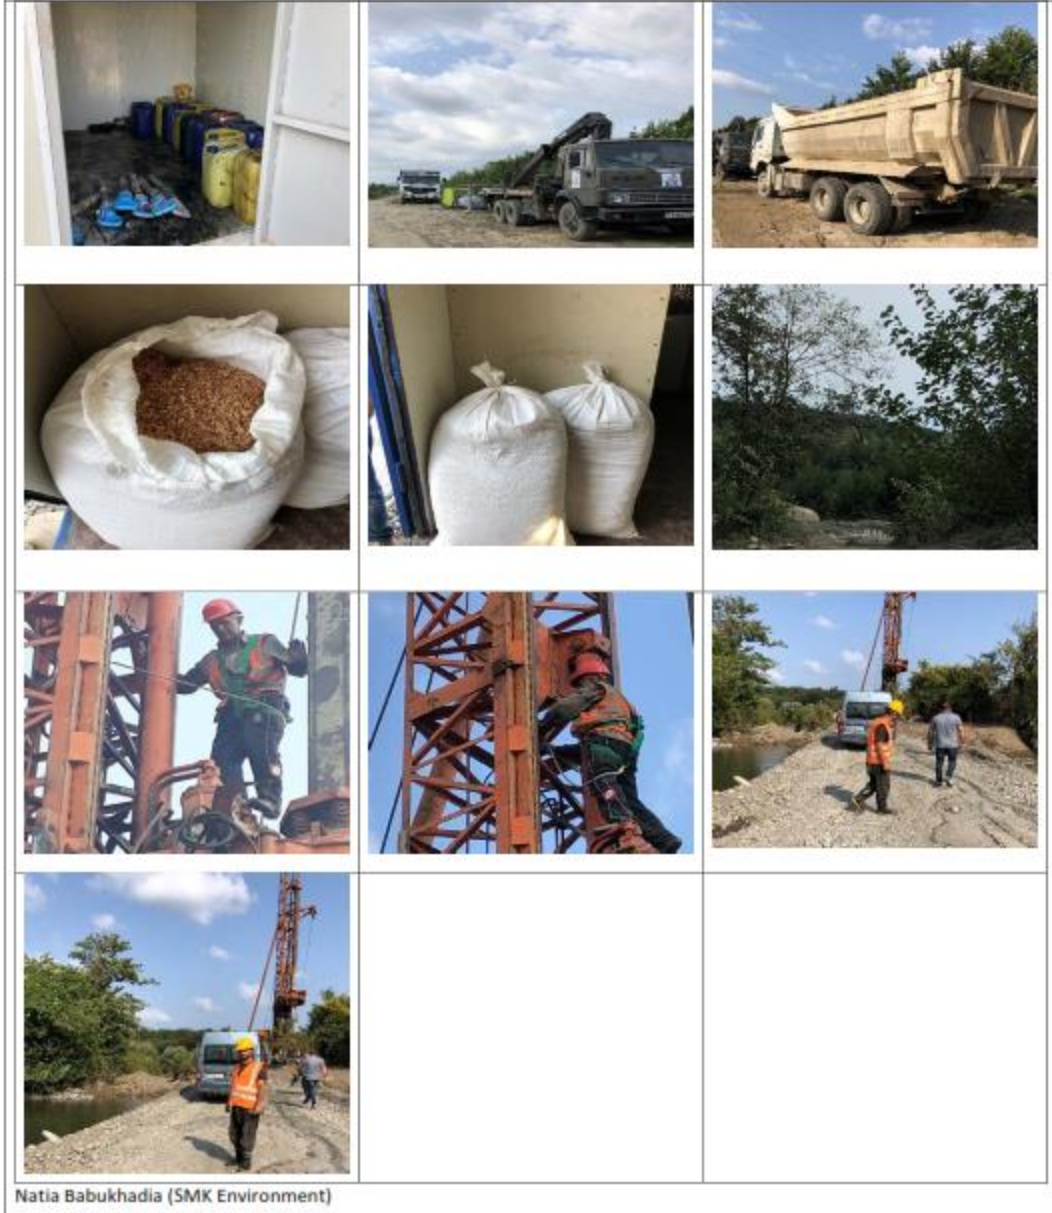
Photos of Rioni river crossing

- All workers are equipped with PPE

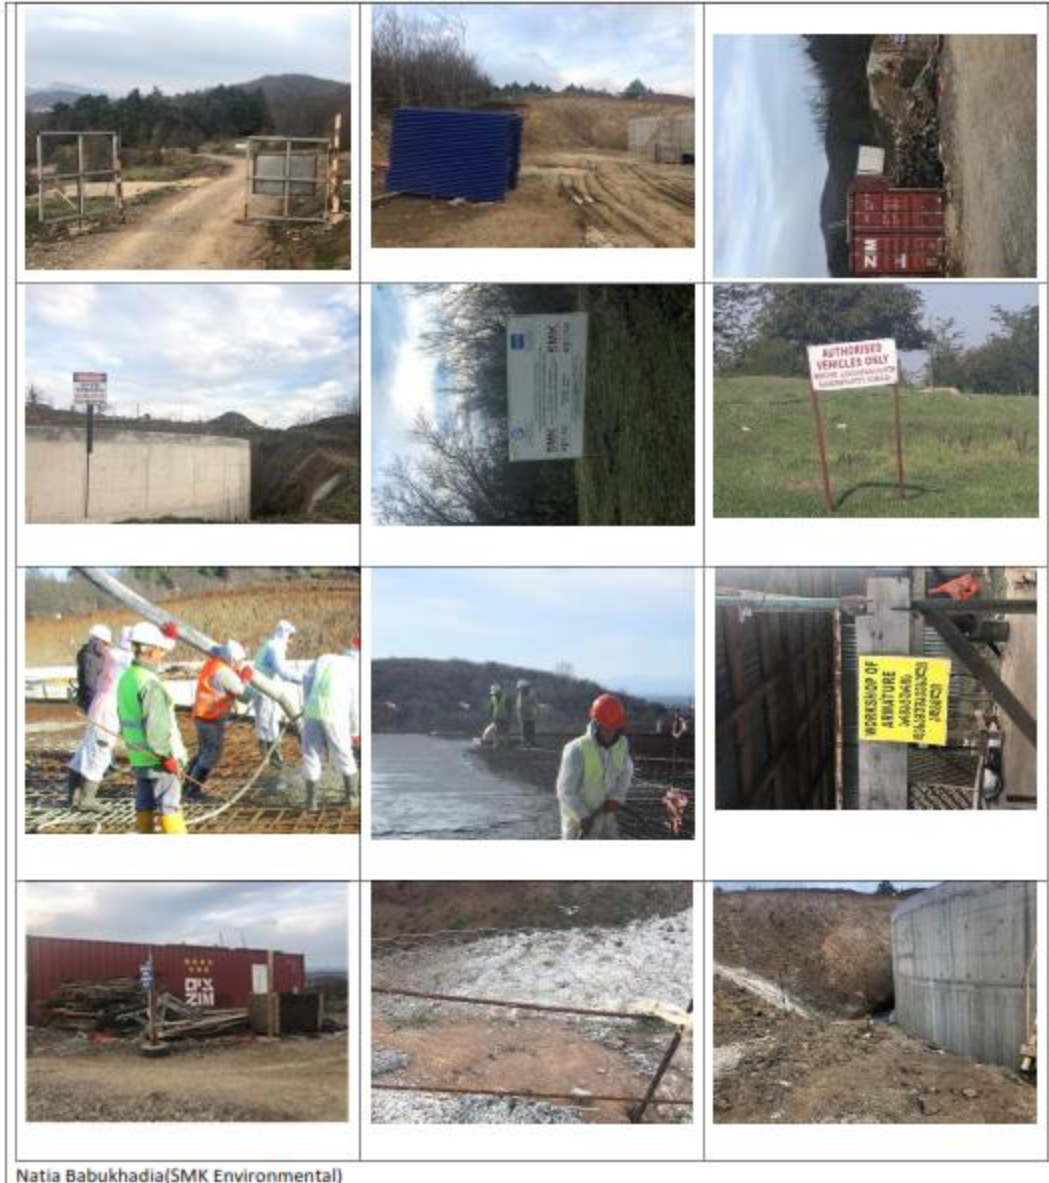
Project Name: <i>Construction of Water Supply in Kutaisi</i>	Corrective Action Plan
Project No: <i>P 43405-ICB-KUT-01</i>	
Project Location: <i>Kutaisi</i>	
Site: <i>Godogani reservoir</i>	
Location: <i>Kutaisi</i>	
Consultant: <i>EPTİSA</i>	
Issue: <i>Health, Safety and Environmental Issues</i>	
Date of Site visit: <i>06/12/2018</i>	Notification Date: <i>18.12.2018</i>
<p><u>Corrective Action Plan</u></p> <p>Godogani</p> <p>SMK has already taken action to correct the subject items</p> <ul style="list-style-type: none"> - SMK took action and proper site gate is arranged. - SMK took action and construction waste is removed from construction and disposed properly. - Construction territory is lighted adequately. - High visible safety signs/tapes and trench side around of deep open excavation is installed from all sides to avoid accidents. - Proper warning and information signs are installed at the entrance and perimeter of the site. - SMK took action and special equipment is used during working at height. - The ladder safety is insured. - Adequate works are completed and cable removed. - SMK took action and proper fencing around concrete washing pit with relevant information/warning sign is installed. - Site engineer Mr. David fulfils duty of safety officer. - Proper fuel/Oil spill response items(sand,sawdust,special containers)are available at site. - Containers with fuel/lubricant is managed properly. - SMK took action and all construction materials are properly segregated and stored adequately. - Waste is collected regularly at the site and placed only at the proper waste container. - Parking area is arranged with relevant sign and transport is parked only at the parking area. - All workrs are equipped with PPE - Site is cleaned regularly. <p>Photos of Godogani Reservoir</p>
